**Site/Project Location:** DAPL Connector Pipeline Project

**Date of Inspection:** 9 March 2017

**ND PSC Case No. PU-16-614**  
**Epping Transmission Company, LLC**

**DAPL Connector Pipeline Project**

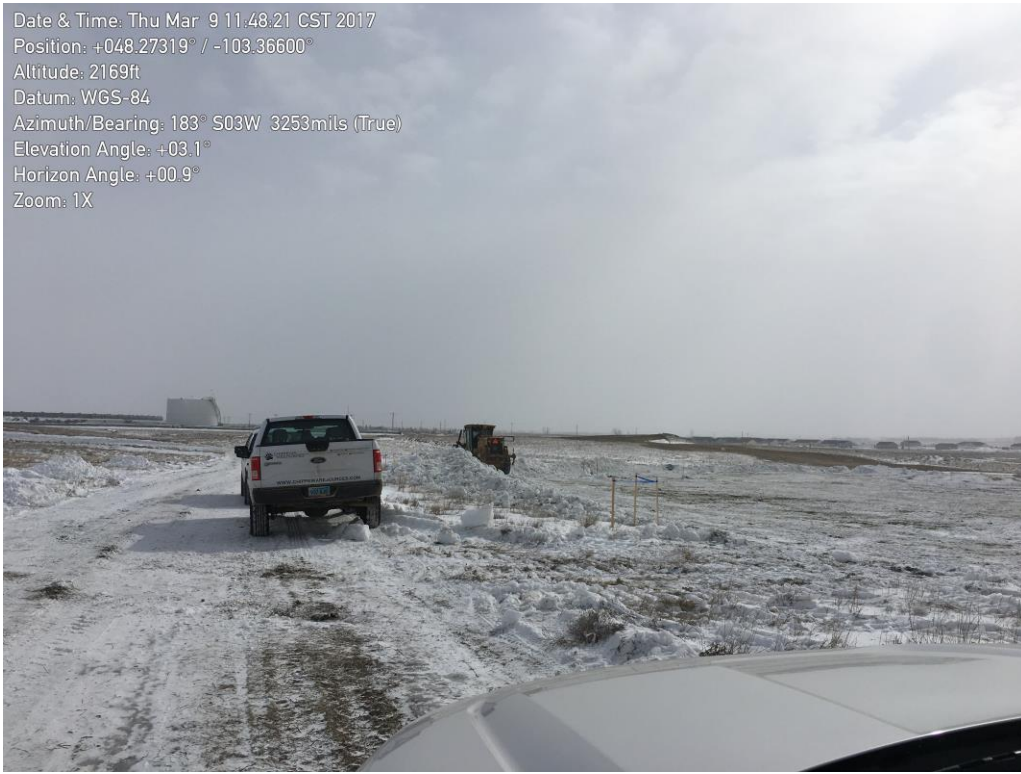
The right-of-way (ROW) was first cleared of snow and pushed aside. Landowner permission granted them to store the snow off the ROW. Graders began ripping the topsoil due to the ground being frozen. The topsoil was stacked on the west side of the ROW and will be used as construction berms. Material and equipment staging was located in the Epping Pumping Station.

**Report Photo #1 "Snow Removal"**

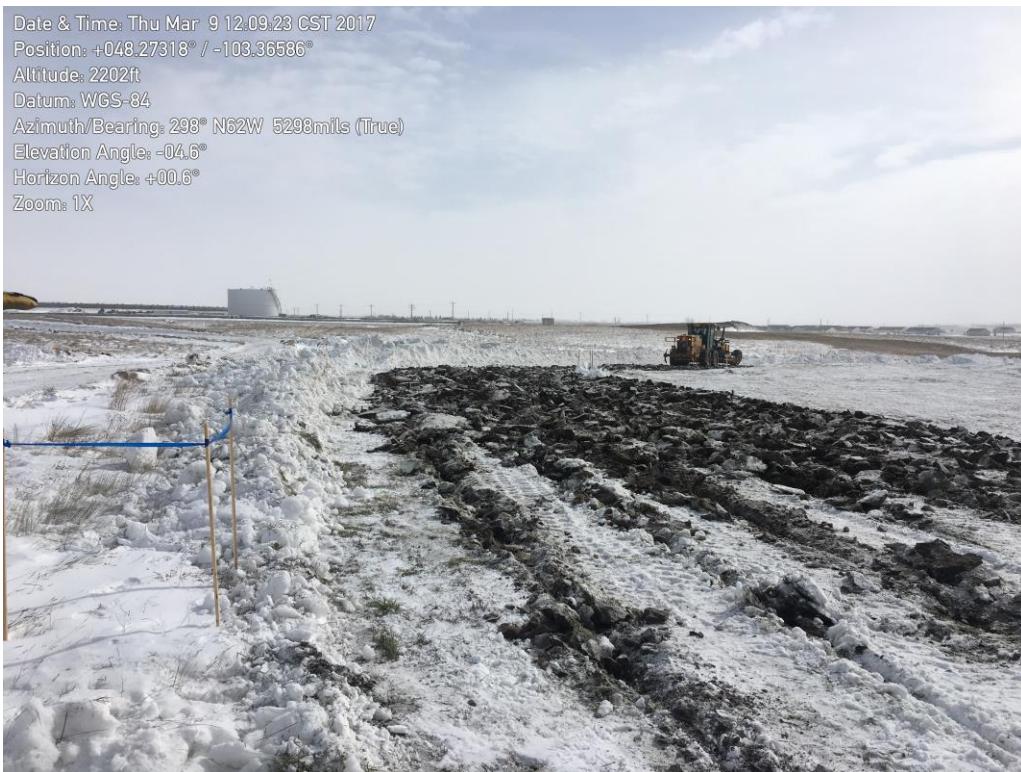
**Report Photo #2 "Grader Ripping Frozen Topsoil"**

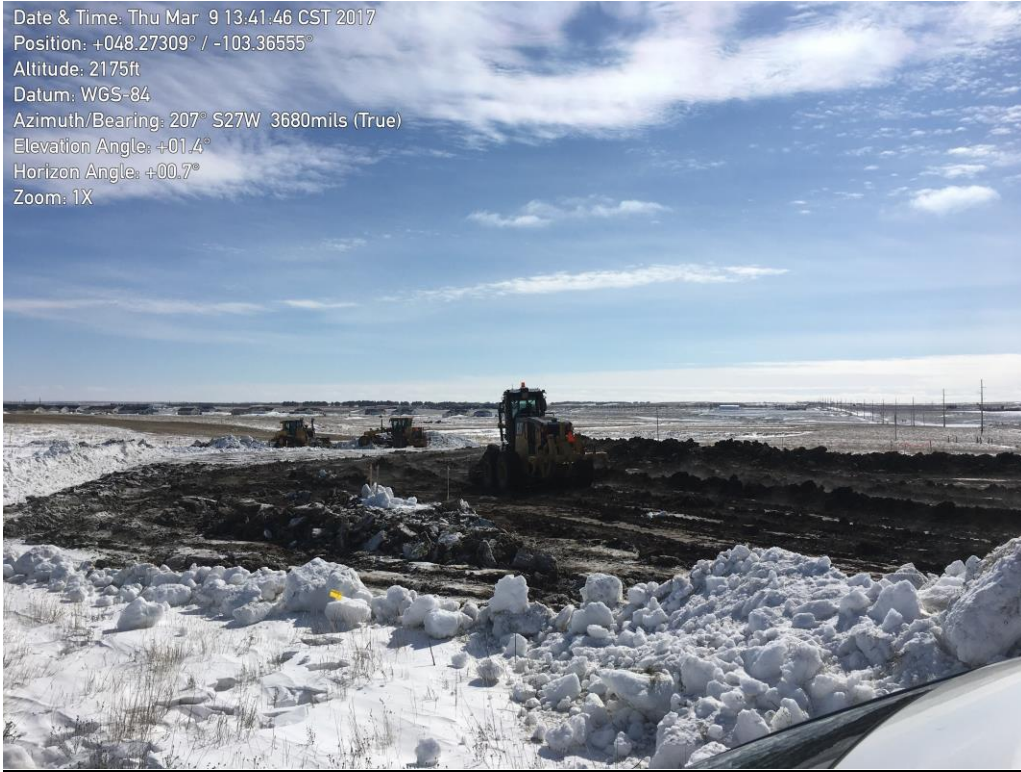
Topsoil removal began on the west side of the Epping Pumping Station. Topsoil was removed to a depth of approximately 12 inches. Stormwater management practices have not been implemented although threat from precipitation runoff or snowmelt to construction area is minimal during winter season. Erosion control devices to be installed throughout the stages of construction.

**Report Photo #3 "Initial Topsoil Removal"**
