Site/Project Location: DAPL Connector Pipeline Project

Date of Inspection: 30 March 2017

ND PSC Case No. PU-16-614
Epping Transmission Company, LLC

DAPL Connector Pipeline Project

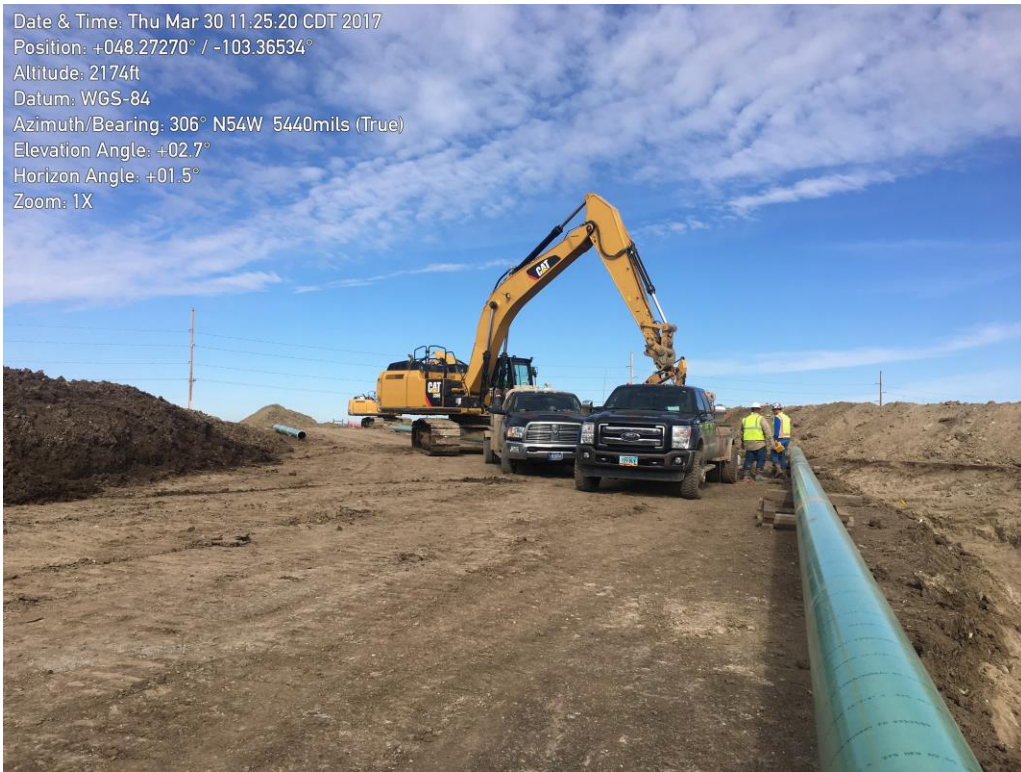
Topsoil and subsoil segregation was still ongoing during the phases of construction. Subsoil was being placed on the opposite side of the ROW away from the topsoil piles. Stormwater management practices were being implemented upon site visit.

Report Photo #1 "Topsoil & Subsoil Segregation"

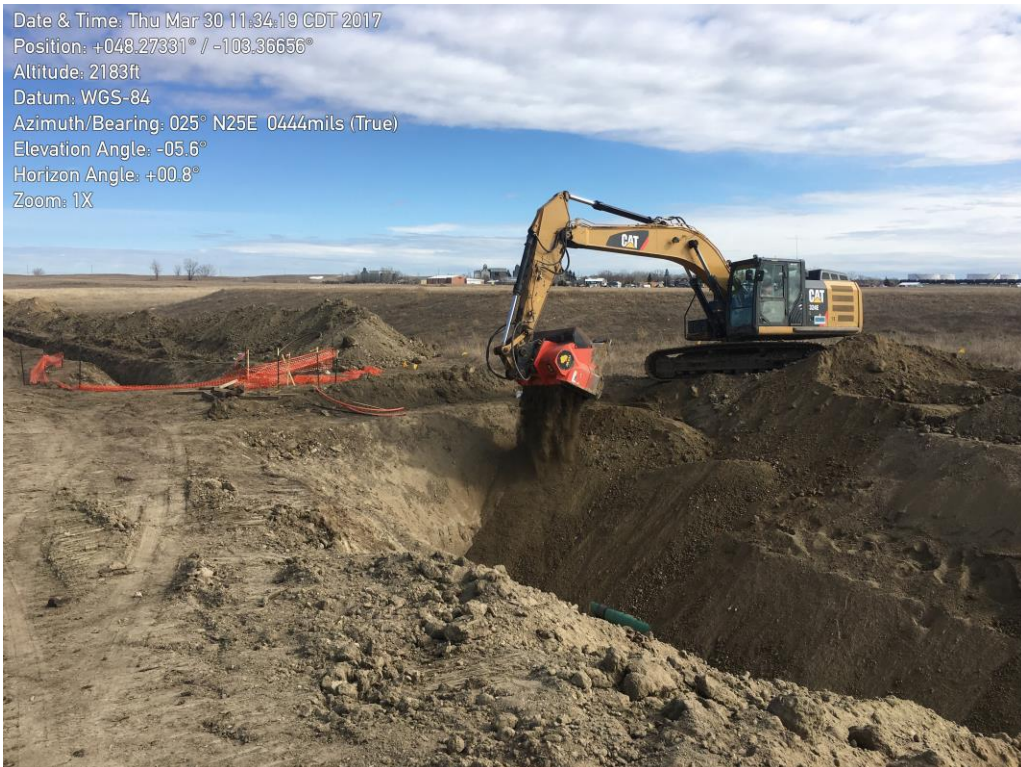
Report Photo #2 "Backfilling Trench"

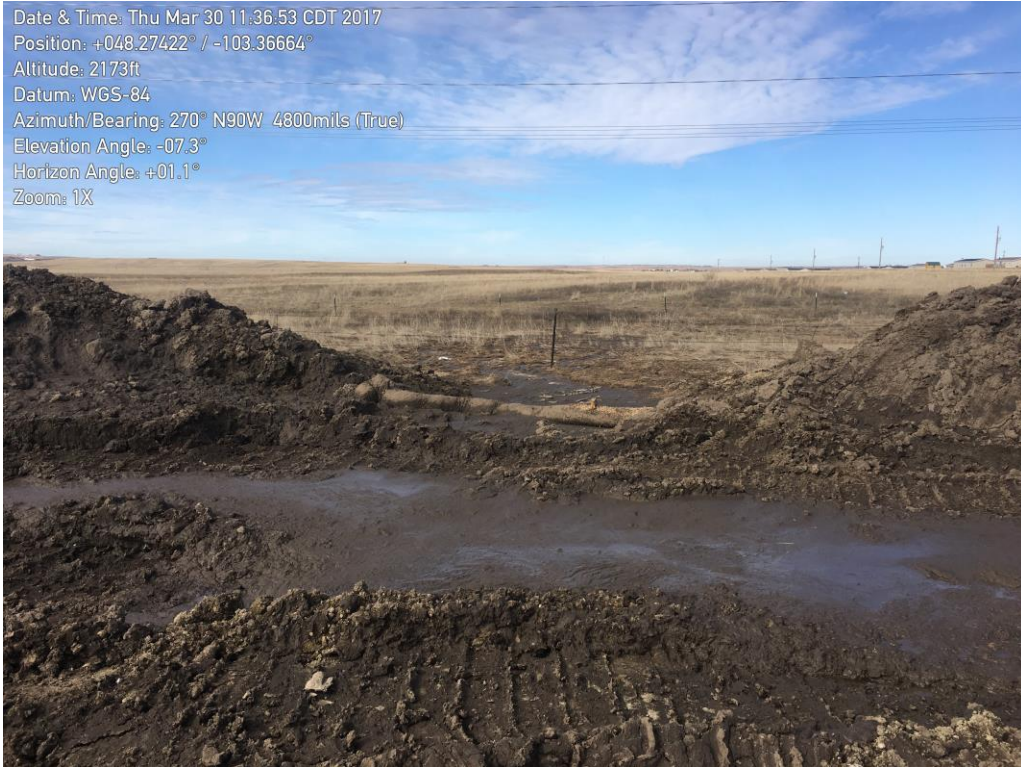
Sediment runoff was observed in a few areas along the ROW. The erosion control devices located at these areas need to be replaced. Near one of the bore pits, a small section of the subsoil pile was out of the ROW. Onsite personnel confirmed this section was to be backfilled today.

Report Photo #3 "Sediment Runoff (ROW extends to fence line)"

Upon visit, Keitu inspector noticed a few areas of concern regarding sediment runoff. Keitu met with 3rd party coordinator and explained these issues. The onsite environmental inspector confirmed the issues would be corrected.

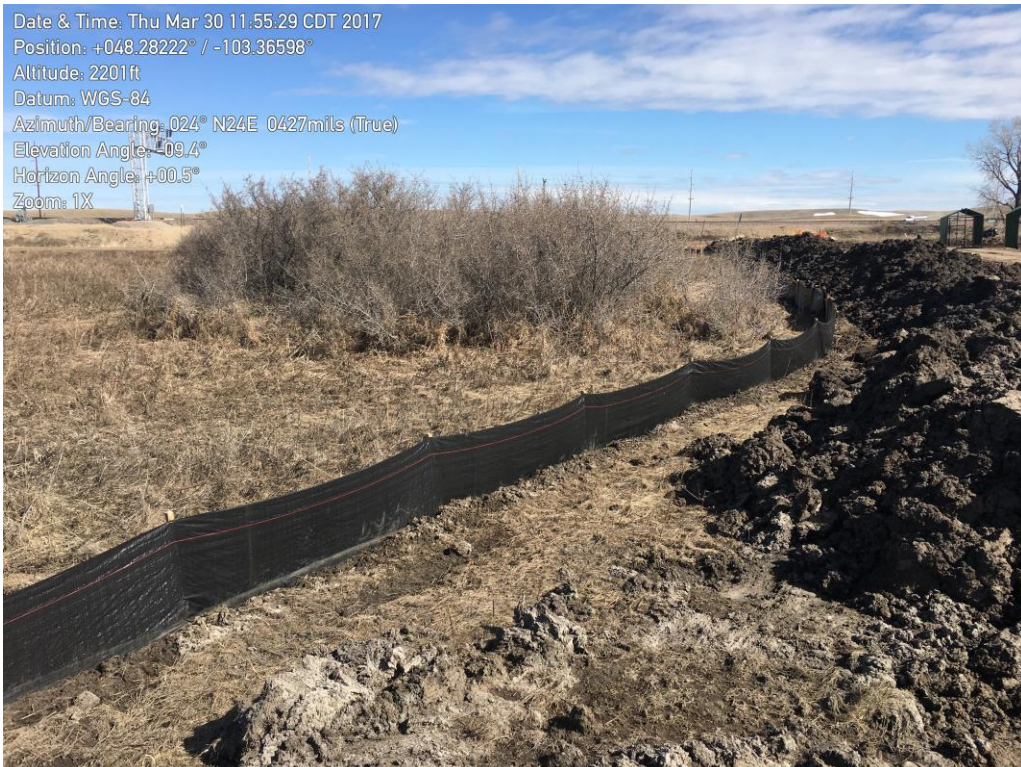
Open trench areas observed and measured were at specific depth or deeper. All waterbodies noted were not disturbed upon the site visit. Silt fence was properly installed to protect from sediment runoff. Some sections of the silt fence need to be stapled.

Report Photo #4 "Silt Fence Protecting Wetland"

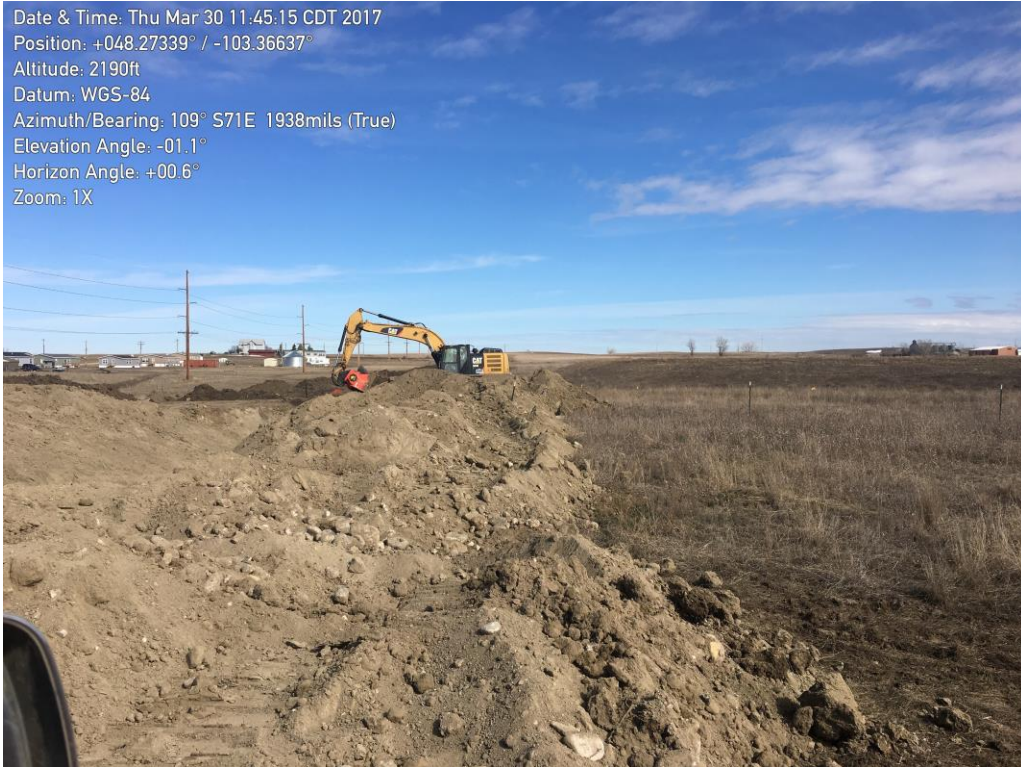
Report Photo #5 "Subsoil Pile Outside of ROW"

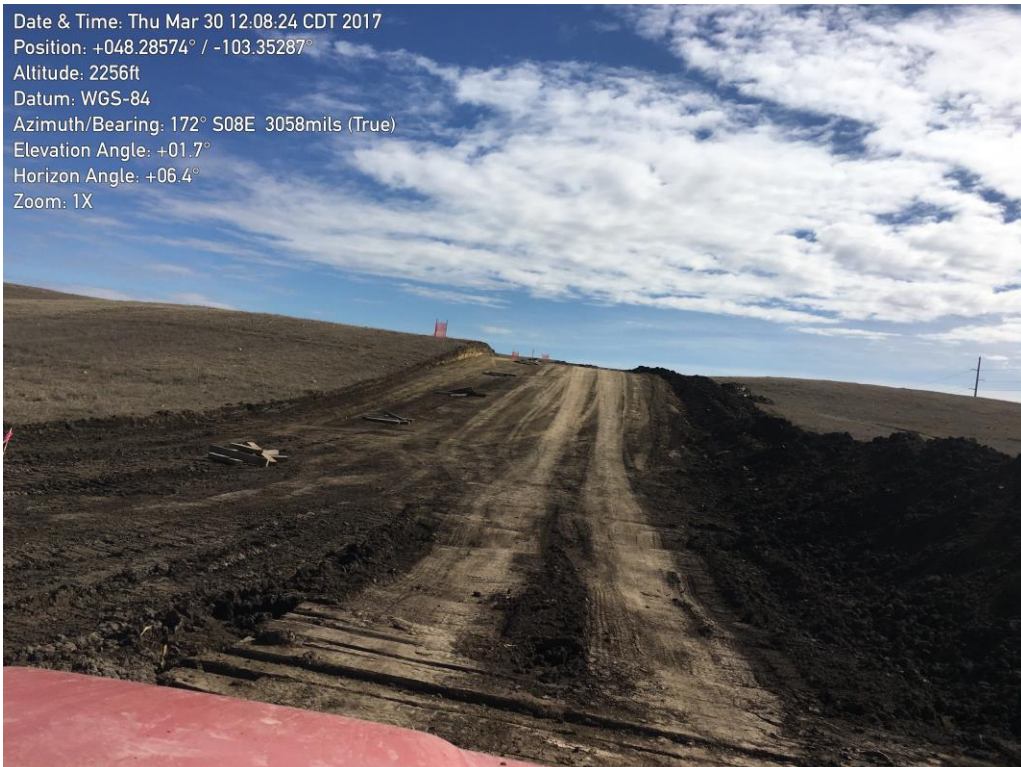
Report Photo #6 "Stripped Topsoil"
