**Revegetation Inspection Report - Epping Transmission Company
Williams County, ND
ND PSC Case No. PU-16-614**

Reclamation and Revegetation Inspection Report

12.75-Inch Crude Oil Pipeline – Williams County
Epping Transmission Company, LLC

ND PSC Case No. PU-16-614

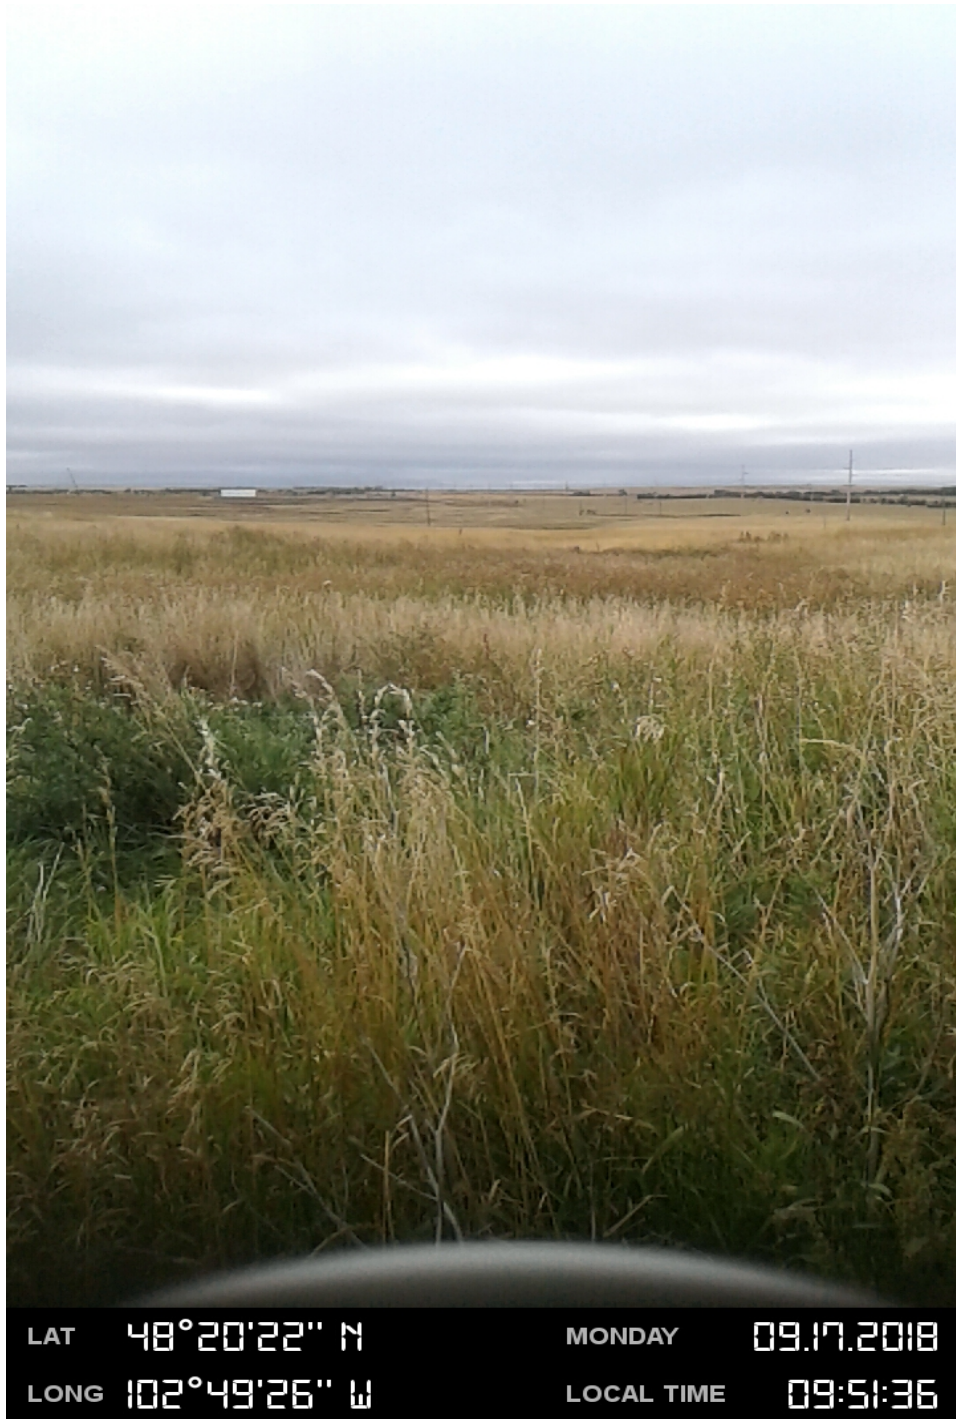
Report Photo #1: Overview of pipeline scar from North to South.

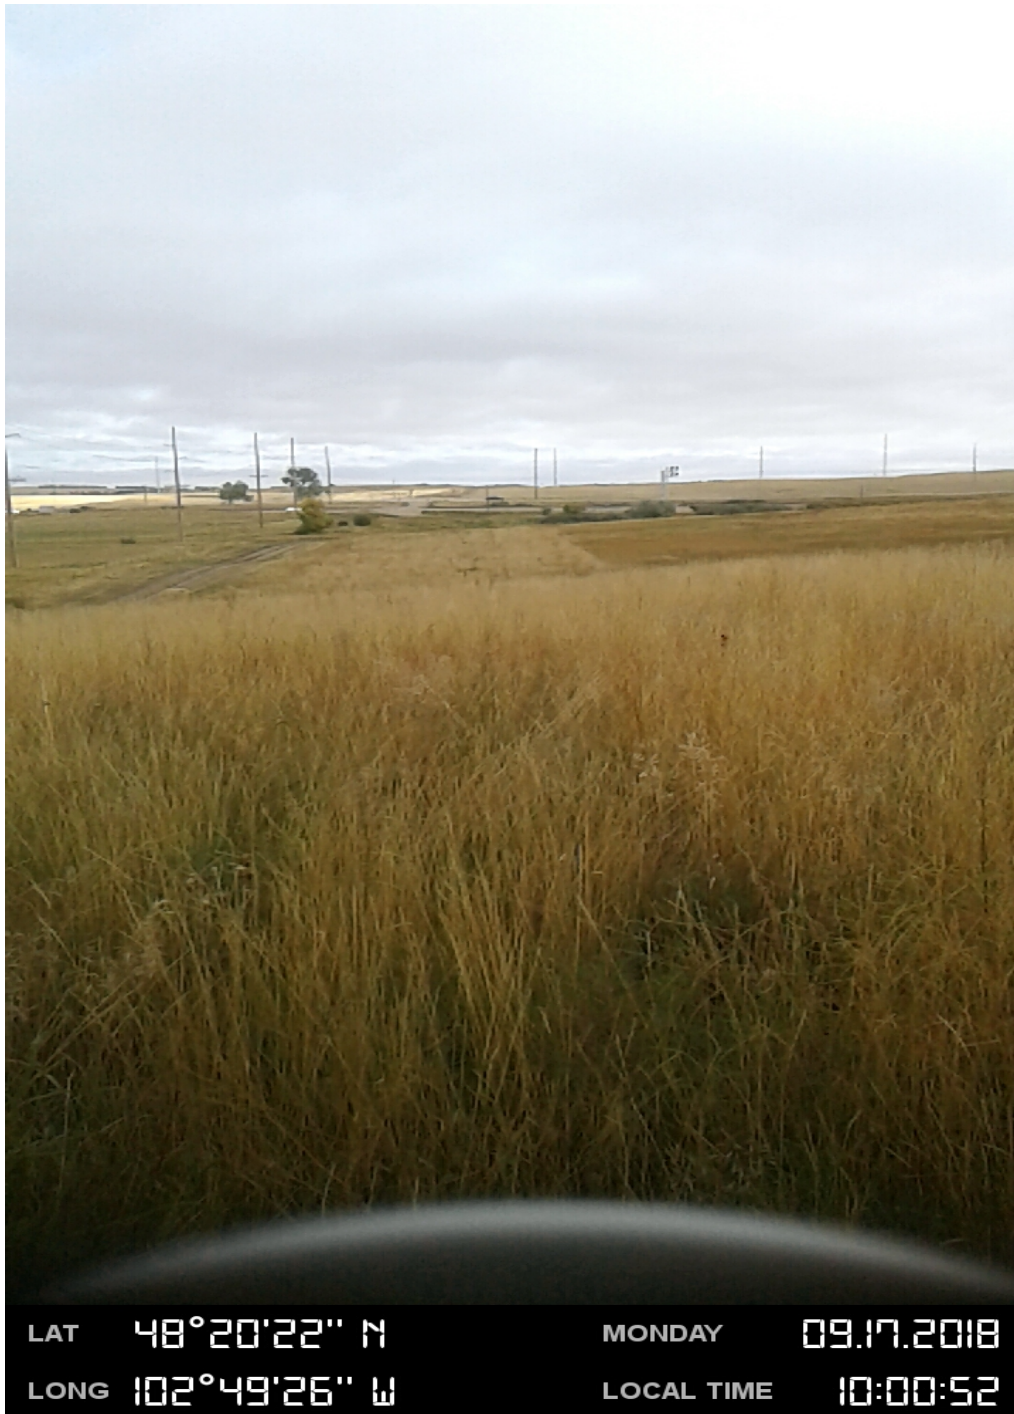
Report Photo #2: Overview of pipeline scar from South to North.

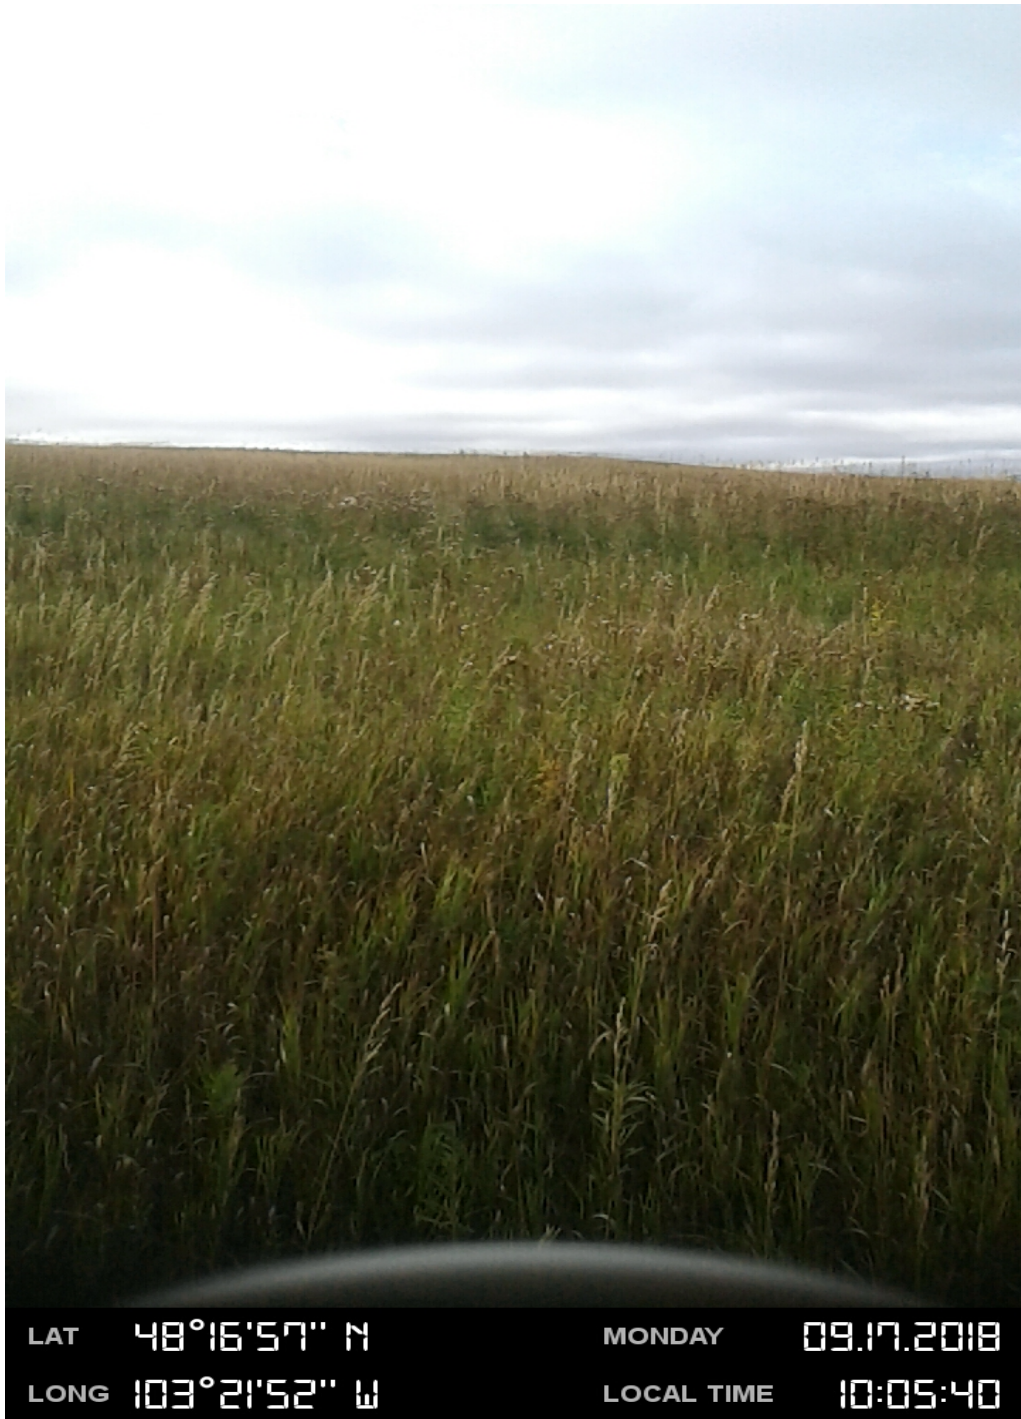
Report Photo #3: Overview of pipeline scar from North to South.

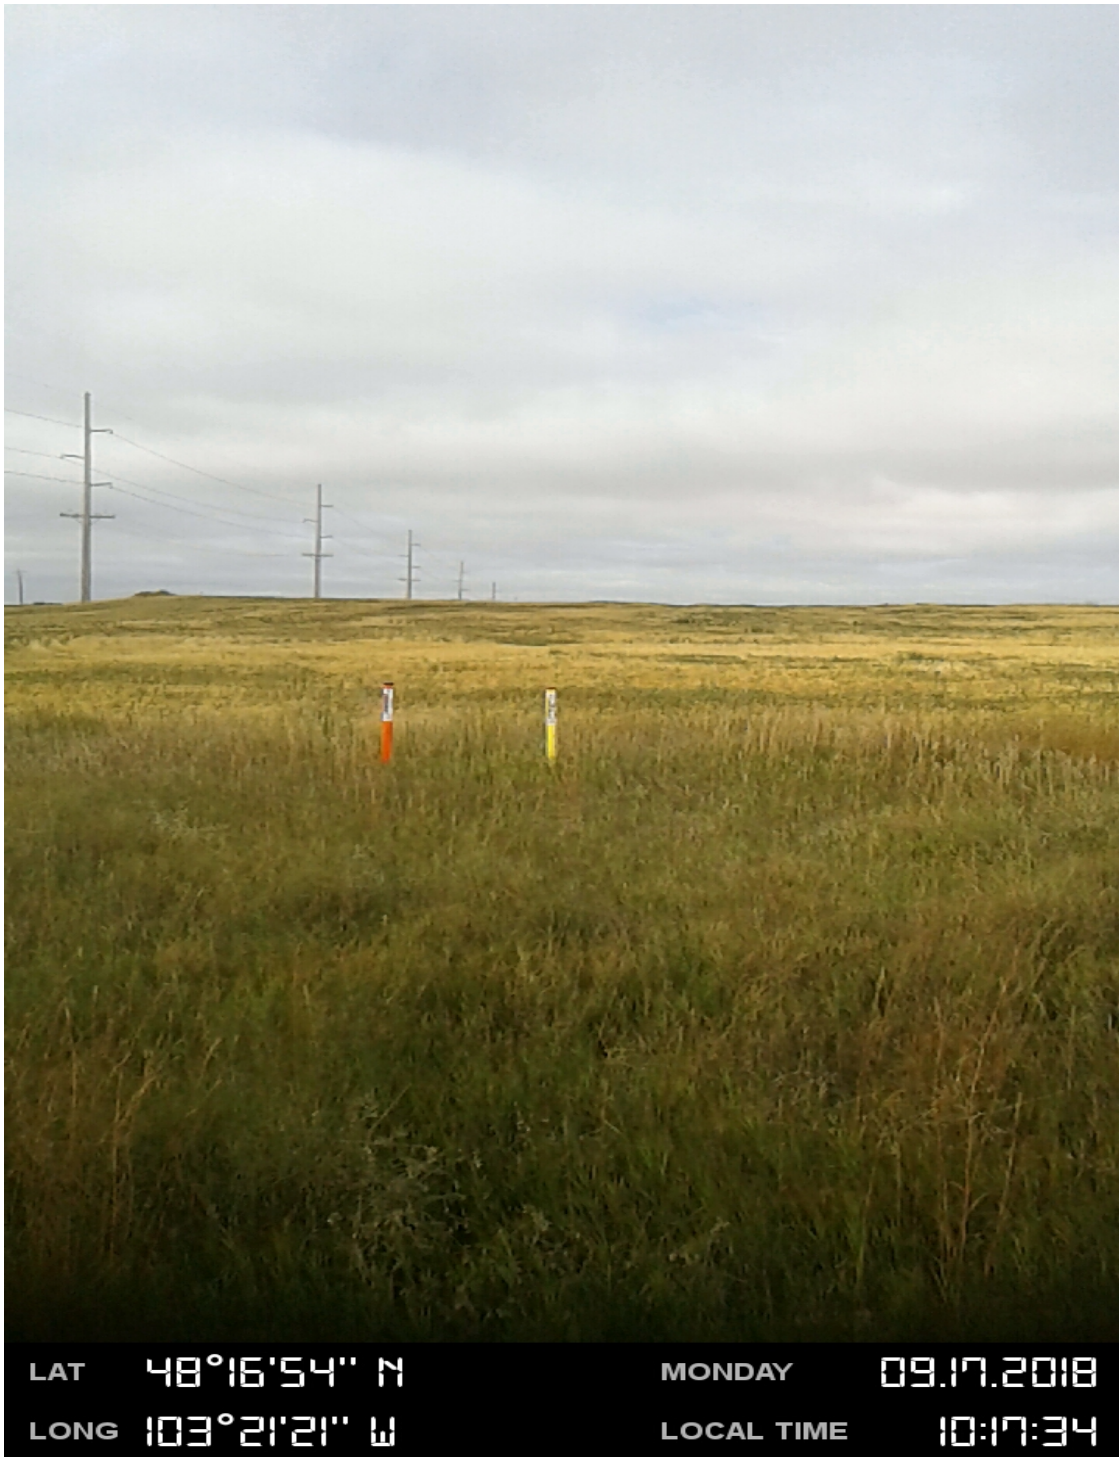
Report Photo #4: Overview of pipeline scar from East to West.
