INSPECTION REPORT

DATE OF INSPECTION: November 8, 2016

PERMITTEE - MINE: Coteau Properties Company - Freedom Mine

PERMIT INSPECTED: NACT-9101

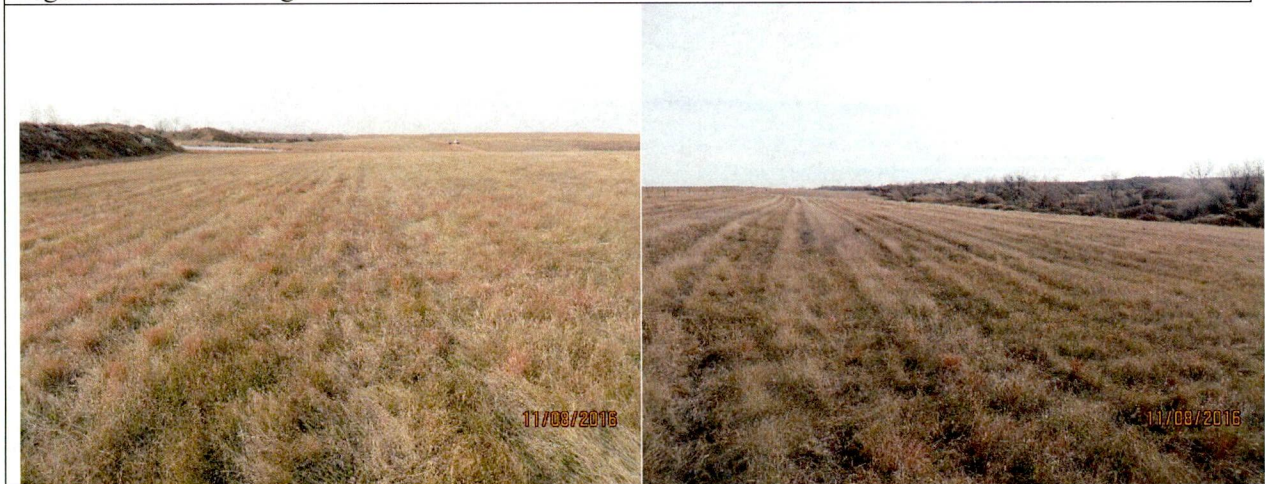
Figure 1: Reclaimed grassland

The reclaimed grassland on this tract consists of areas of re-disturbed orphan spoil where no soil was available for salvage and areas where topsoil and subsoil was salvaged and respread. Although no SPGM was available for salvage on the re-disturbed orphan spoil areas, the reclaimed orphan spoil area was respread with 8 inches of subsoil and 4 inches of topsoil and planted to a diverse mixture consisting of 17 species of native and introduced grasses and forbs. The reclaimed native grassland was seeded to the Coteau's native grassland seed mix that consist of 7 native grass species. These lands were reclaimed and seeded in 2007, 2008, 2009 and a small area was seeded 2013. The seeded species and other invasive species have established very well on this reclaimed grassland and these species are providing excellent ground cover through the entire area. It was very difficult to determine the boundary between reclaimed native grassland and the reclaimed orphan spoil due to the uniformity of vegetative stand. This reclaimed native grassland was hayed later in the growing season which made determining species composition more difficult and perhaps made the grassland tracts appear more similar than it actually is. In any event, this reclaimed grassland is well established with little bluestem, Kentucky bluegrass, smooth brome grass, switchgrass, western and intermediate wheatgrass, hard fescue, sweet clover, black medic and sideoats grama. The established vegetation is providing excellent protection from erosion. The majority of this tract drains to the 3 sediment ponds that have been converted to wetlands, although it appeared that a small portion of the tract may drain into a pond within the orphan spoil. The images in Figure 1 below show the reclaimed grassland.

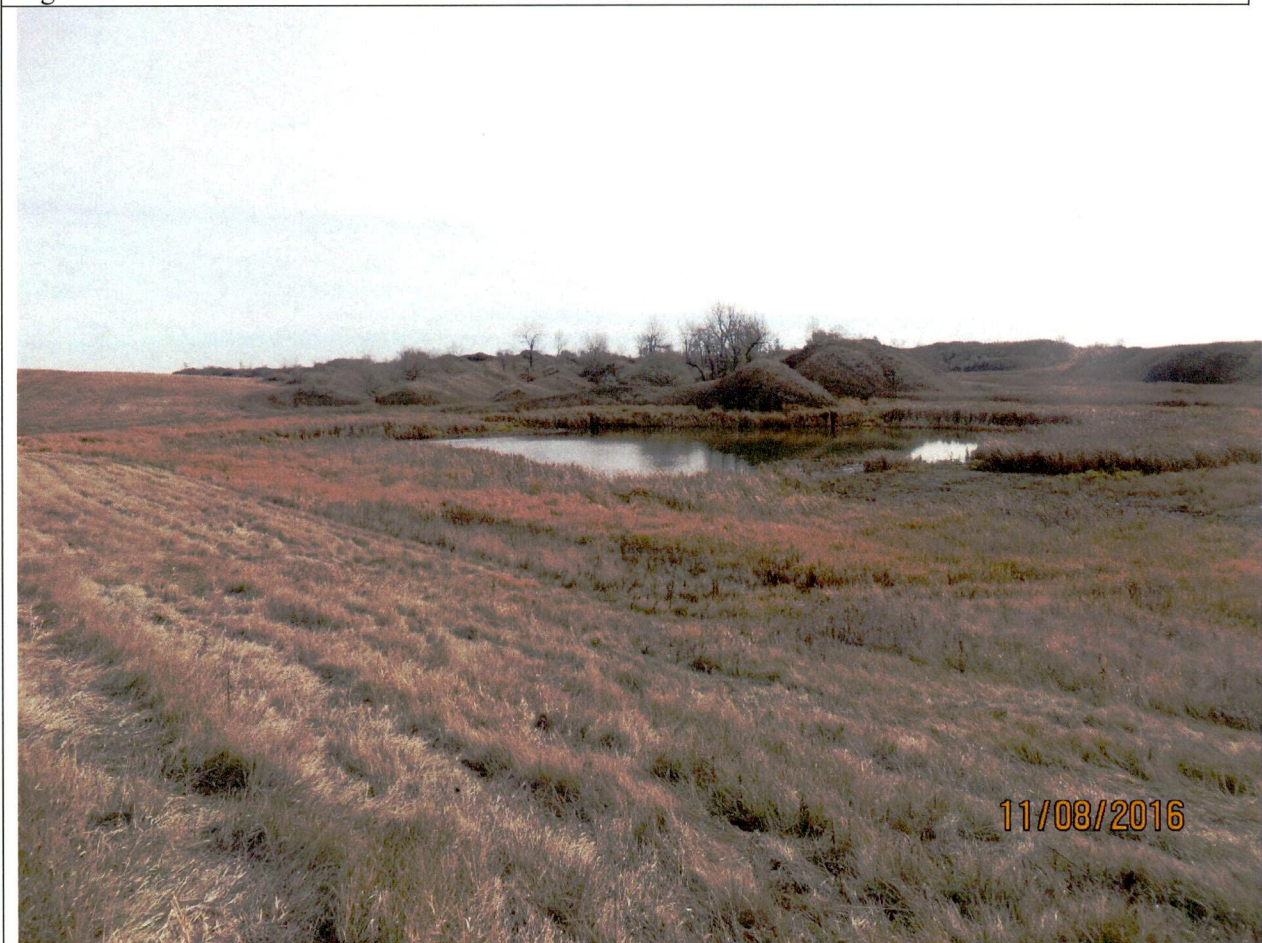
Figure 2: CW-D17-04

CW-D17-04 was holding water several feet below spill elevation and most of the pool area of the wetland was supporting wetland vegetation. However, there was a small open water zone in this wetland which indicates that it has been functioning as a semi-permanent wetland during these recent years of higher than normal precipitation. The open water zone is surrounded by cattails, and bulrush to a lesser extent. Reed canarygrass was quite prevalent around this wet-meadow vegetation zone. Switchgrass, Canada thistle, and Kentucky bluegrass were observed in the low prairie zone. The emergency spillway was supporting a heavy stand of reed canarygrass and it did not appear that water had flowed through this spillway recently. The embankment to this wetland is well vegetated and no erosion was noted in this area. The riser to this wetland is capped with a trash rack and a gate valve was noted on the embankment that would allow one to regulate the water level of the pond/wetland. Figure 2 shows this wetland.

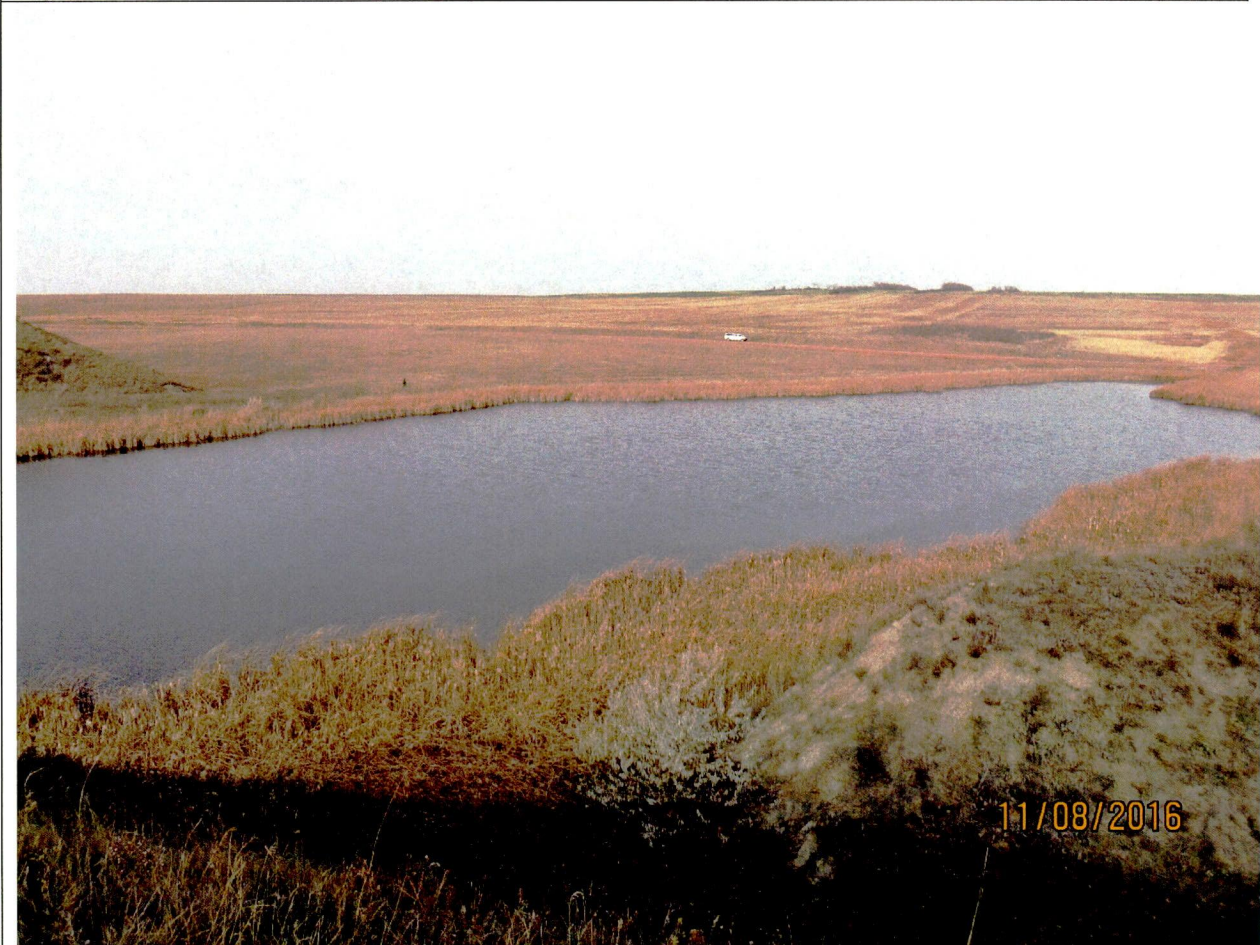
Figure 3: CW-D17-03

CW-D17-03 was holding water at spill elevation. A developed spring located about ½ mile north of this wetland apparently flows enough water to keep this wetland at spill elevation on a permanent basis. This spring flow is allowing this wetland to function as a permanent or semi-permanent wetland and the majority of the pool area of the pond is an open water zone. The open water zone is lined with cattails and bulrush, and phragmites to a lesser degree, along the shoreline and the upper reaches of the shoreline is supporting species such as reed canarygrass, Aster sp., Canada thistle, switchgrass, and other low prairie species. The spillway is also lined with cattails and concrete matting is in place at the end of the

spillway to keep erosion from occurring, although it appeared that water may be flowing under some of the matting. A picture of CW-D17-03 is shown in Figure 3.

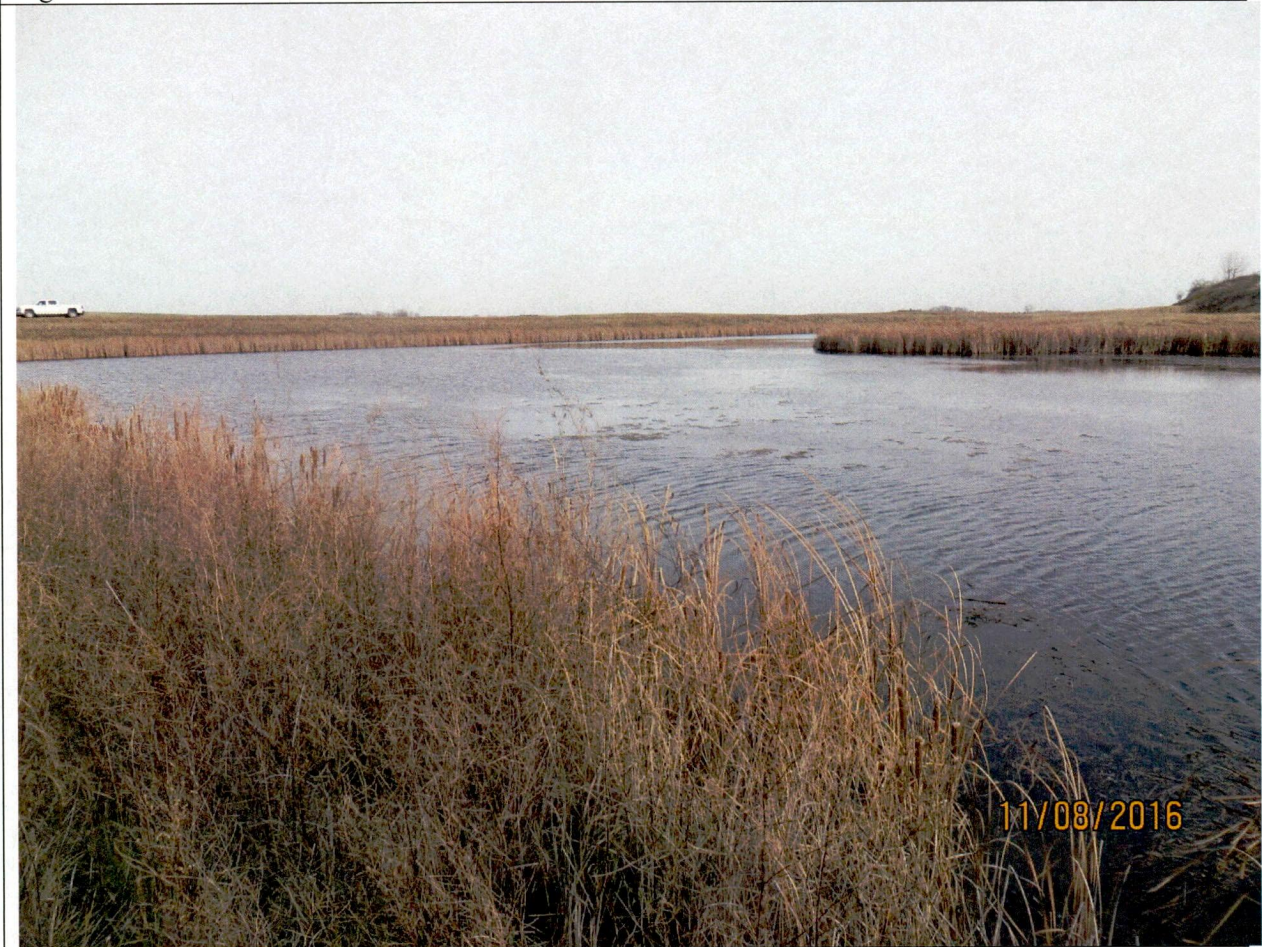
Figure 4: CW-D16-02

Wetland CW-D16-02 was designed as a semi-permanent wetland. This wetland is in the original drainage way of East Antelope Creek which has been diverted upstream into Harmony Lake. Water would flow through this wetland if the East Antelope Creek block/diversion was removed. This wetland was holding water several feet below spill elevation. The spillway is lined with cattails which is also the principal vegetation established around the large open water zone in this wetland. There was evidence of muskrat activity in this wetland and the wetland appears to be functioning as intended. CW-D16-02 is shown in Figure 4.

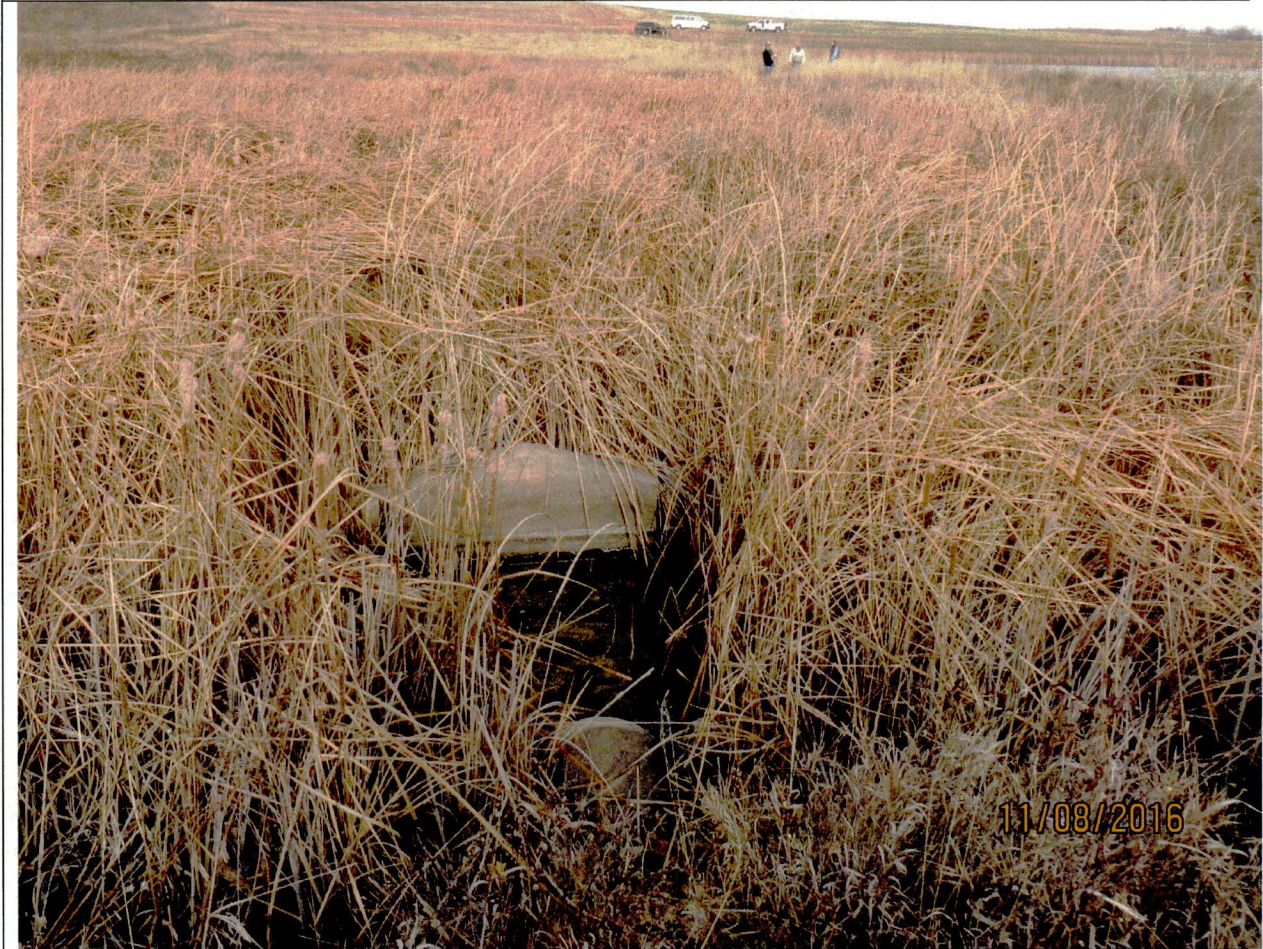
Figure 5: Harmony Lake principal outlet

The principal outlet of Harmony Lake is located immediately west of wetland CW-D16-02 adjacent to the original channel of East Antelope Creek. There is a concrete energy dissipater at this discharge point and the area adjacent to the outlet is heavily established with cattails (see figure 5). No water was discharging from Harmony Lake at the time of this inspection.

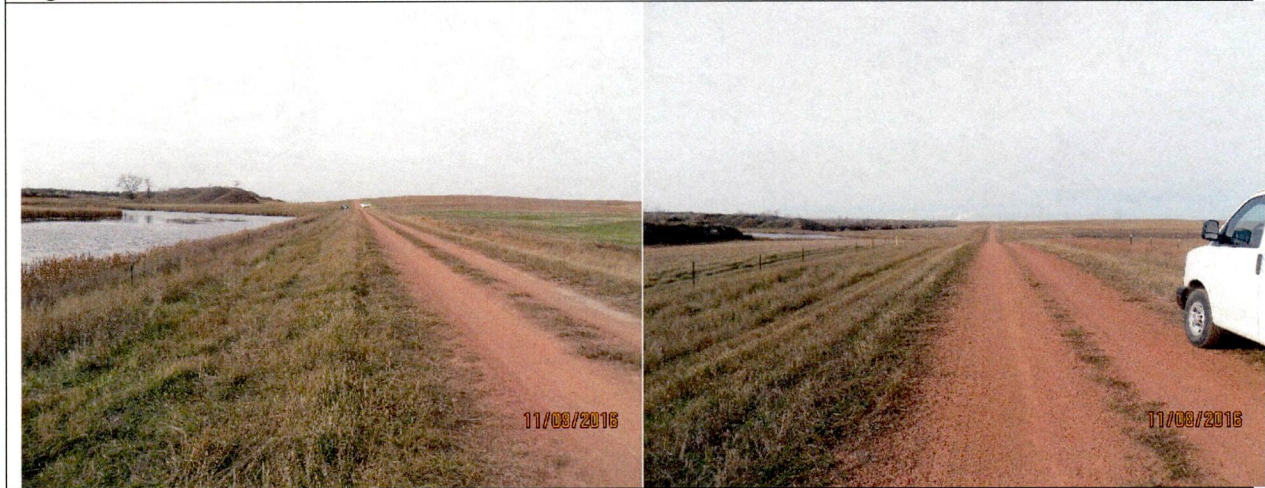
Figure 6: Section line trail on the north side of Sections 16 and 17.

The reclaimed section line trail located along the north side of Final Bond Release No. 6 has been constructed to serve as a very functional road compared to that which existed prior to mining. This road is built up similar to a county road. It has functional ditches and the affected portion has been surfaced with scoria. Mr. Leingang indicated that Coteau was in the process of having this road opened by the county to allow the public access to the north side of the Harmony Lake Recreation Area. The road ditch associated with this road is well vegetated. There are two culverts under this road immediately upstream from CW-D16-02. Rock is in place at the outlet ends of these culverts to keep erosion from occurring. Figure 6 shows the reconstructed section line trail.
