## JOHNSONS CORNER – ALEXANDER 8-INCH CRUDE OIL PIPELINE PROJECT (PU-16-695) Permit Compliance Inspection Report 2020

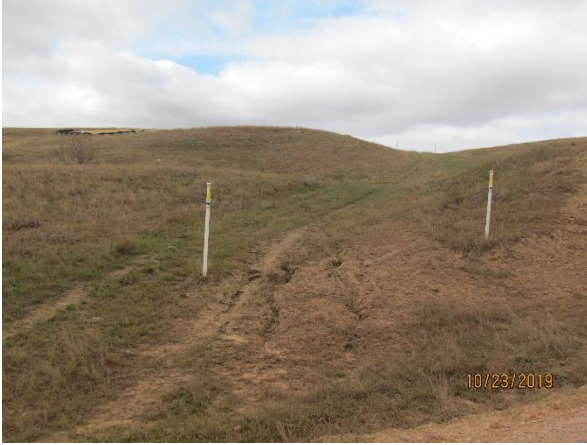
- sustainable vegetation establishment was observed throughout the pipeline corridor with one (1) minor erosion and sedimentation issue in Section 33, T150N, R97W (**Appendix B, Photo 1**).
- tree and shrub mitigation is in process and additional documentation and planting is required (refer to Docket 47 and 48)
- pipeline identification markers maintenance: leaning pipeline identification markers were observed (refer to representative site photography in **Appendix B**):

Photo 1: Bare earth and rill erosion  
(Section 33, T150N, R97W)

Overall, the Project appears to have been constructed and maintained as designed, with minimal impacts to the surrounding natural or human environment. The site compliance investigations observed the establishment of sustainable vegetation, with the exception of one (1) minor erosion and sedimentation issue (**Appendix B, photo 1**; Section 33, T150N, R97W). Also observed were leaning pipeline identification markers (signage) at Section 5, T150N, R99W (photo 2), Section 34, T150N, R96W (photo 4), and Section 34, T159N, R97W (photo 6). Please refer to **Appendix B** for photographs and **Exhibit A** for the photo location map. The correctable issues identified would be the maintenance of pipeline identification markers and confirm they are straight in their alignment with the pipeline and to regrade and restore vegetation in the area with bare earth and rill erosion observable

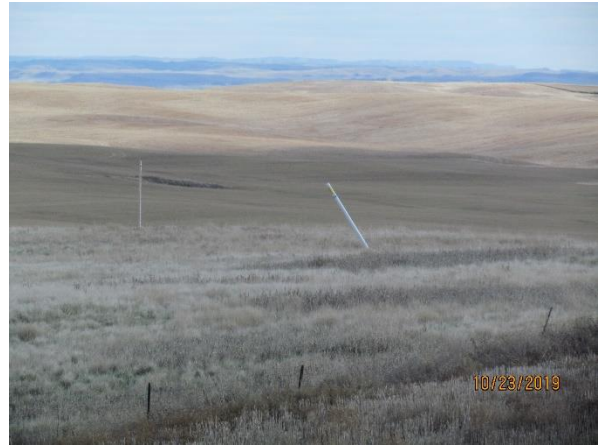
- Section 5, T150N, R99W (photo 2)
- Section 34, T150N, R96W (photo 4)
- Section 34, T159N, R97W (photo 6)

Photo 2: Leaning pipeline identification marker  
(Section 5, T150N, R99W)

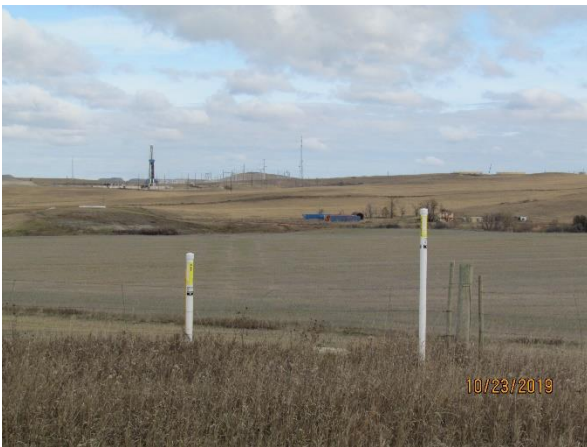
Photo 3: Pipeline corridor located south of Johnsons  
Corner facility; looking south. (Section 26, T150N, R96W)

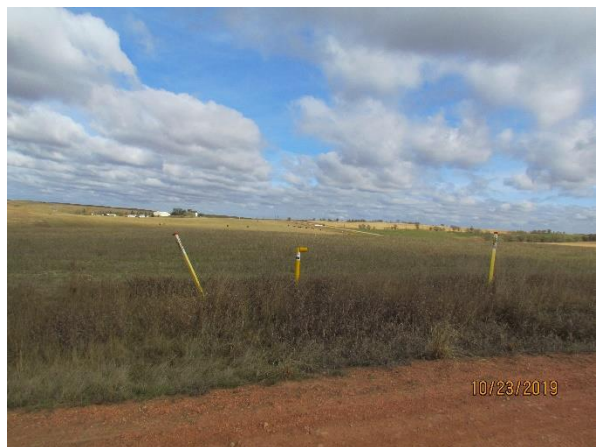
Photo 4: Leaning pipeline identification marker along  
restored pipeline corridor. (Section 34, T150N, R96W)

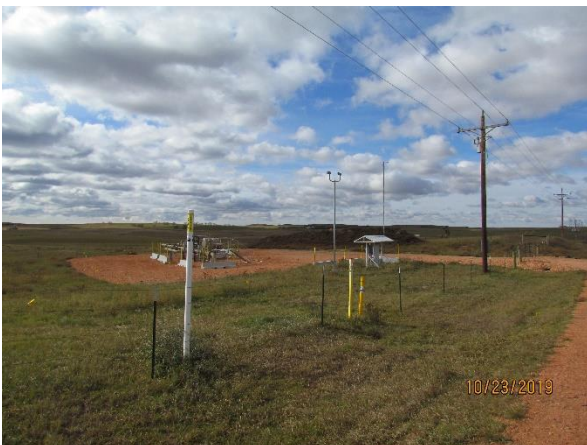
Photo 5: Restored pipeline corridor.  
(Section 34, T149N, R96W)

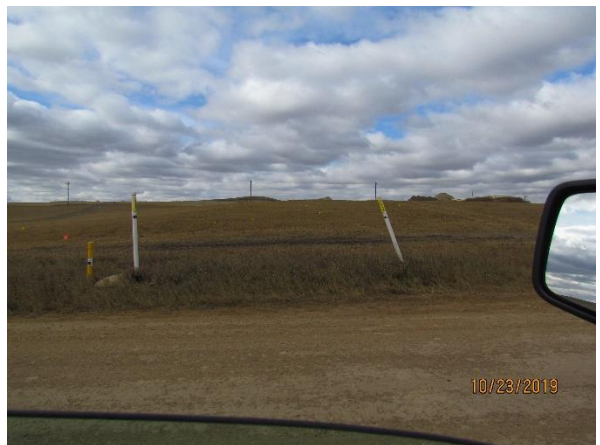
Photo 6: Leaning pipeline identification marker  
(Section 34, T150N, R97W)

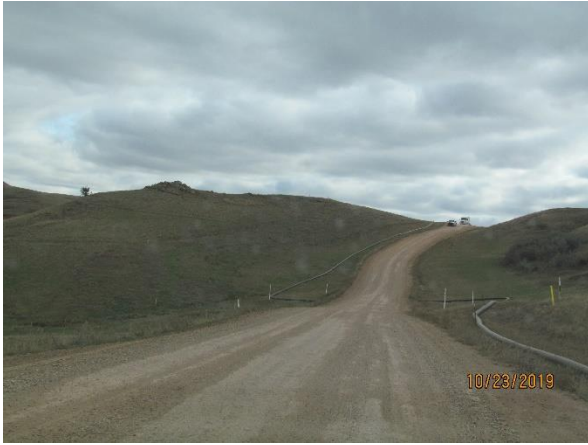
Photo 7: View of pipeline corridor  
(Section 33, T150N, R97W)

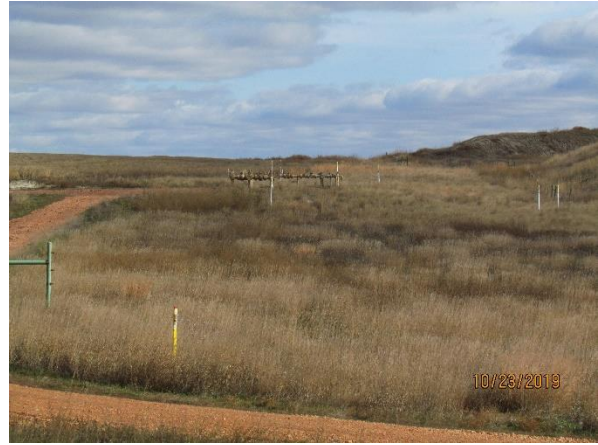
Photo 8: Pipeline restored corridor and Midway facility.  
(Section 7, T149N, R98W)

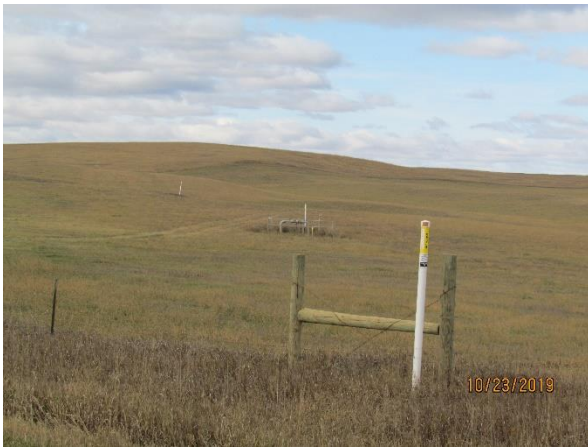
Photo 9: View of restored pipeline corridor.  
(Section 11, T149N, R99W)

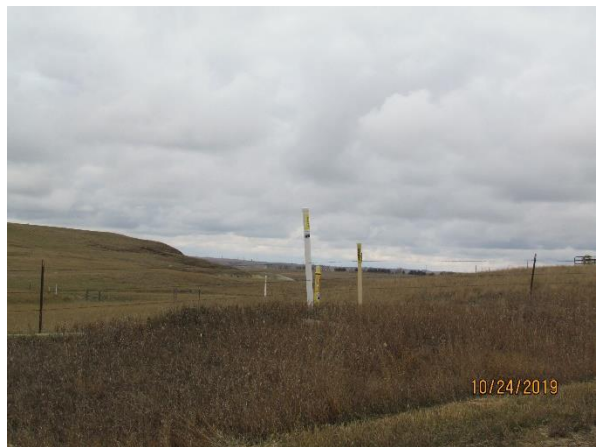
Photo 10: View of restored pipeline corridor  
(Section 35, T152N, R101W)

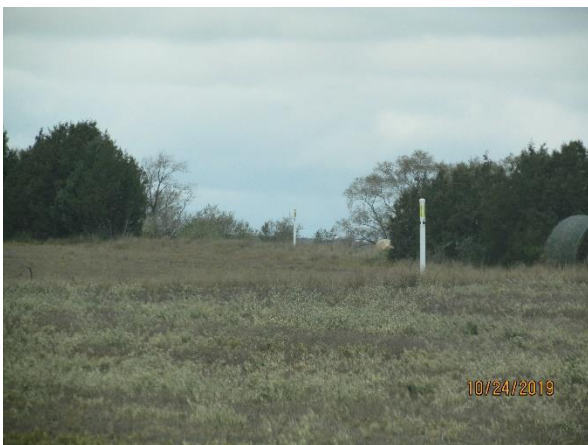
Photo 11: Restored pipeline corridor  
(Section 35, T152N, R101W)

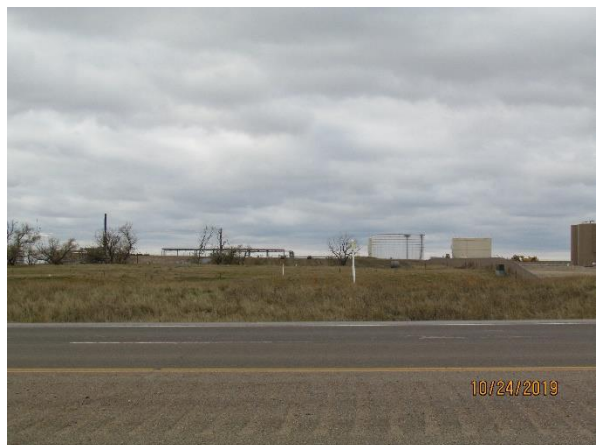
Photo 12: Looking west, across US Hwy 85, to the Alexander Facility  
(Section 19, T152N, R101W)
