Savage Bakken Connector

Case No. PU-16-753

As-Built Inspection Report

RE: Case No. PU-16-753
Savage-Bakken Connector Line
10-Inch Crude Oil Pipeline Project -
Williams County
As-Built Inspection Report

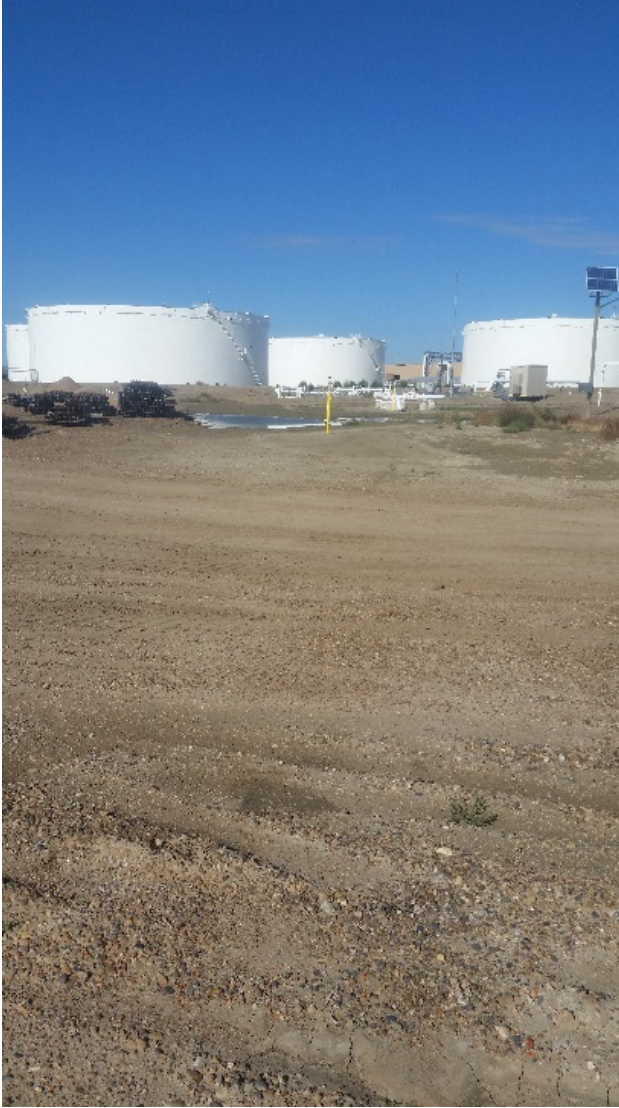
#1 - STA 3+63 BK, gravel graded to match existing	
#2 - STA 3+63 AH, topsoil replaced to match existing grade	
#3 - STA 3+63 LT BK, no erosion control at grading limits for ditch flowing east.

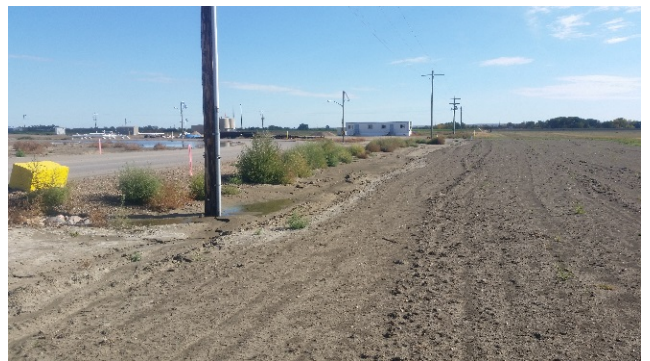
#4 - STA 5+80 BK, replaced grade drains into ditch flowing east out of project area.	
#5 - STA 6+00 AH, grade break at point of Bore #1, ditch flows to the W then SE

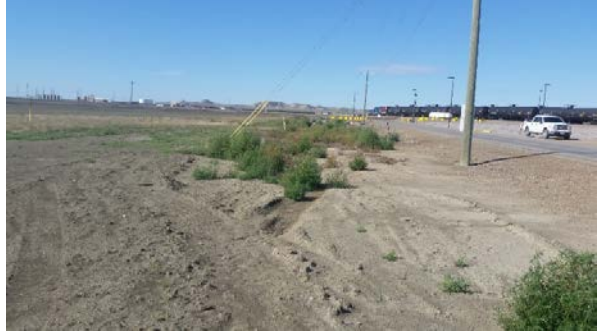
#6 - STA 7+75 AH, minor erosion in ditch over Bore #1 area	
#7 - STA 10+75 LT BK, Erosion and sediment deposition at culvert that drains SE into farm field.

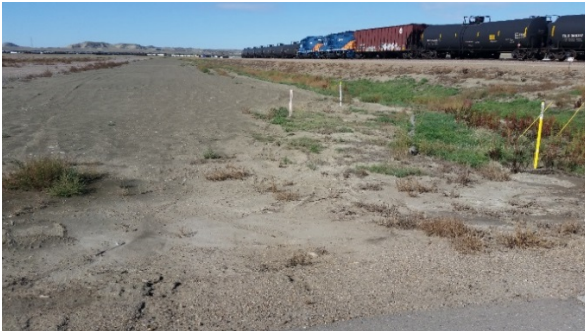
#8 - STA 13+80 AH, graded to match existing grades. In-place fiber roll near culvert.	
#9 - STA 14+50 AH, topsoil graded to match existing grade. Drains to ditch at RT.

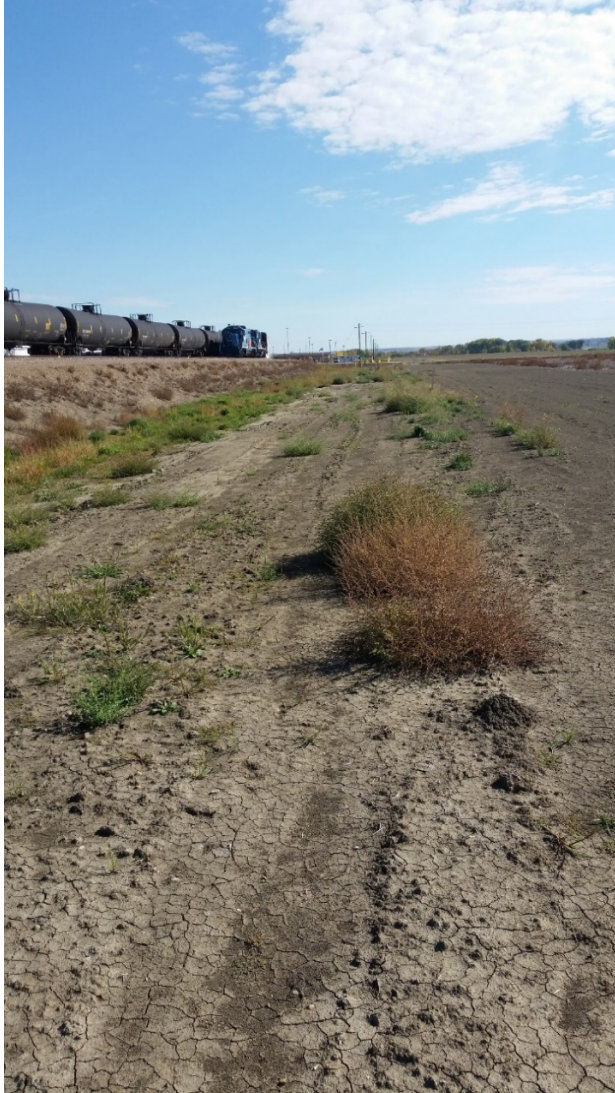
#10 - STA 22+00 BK, graded area drains to ditch which flows east.	
#11 - STA 27+45 BK, graded area over pipeline. Exist ditch grade restored.	
#12 - STA 27+60 AH, area graded to match existing. Existing ditch line not disturbed.

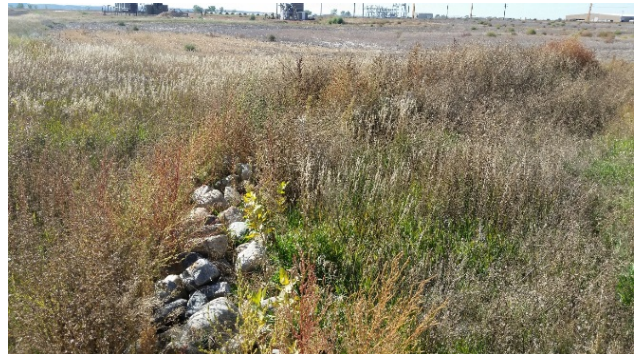
#15 - STA 33+35 LT, Existing riprap at corner of ditch.	
#16 - STA 41+00 AH, topsoil replaced and graded to match existing grades	
#17 - STA 41+40 BK, topsoil replaced to match existing grade

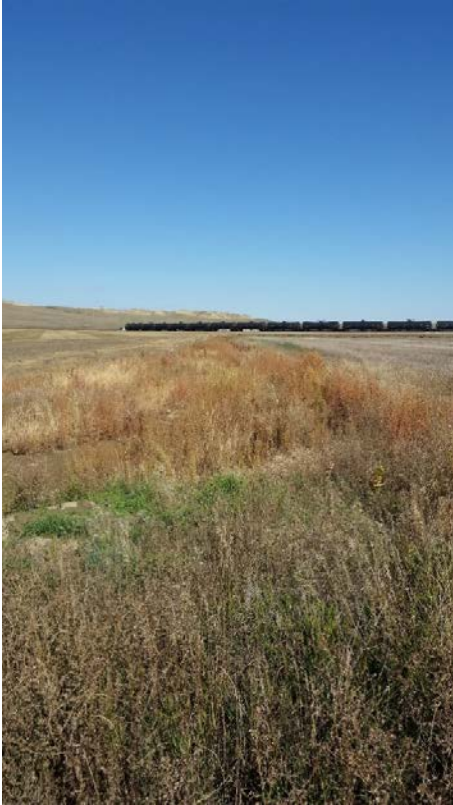
#13 - STA 33+40 BK, graded area to the LT matches existing. Ditch running parallel to work area was full vegetated and non-disturbed.	
#14 - STA 33+40 AH, graded area to RT, vegetated ditchline on LT

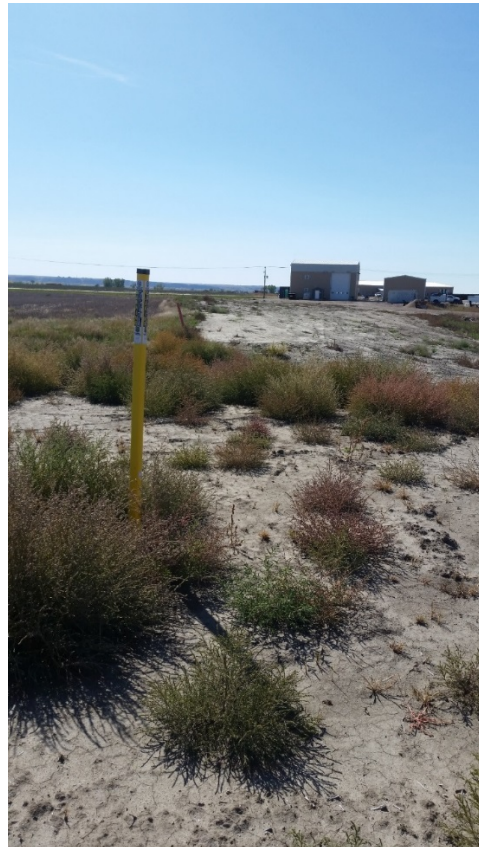
#18 - STA 45+75 AH, site graded to drain to the west	
#19 - STA 45+75 BK, Pipeline route graded to match existing. Drains to ditch to the S.	
#20 - STA 45+75 AH, Grading drains to ditch that runs SSW. No erosion control devices in place.

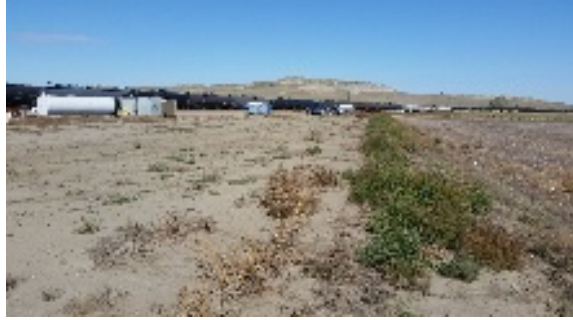
#21 - STA 45+75 RT AH, ditch line upstream from construction area	
#22 - STA 50+75 BK, graded area with berm on RT of centerline	
#23 - STA 59+00 BK, gravel in stockyard replaced and graded to pre-construction conditions

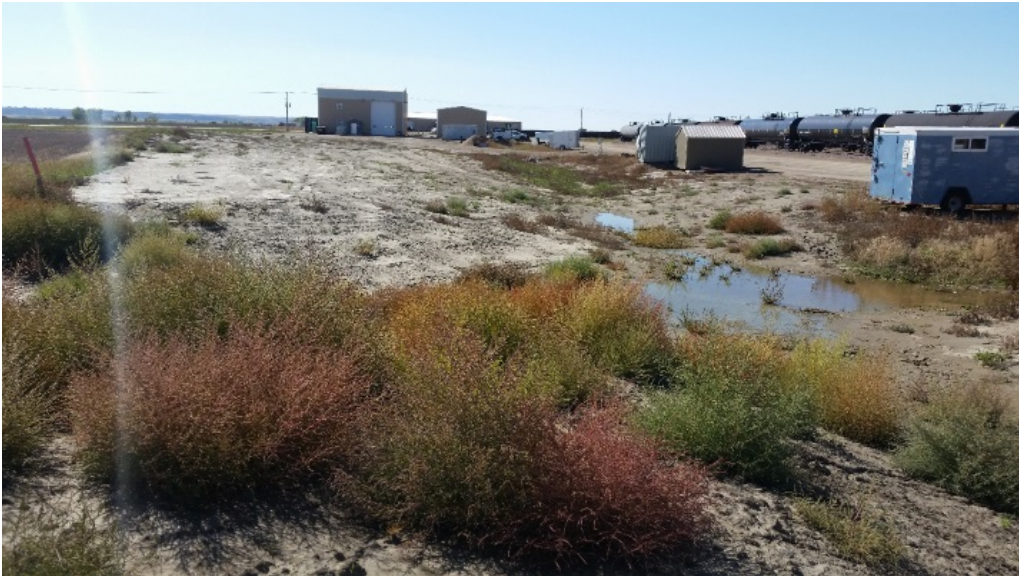
Project: Savage Bakken Petroleum Hub Connector - 10" Crude Oil Pipeline	Contractor or Sub: ProPipe
Work Performed & Location: <p>*All site grading is complete along the pipeline route and appears to be placed back to existing grades. All topsoil piles were spread over disturbed areas with no large clumps visible. All spread topsoil was graded to match surrounding grades and appears to be as existing prior to construction. In areas that pipeline was installed under gravel driveways or stock yards, all gravel was replaced to grades that match surrounding area. Gravel was graded smooth with no soil visible in gravel.</p> <p>* At STA 3+48, it was observed that the ditch that runs parallel to construction area between STA 3+48 - STA 7+81 that drains to the east had no erosion control devices to catch any sediment traveling along ditch. There was evidence of sediment deposition throughout ditch line. (See photo #3). Potential need for fiber rolls in ditch bottom.</p> <p>* At STA 4+00, it was noted that all replaced grades matched existing grades and appear to be replaced to existing conditions. Topsoil may need disced prior to seeding. (See photo #2).</p> <p>* At STA 10+75, It was noted that existing culvert that drains SE into farms field had large amounts of sediment deposition in front of it and had sediment draining into field. Gully erosion was taking place in ditch bottom up & down station from it. Some of the sediment could be coming from drainage area to the north (inside rail loop), but most of the sediment was coming from the erosion of the ditch bottoms along stationing. No construction had taken place in this area due to being within Bore #1. Up station, the ditch running between STA 14+00 - STA 23+00 drains to the east across the site access road and to this drainage culvert and then SE into the same field. (See photo #7). Erosion control devices needed in this area and along ditch flowline.</p> <p>* Disturbed area between STA 14+00 - STA 26+00 were graded to match existing ground elevation. Most of disturbed area drains to the north into ditch that runs parallel to pipeline. (See photo #8- #10)</p> <p>* At STA 45+50 - STA 50+00, It was noted that disturbed areas drained into ditch to the west of pipeline, and no erosion control devices were installed to mitigate erosion or transportation of soils along ditch in the event that soil was eroded off hill and into ditch. Ditch runs from N to S then SW from rail stockyard. (See photo #20 & #21)</p>

- STA 3+48 LT for ditch flowing to the east
- STA 10+75 LT for ditch flowing SE into farm field, and along ditch bottom that is eroding to the east and west.
- STA 45+50 - STA 50+00 RT along bottom of hill prior to ditch bottom
- STA 105+60 potentially. Ditch is relatively flat and drains to existing low areas.

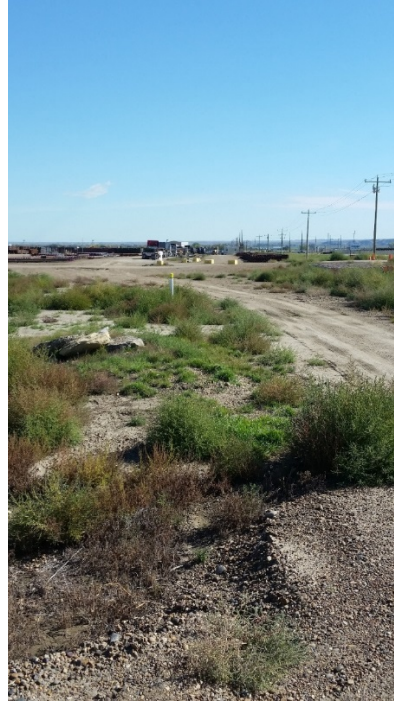
#24 - STA 59+00 AH, graded gravel in stockyard	
#25 - STA 70+50 BK, rocks from excavation left on surface in gravel stockyard edge	
#26 - STA 70+50 AH, area over Bore #2

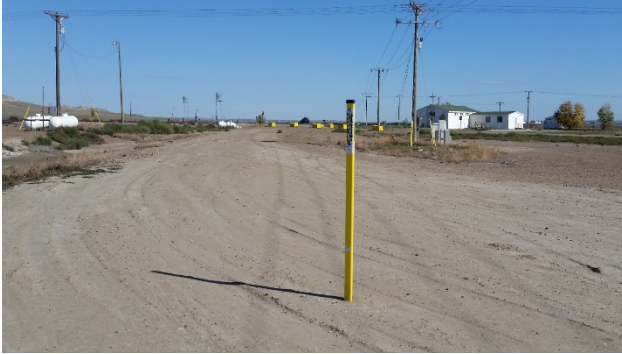
#27 - STA 81+00 BK, graded gravel/soil area replaced to existing conditions. No vegetation	
*See attached map with location of each photo, and attached pages of photo's

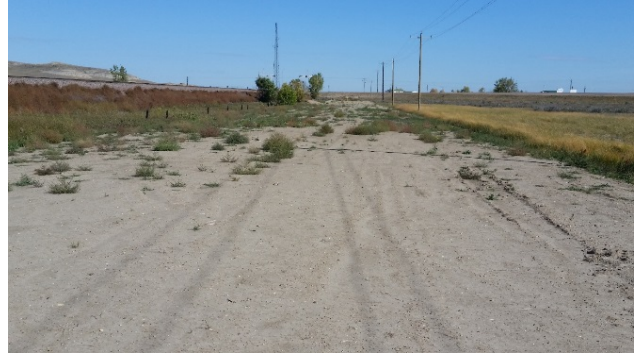
#28 - STA 81+00 AH, area graded to match existing prior to Bore #3	
#29 - STA 94+00 BK, area was graded to match surrounding area. Drains to the west ditch.

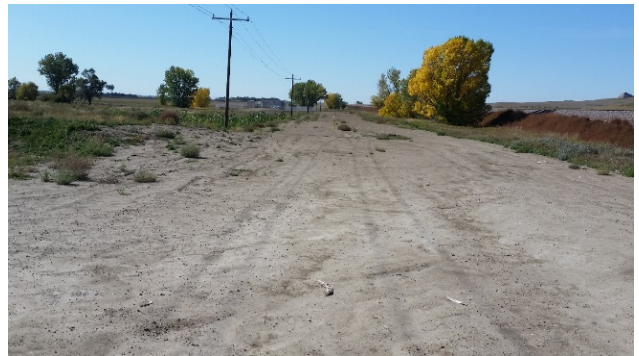
#30 - STA 94+00 AH, Site graded to match existing grades	
#31 - STA 97+00 LT AH. Cottonwood saplings sprouted in Clear & Grub area.	
#32 - STA 104+25 RT AH, graded ditch and gravel used as sediment block at exit of culverts under access roadway. No erosion control devices

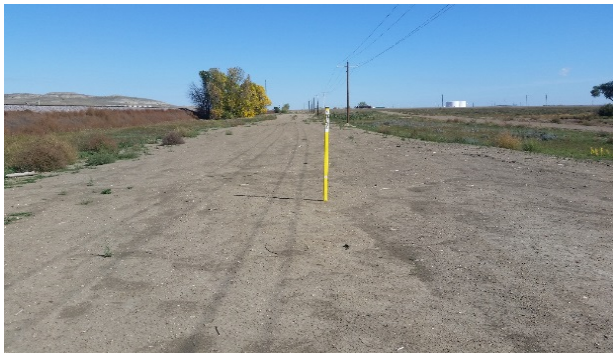
#33 - STA 102+50 BK, disturbed area graded to drain into ditch to the west. All topsoil replaced to match existing	
#34 - STA 103+00 AH, grading completed at connecting to Receiver Point.

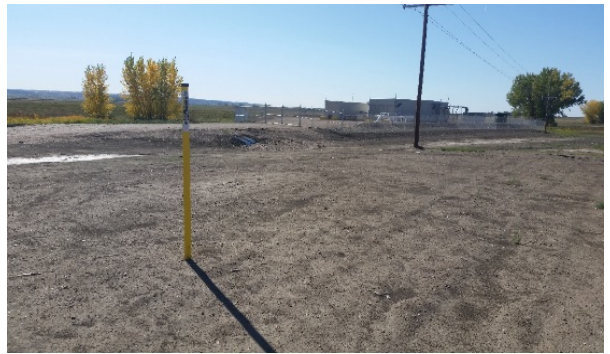
Project: Savage Bakken Petroleum Hub Connector - 10" Crude Oil Pipeline	Contractor or Sub: ProPipe
Work Performed & Location: * Between STA 47+00 - STA 51+00, disturbed area was graded to provide drainage to the ditch to the west. A berm was graded at east construction limits to facilitate this drainage. (See photo #22). This berm next to the agricultural land matches what was existing prior to construction. * Between STA 52+22 - STA 72+28 (Bore #2), all gravel and soil in stockyard was replaced and graded to match existing. (See photos #23 - #27) * It was observed that multiple Cottonwood trees had sprouted in Clear & Grub area at STA 97+00 LT. (See photo #31) * Between STA 86+59 - STA 103+00, site was graded to match conditions prior to construction. Graded to provide drainage to the north side that runs along the railroad tracks. Existing low areas between this station range were left as-is for grade, with areas showing potential for collection of surface waters. (See photos #30 - #33) * No erosion control devices were installed between STA 86+59 - STA 105+63. At end of pipeline at Receiver station, gravel was used as sediment filter before and after double culverts under access road to Receiver station. (See photo #34 & #35)

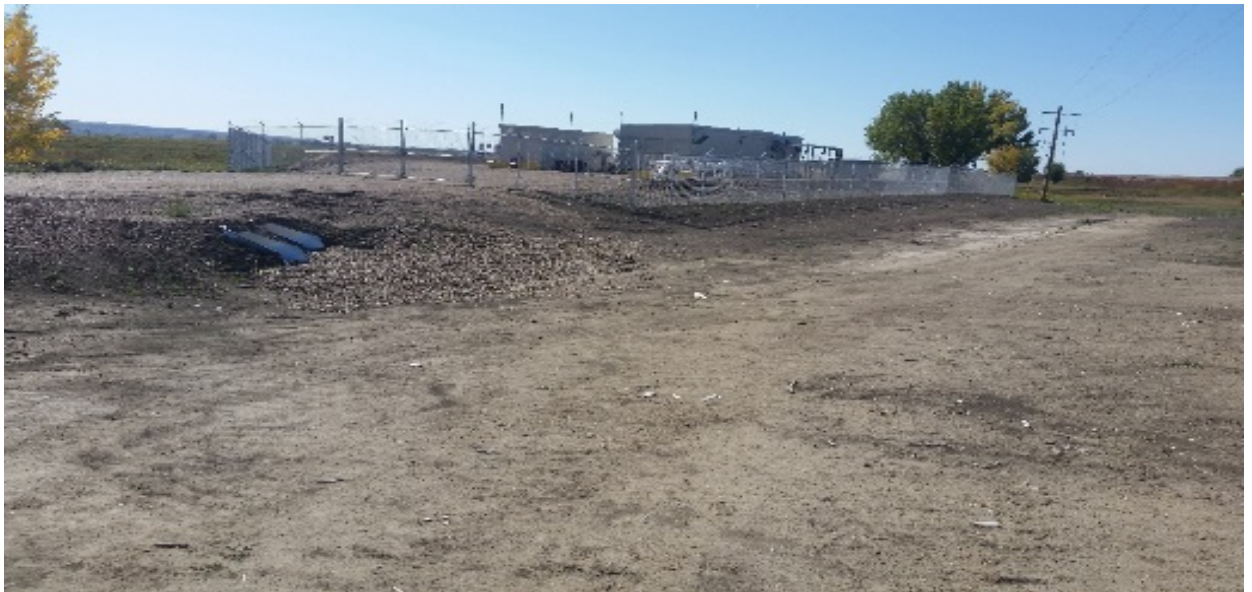
#35 - STA 103+50 AH, ditch was graded around Receiver pad and drains to the NNE.	
*See attached map with location of each photo, and attached pages of photo's	
*(AH=Ahead Stationing, BK=Back Stationing)
