Savage Bakken Connector

Case No. PU-16-753

Reclamation and Revegetation Inspection Report

RE: Case No. PU-16-753
Savage-Bakken Connector Line
10-Inch Crude Oil Pipeline Project -
Williams County
Reclamation and Revegetation Inspection
Report

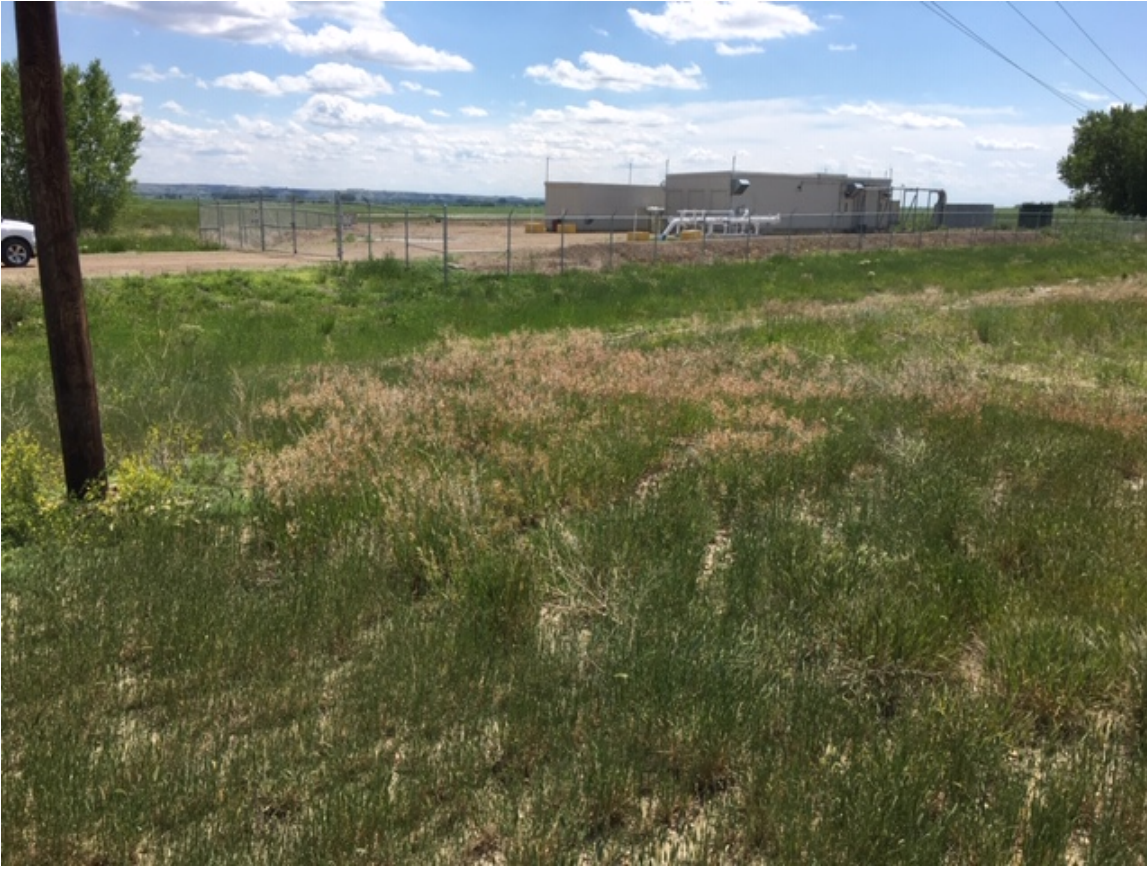
#1 - STA 105+00 AH, Connection point receiver pad.	
#2 - STA 103+50 BK, area shows windrow seeding and coverage matching existing vegetation to the RT and LT.

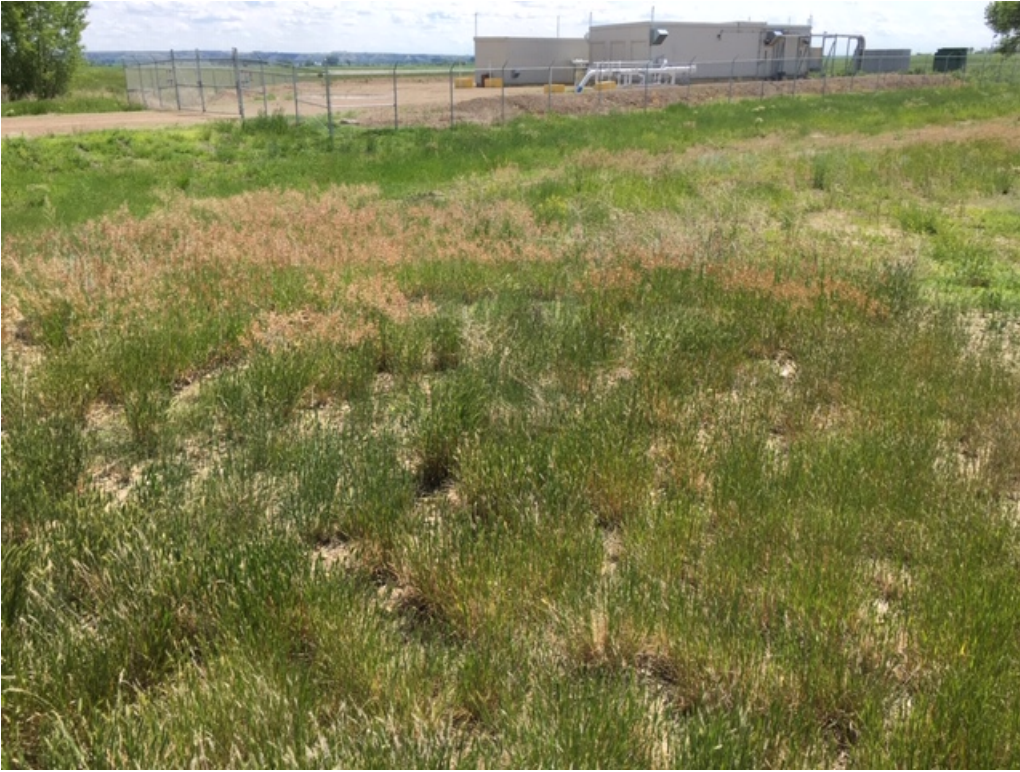
#3 - STA 105+00 AH, vegetation near connection pad buildings.	
#4 - STA 105+00 AH, trees on the NW side of the connection site pad.	
#5 - STA 105+00 BK, trees on the N side of the connection site pad.

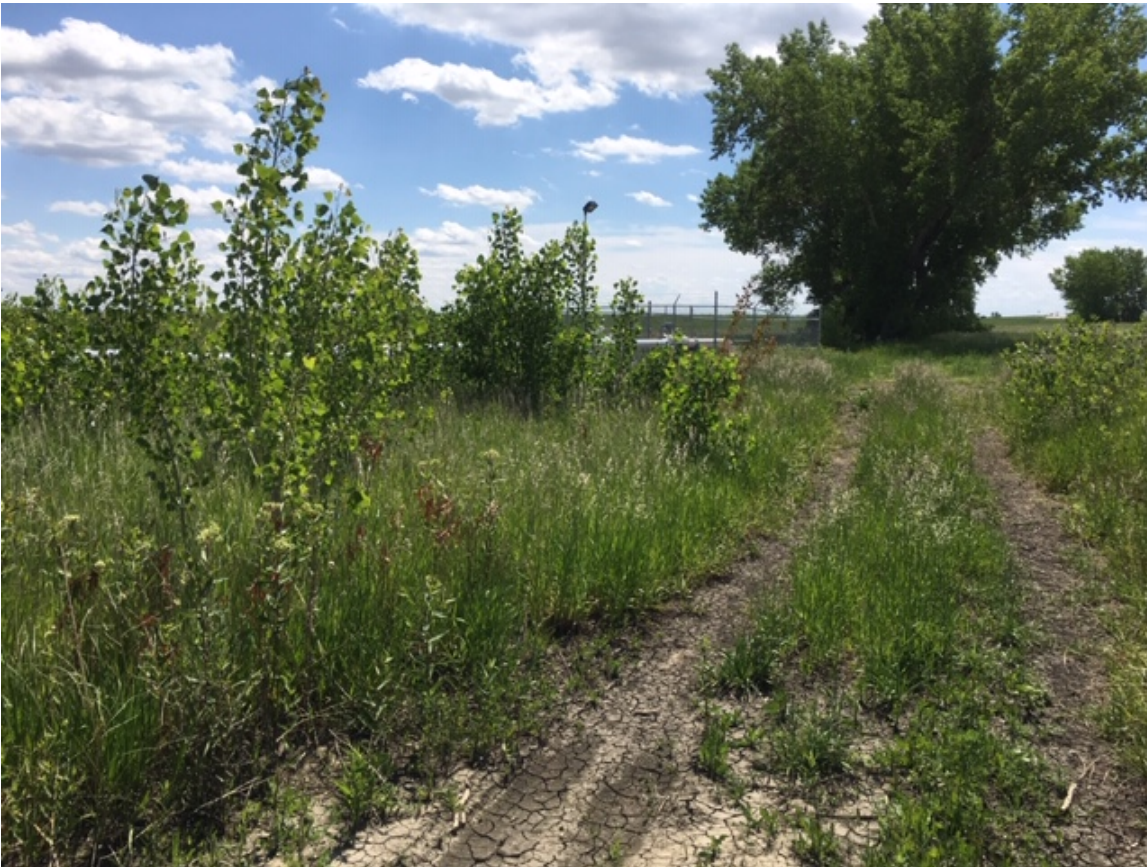
#6 - STA 105+00 BK, trees on the S side of the connection site pad	
#7 - STA 105+00 AH, trees and vegetation on the SE side of the connection pad. Barren area due to soggy/saturated soil.

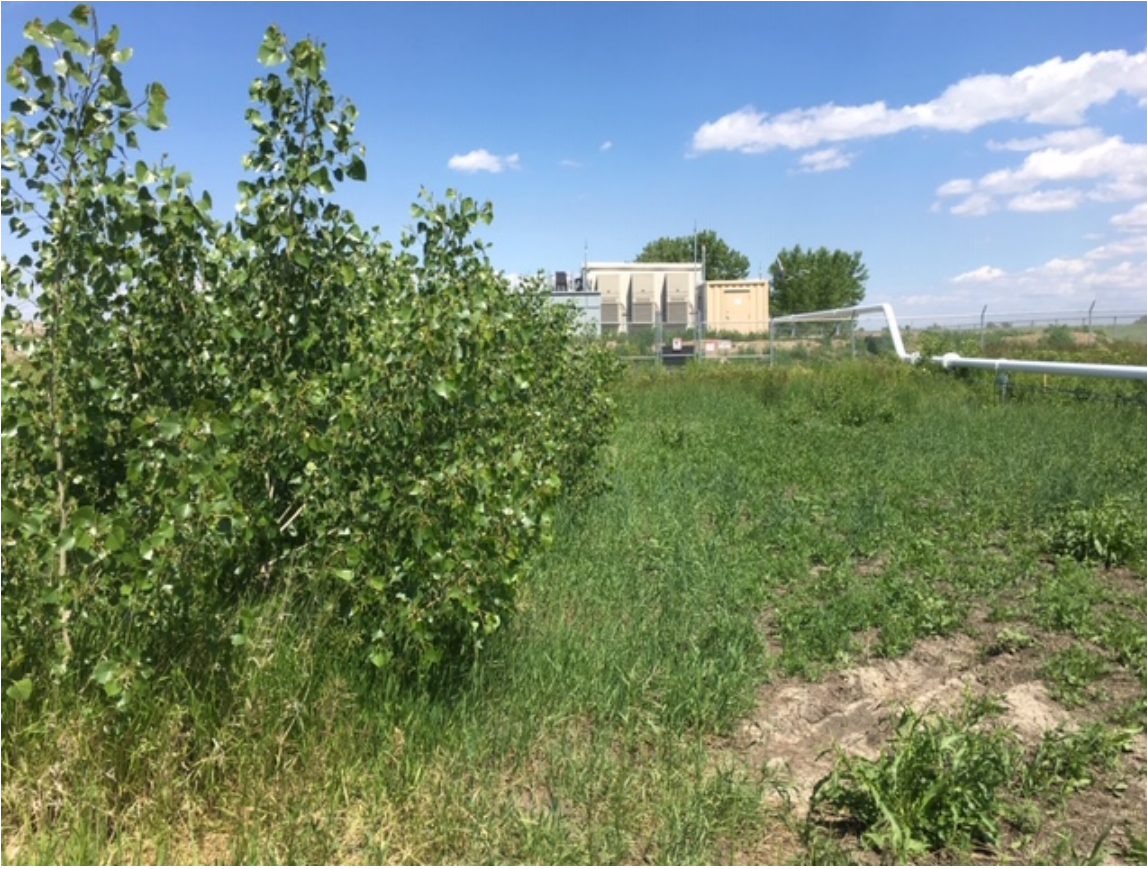
#7

Area of concern noted between STA 6+00 - STA 13+00 where drainage ditch slope has barren areas. This area is mostly underground bored pipeline. Also area of concern is between STA 100+00 - STA 105+63.36, where vegetation was patchy and not complete in coverage. This area appears to be a low lying wet area, and may be a result of the planted vegetation not fully germinating and growing. Area did not show any signs of erosion or sediment transportation due to being the low area withing the surrounding area. Both areas show no sign of erosion but may need additional seeding/re-vegetation.

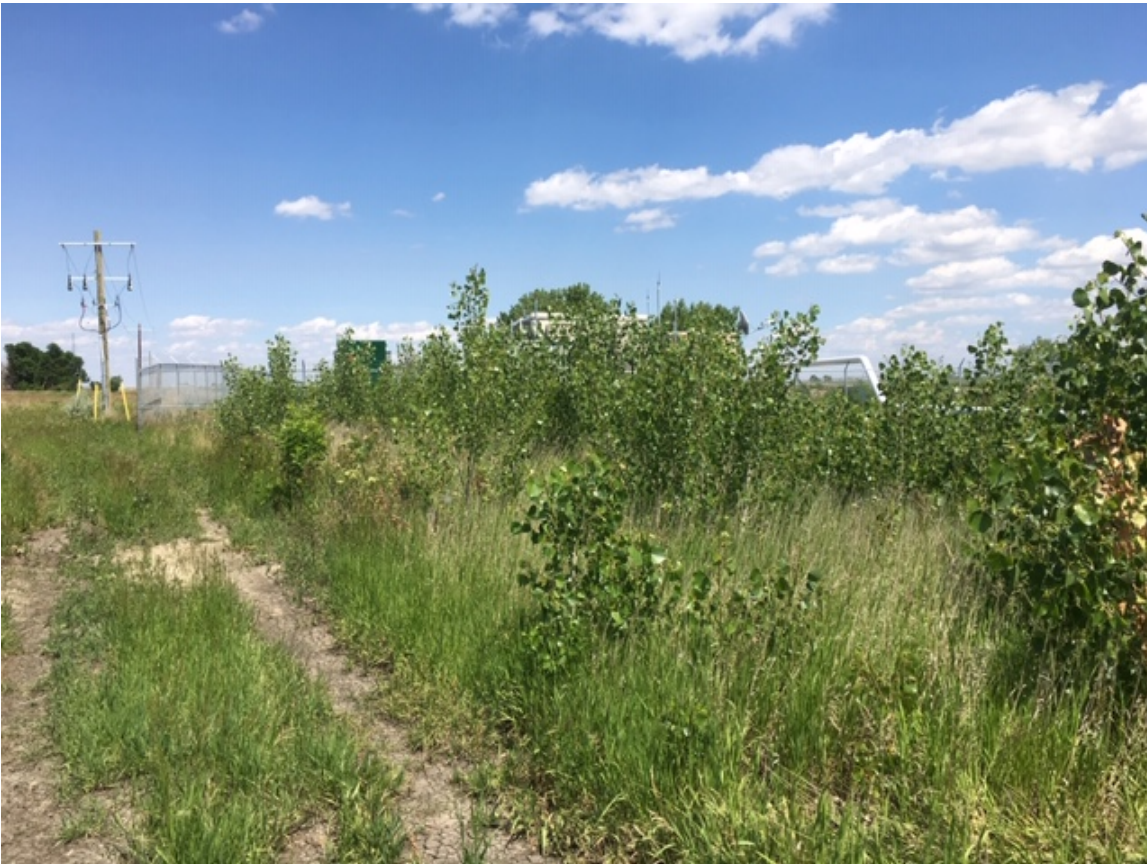
#8 - STA 105+25 BK, trees and vegetation on the SE side of the connection point	
#9 - STA 105+30 AH, barren soils near the connection point due to soggy/saturated soils in low area.

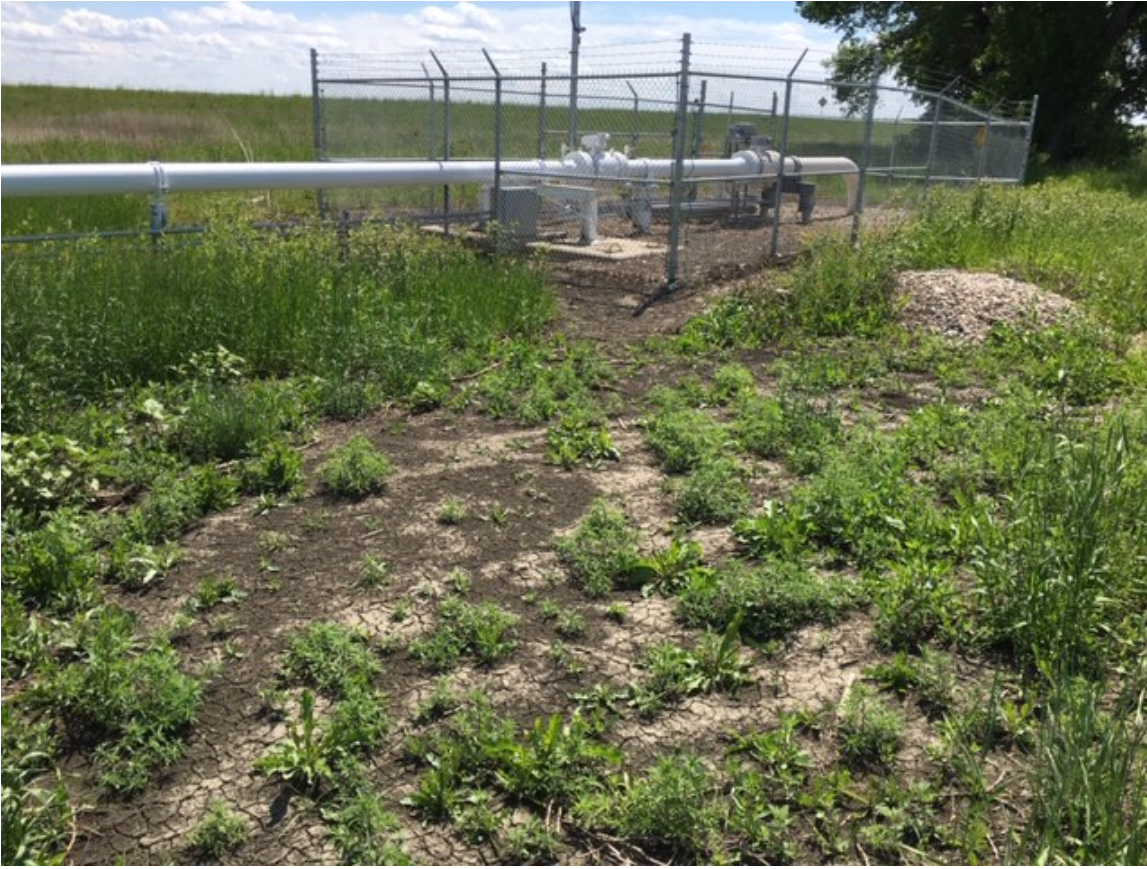
#10 - STA 105+36 AH, barren soils near the connection point due to soggy/saturated soils in low area.	
#11 - STA 93+00 AH, seeded area of disturbed work area. vegetation is in windrows and is spreading.

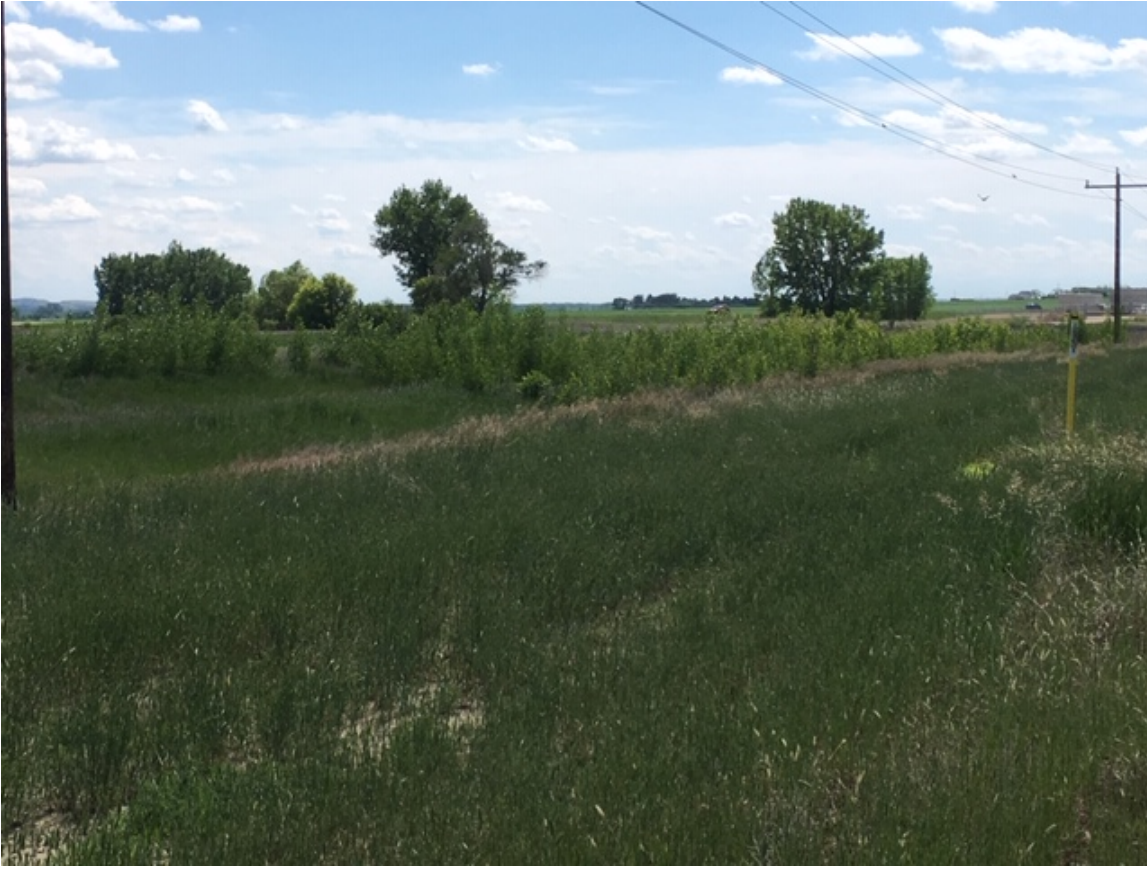
#12 - STA 95+00 AH, seeding of disturbed area and existing trees/shrubs near construction area.	
# 13 - STA 101+00 AH, vegetation establishment over disturbed area, matches surrounding area vegetation.

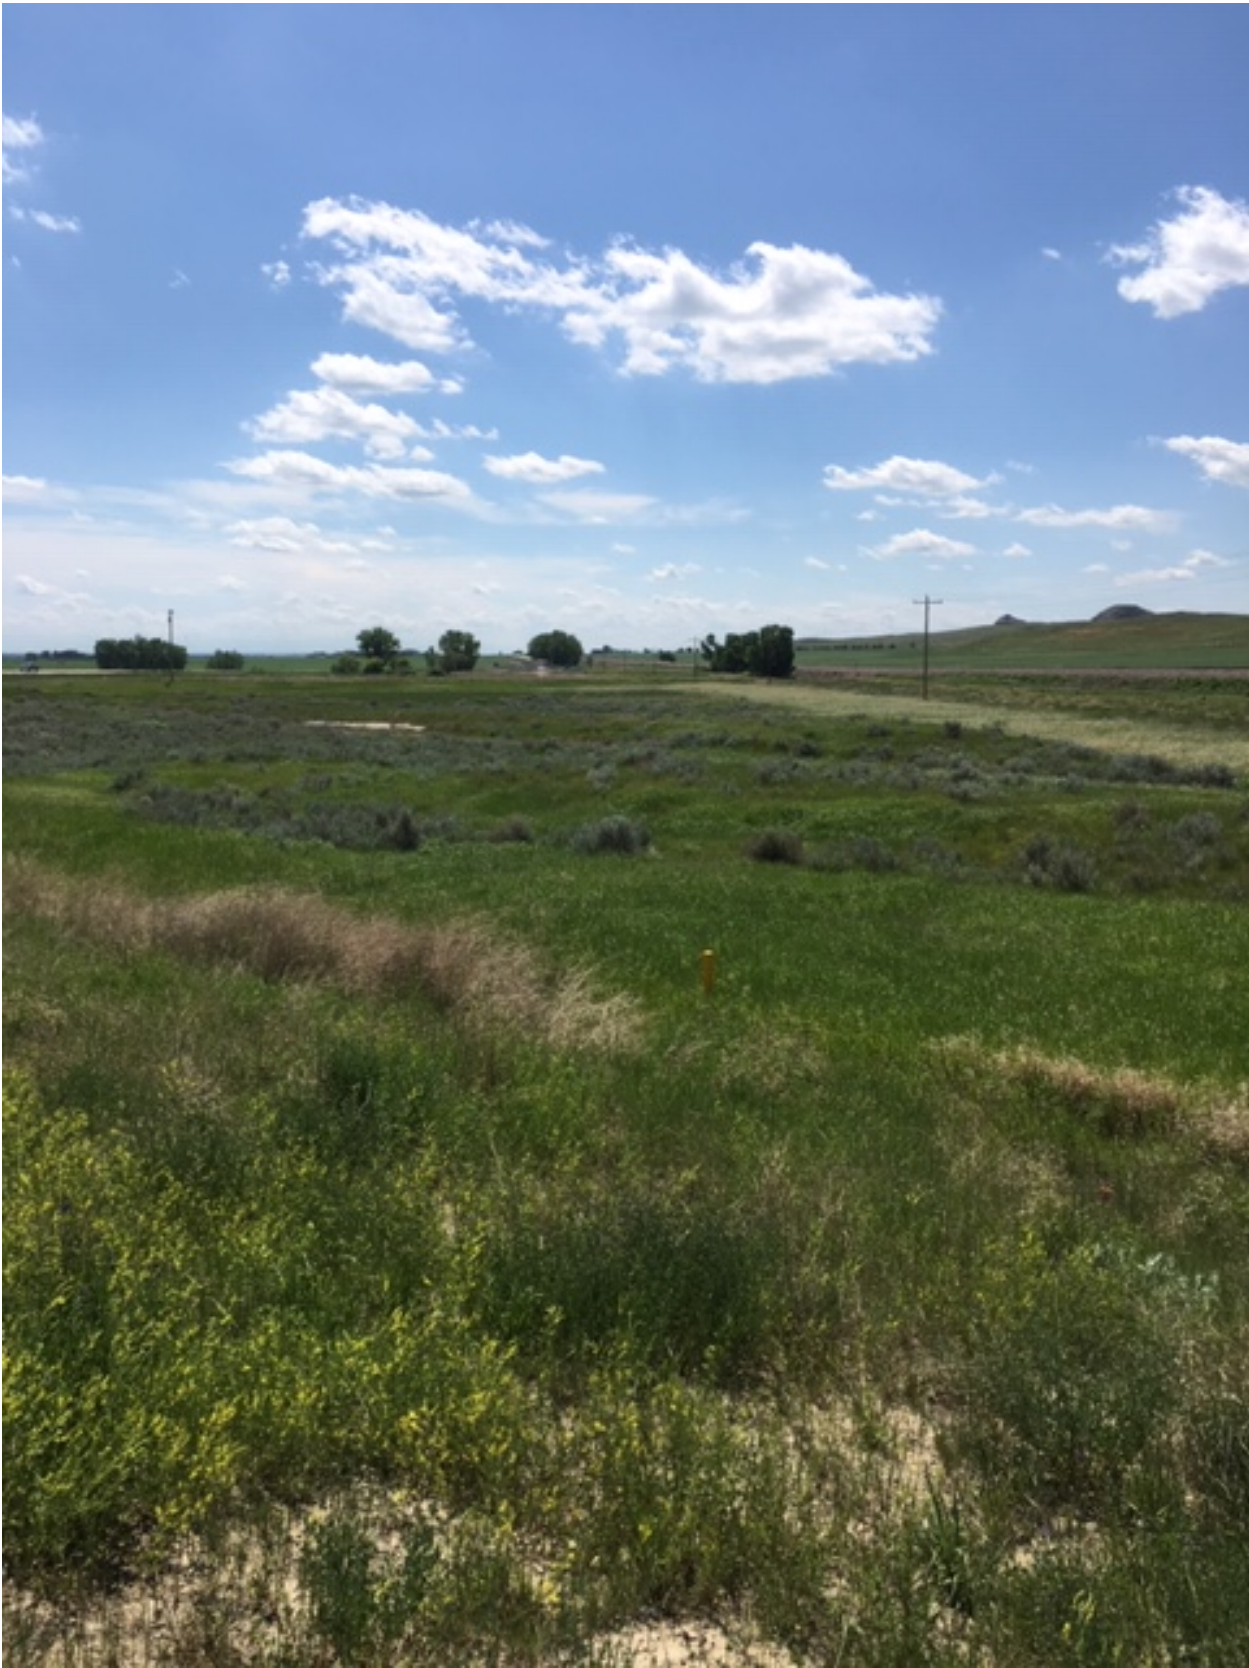
#14 - STA 86+00 AH, area of lighter color in the top-right of the picture is pipeline route and shows vegetation coverage. Color of new vegetation is different than surrounding areas vegetation.

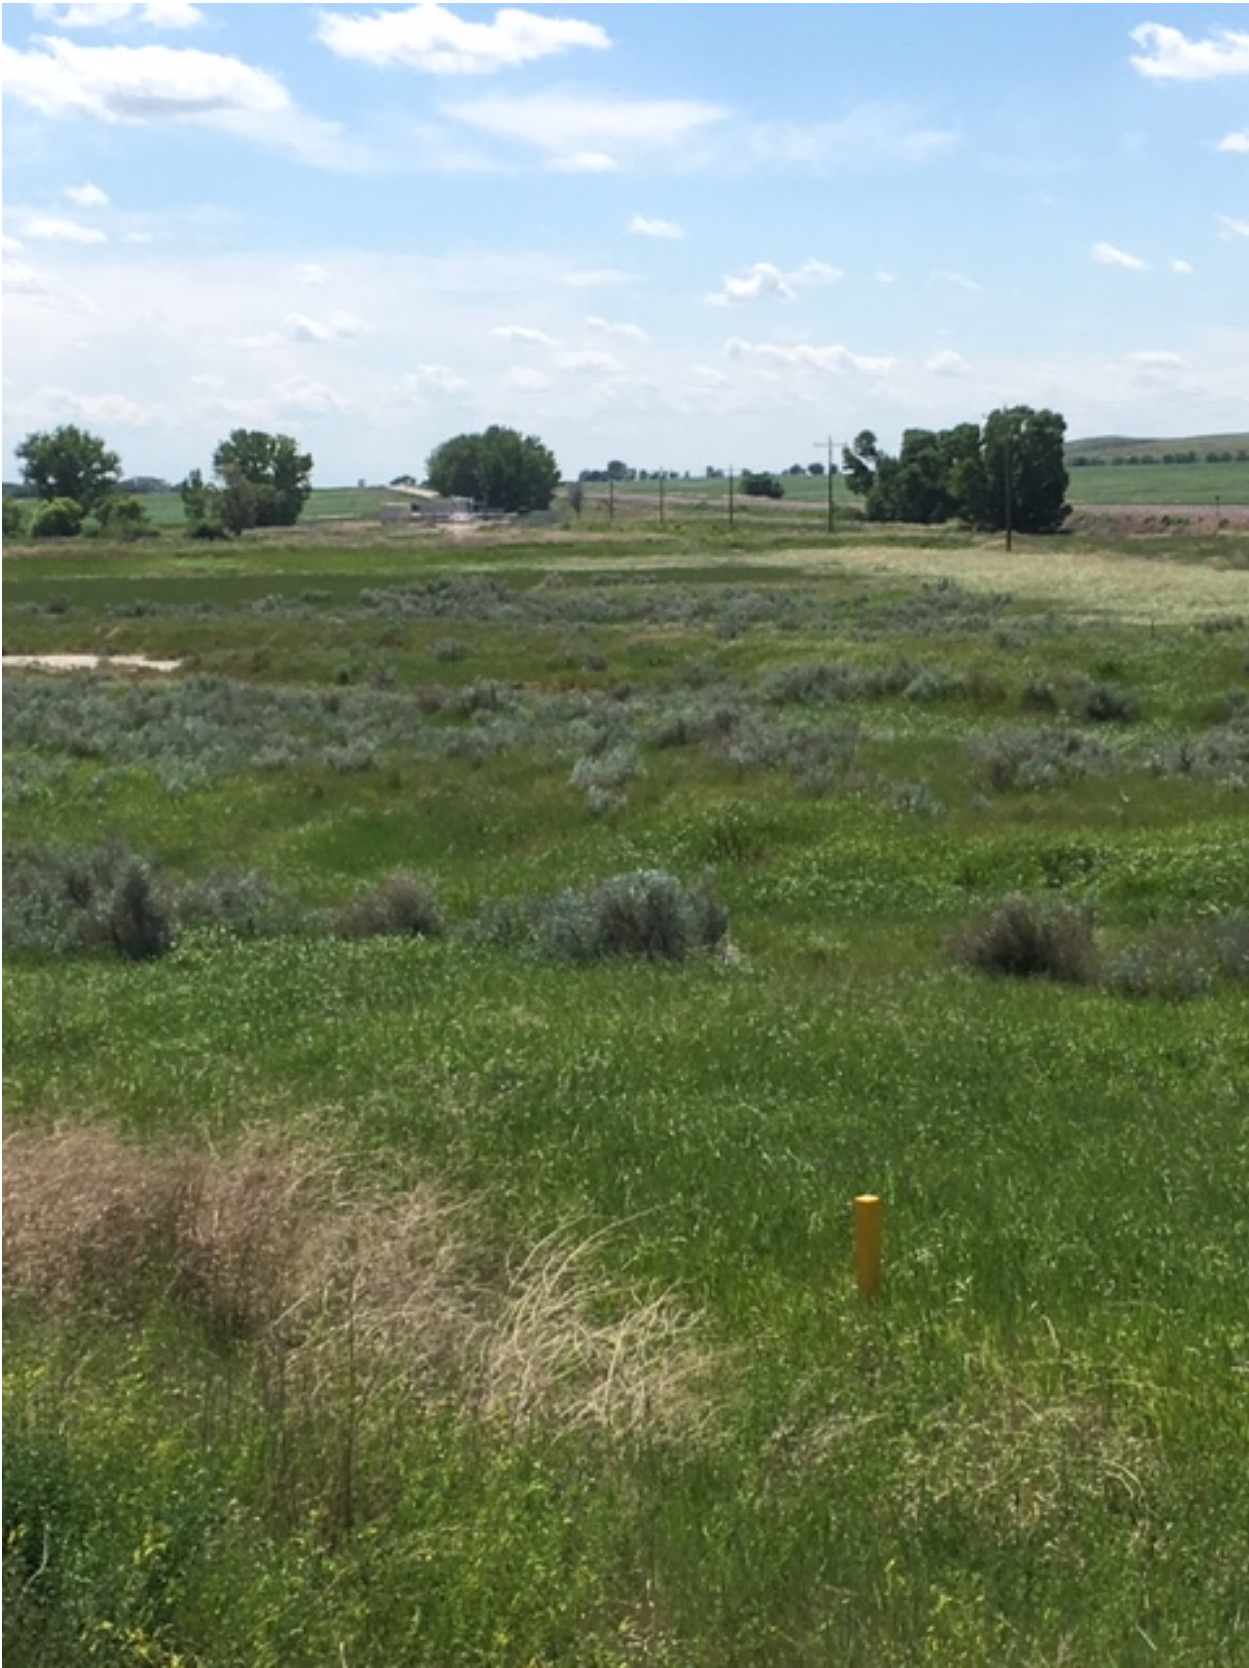
#15

# 15 - STA 86+00 AH, zoomed in view of the vegetation and overview to compare color verse surrounding area.	
*See attached map with location of each photo, and attached pages of photo's	
*(AH=Ahead Stationing, BK=Back Stationing)

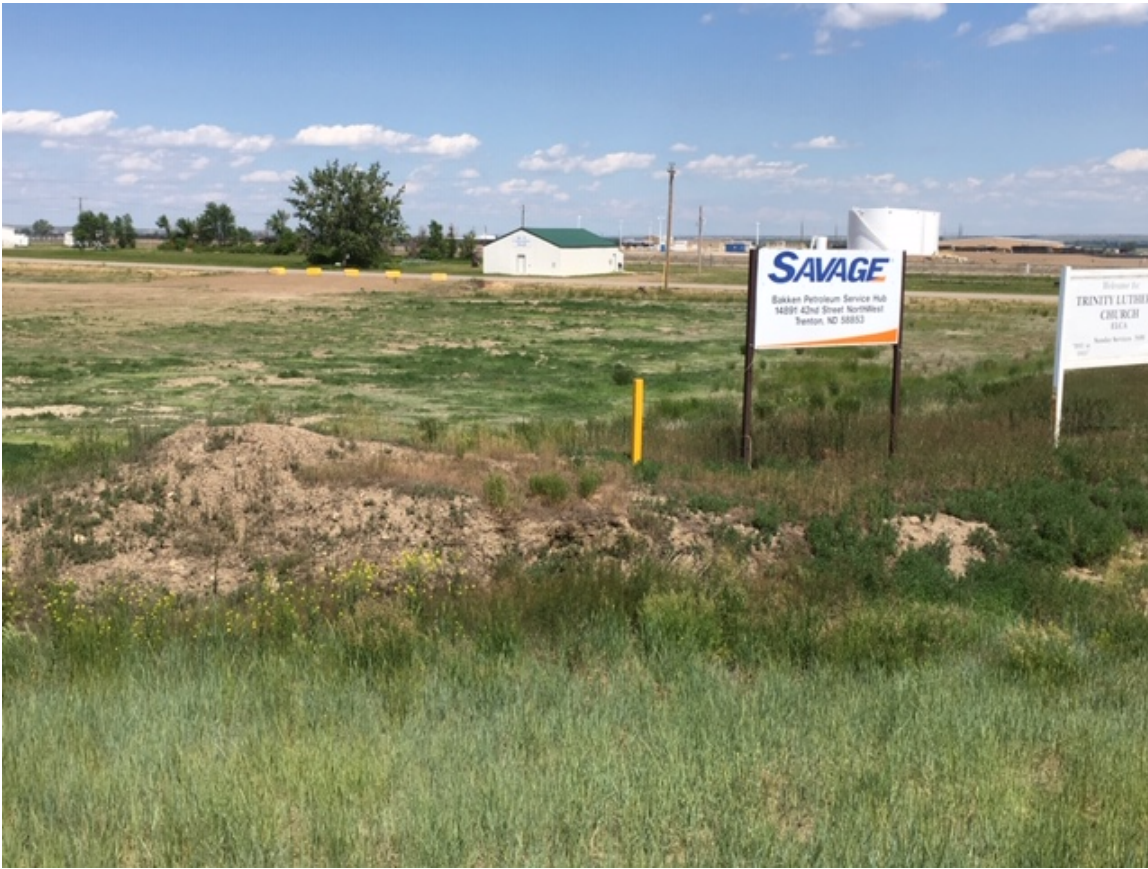
- #16 - STA 83+00 BK, looking east, start of bore area with vegetation growth.
- #17 - STA 83+00 BK, looking NE, area leading into the ND HWY 1804 bore was vegetated into the existing gravel parking lot.

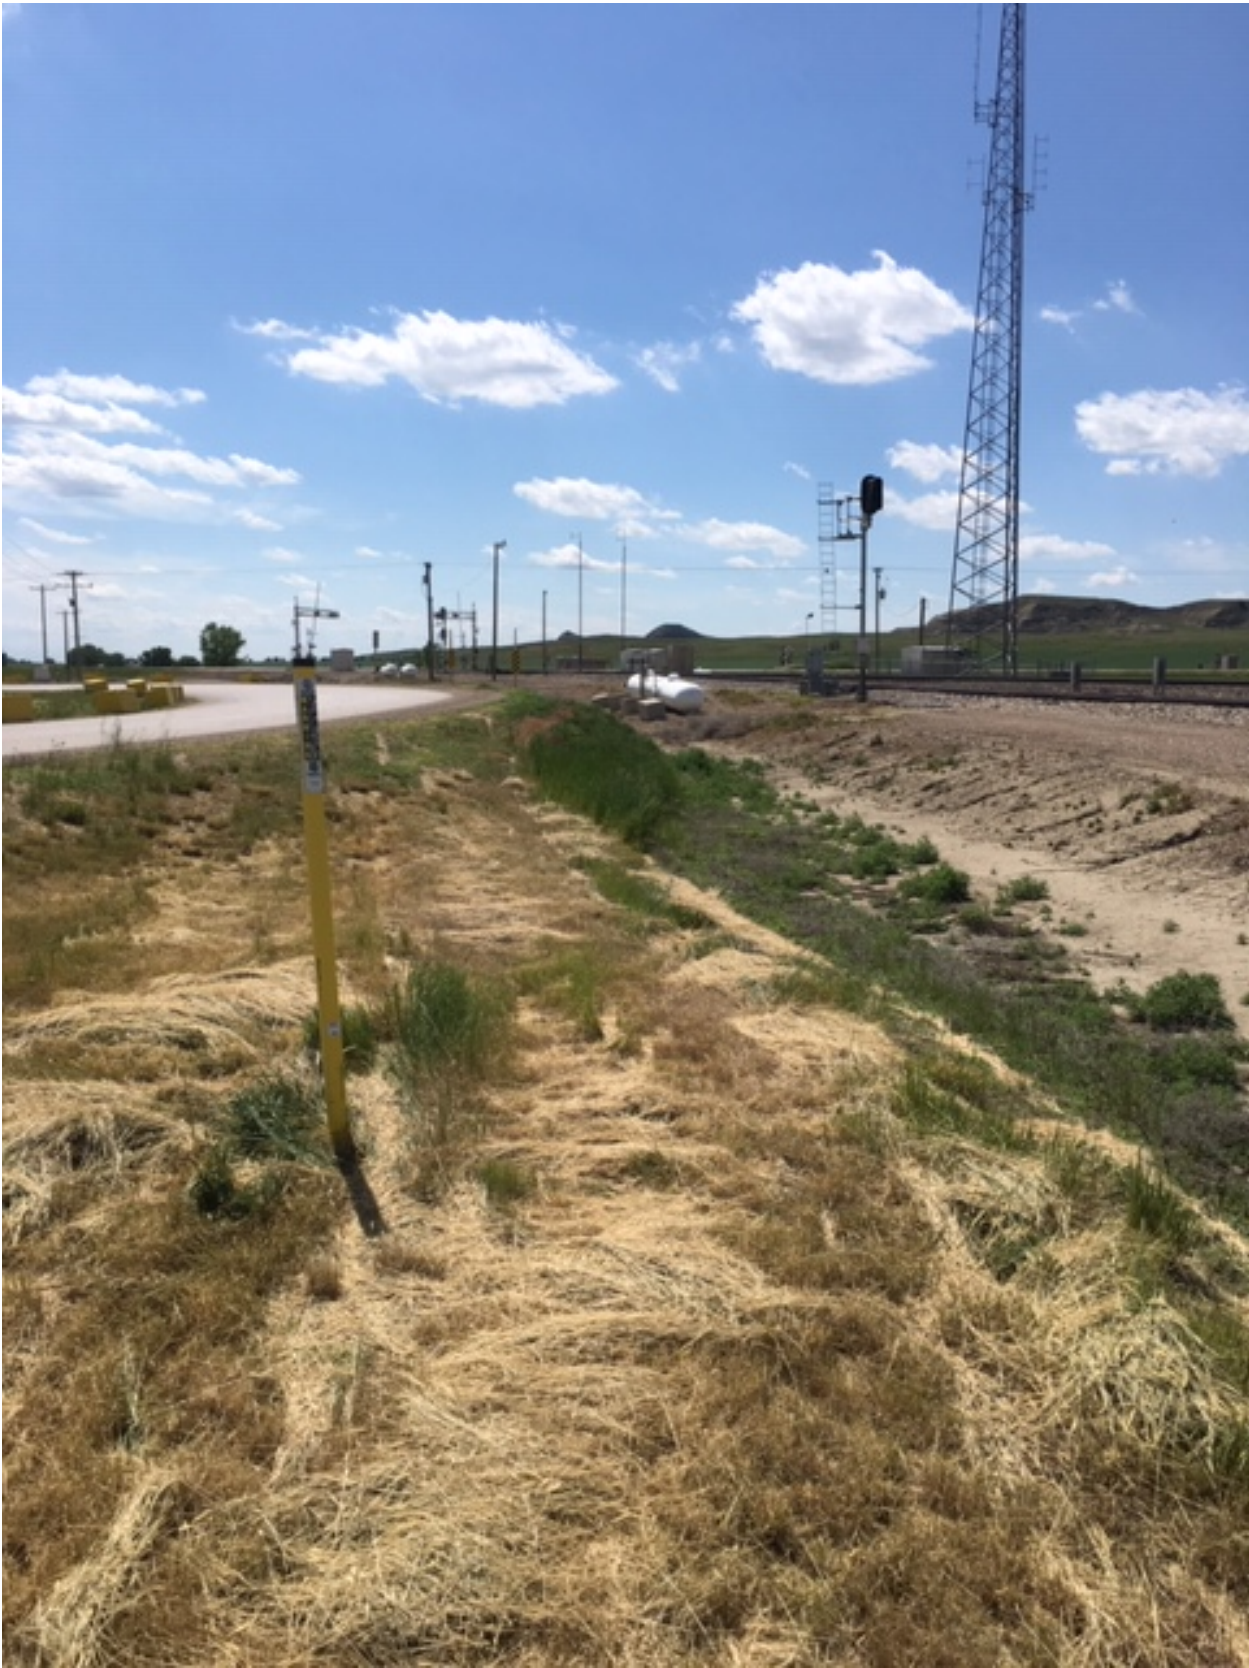
- #18 - STA 74+50 BK, area was vegetated with grass species leading into the existing gravel parking lot.
- #19 - STA 72+00 BK, area between the gravel parking lot and the roadway was vegetated for any disturbances due to construction.

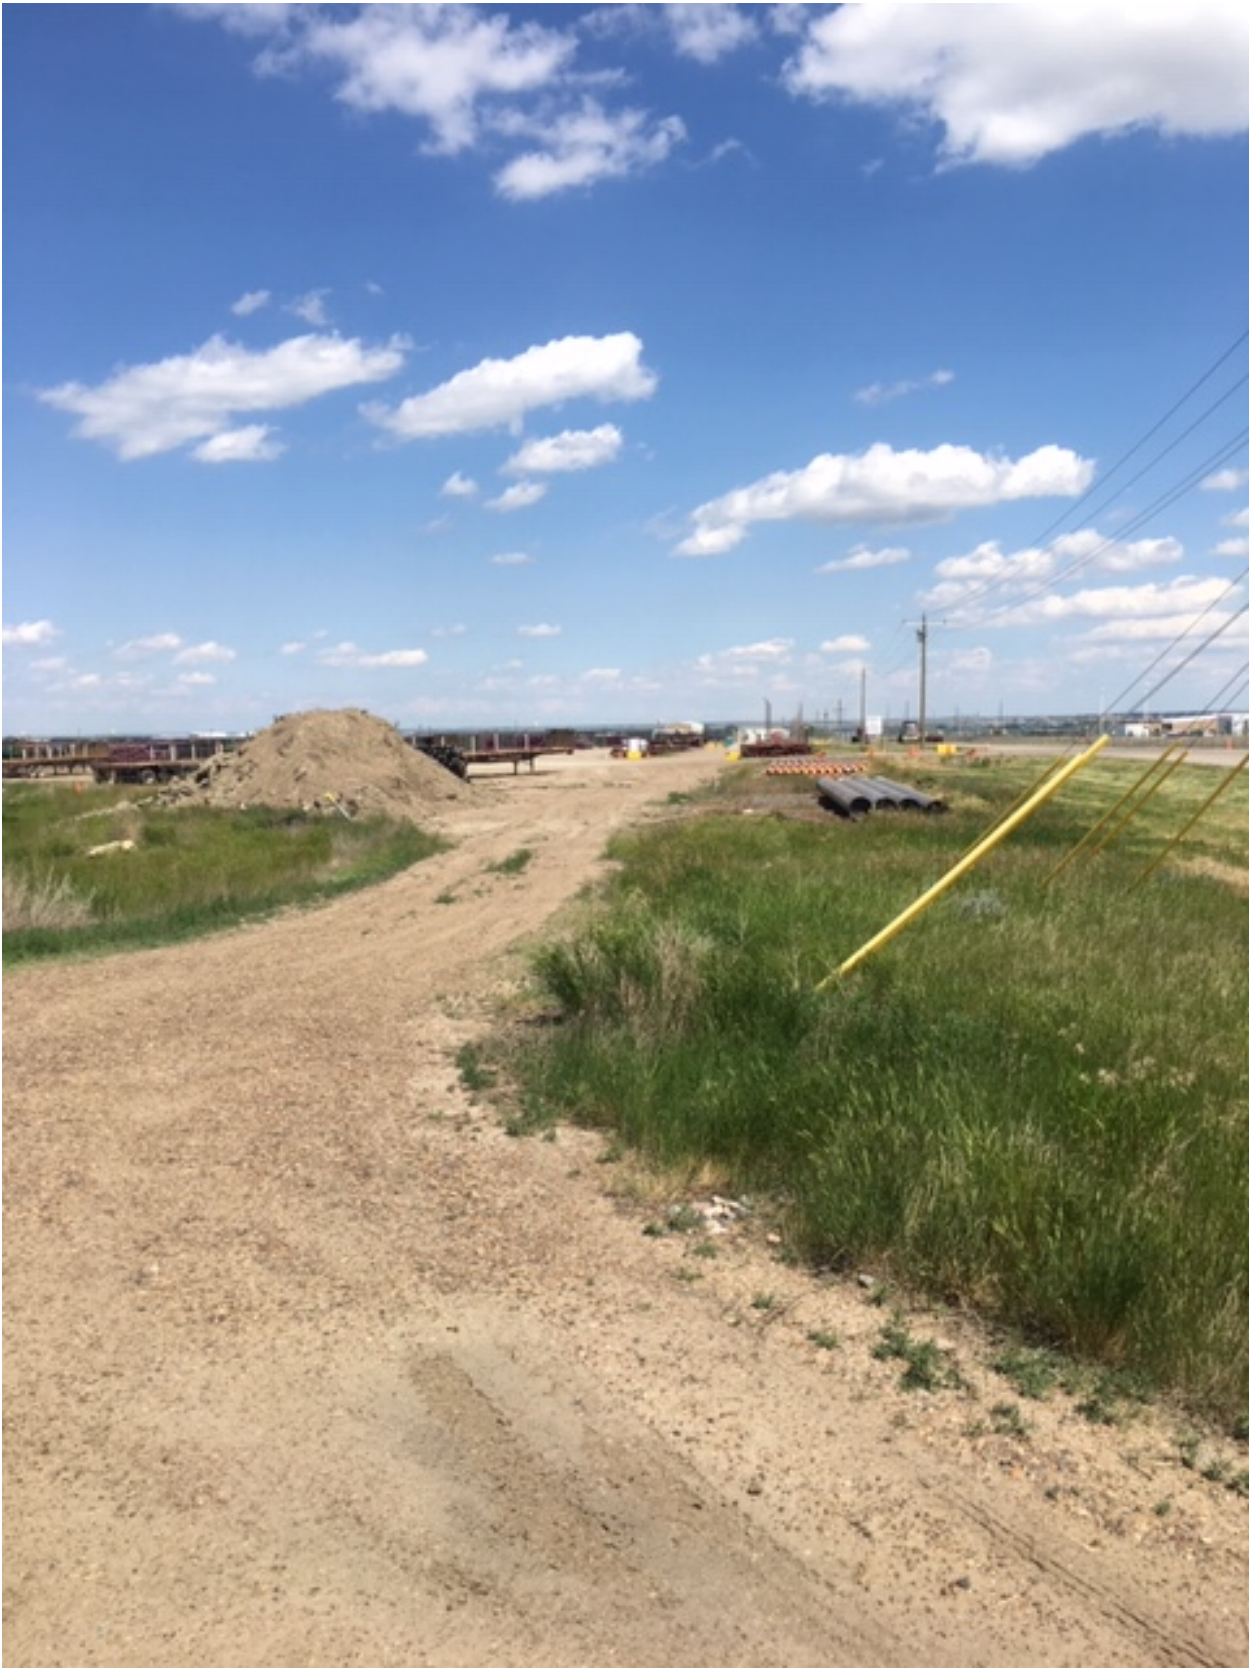
- #20 - STA 72+00 BK, dirt roadway over pipeline prior to bore.
- #21 - STA 52+00 BK, area is well vegetated over all disturbed areas. Overview of pipeline through farm land crops.

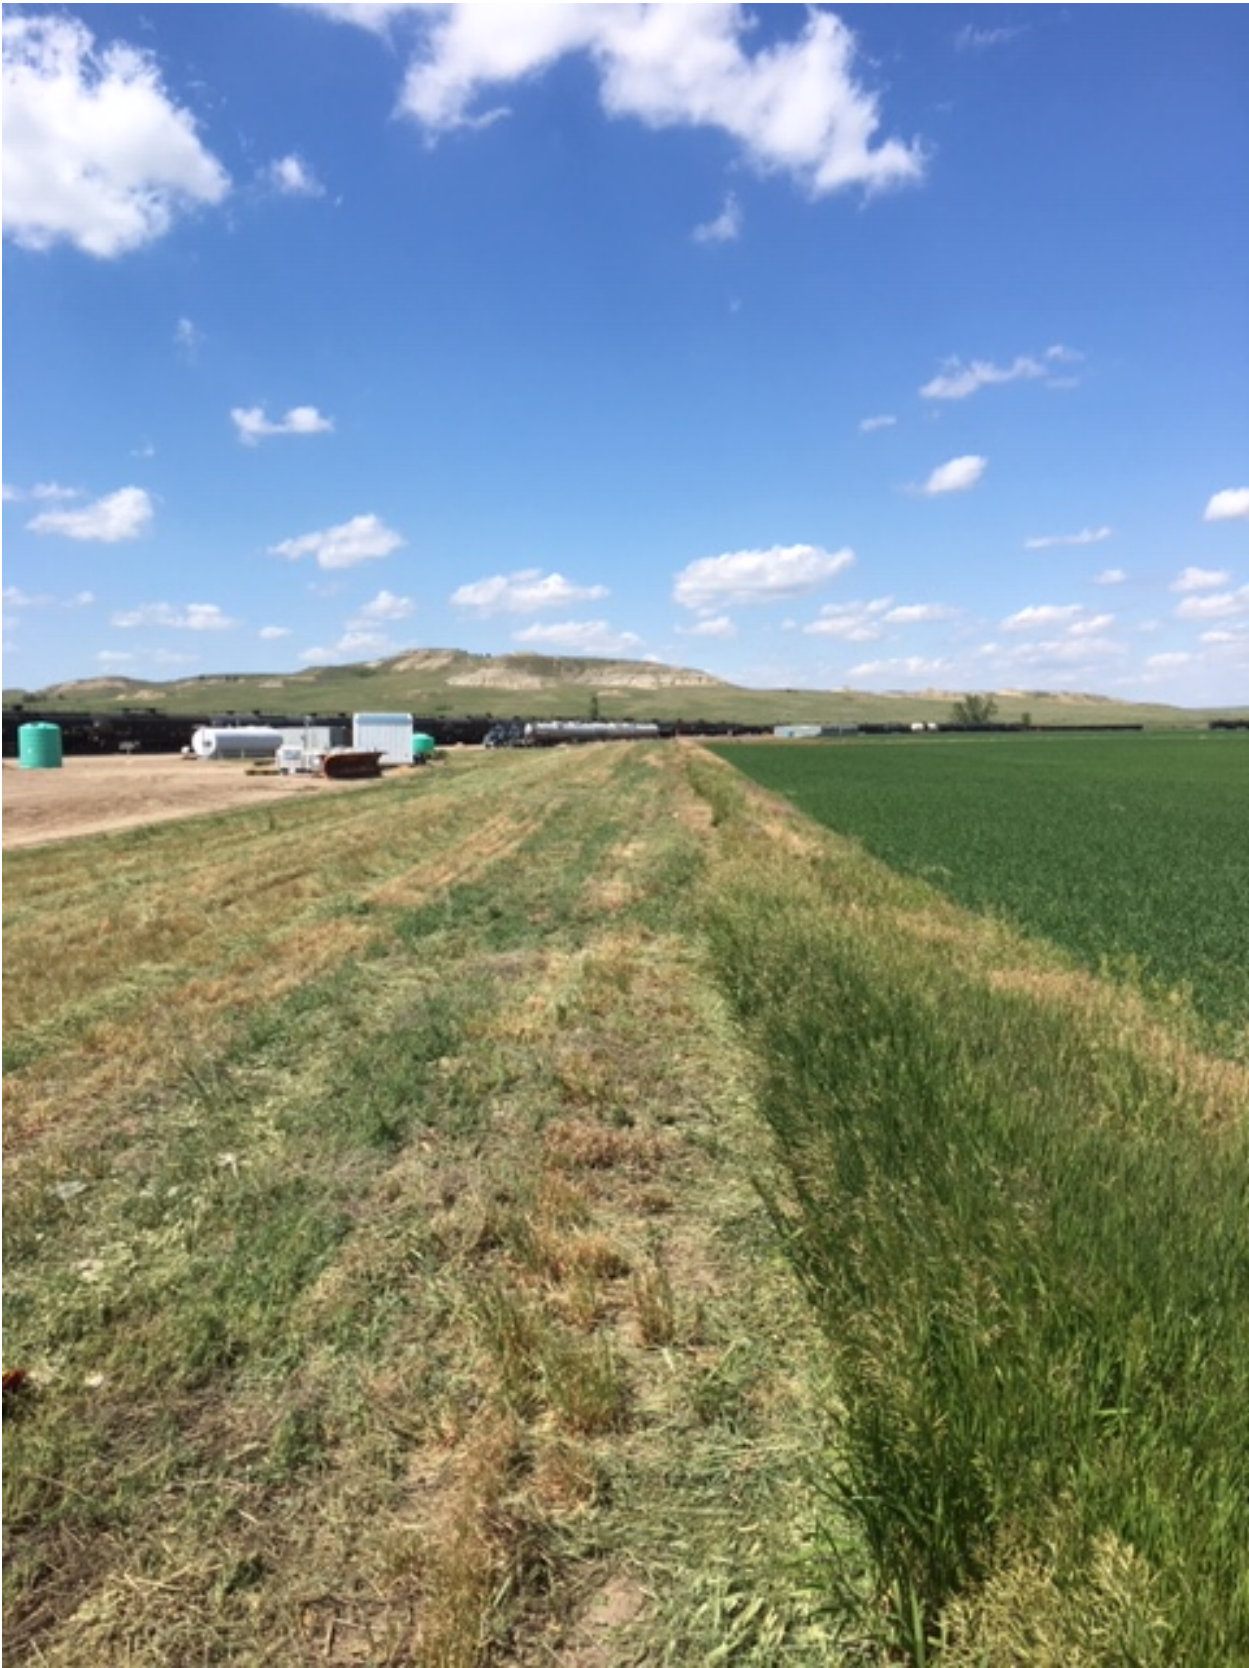
- #22 - STA 50+00 BK, area is well vegetated next to the farmed crop land. At STA 46+50 (bend in pipeline to the east) area becomes farmed cropland once again.

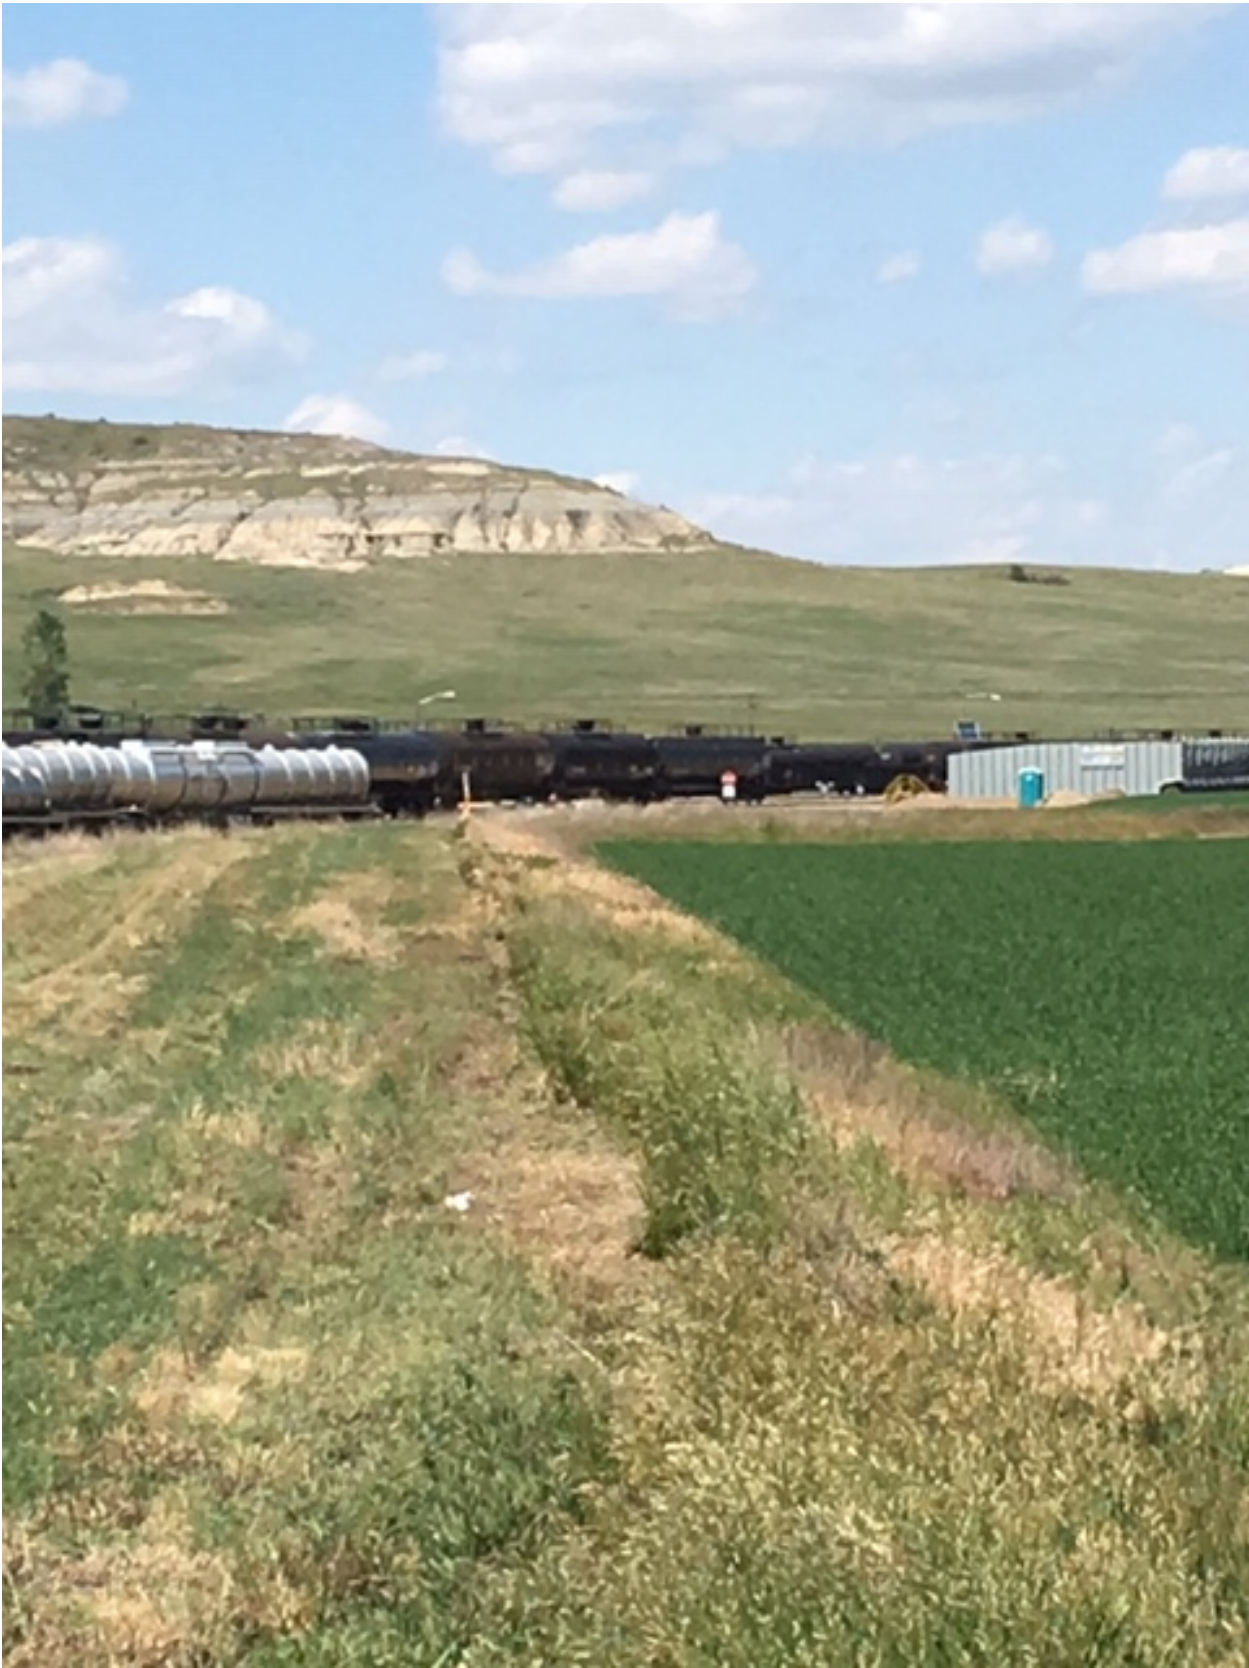
- #23 - STA 45+50 BK, area is well vegetated next to the farmed crop land.
- #24 - STA 25+00 AH, area vegetated with crop land over soil storage areas.
- #25 - STA 25+00 BK, area vegetated with crop land over soil storage areas.

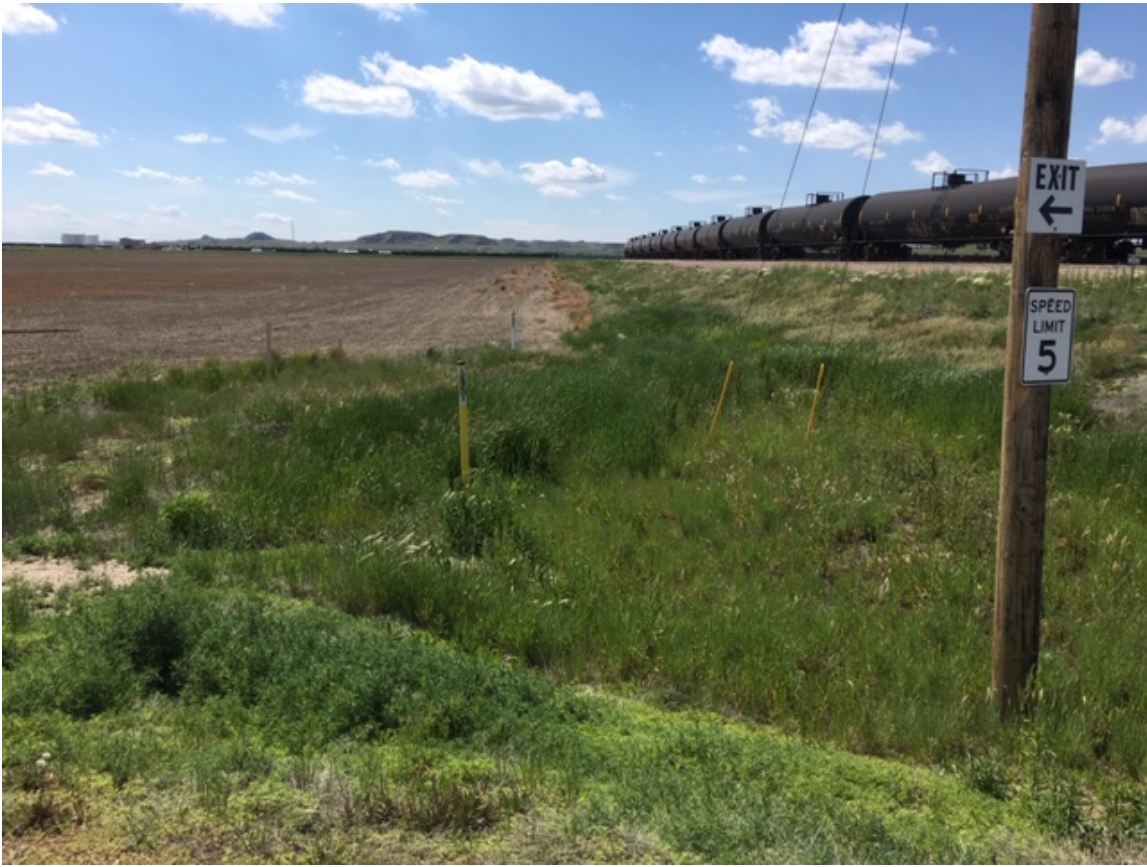
- #26 - STA 13+50 AH, area vegetated with crop land over soil storage areas. Vegetative cover to the RT matches existing vegetation in the drainage ditch areas.

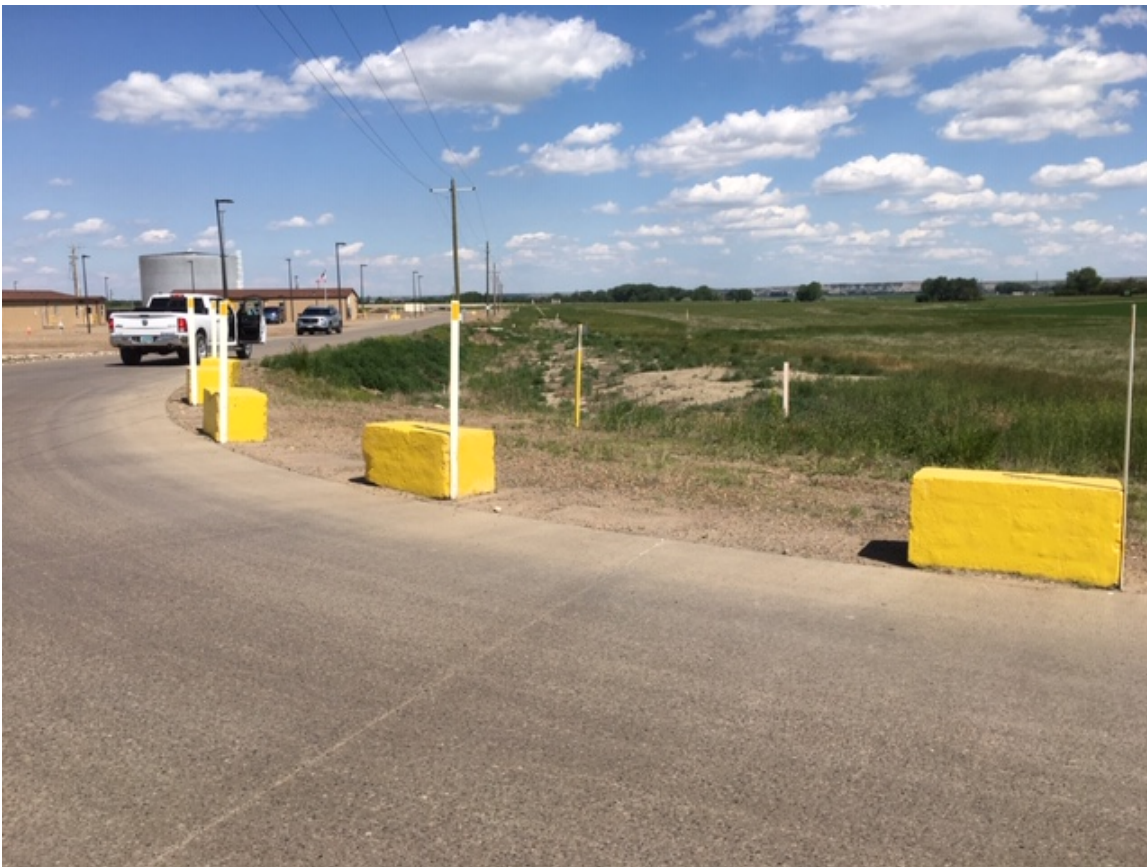
- #27 - STA 13+50 BK, crossing of the access roadway to Savage Bakken
- #28 - STA 13+00 BK, various barren areas on the LT of the pipeline alignment on the drainage ditch slope.
