Savage Bakken Connector

Case No. PU-16-753

Reclamation and Revegetation Inspection Report

RE: Case No. PU-16-753
Savage-Bakken Connector Line
10-Inch Crude Oil Pipeline Project -
Williams County
Reclamation and Revegetation Inspection
Report

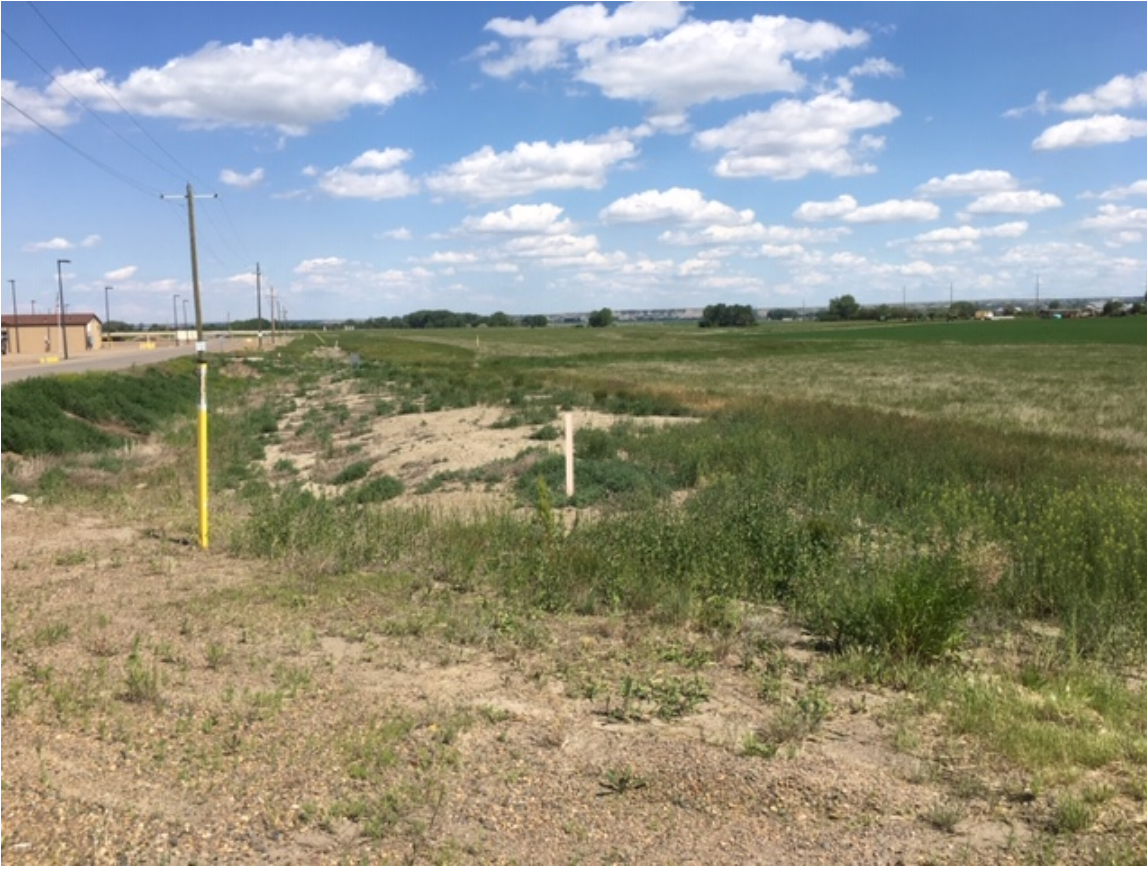
Area of concern noted between STA 6+00 - STA 13+00 where drainage ditch slope has barren areas. This area is mostly underground bored pipeline. Also area of concern is between STA 100+00 - STA 105+63.36, where vegetation was patchy and not complete in coverage. This area appears to be a low lying wet area, and may be a result of the planted vegetation not fully germinating and growing. Area did not show any signs of erosion or sediment transportation due to being the low area withing the surrounding area. Both areas show no sign of erosion but may need additional seeding/re-vegetation.

- #27 - STA 13+50 BK, crossing of the access roadway to Savage Bakken
- #28 - STA 13+00 BK, various barren areas on the LT of the pipeline alignment on the drainage ditch slope.

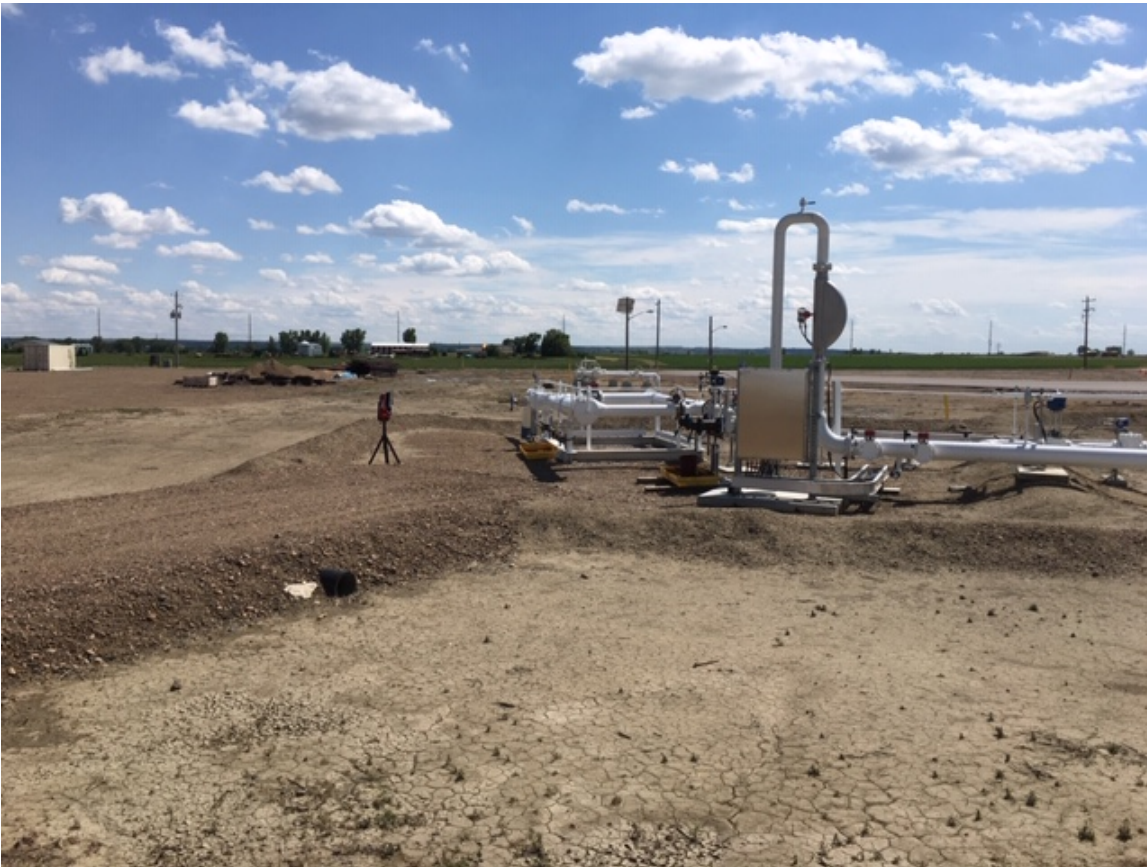
- #29 - STA 0+00 BK, area was previously gravel surface and remains gravel surface. No vegetation.
- #30 - STA 4+00 AH, vegetation established at road crossing and along the ditch line and soil storage areas.

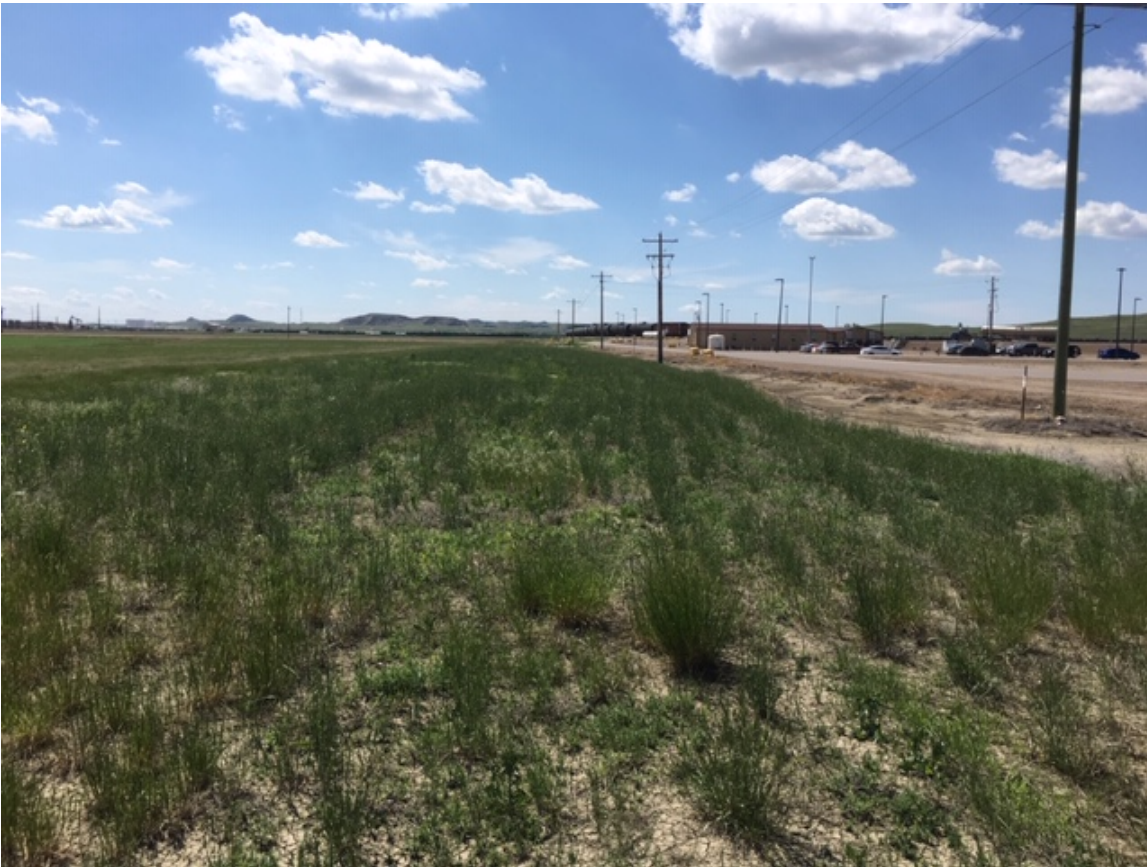
- #31 - STA 4+50 AH, Vegetation over top of pipeline and soil storage areas matching existing vegetation to (left of picture).
