Mapleton Terminal PSC Monthly Activity Report: June 2017

STORMWATER FIELD INSPECTION – MAPLETON TERMINAL CONSTRUCTION

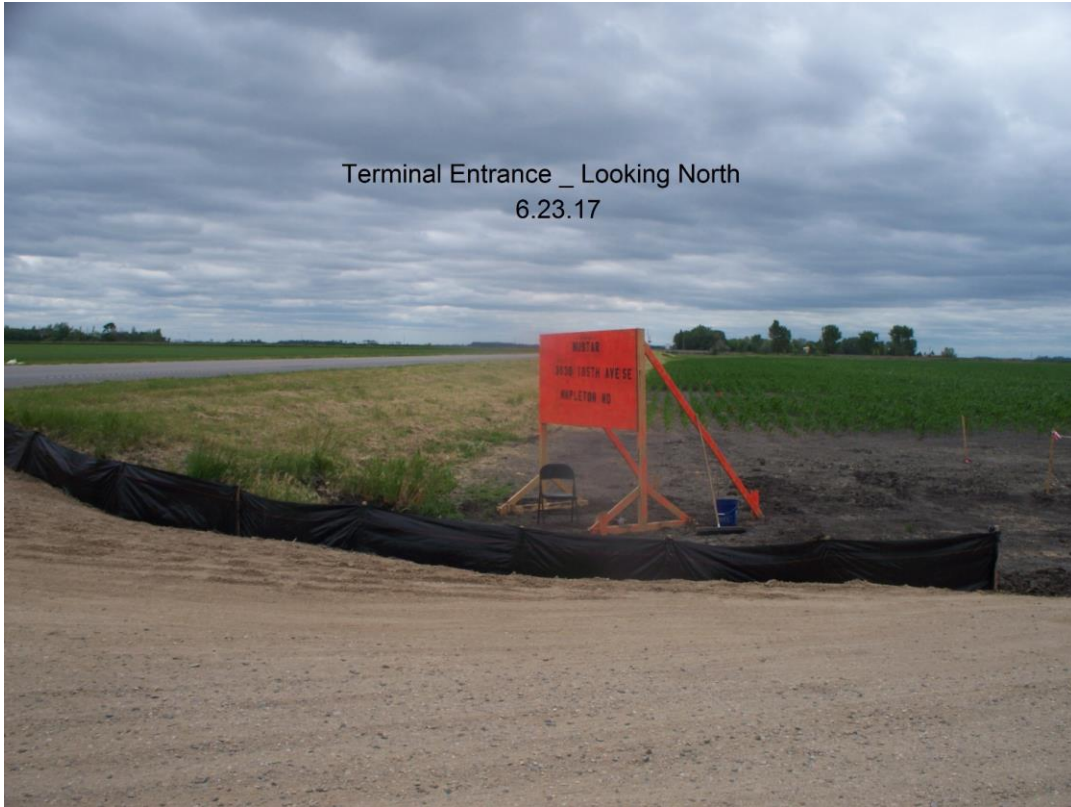
Terminal entrance looking north

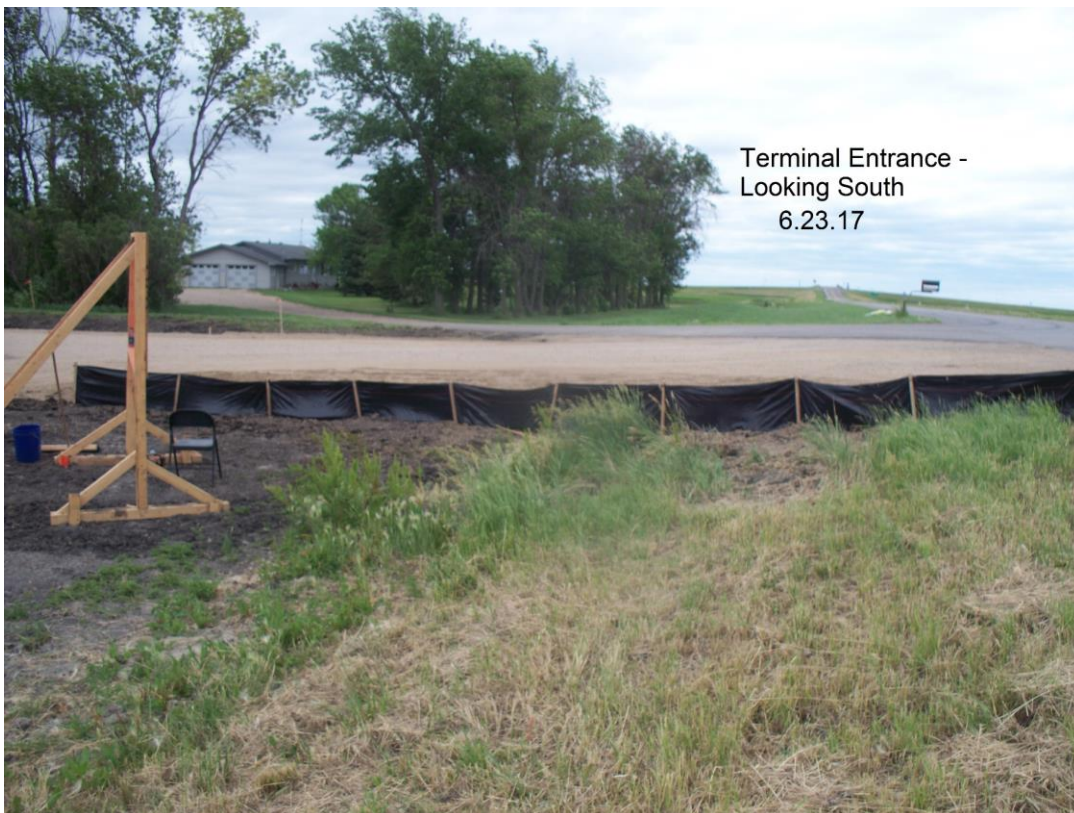
Terminal entrance, looking south

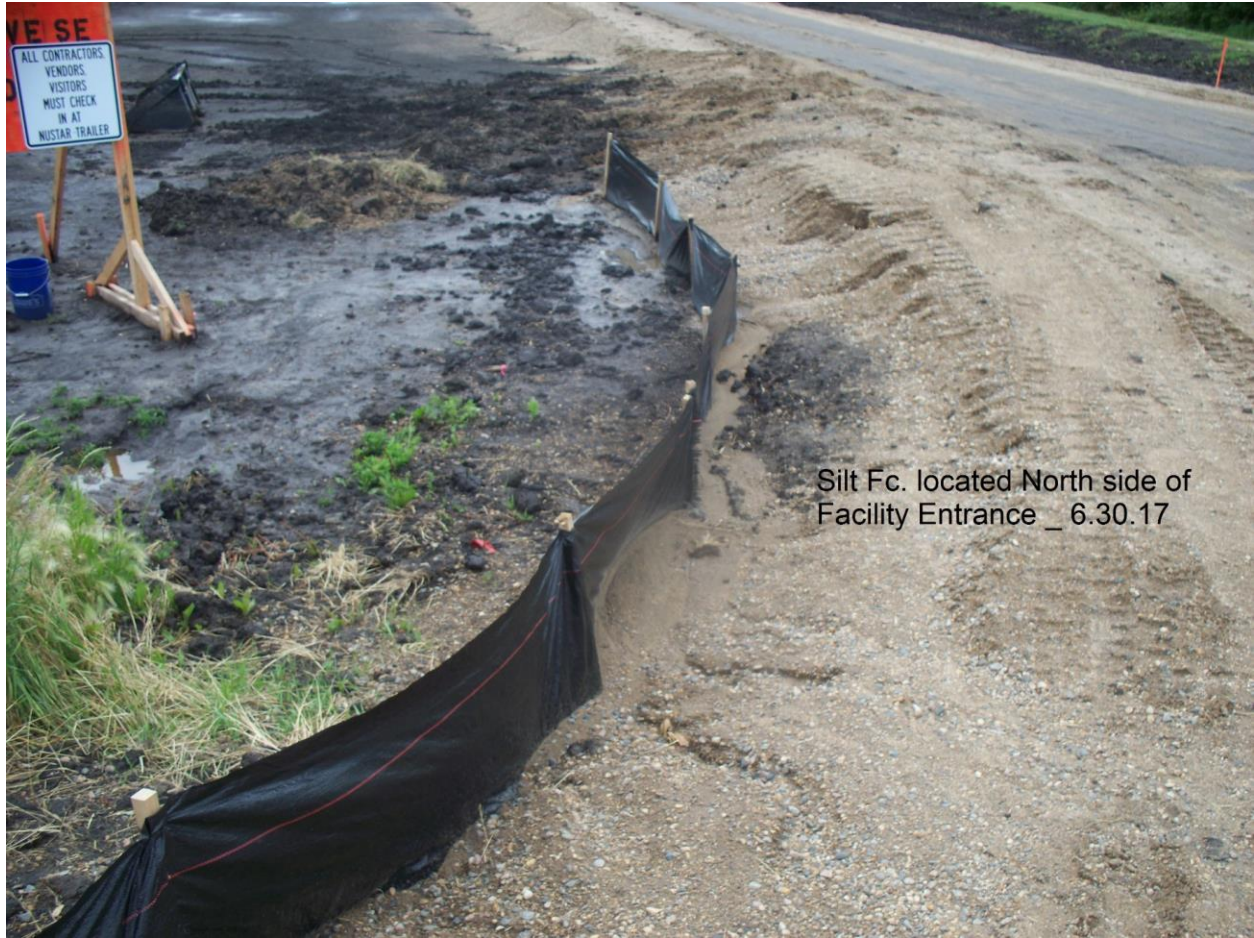
Silt Fc. located North side of
Facility Entrance _ 6.30.17

Silt fence at entrance after precipitation event of June 30, 2017
