Mapleton Terminal PSC Monthly Activity Report: July 2017

NuStar Mapleton Terminal Weekly Reports

Select Site Photographs of the NuStar Mapleton Terminal, Cass County, North Dakota

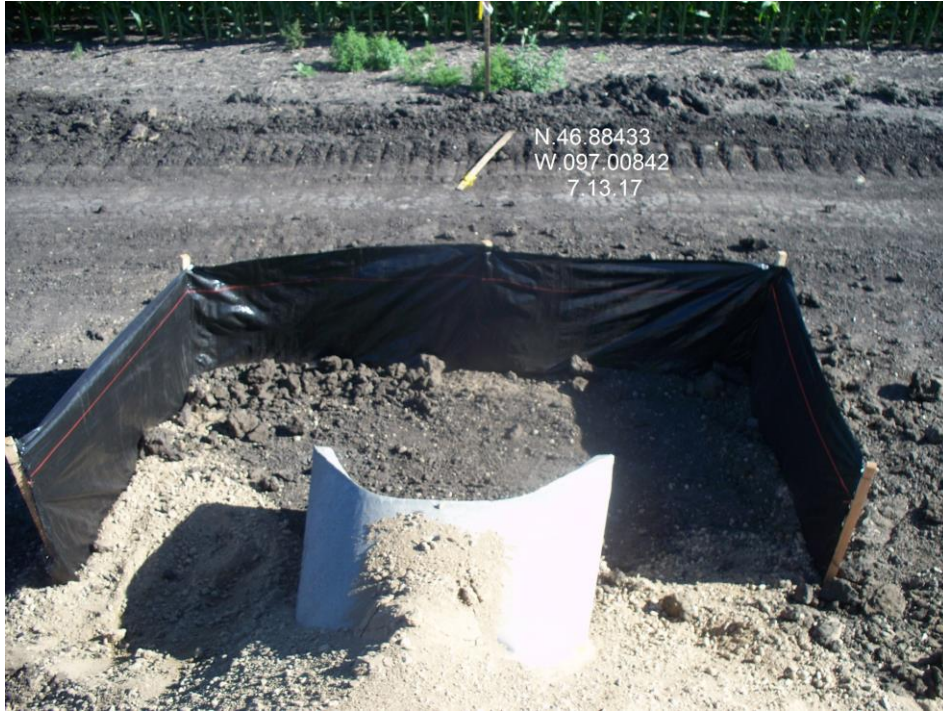
East culvert installation with silt fence

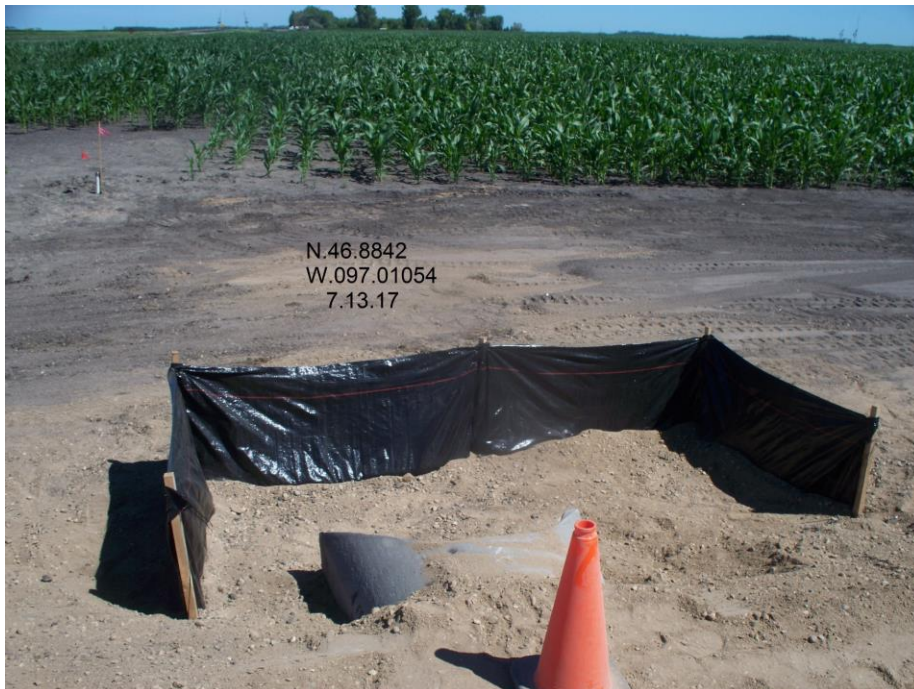
West culvert installation with silt fence

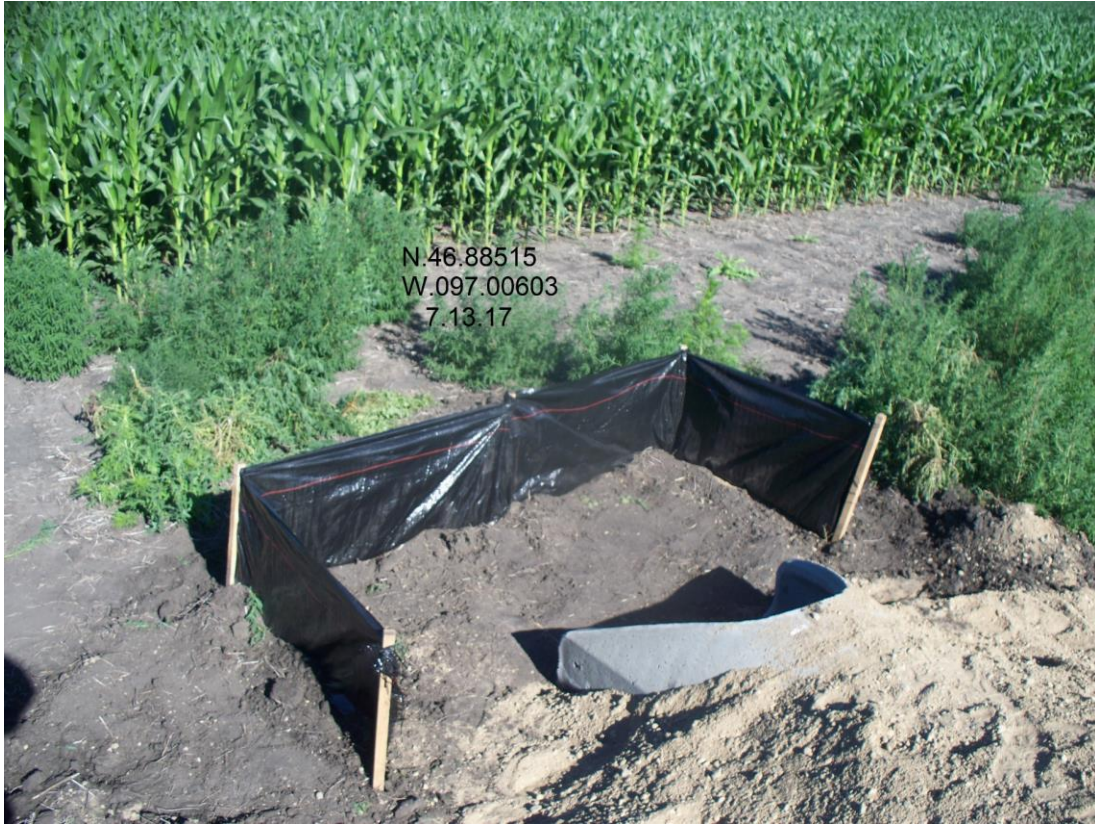
North culvert with silt fence
