RE: October 2017 Monthly Activity Report for Case No. PU-17-51 (NuStar Pipeline Operating Partnership L.P., Mapleton Terminal)

Mapleton Terminal PSC Monthly Activity Report: October 2017

NuStar Mapleton Terminal Inspection Reports

STORMWATER FIELD INSPECTION – MAPLETON TERMINAL CONSTRUCTION

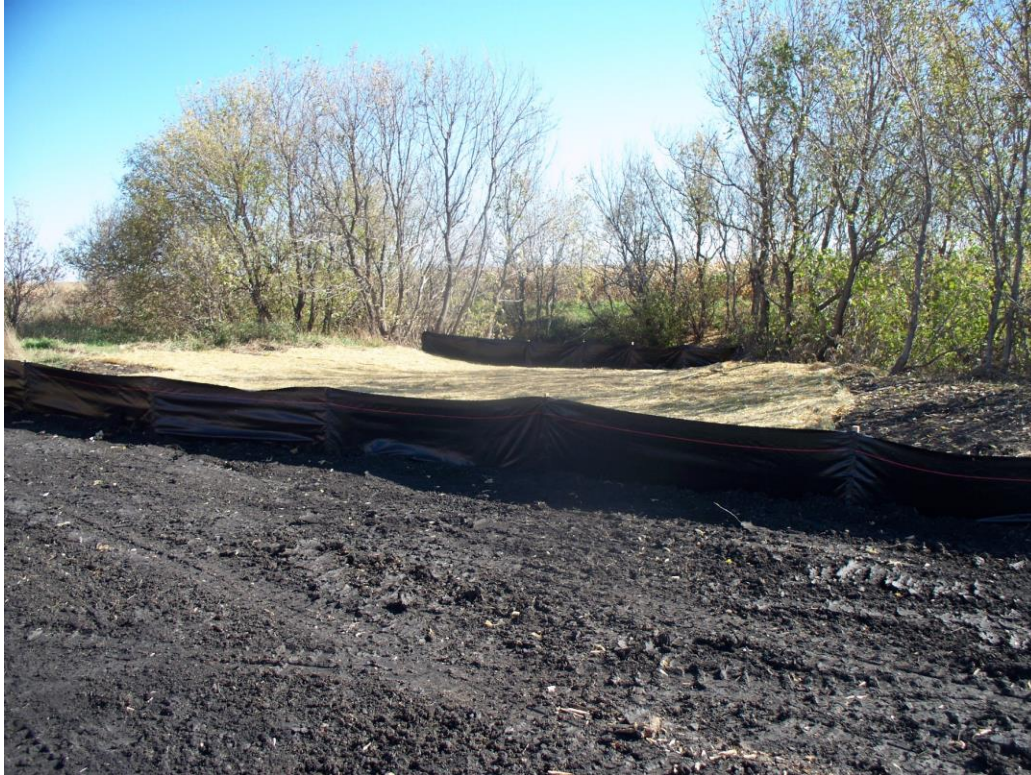
Silt fence and erosion control blanket installed near tributary to the Sheyenne River

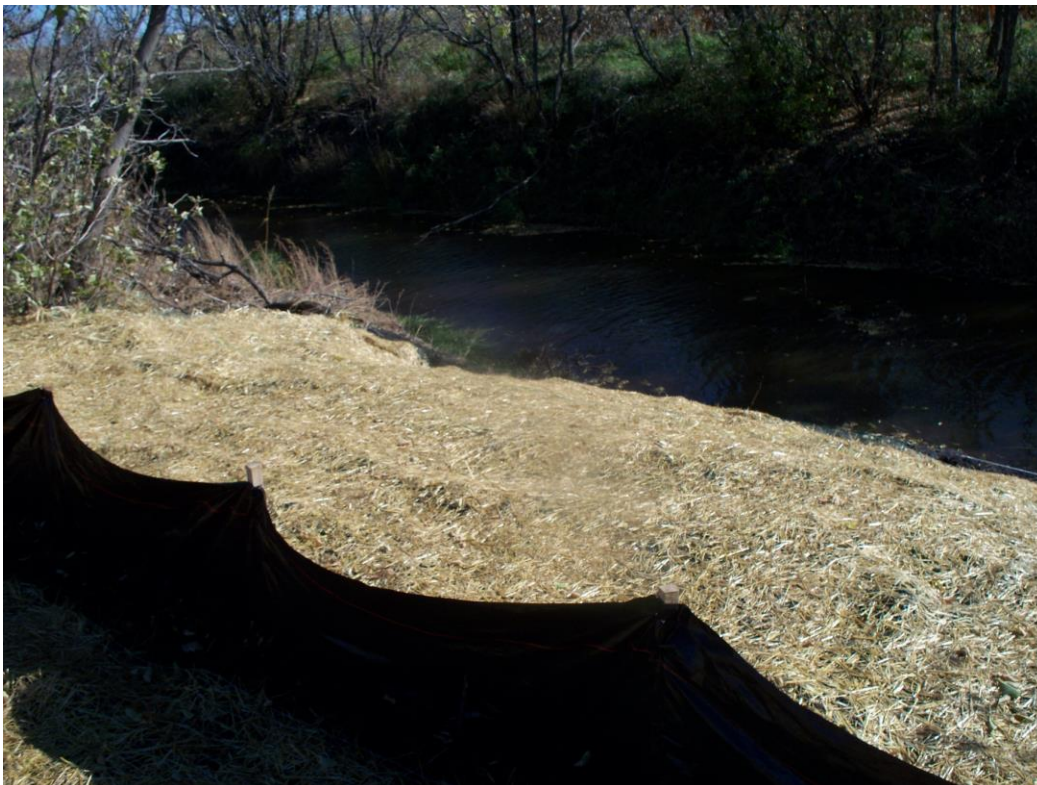
Silt fence, erosion control blanket, and tributary to Sheyenne River

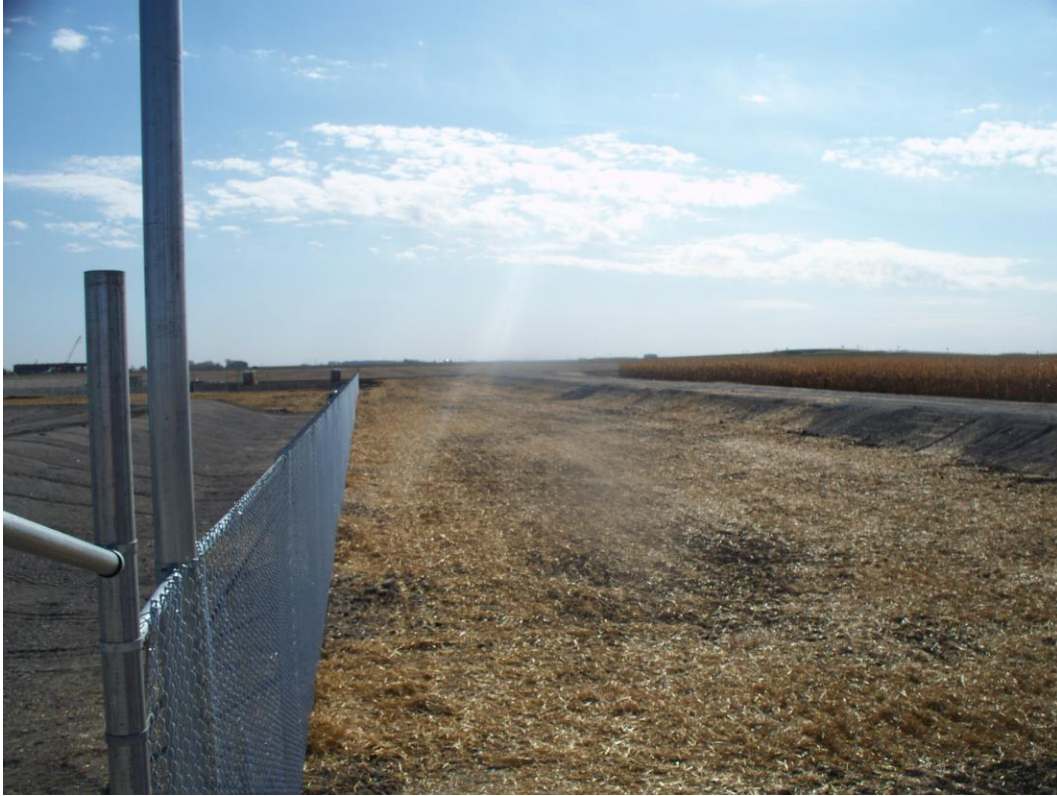
Seeding/mulching at terminal site; 165th Avenue to the right, looking south.

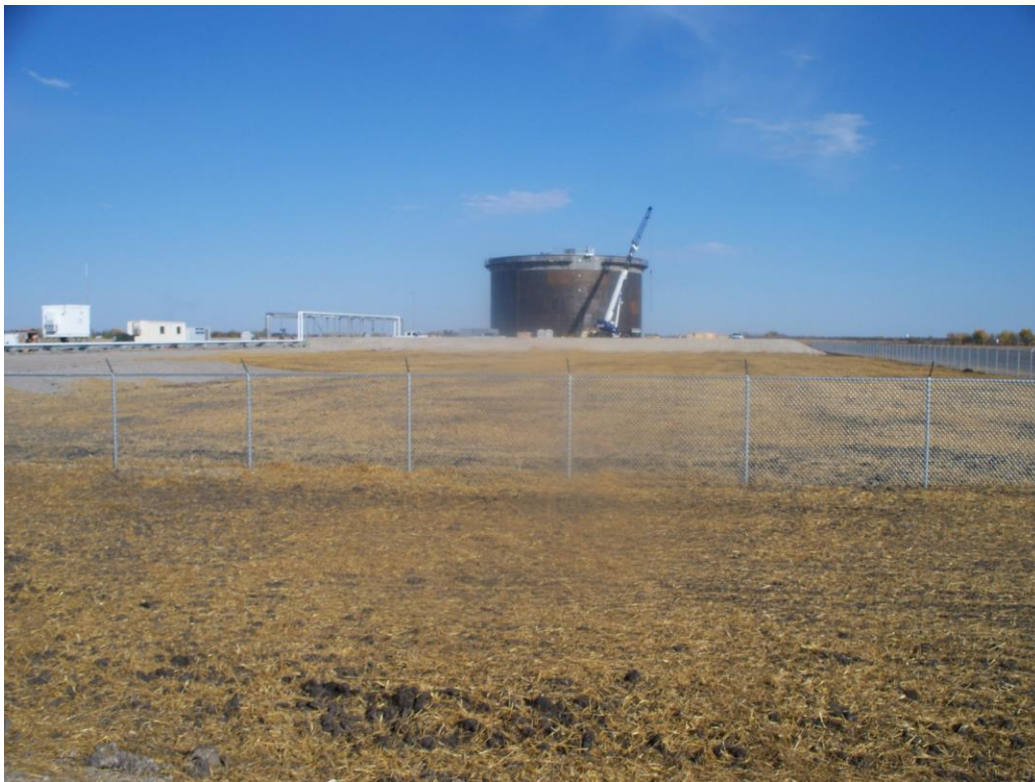
Tank construction nearing completion; seeding of terminal site, looking east.

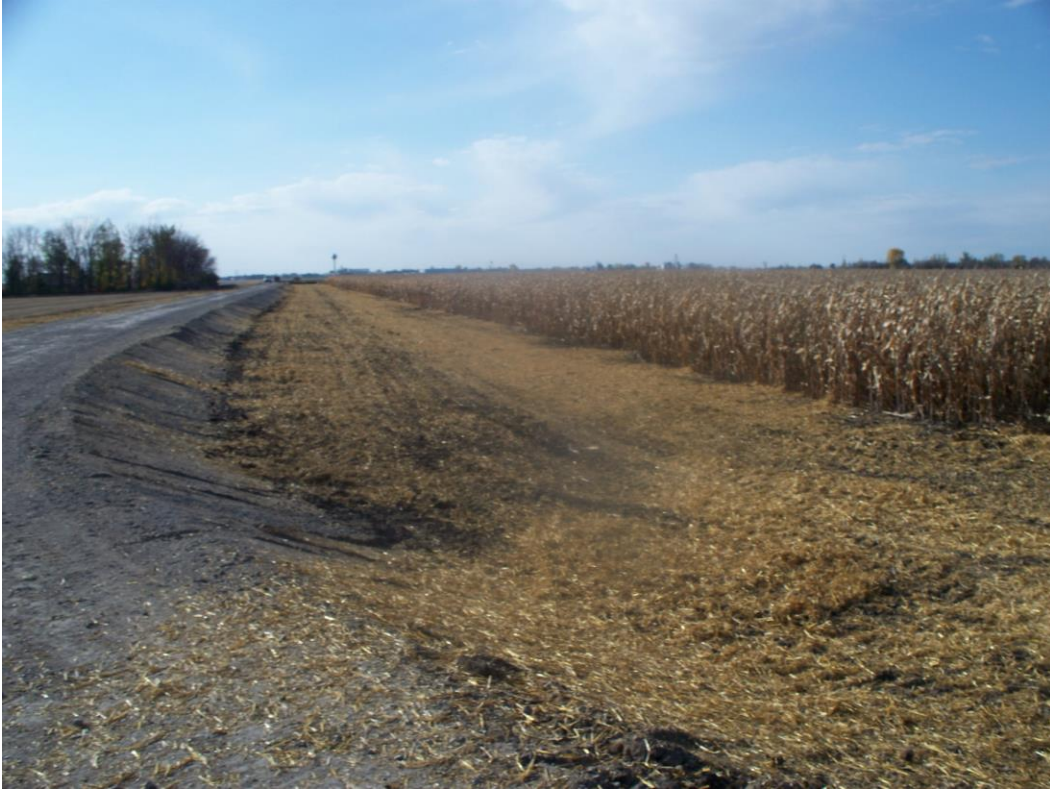
Terminal access road, looking west.

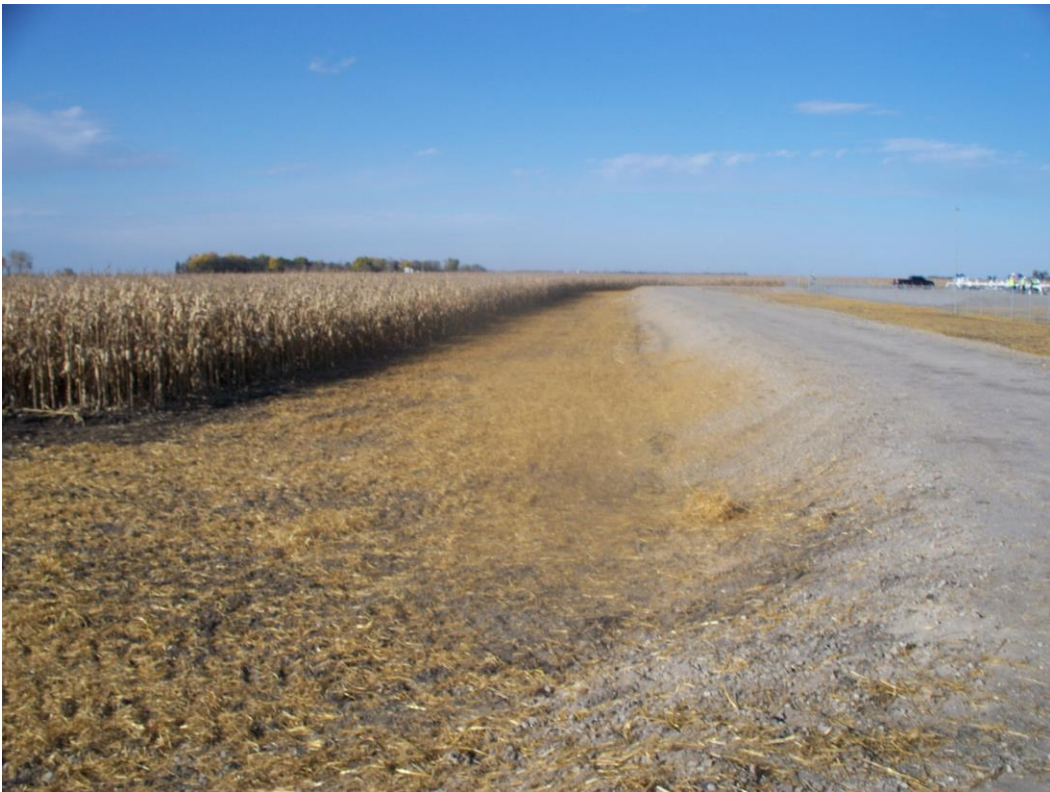
Terminal access road, looking north.
