Interim Topsoil Inspection Report Cenex 10" Refined Fuels Pipeline PU-17-97

Prepared for:
**North Dakota
Public Service Commission**

PU-17-97 CONSTRUCTION INSPECTION

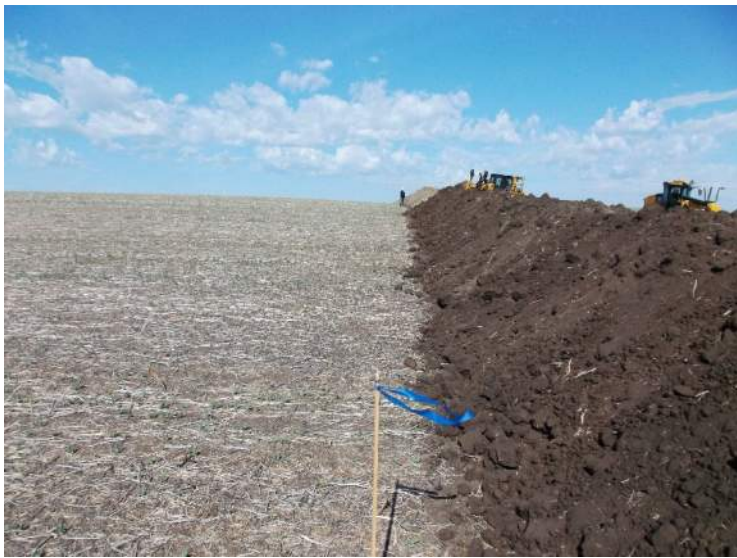
Observation Point: 4

Photo Description: Topsoil properly stockpiled within ROW boundary.

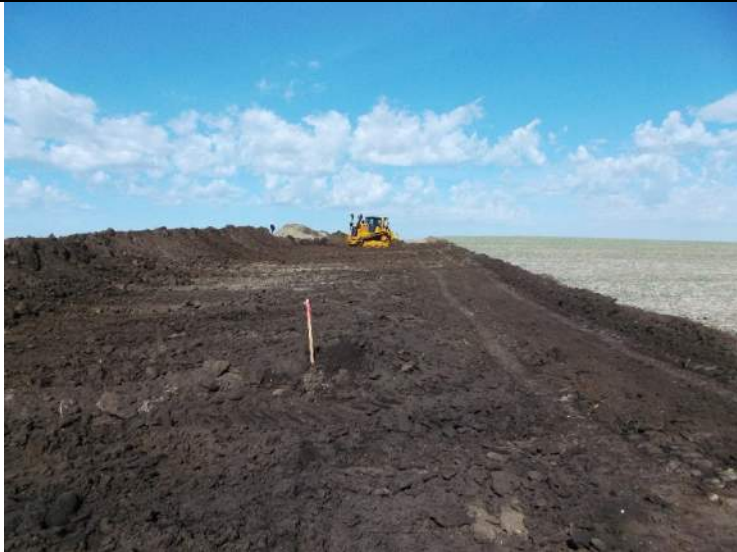
Observation Point: 5

Photo Description: ROW stripped of topsoil to approximately 12 inches on a backslope of Williams-like soil.

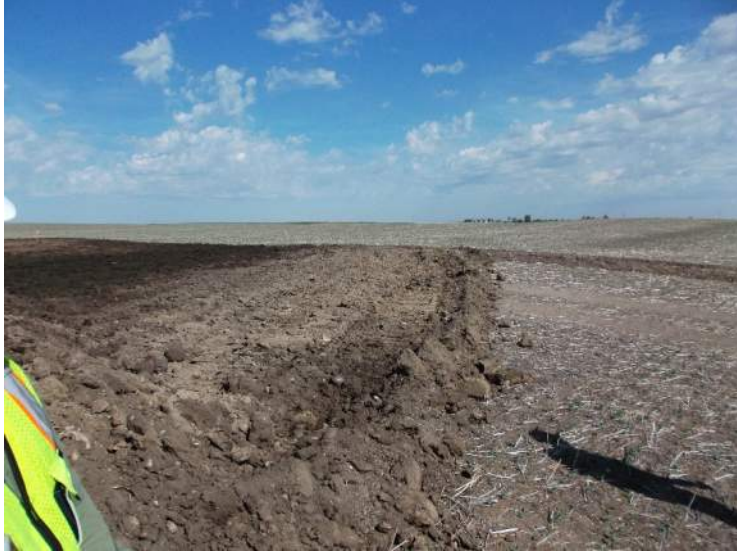
Observation Point: 7

Photo Description: Topsoil stripped slightly to deep by approximately 2-3 inches. Limited topsoil present. Naturally poor soil quality on shoulder slope. Zahl-like soil. Stripping terminated at location.

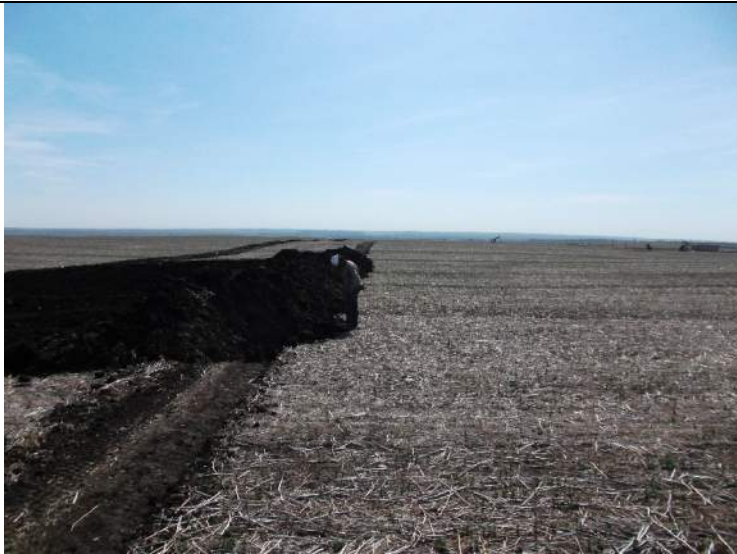
Observation Point: 8

Photo Description: Topsoil stockpile slightly beyond ROW boundary. Discussed and resolved with on-site inspectors.

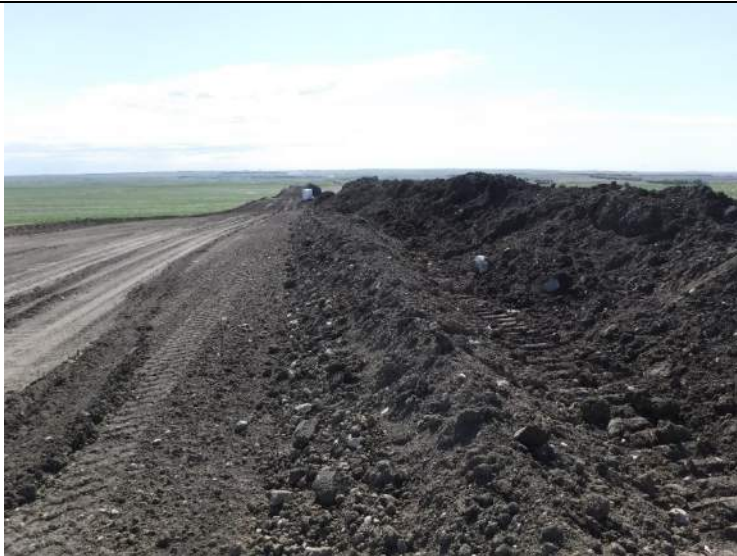
Observation Point: 603c

Photo Description: View of the soil stockpiles. It appears that subsoil was properly stockpiled separate from topsoil.

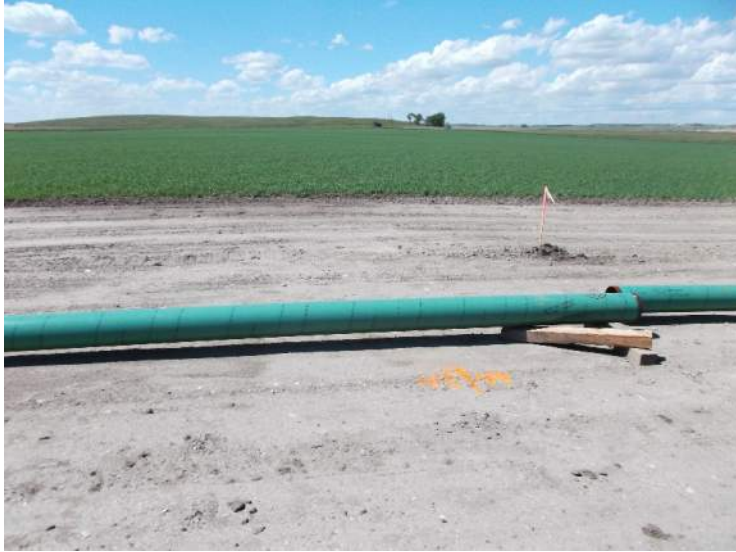
Observation Point: 65b

Photo Description: Opposite side of ROW. Stake shows depth of topsoil removed. Approximately 2-3 inches.

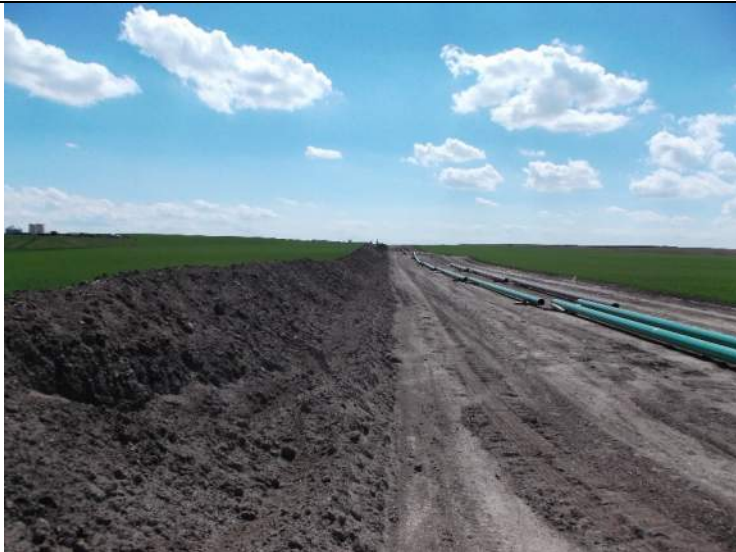
Observation Point: 66

Photo Description: Topsoil and subsoil stockpiles. Most of subsoil used to grade and level ROW. Limited amount left for stockpile. Subsoil stockpile touching topsoil stockpile. Issue will be resolve with motor grader activities after filling trench.

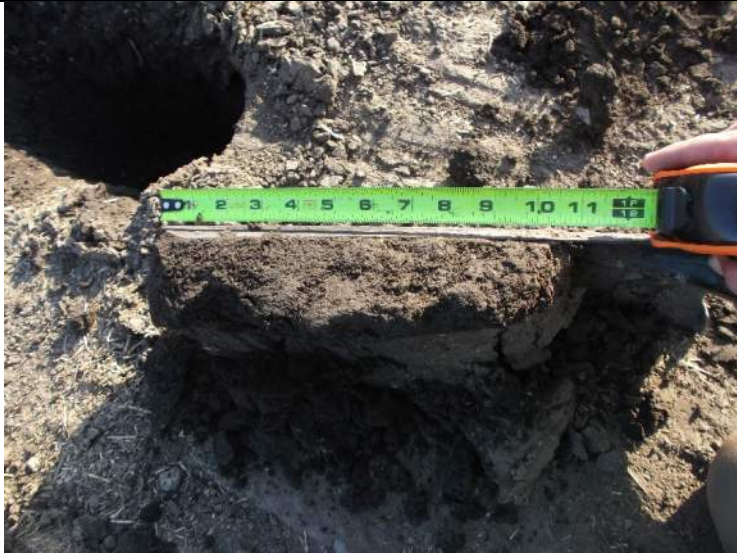
**Observation Point: 74**

Photo Description: Approximately 10-11 inches Topsoil remaining after initial topsoil removal on southside of ROW. Issue brought to the attention of Mr. Oliver (Frontier). Resolved with contractor and later fixed.

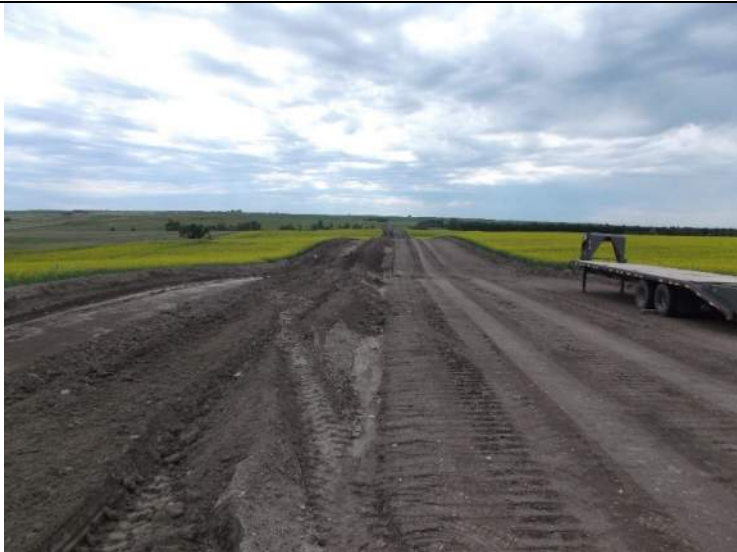
**Observation Point: 85**

Photo Description: Buried pipe. Soil covering pipe and soil on southside of ROW is violently effervescent. Northside of ROW and topsoil stockpile is non-effervescent.

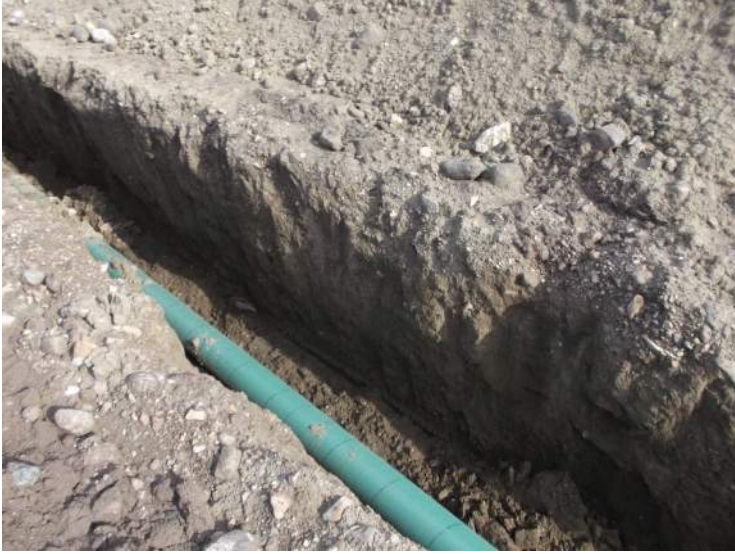
Observation Point: 93

Photo Description: Trench with a pipe depth of approximately 60 inches. No topsoil horizon present on trench wall.
