# Topsoil Removal Inspection Report Cenex 10" Refined Fuels Pipeline PU-17-97

*Prepared for:*  
**North Dakota  
Public Service Commission**

**WENCK Associates, Inc.**  
301 1st Street NE, Suite 202  
Mandan, ND 58554  
Phone: 701-751-3370  
Fax: 763-479-4242

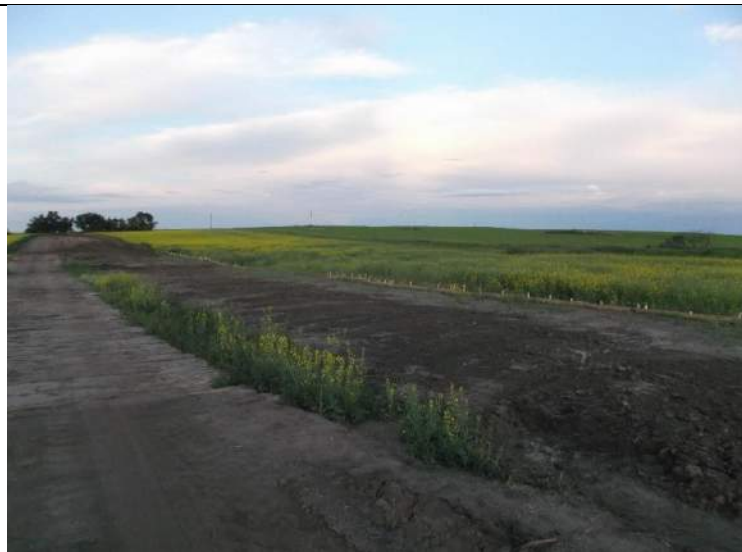
**Observation Point: 166b**

Photo Description: Topsoil has been replaced over trenched area correctly.

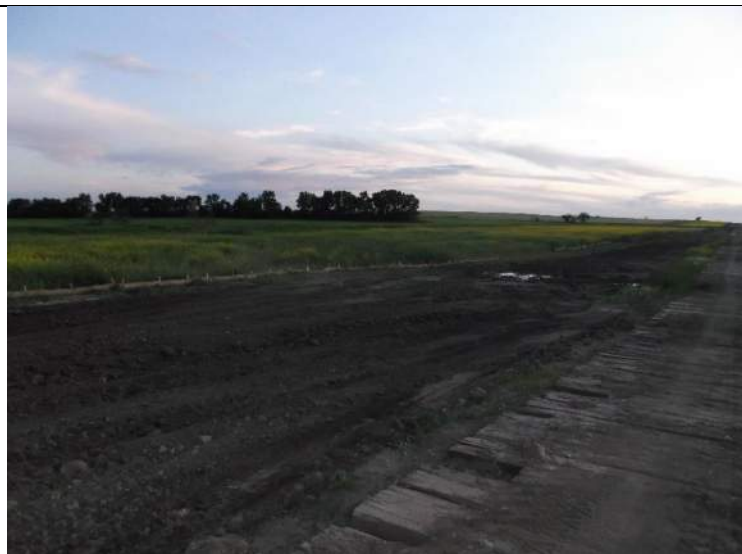
**Observation Point: 167a**

Photo Description: Topsoil replaced over trenched area correctly.

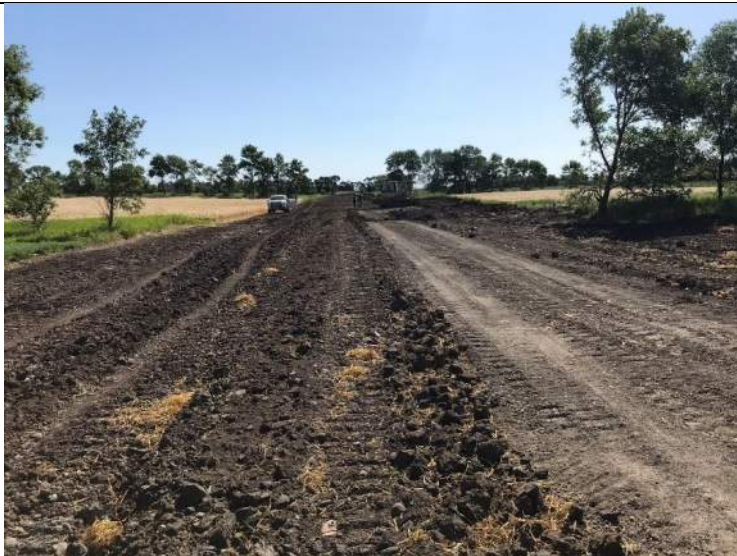
**Observation Point: 648a**

Photo Description: Topsoil reclamation occurring late due to wet period during previous month. Topsoil was reapplied and then ripped to alleviate deep compaction. Ripping mixed subsoil with topsoil in these areas. Recommended ripping before topsoil reapplication.

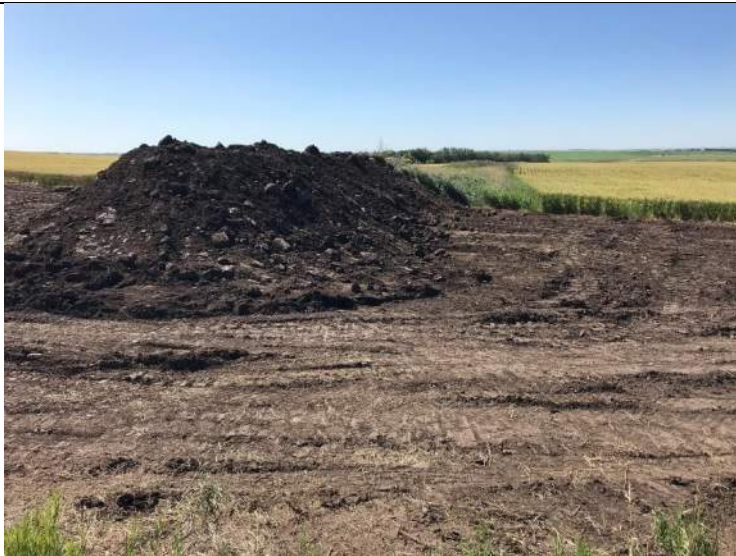
**Observation Point: 649b**

Photo Description: Rock and soil berm was removed during initial topsoil stripping and replaced after pipeline installation. Extends to the south as seen in the photo.

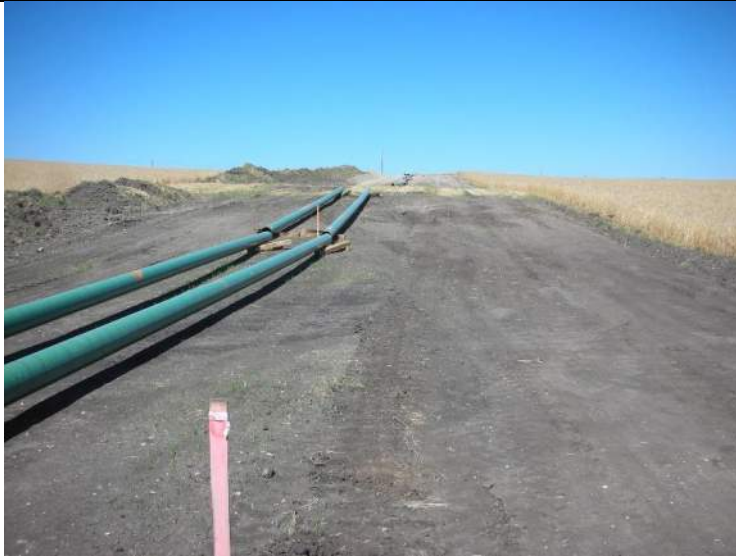
**Observation Point: 2732**

Photo Description: Location of ROW which is recommended to have an additional 3-inches stripped.

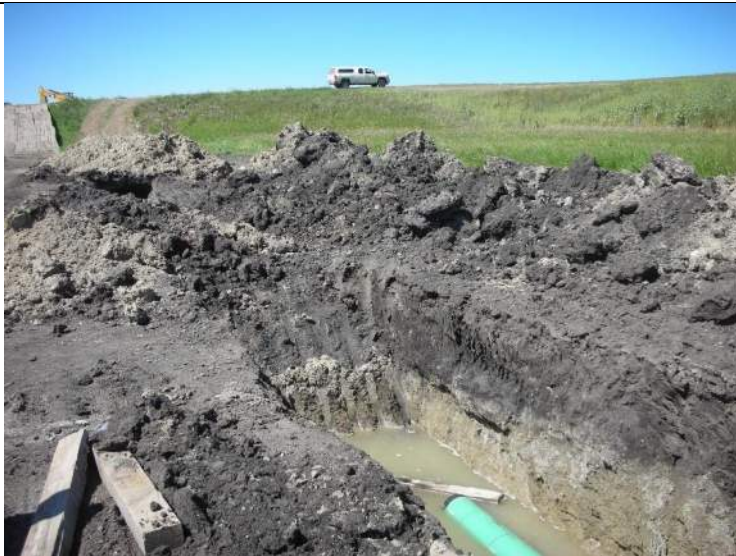
**Observation Point: 2735**

Photo Description: Isolated area of mixing & inadequate strip depth.

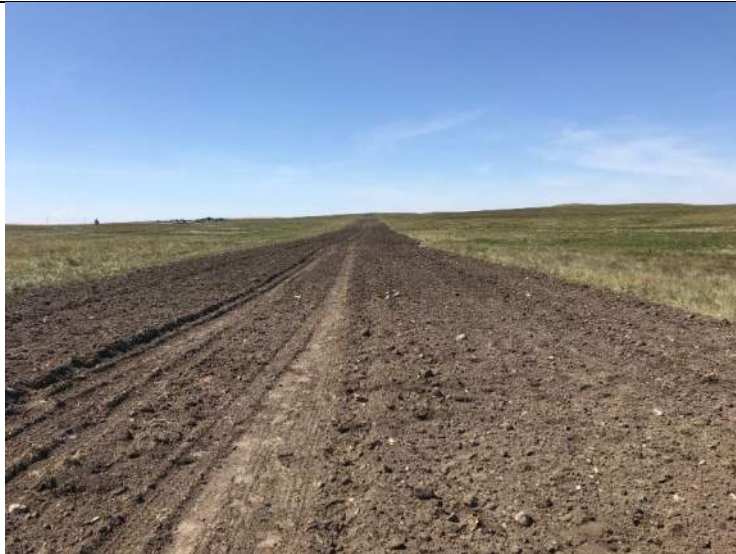
**Observation Point: 901**

Photo Description: Satisfactory reclamation of ROW. Recommend rock picking.
