# Construction Inspection Report Cenex 10" Refined Fuels Pipeline PU-17-97

Prepared for:  
**North Dakota  
Public Service Commission**

**WENCK Associates, Inc.**  
301 1st Street NE, Suite 202  
Mandan, ND 58554  
Phone: 701-751-3370  
Fax: 763-479-4242

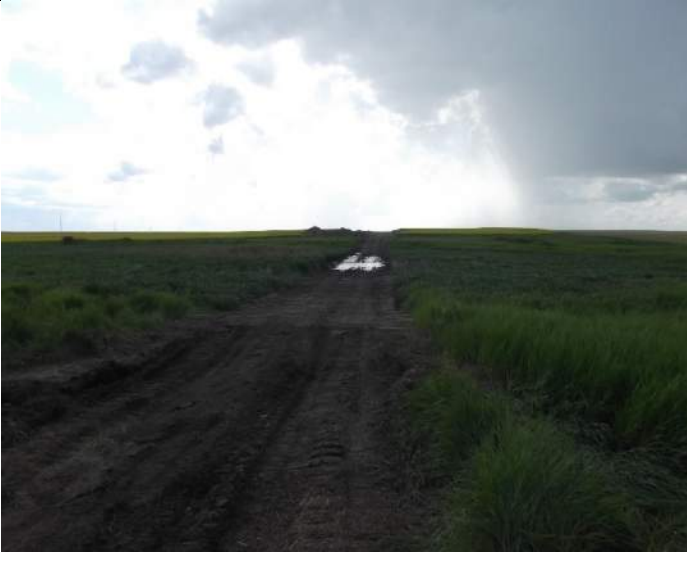
<p><b>Observation Point: 145</b>  Date Taken: July 17, 2019  Direction Photo is Taken: West  Station 4250+00 Spread 1</p> <p>Photo Description: View of wetland with timber mats in place. Mr. Bishop explained that this wetland would be bored under.</p> <p>Latitude: 48.29871  Longitude: -103.33710</p>

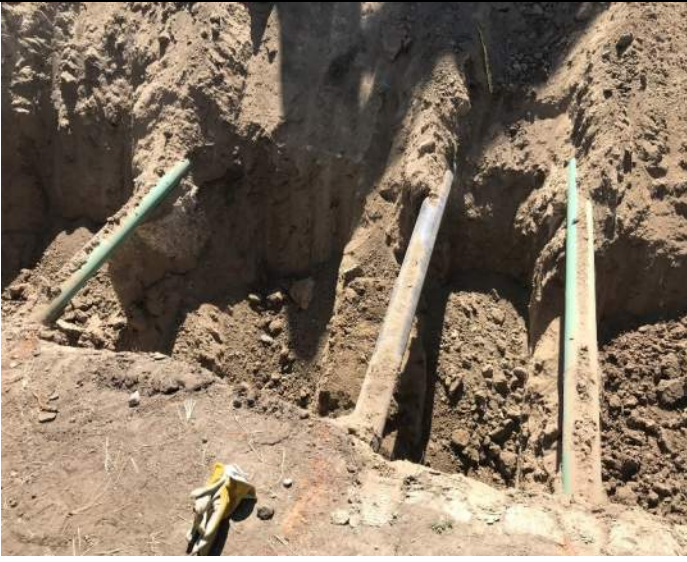
<p><b>Observation Point: 654a</b>  Date Taken: July 29, 2019  Direction Photo is Taken: NA  Station 3726+00 Spread 1</p> <p>Photo Description: Ground view of soil removal where the Cenex pipeline intersected 5 other pipelines. Confirmed the depth of pipeline installation in the current construction area to be a minimum 48 inches</p> <p>Latitude: 48.28949  Longitude: -103.53953</p>

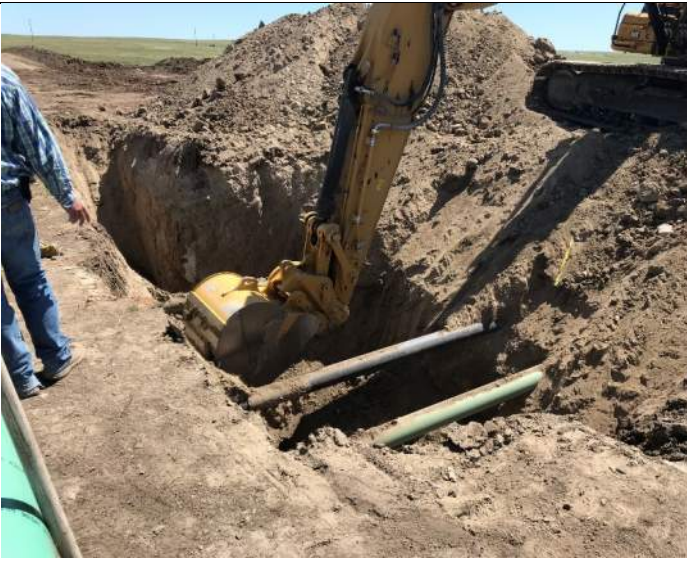
<p><b>Observation Point: 654b</b>  Date Taken: July 29, 2019  Direction Photo is Taken: NA  Station 3726+00 Spread 1</p> <p>Photo Description: Ground view of soil removal where the Cenex pipeline intersected 5 other pipelines. Spotter present in photo for backhoe operator.</p> <p>Latitude: 48.28949  Longitude: -103.53953</p>

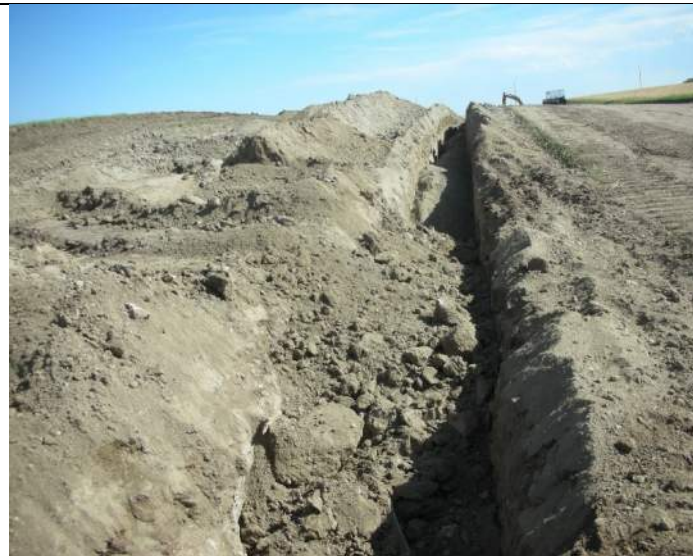
**Observation Point: 2737**

Photo Description: Initial backfilling of trench. Subsoil appropriately used.

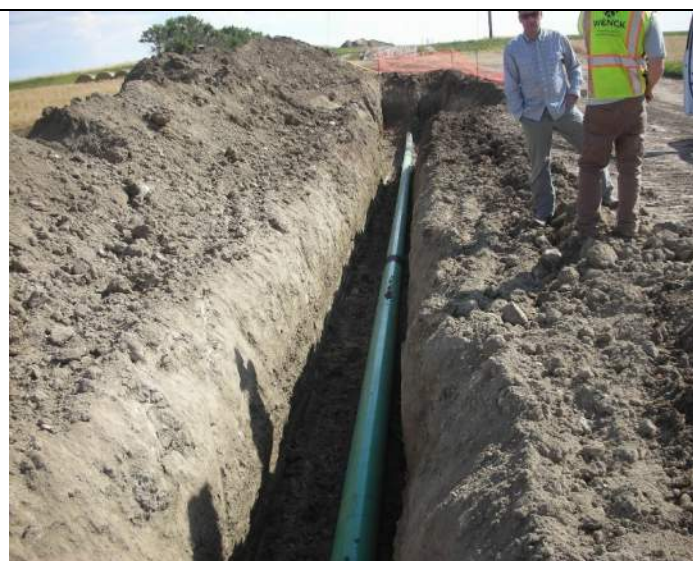
**Observation Point: 2738**

Photo Description: Pipe depth at approximately 52-inches. Appropriately no topsoil in trench profile.

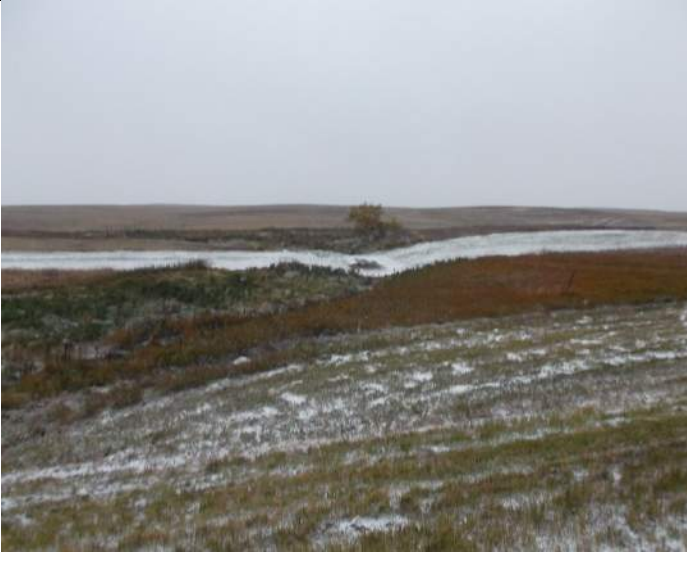
<p><b>Observation Point: 212</b>  Date Taken: October 9, 2019  Direction Photo is Taken: North  Station 3081+00 Spread 1</p> <p>Photo Description: Erosion control fabric placed in swale to mitigate against water erosion.</p> <p>Latitude: 48.277135  Longitude: -103.769380</p>
 	<p><b>Observation Point: 148</b>  Date Taken: July 17, 2019  Direction Photo is Taken: East  Station 5712+00 Spread 2</p> <p>Photo Description: Dakota skipper (<i>Hesperia dacotae</i>) habitat fenced off 10 feet from avoidance area and taped off to give 50-foot buffer.</p> <p>Latitude: 48.24469  Longitude: -102.80559</p>

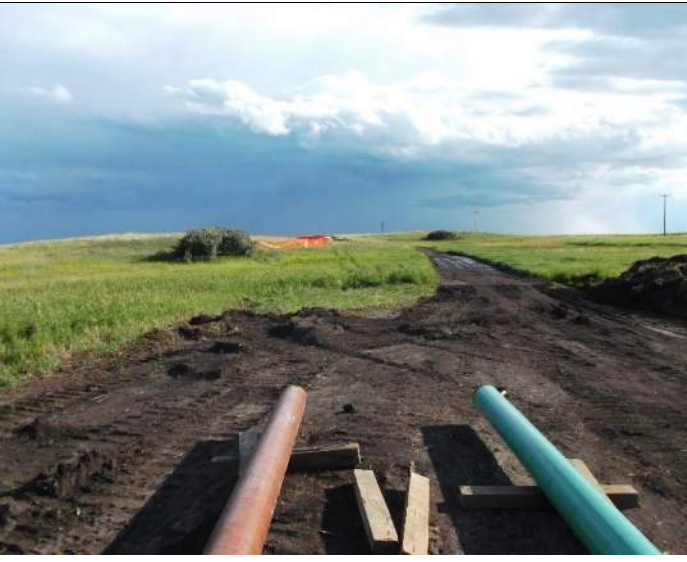
<p><b>Observation Point: 149</b>  Date Taken: July 17, 2019  Direction Photo is Taken: South  Station 5706+00 Spread 2</p> <p>Photo Description: Bore pipe to go under wetland and Dakota skipper habitat.</p> <p>Latitude: 48.24564  Longitude: -102.80500</p>

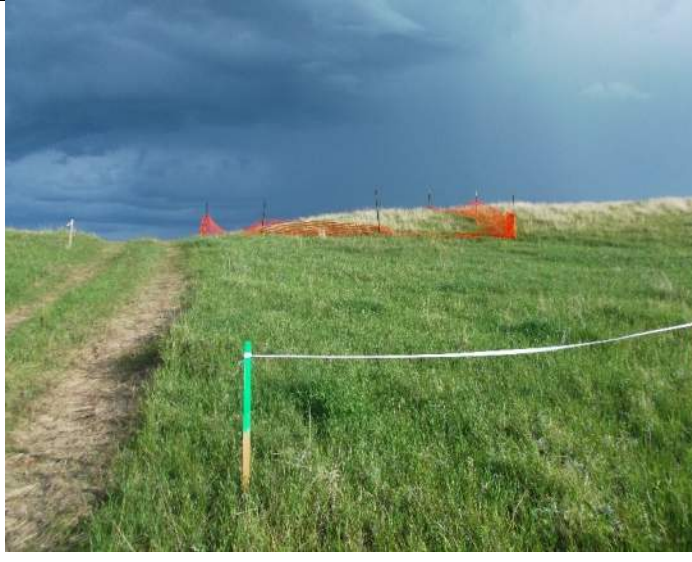
<p><b>Observation Point: 150a</b>  Date Taken: July 17,2019  Direction Photo is Taken: South  Station 6132+00 Spread 2</p> <p>Photo Description: Dakota skipper habitat fenced off 10 feet from avoidance area and taped off to give 50-foot buffer.</p> <p>Latitude: 48.20914  Longitude: -102.66808</p>

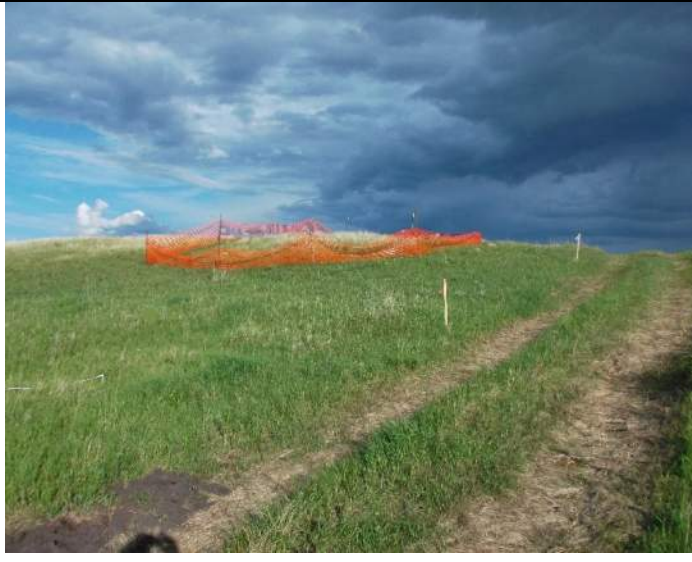
<p><b>Observation Point: 150b</b>  Date Taken: July 17,2019  Direction Photo is Taken: South  Station 6132+00 Spread 2</p> <p>Photo Description: Dakota skipper habitat fenced off 10 feet from avoidance area and taped off to give 50-foot buffer.</p> <p>Latitude: 48.20914  Longitude: -102.66808</p>

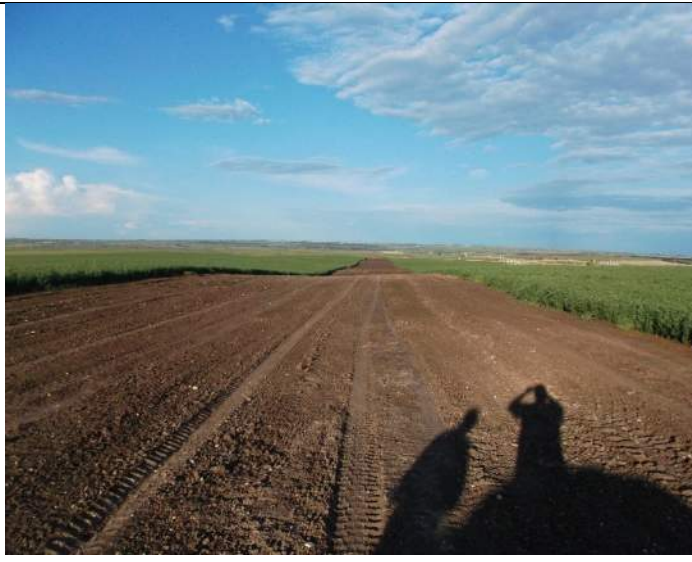
<p><b>Observation Point: 153</b>  Date Taken: July 17,2019  Direction Photo is Taken: East  Station 4787+00 Spread 2</p> <p>Photo Description: Topsoil properly redistributed along ROW. Awaiting aeration before seeding.</p> <p>Latitude: 48.28869  Longitude: -103.12904</p>

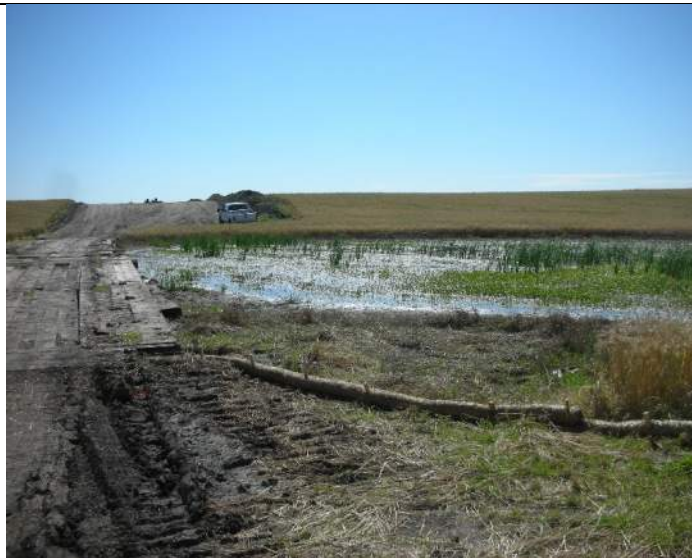
**Observation Point: 2730**

Photo Description: Overlooking wetland with straw wattles for erosion control and timber mats.

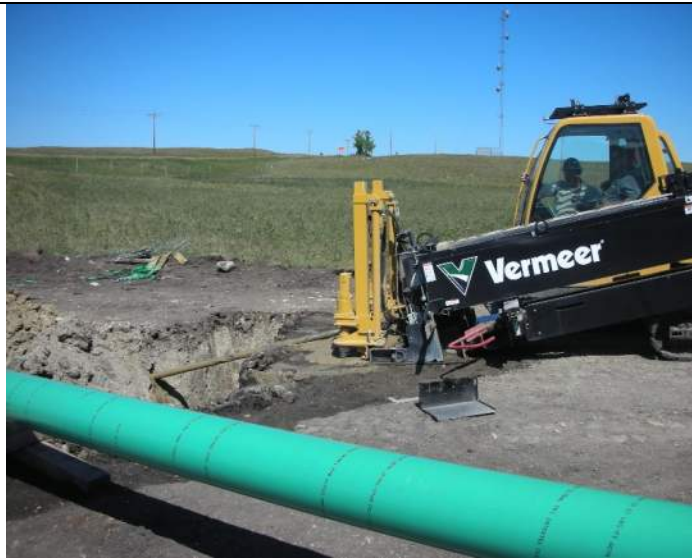
**Observation Point: 2733**

Photo Description: Contractors boring under road.

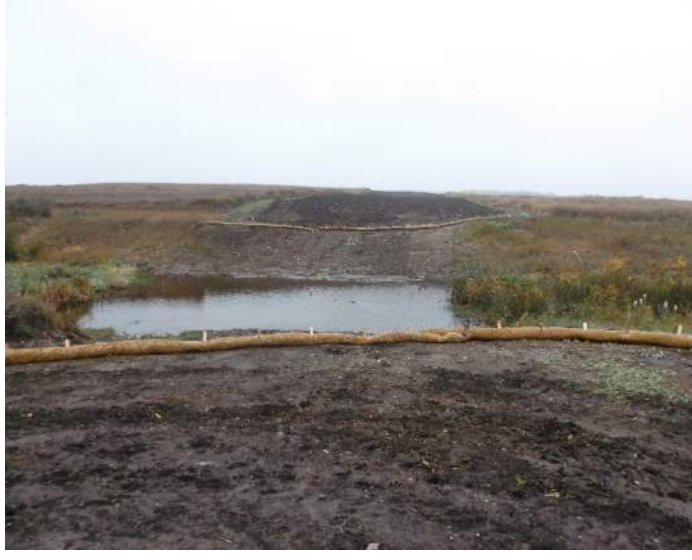
<p><b>Observation Point: 216</b>  Date Taken: October 9, 2019  Direction Photo is Taken: East  Station 5552+00 Spread 2</p> <p>Photo Description: Overlooking wetland with straw wattles. ROW was tilled by contractors and then again by landowner. This feature was trenched before persistent rains filled the basin.</p> <p>Latitude: 48.255731  Longitude: -102.848349</p>

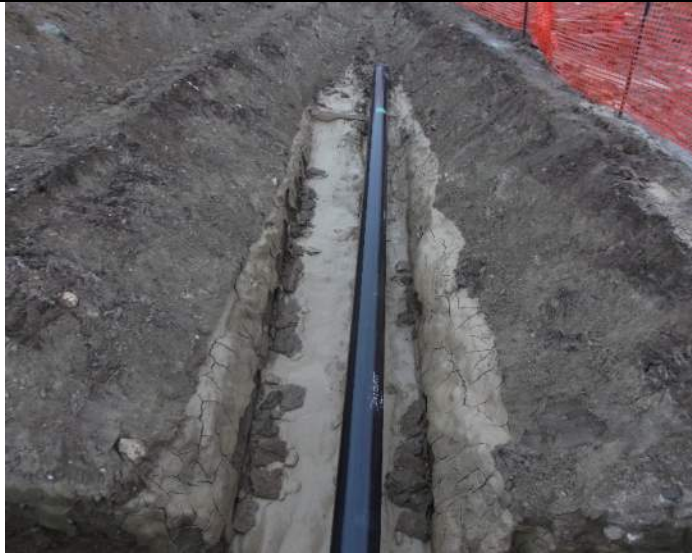
<p><b>Observation Point: 217</b>  Date Taken: October 9, 2019  Direction Photo is Taken: North  Station 5959+00 Spread 2</p> <p>Photo Description: Pipe in trench at approximately 48-inches.</p> <p>Latitude: 48.211989  Longitude: -102.734508</p>

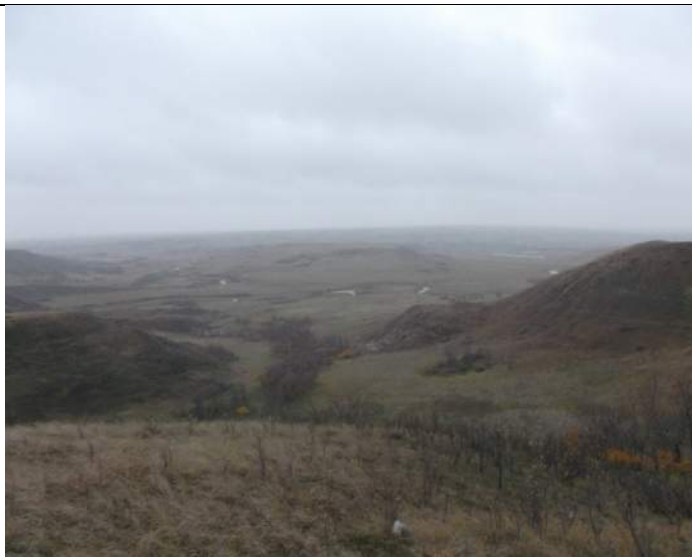
<p><b>Observation Point: 218</b>  Date Taken: October 9, 2019  Direction Photo is Taken: Northwest  Station 5945+00 Spread 2</p> <p>Photo Description: Overlooking White Earth River. This area will utilize 3 HDDs. Downhill from Observation Point, under the river, and up the hill in background continuing under a Geographical Unstable Area in N1/2 of Section 27, Township155N, Range 94W.</p> <p>Latitude: 48.215661  Longitude: -102.734507</p>
