Interim As-Built Construction Inspection Report Cenex 10" Refined Fuels Pipeline PU-17-97

Prepared for:
**North Dakota Public Service
Commission**

WENCK Associates, Inc.
301 1st Street NE, Suite 202
Mandan, ND 58554
Phone: 701-751-3370
Fax: 763-479-4242

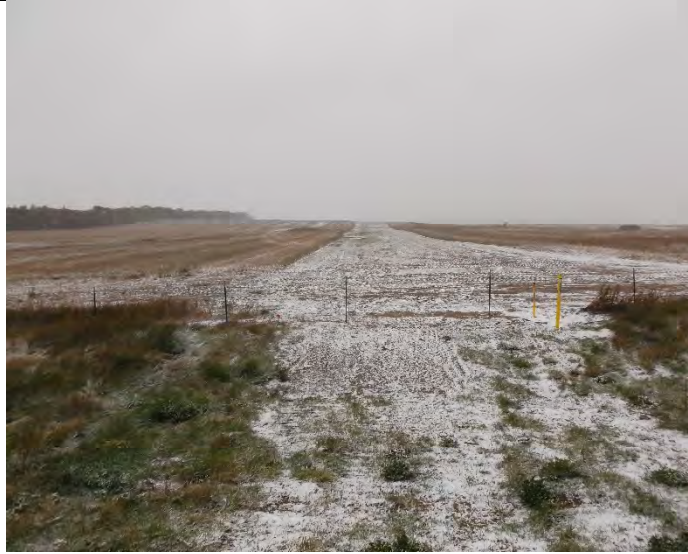
**Observation Point: 211a**

Photo Description: Overview of typical conditions within ROW, exemplifying final work product of pipe trench backfilling, topsoil replacement, and fence replacement.

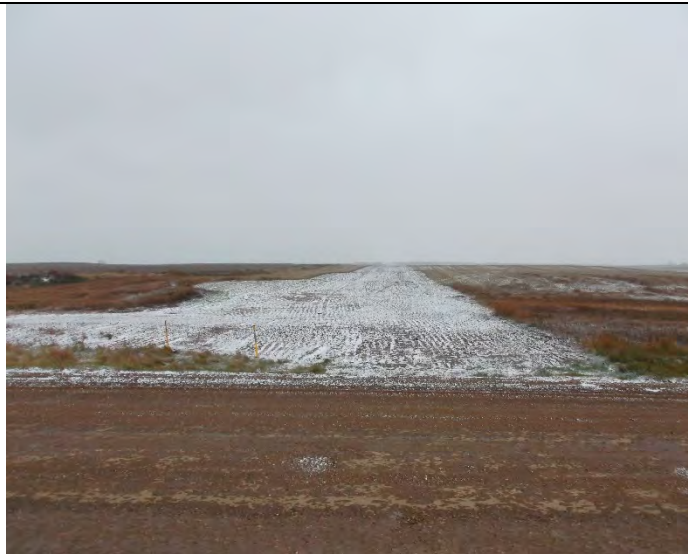
**Observation Point: 211b**

Photo Description: Overview of typical conditions within ROW, exemplifying final work product of pipe trench backfilling and topsoil replacement, and fence replacement. Note road appears to have been bored.

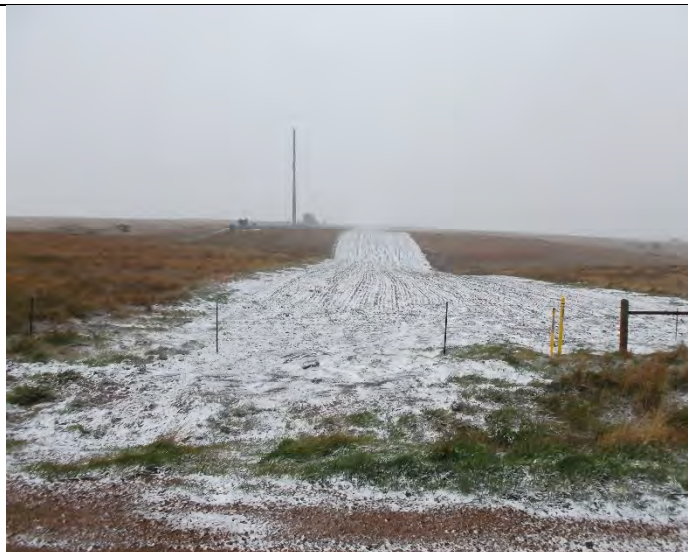
**Observation Point: 213a**

Photo Description: Overview of typical conditions within ROW, exemplifying final work product of pipe trench backfilling, topsoil replacement, and fence replacement. Note road appears to have been bored.

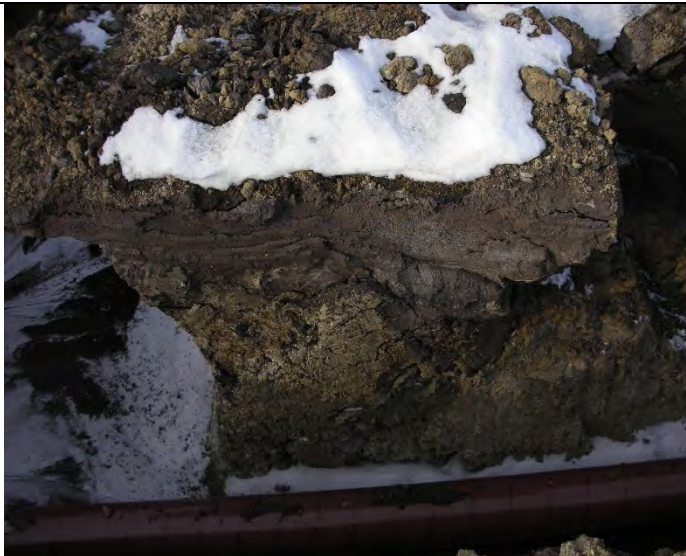
**Observation Point: 2796**

Photo Description: Pipe depth at approximately 60-inches at HDD tie-in area; a minimum of 72-inches under unimproved sections lines is required, which occurs adjacent to the west of observation point. Note the pipe is at a slight downward angle towards section line, assumingly to appropriate minimum depth. Topsoil inadequately stripped, approximately 12-inches of topsoil remain in trench soil profile.

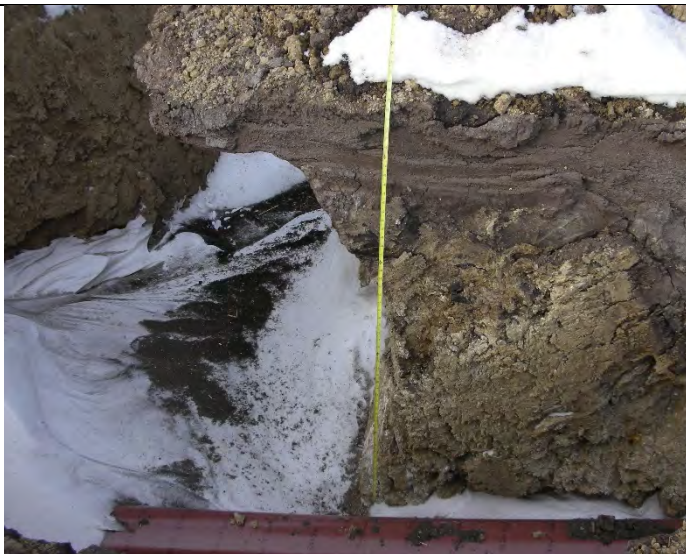
**Observation Point: 2797**

Photo Description: Pipe depth at approximately 60-inches; a minimum of 72-inches under unimproved sections lines is required, of which occurs immediately to the west of observation point. Note the pipe is at a slight downward angle towards section line. Topsoil inadequately stripped, approximately 12-inches of topsoil remain in trench soil profile.

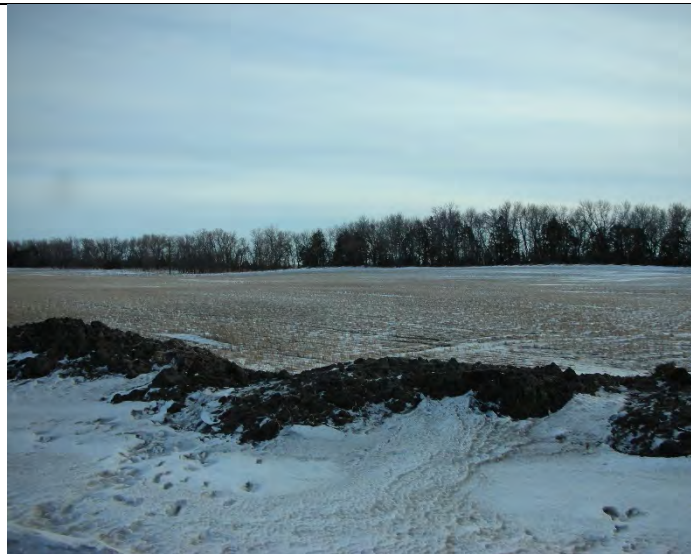
**Observation Point: 2798sw**

Photo Description: Frozen topsoil stockpile crossing slight drainage swale, no erosion control observed.

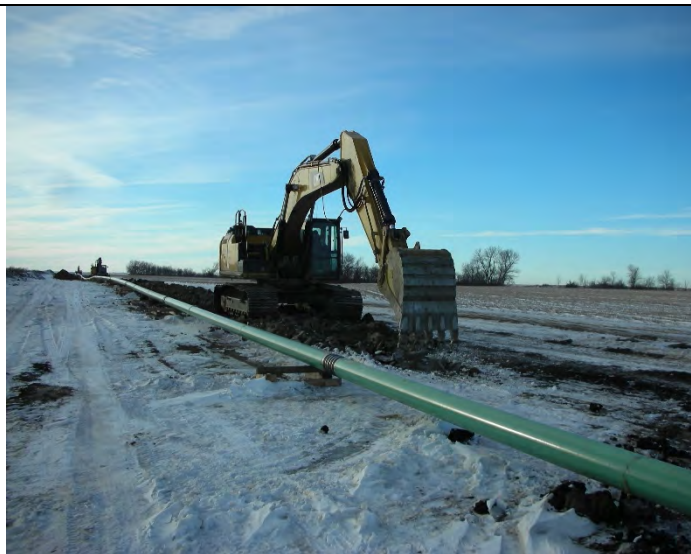
**Observation Point: 2799w**

Photo Description: Excavator actively trenching through subsoil frost layer. Topsoil has previously been appropriately stripped.

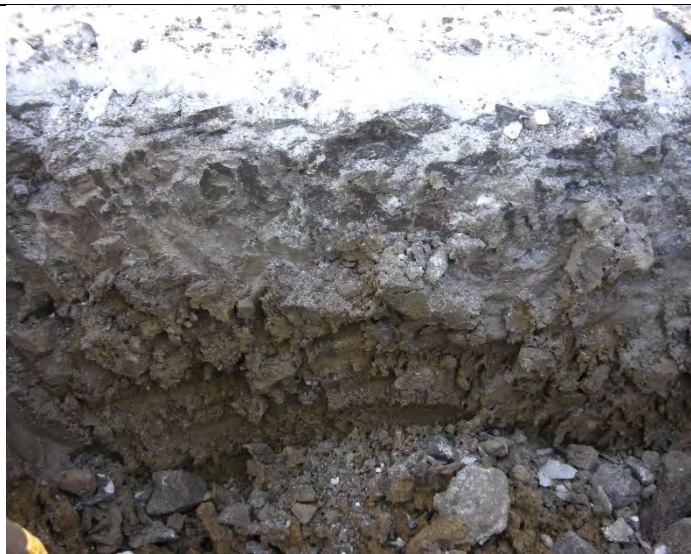
**Observation Point: 2800**

Photo Description: View of recent trenching activities, exemplifies topsoil was stripped properly when the activity was performed previous to frost conditions. Frost layer measured to 20-inch depth.

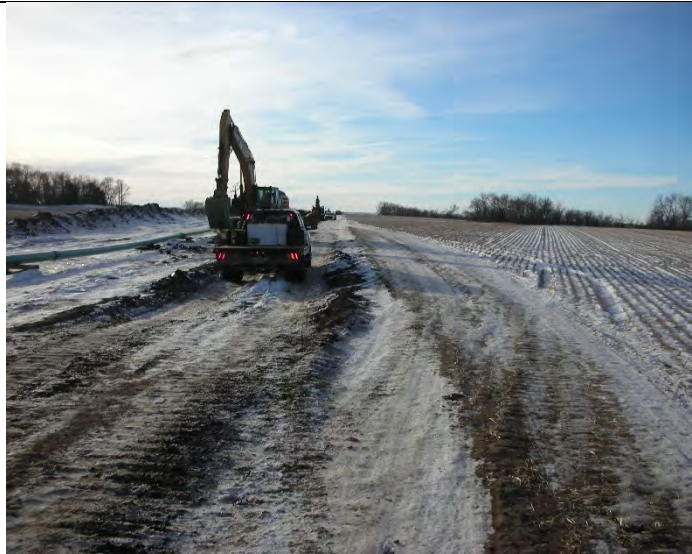
Observation Point: 2801w
Date Taken: January 21, 2020
Direction Photo is Taken: West
T155R84S36 Spread 2

Photo Description: Slight off ROW tracking observed north of the ROW.

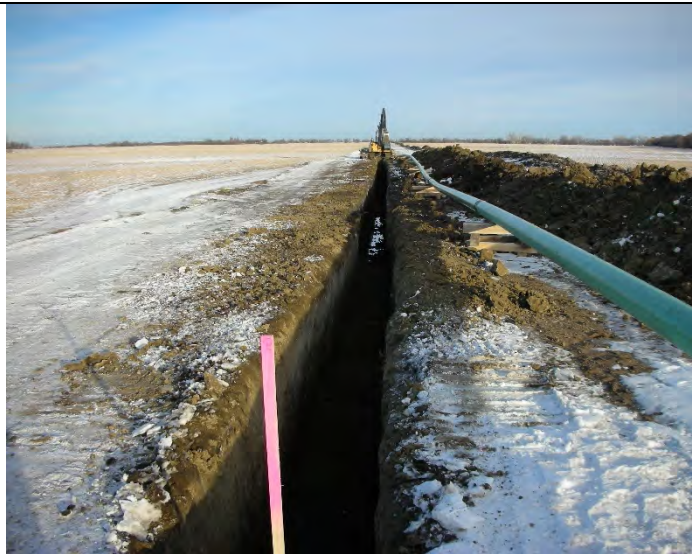
Observation Point: 2802e
Date Taken: January 21, 2020
Direction Photo is Taken: East
T155R84S36 Spread 2

Photo Description: Trench showing properly segregated soils.

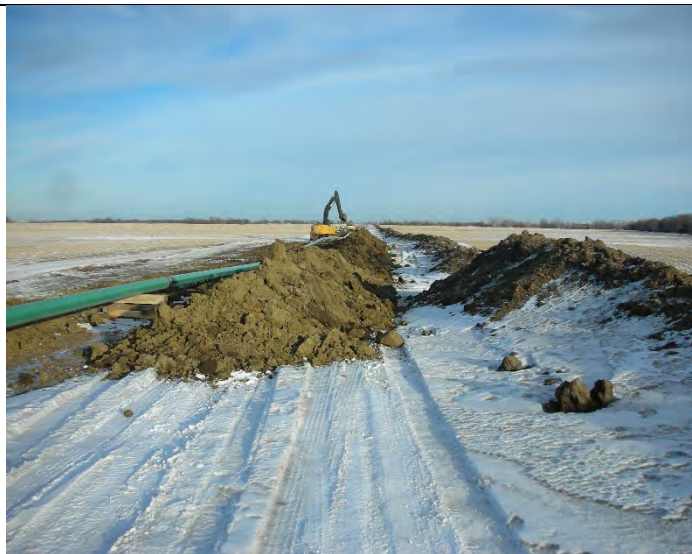
Observation Point: 2803e
Date Taken: January 21, 2020
Direction Photo is Taken: East
T155R84S36 Spread 2

Photo Description: View slightly to the south of observation point 2802e. Properly segregated topsoil and subsoil piles.

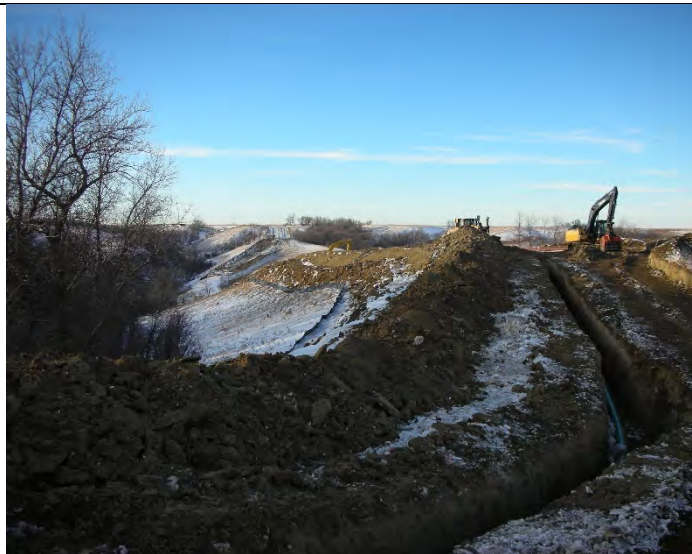
Observation Point: 2804w
Date Taken: January 21, 2020
Direction Photo is Taken: West
T155R84S35 Spread 2

Photo Description: Overview of subsoil backfill and silt fence.

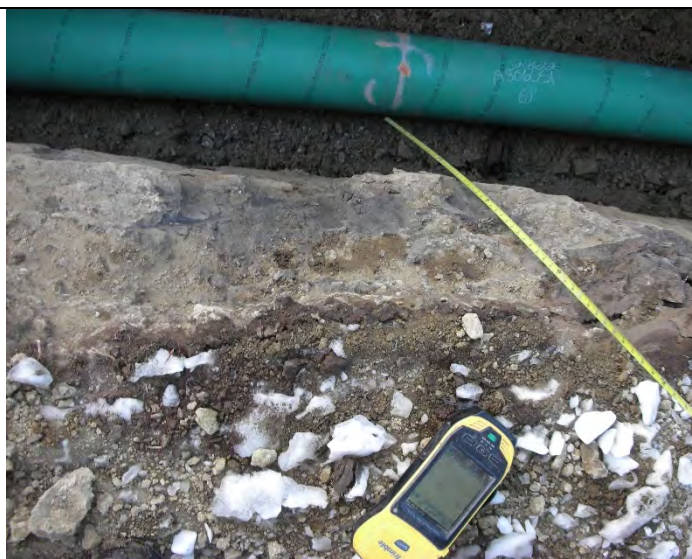
Observation Point: 2805
Date Taken: January 21, 2020
Direction Photo is Taken: N/A
T155R84S35 Spread 2

Photo Description: Pipe depth approximately 60 inches. Trench profile appropriately shows no evidence of topsoil.

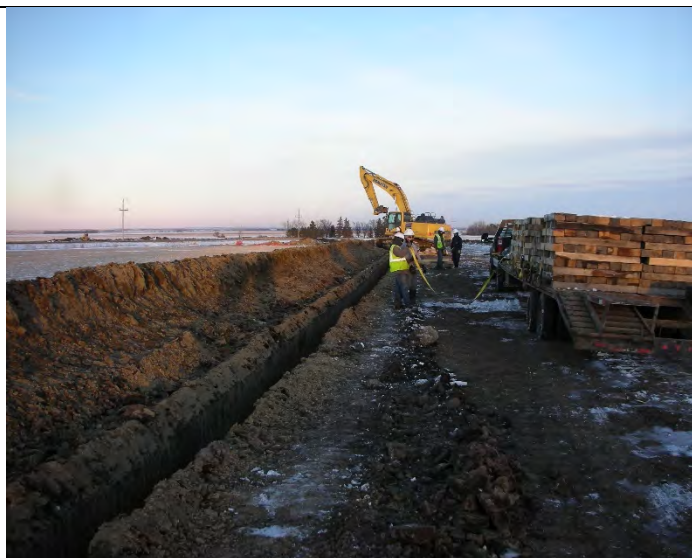
Observation Point: 2806e
Date Taken: January 21, 2020
Direction Photo is Taken: East
T154R85S11 Spread 2

Photo Description: Winter trenching, no observed issues with topsoil.

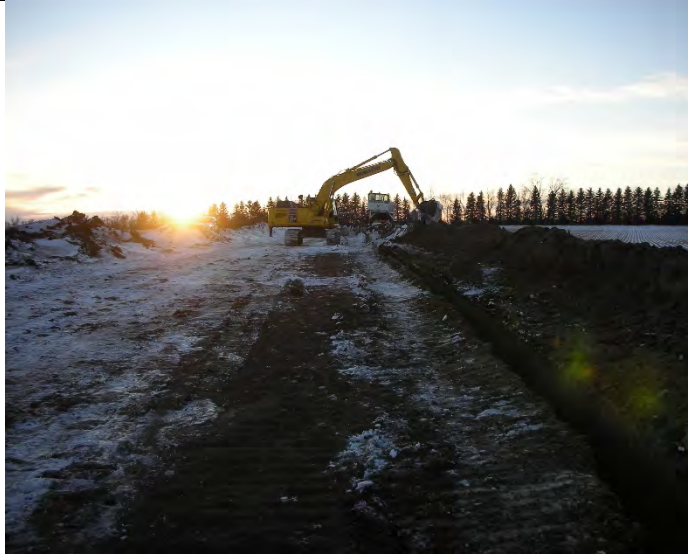
**Observation Point: 2807w**

Photo Description: Winter trenching, no observed issues with topsoil.

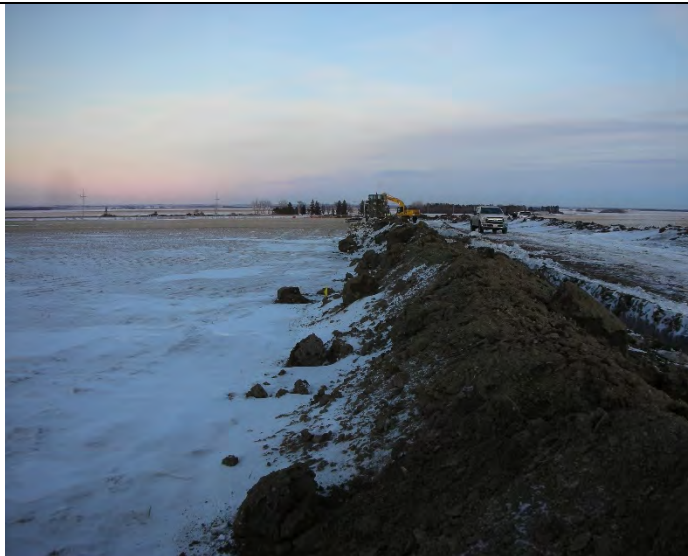
**Observation Point: 2808e**

Photo Description: Subsoil stockpile near ROW edge, some areas of subsoil appeared placed atop in-situ topsoil.

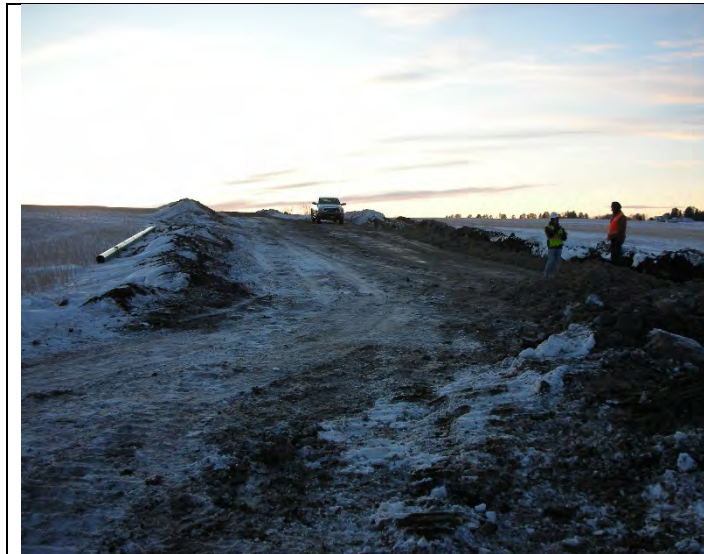
**Observation Point: 2810w**

Photo Description: Previously stripped ROW with topsoil to south (left), awaiting spring replacement; no issues.

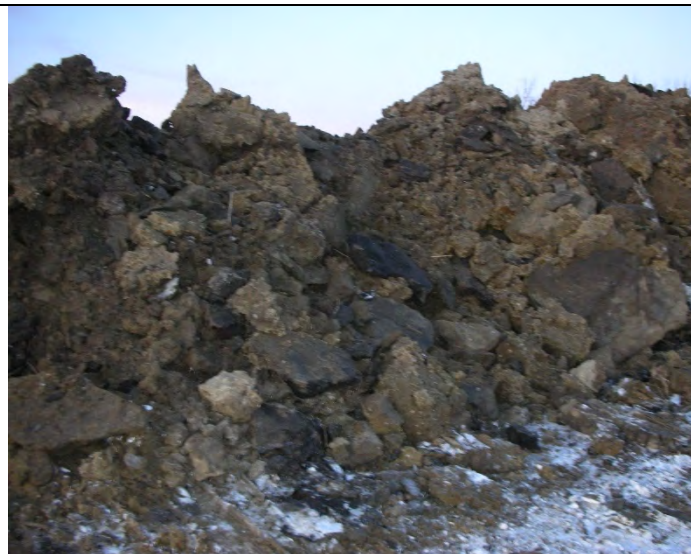
**Observation Point: 2811**

Photo Description: Mixed subsoil and topsoil stockpile at HDD tie-in area.

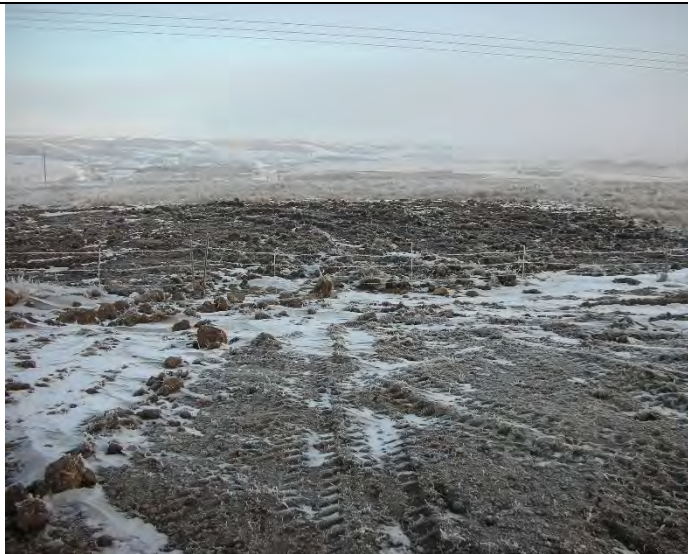
**Observation Point: 2814n**

Photo Description: Rebuilt fence and soils appropriately replaced along ROW.

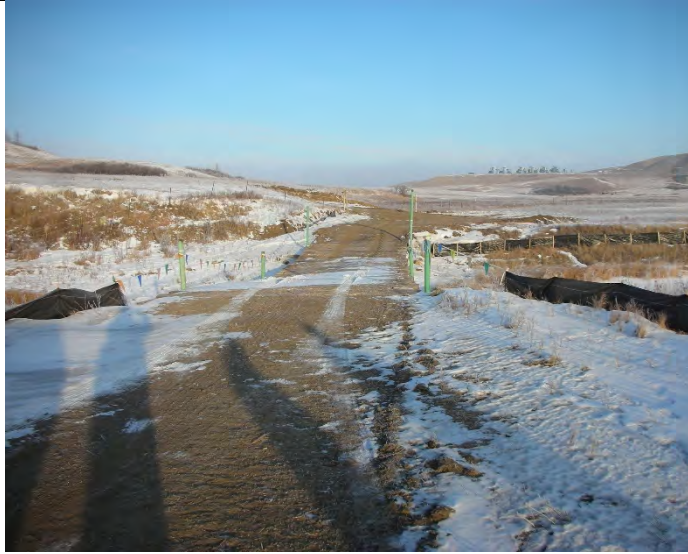
**Observation Point: 2816nw**

Photo Description: Temporary bridge across White Earth River, silt fence, and replaced cattle fence.

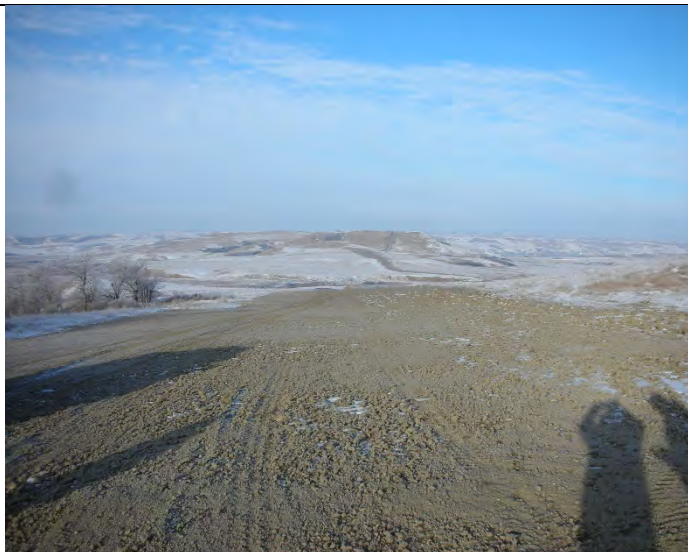
**Observation Point: 2818w**

Photo Description: Overview of typical conditions within ROW, exemplifying final work product of pipe trench backfilling and topsoil replacement construction phase.

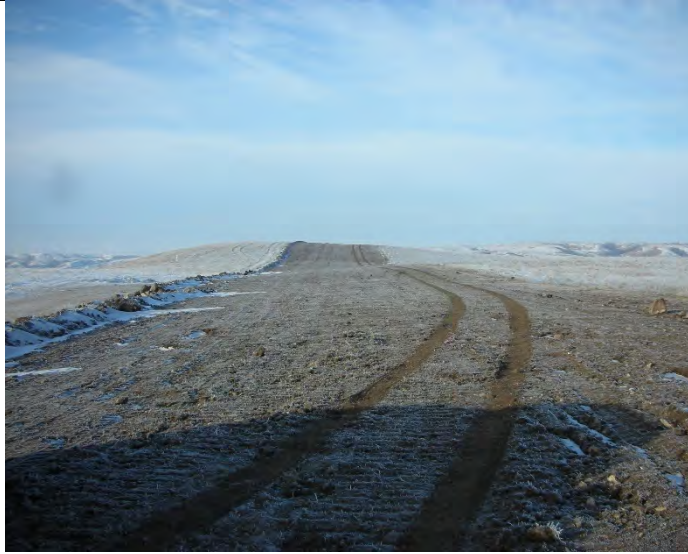
**Observation Point: 2822w**

Photo Description: Overview of typical conditions within ROW, exemplifying final work product of pipe trench backfilling and topsoil replacement construction phase.

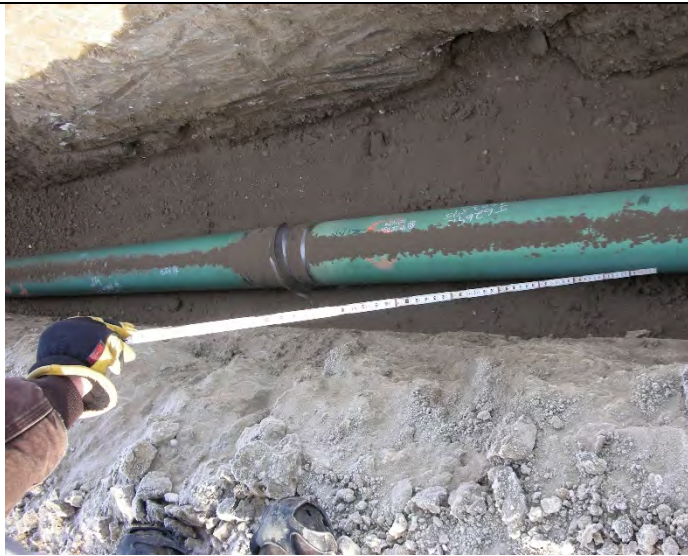
**Observation Point: 2823**

Photo Description: Pipe measured at 54-inches at rerouted portion of ROW for archeological avoidance area.

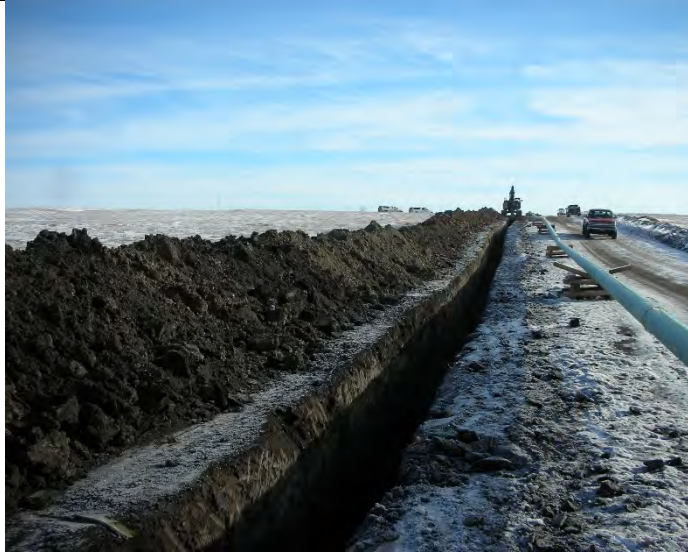
**Observation Point: 2825e**

Photo Description: Overview of pipe trenching and segregation of topsoil and subsoils. Minor remaining topsoil in low areas, resulting in some mixing into subsoil piles.

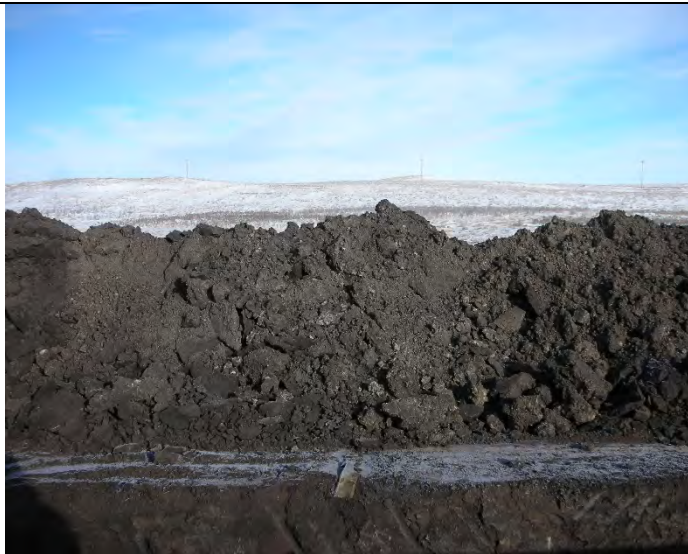
**Observation Point: 2826**

Photo Description: Exemplification of topsoil mixed with subsoil stockpiles described in Observation Point 2825e.

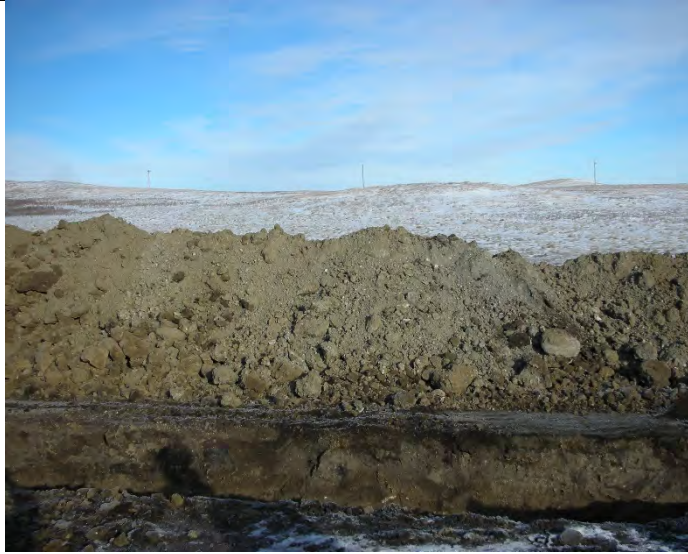
**Observation Point: 2828**

Photo Description: Exemplification of appropriately segregated subsoil.

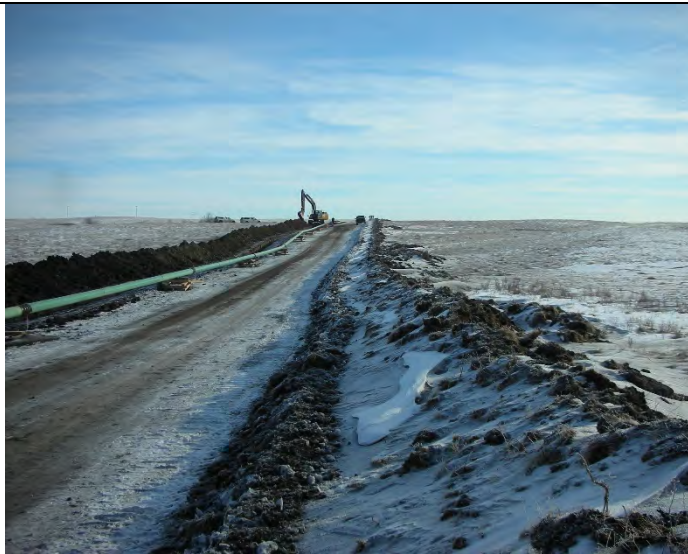
**Observation Point: 2829e**

Photo Description: Overview of topsoil stockpile exemplifying stockpile uniformity of size. Topsoil stockpiles should vary in size based upon salvage depths described in Observation Point 2825e.
