**PU-17-97  
Cenex Pipeline, L.L.C.  
10" Refined Fuels Pipeline  
Reclamation Inspection Report**

File No. 227701128

August 2022

**North Dakota Public Service Commission**  
600 E. Boulevard Avenue  
Bismarck, ND 58505-0480

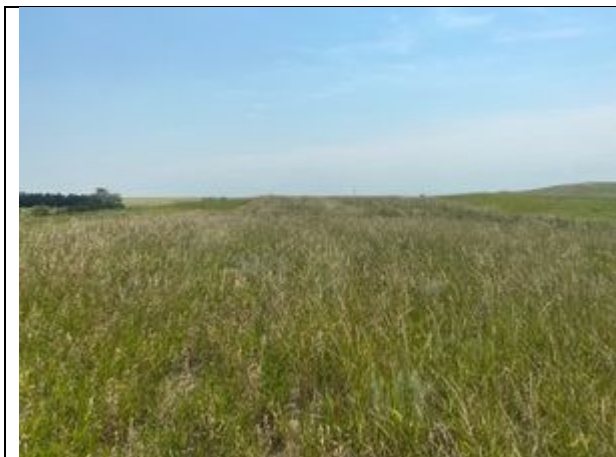
Photo Description: Crested and western wheatgrasses dominate with 70% coverage. No noxious weeds present. Topsoil appears replaced and soil reclamation is appropriate.

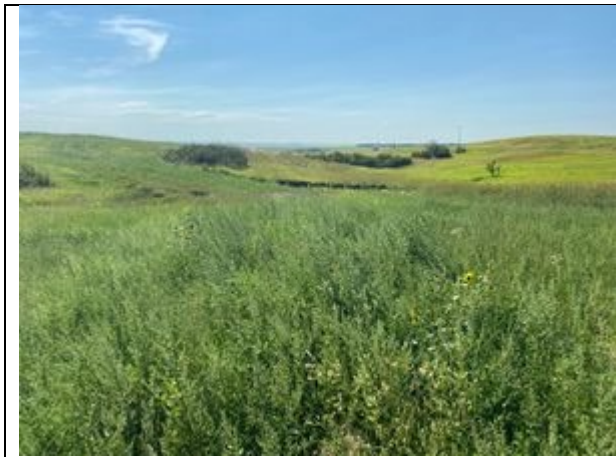
Photo Description: Overall good vegetative cover on the reclaimed ROW, but approximately evidence of  $\geq 5$ in subsidence observed.

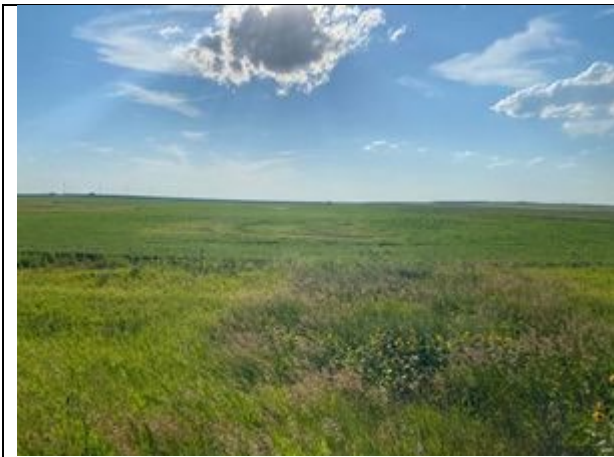
Photo Description: Compaction along the right of way inhibiting proper plant growth. Recommend addressing to be compliant.

Soil decompaction and additional fill at select areas could mitigate the adverse impacts of observed compaction and subsidence (**Appendix A; Observation Points 28, 53, 59**). Without corrective measures, landowners producing crops in the compacted portions of the ROW soil may experience declined crop yields due to poor root penetration. Though these issues were isolated, Cenex should

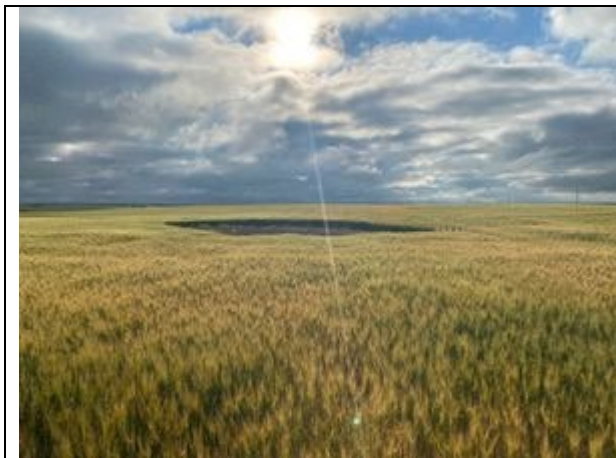
Photo Description: Appropriate vegetative cover on reclaimed ROW. No observed excess weeds in rangeland/pasture.

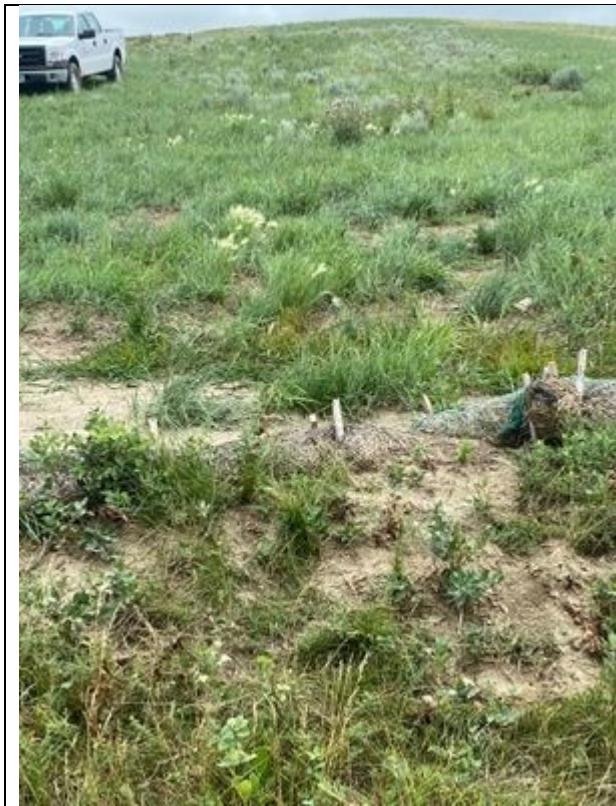
**Observation Point: 44**  
Date Taken: August 3, 2022 11:21 AM  
Direction Photo is Taken: East  
Land Use: Rangeland

Photo Description: Good vegetative cover. Barnyard grass, prairie sage, western Snowberry, plumeless thistle, yellow coneflower, and various perennial grass.

The two noxious weed species observed were Canada thistle (perennial) and plumeless thistle (biennial). Stantec recommends Cenex address the infestations of noxious weeds in the ROW. For Canada thistle control, Stantec recommends infested areas be treated at the beginning of the 2023 growing season according to Cenex's weed management plan and from the recommendations from the local noxious weed board and landowners (per PU-17-97 Docket #1). The locations observed with noxious weeds should be monitored for at least two years to allow for the lifecycle of weeds, and to ensure infestations do not spread.

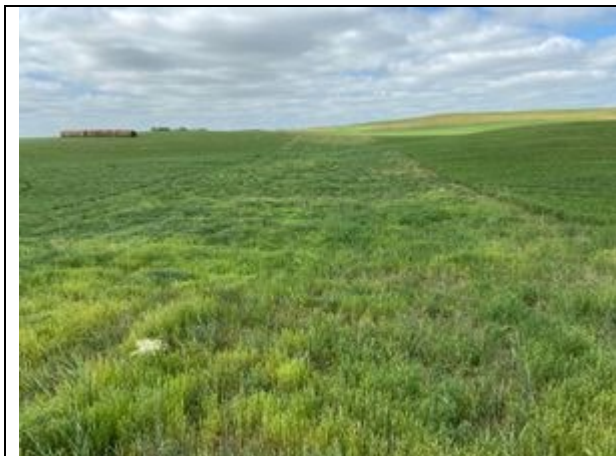
Photo Description: Kochia dominates ROW. Recommended mowing and supplemental native grass seeding.

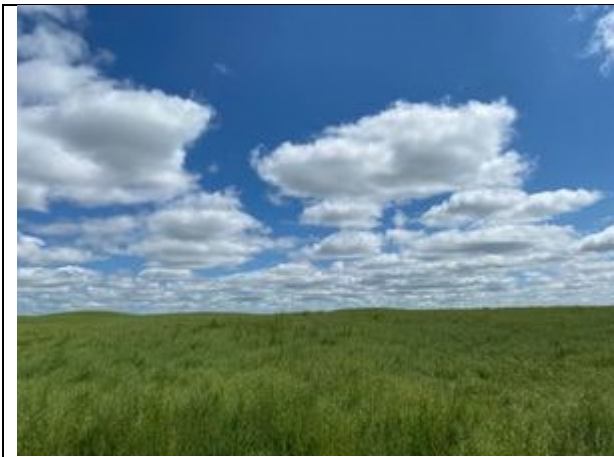
Exposed subsoil and/or mixed topsoil was observed at one location (**Appendix A; Observation Point 53**) in the ROW, which was affecting crop growth surrounding the area. Stantec recommends the PSC inquire about this area with Cenex. Adding topsoil, biological amendments, or organic matter could be possible methods to increase the organic matter content and improve vegetative restoration.

Photo Description: Mixed topsoil and subsoil was replaced. Compaction and subsidence prevalent. The area west of observation point contains a significant amount of Canada thistle.

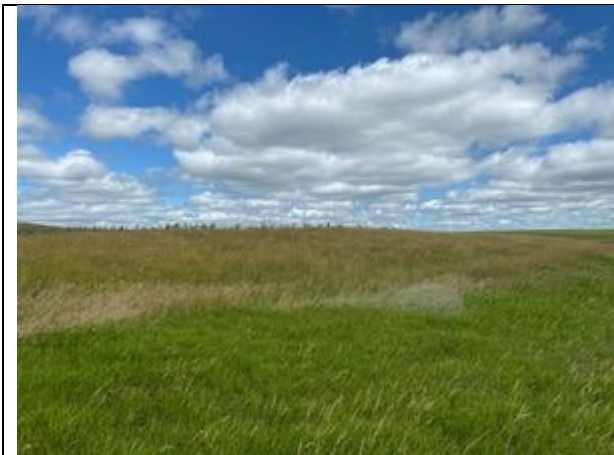
Photo Description: Overall, ROW is well vegetated with wheat comparable to the surrounding field. No noxious weeds observed in the ditch, field, or reclaimed rangeland.

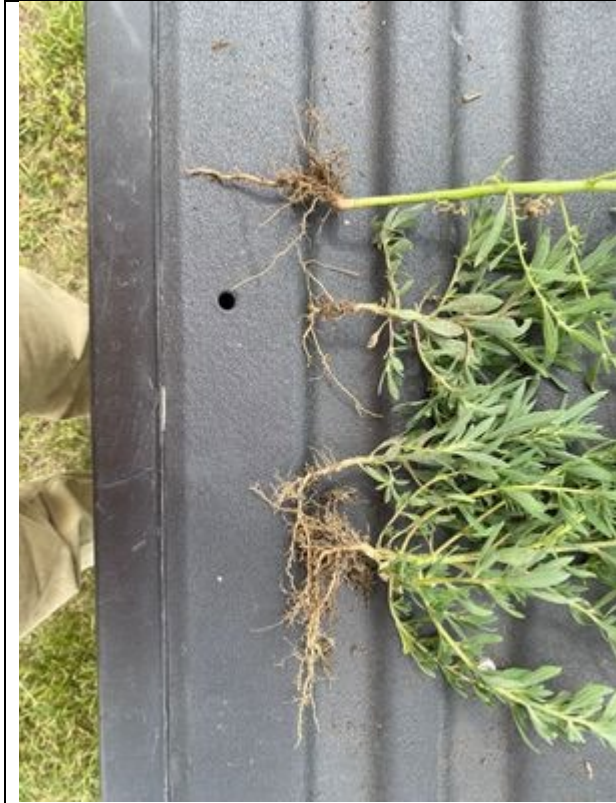
**Observation Point: 59**

Photo Description: Photo showing root restriction from kochia specimens taken from ROW. Severe compaction in area of ROW. No crops were able to grow. Recommended deep ripping or other corrective measures to relieve compaction.

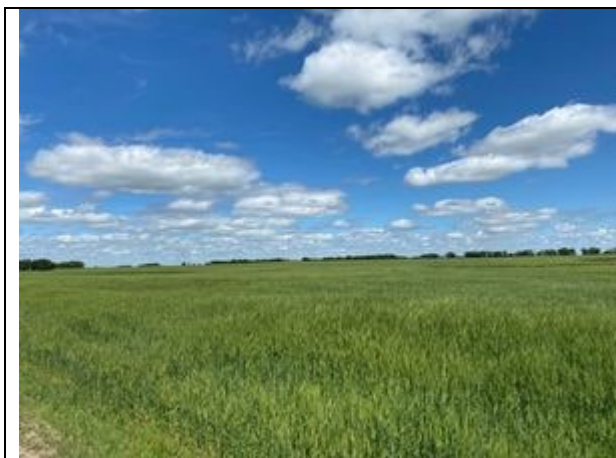
Photo Description: Reclaimed wheat field in good condition.
