Public Service Commission State of North Dakota

INSPECTION REPORT

DATE OF INSPECTION: March 22, 2017

PERMITTEE - MINE: Dakota Westmoreland Corporation (DWC) - Beulah Mine

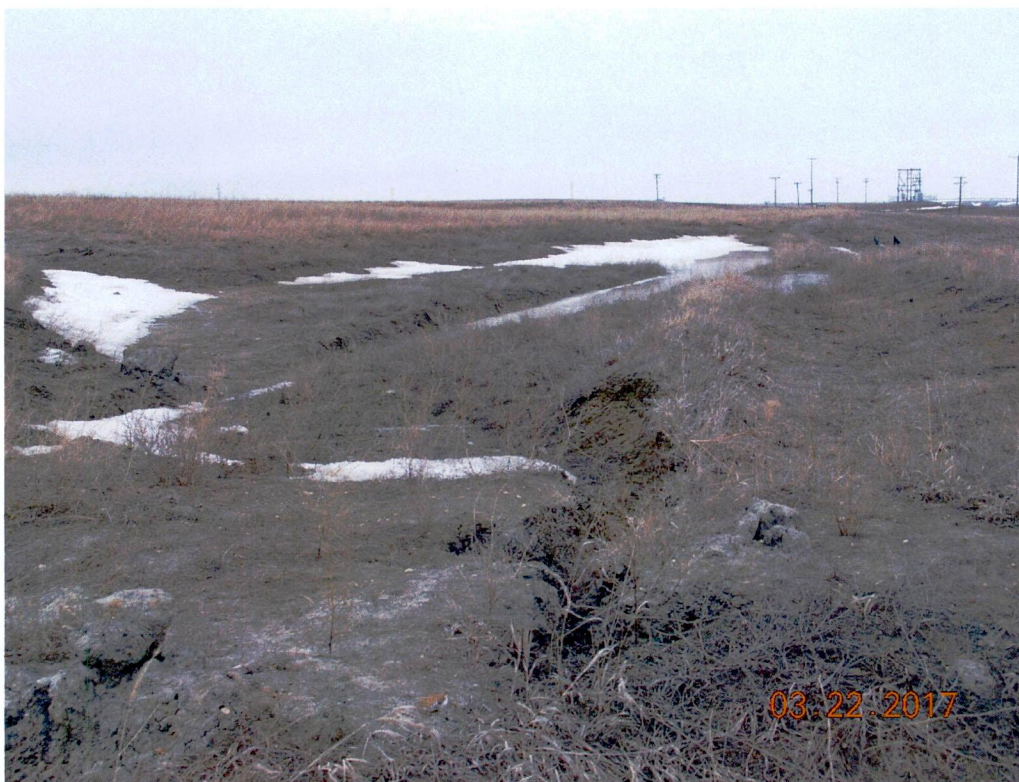
The sump in Special Variance Zone #7 (spoil stockpile to reclaim Pond 86 and its associated sump that also contains haul road runoff) located in the NW¼SW¼ of Section 15 was viewed during the inspection. Please refer to Figures 1 and 8 for the sump location. It appeared that the spoil stockpile sump overflowed and cut down to an adjoining linear sump to the north that was apparently installed to detain runoff from reclaimed land for which ten-year revegetation period was initiated in 2010 as pictured in Figure 2. It also appeared that comingled sump drainage flowed through a silt fence to the undisturbed intermittent stream bank in the NW¼SW¼ of Section 15 as pictured in Figure 3. Runoff detained in the spoil stockpile and haul road runoff sump must be pumped to Pond 86 as specified on page 3.8.8 of the KRSB-8603 permit rather than being discharged through a silt fence.

Figure 2. Special Variance Zone #7 spoil stockpile sump overflow to an adjoining linear sump to the north that was apparently installed to detain runoff from reclaimed land - facing north - see Figures 1 and 8 for location.

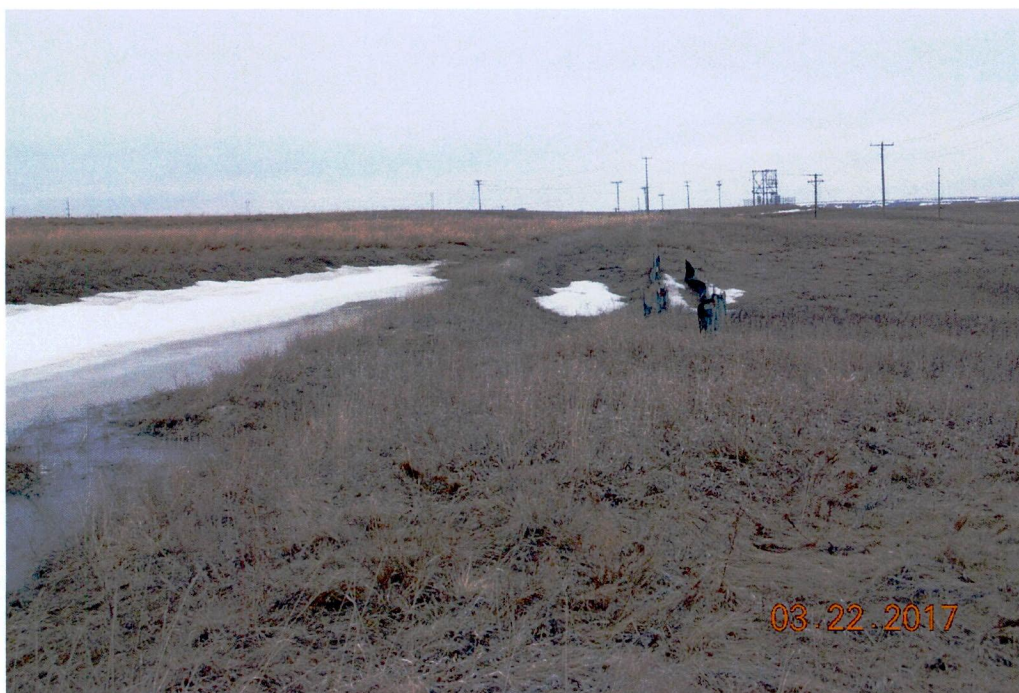
Figure 3. Special Variance Zone #7 spoil stockpile sump and adjoining linear sump for reclaimed land coming drainage flow through a silt fence to the undisturbed intermittent stream bank in the NW¼SW¼ of Section 15 - facing north - see Figures 1 and 8 for location.

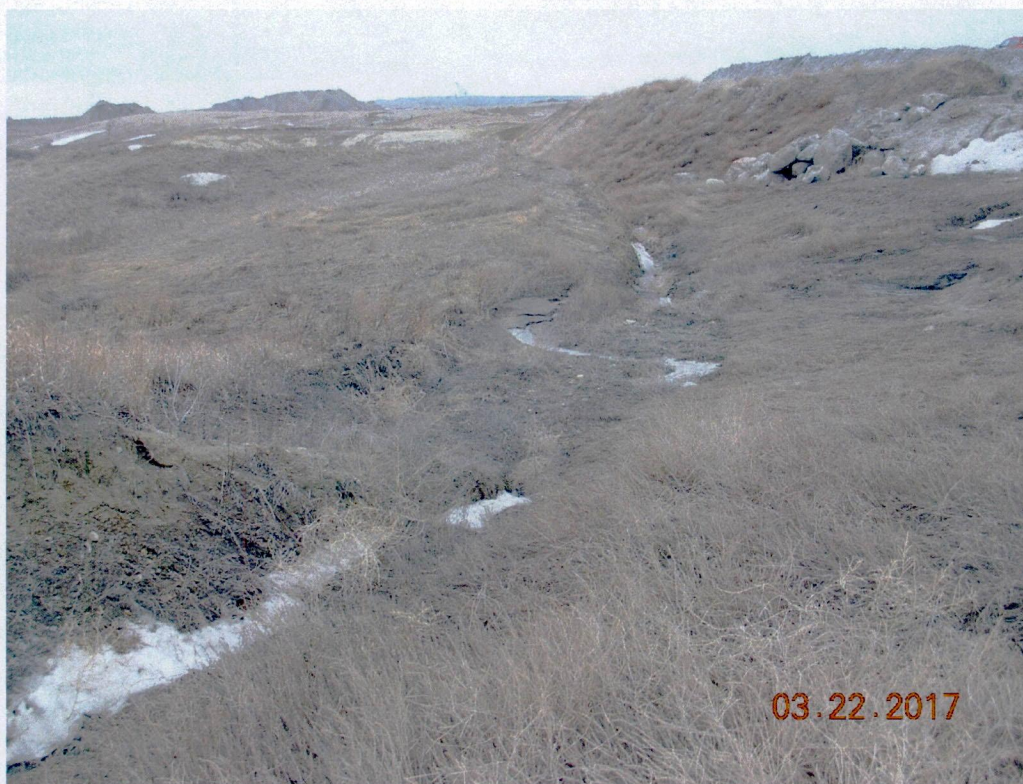
Diversion 99E-B located in the in the E½E½ of Section 20 was viewed during the inspection. The diversion routes Silver Pit and haul road runoff west to Sump 99E. Please refer to Figure 1 for the diversion location. As pictured in Figures 4 and 5, the diversion requires maintenance to remove sediment where it has accumulated about 150 feet east of Sump 99E and where sediment laden runoff is at risk of overtopping the diversion and causing sediment deposition in the undisturbed intermittent stream buffer zone.

Figure 4. Sediment accumulated in Diversion 99E-B about 150 feet east of Sump 99E where sediment laden runoff is at risk of overtopping the diversion and causing sediment deposition in the undisturbed intermittent stream buffer zone to the south - facing west with Sump 99E in background - see Figure 1 for location.

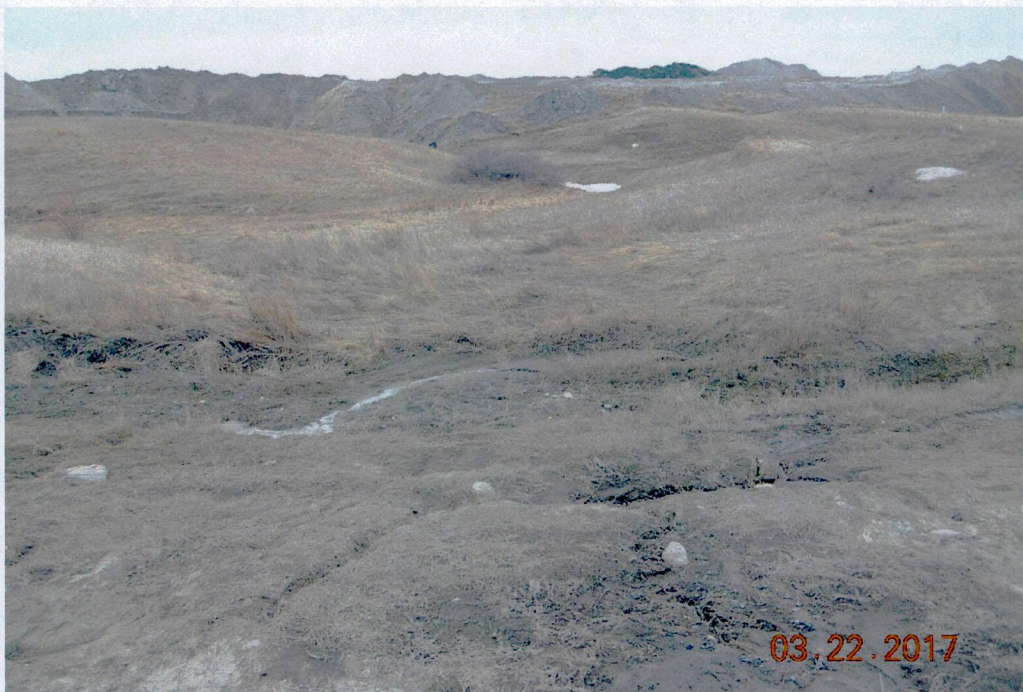
Figure 5. Sediment accumulated in Diversion 99E-B about 150 feet east of Sump 99E where sediment laden runoff is at risk of overtopping the diversion and causing sediment deposition in the undisturbed intermittent stream buffer zone to the south - facing south with Iron Pit spoil in background - see Figure 1 for location.

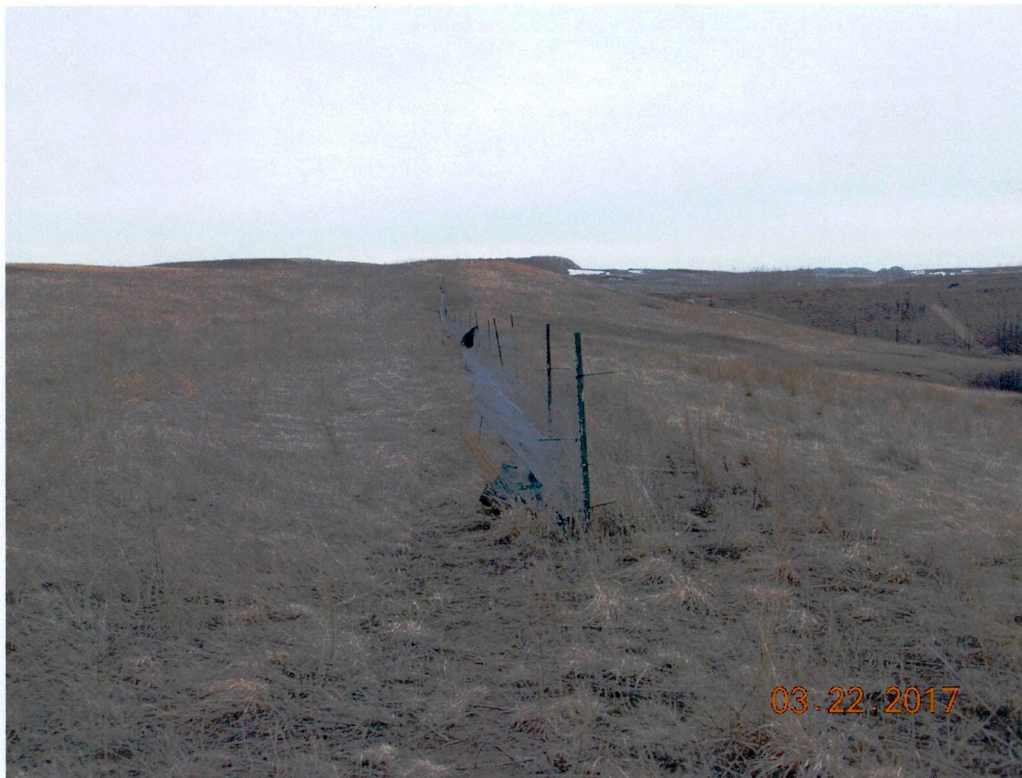
DWC personnel inquired during the inspection about removing between 600 and 800 feet of silt fence that had been installed at the mining disturbance boundaries along the east and west banks of the undisturbed intermittent streambank in the SW $\frac{1}{4}$ of Section 15 following suitable plant growth material respreading and stabilization for grade approval areas Gold2-2011 and Gold1-2009 adjacent the east bank, and for Gold1-2013 adjacent the west bank. Please refer to Figure 1 for the silt fence locations. All of the grade approval areas were reclaimed to postmine native grassland. The ten-year revegetation period for grade approval areas adjacent the east bank were originally initiated in 2012 but were re-initiated in 2014, while the ten-year revegetation period for the grade approval area adjacent the west bank was initiated in 2014. At the time of inspection as pictured in Figures 6 and 7, the east bank silt fence needed repair but the reclaimed native grassland was well vegetated and lacked any indication of erosion, while the west bank silt fence was in good condition but reclaimed native grassland erosion documented in the June 11, 2015 inspection report may not have been repaired. DWC personnel were informed that the silt fence removal request will be further evaluated during the next Beulah Mine inspection.

Figure 6. Silt fence installed at the mining disturbance boundary along the east bank of the undisturbed intermittent streambank in the SW¼ of Section 15 for grade approval areas Gold2-2011 and Gold1-2009 - facing south - see Figure 1 for location.

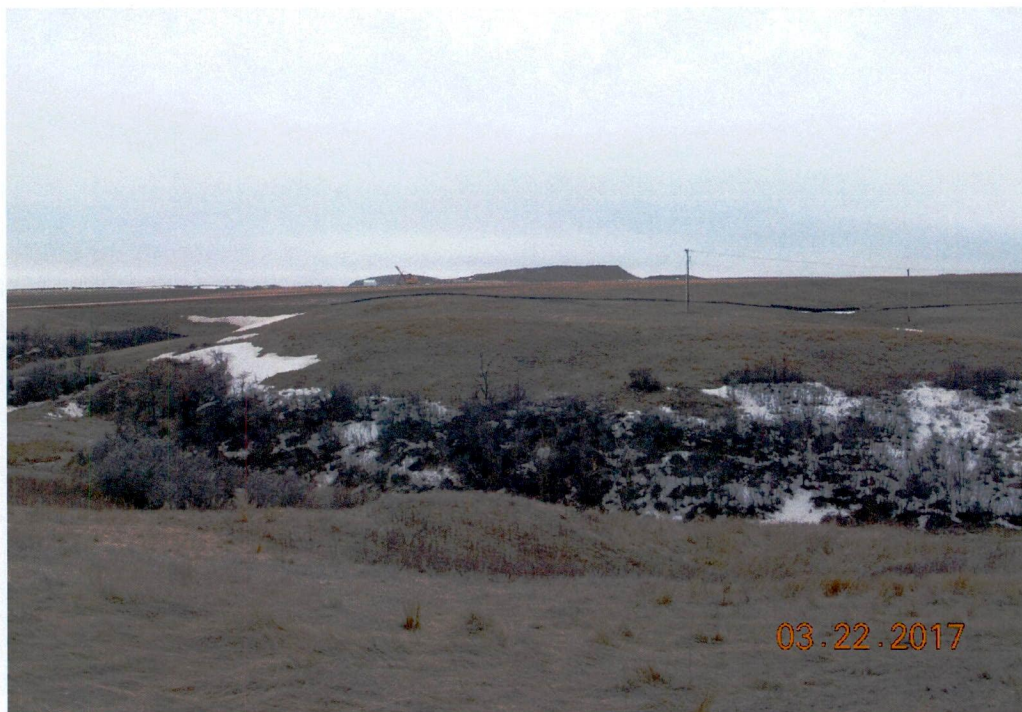
Figure 7. Silt fence (in background) installed at the mining disturbance boundary along the west bank of the undisturbed intermittent streambank in the SW¼ of Section 15 for grade approval area Gold1-2013 - facing southwest - see Figure 1 for location.

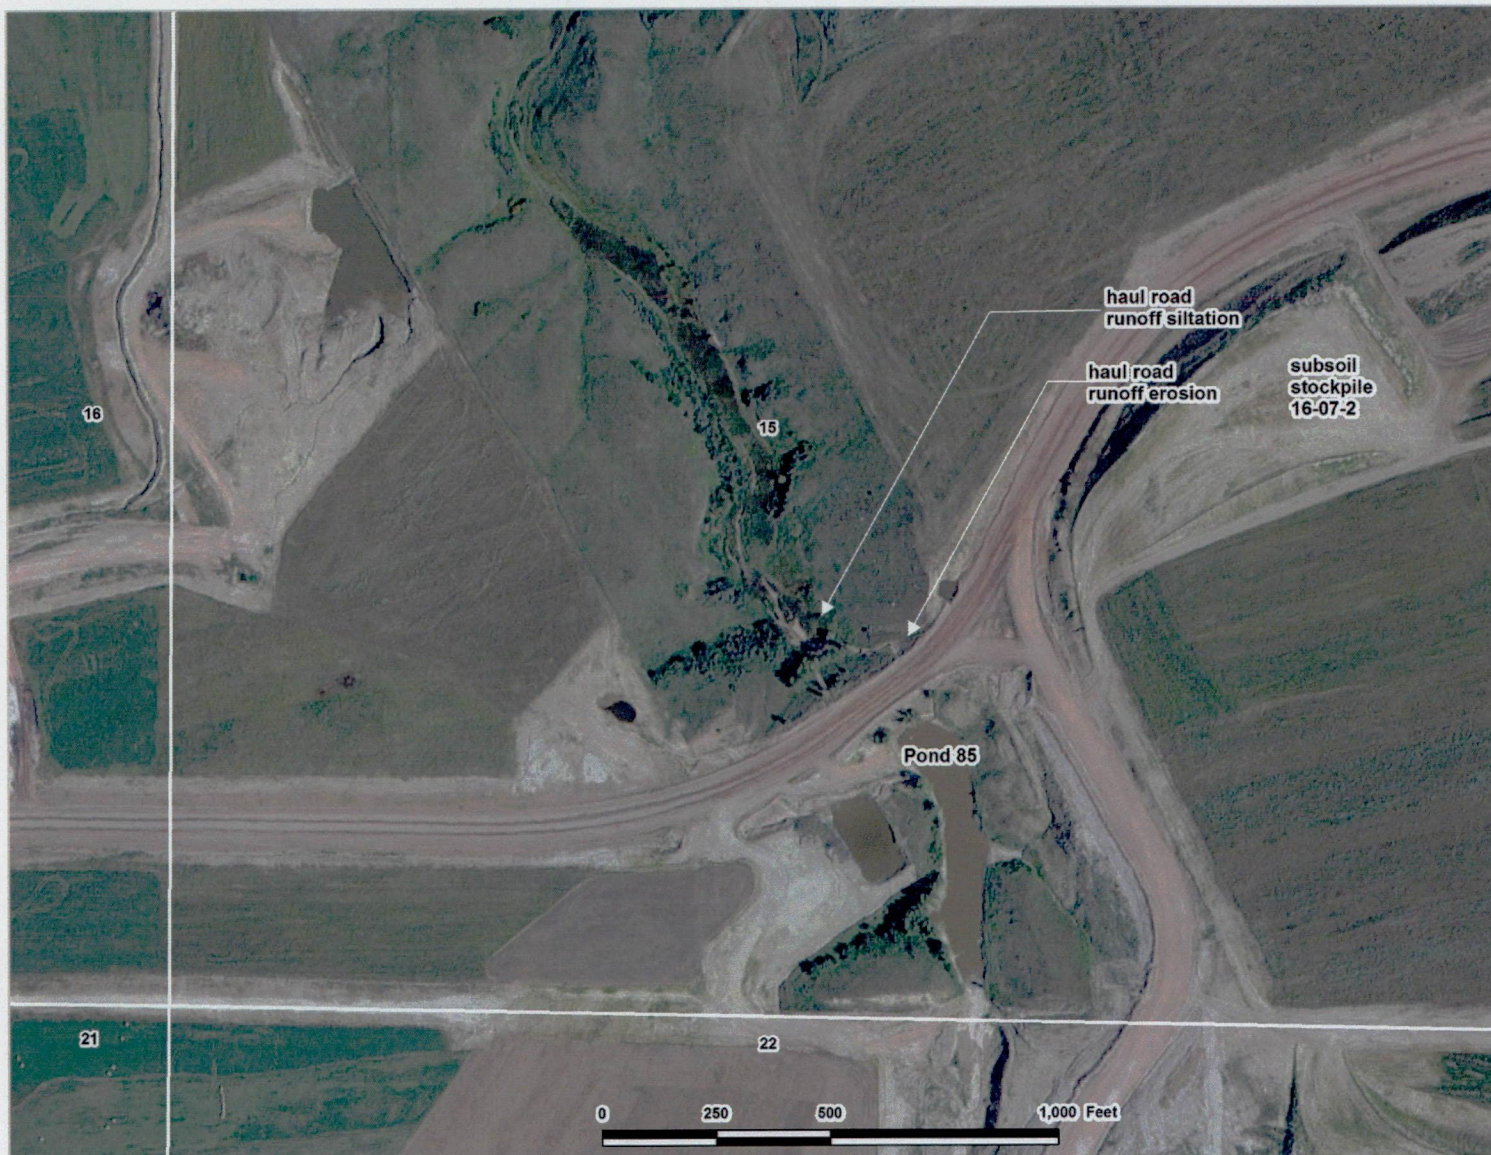
An erosional gully through undisturbed land, and attendant siltation in an intermittent stream, were observed during the inspection on the north side of the haul road in the S $\frac{1}{2}$ SW $\frac{1}{4}$ of Section 15. Please refer to Figure 1 for the general location and Figures 8 and 9 for the detailed location of haul road erosion and siltation. As pictured in Figures 8 and 9, the Pond 85 embankment functions as the intermittent stream haul road crossing at this location. The intermittent stream tributary to Brush Creek drains from Permit KRSB-8603 northward into Permit NACC-1302 and through a culvert under the Coyote Creek Mine haul road in the SW $\frac{1}{4}$ SW $\frac{1}{4}$ SW $\frac{1}{4}$ of Section 10. As described by DWC personnel, runoff from the haul road segment crossing the intermittent stream in the S $\frac{1}{2}$ SW $\frac{1}{4}$ of Section 15 in Permit KRSB-8603 is controlled by conveying runoff south to Pond 85 by way of a drainage grate culvert inlet along the haul road's north berm and through a culvert under the haul road to an outlet at Pond 85 as pictured in Figure 9. The haul road drainage grate culvert inlet is also pictured in Figure 10 and the haul road drainage culvert outlet to Pond 85 is also pictured in Figure 11. At some unknown time the haul road drainage grate culvert inlet and uncontrolled haul road runoff began flowing over the north haul road berm at the drainage grate location and formed an erosional gully in the undisturbed intermittent stream bank north of the Pond 85 embankment. Figures 12 and 13 picture the uncontrolled haul road runoff flow over the haul road berm at the drainage grate location. As evidenced from the 2016 aerial photography in Figures 8 and 9, the haul road runoff erosion and siltation is not a recent development. Figures 14a, 14b, and 14c picture the erosional gully and siltation in three consecutive photographs facing east and rotating north atop the north haul road berm at the upper end of the concrete drainage channel also pictured and labeled in Figure 9 that no longer functions as a haul road runoff control structure. Figure 15 pictures the haul road runoff erosion and siltation as viewed from the intermittent stream's west bank about 600 feet north of the haul road. Siltation in the intermittent stream occurred in an area of soil mapped as 0/0 inch lift (topsoil/subsoil salvage thickness) map unit 85 (strongly saline land) that has no topsoil or subsoil salvage value for mining reclamation according to the soil survey in Section 2.4 of Permit KRSB-8603.

Figure 8. Detailed location of haul road erosion and siltation in the S $\frac{1}{2}$ SW $\frac{1}{4}$ of Section 15 where the Pond 85 embankment functions as the intermittent stream haul road crossing at this location. Also shown in the upper left is Special Variance Zone #7 (spoil stockpile to reclaim Pond 86 and its associated sump). Aerial photography is courtesy of the USDA-NAIP dated August 9, 2016 - see Figure 1 for location.

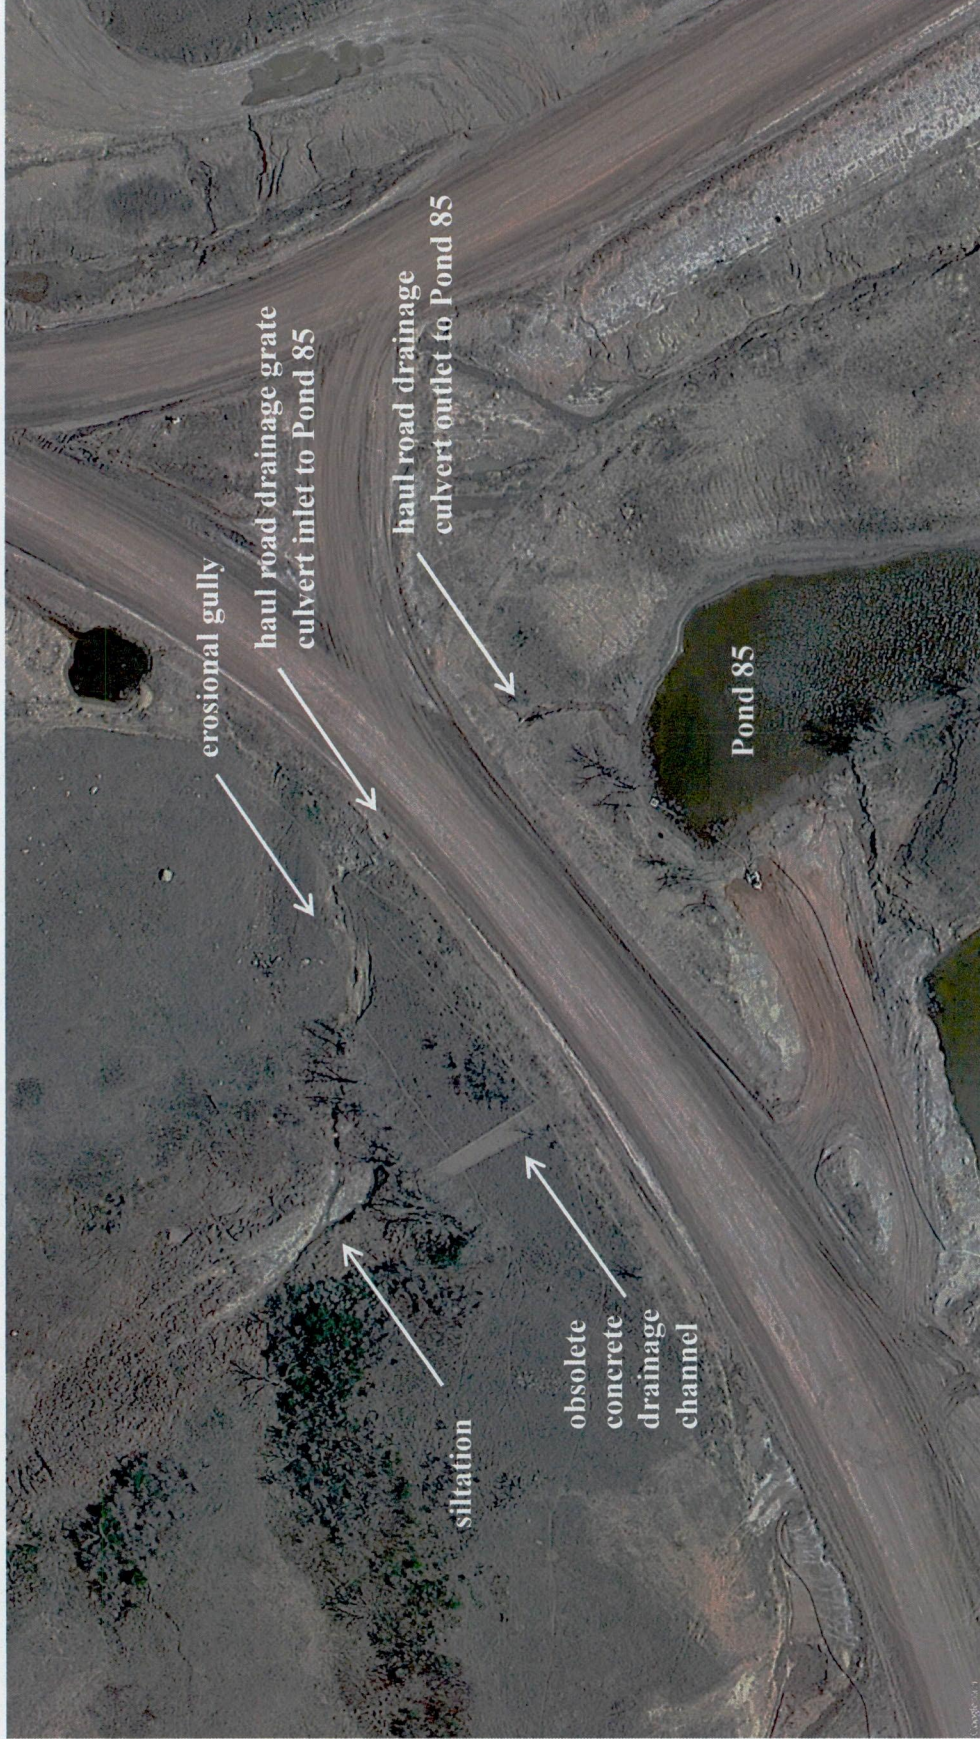
Figure 9. Locations of haul road erosion and siltation as well as drainage grate culvert inlet on north side of haul road and haul road drainage culvert outlet to Pond 85 on south side of the haul road in the S $\frac{1}{2}$ SW $\frac{1}{4}$ of Section 15 in Permit KR5B-8603. Aerial photography is courtesy of Google Earth dated May 2, 2016 - see Figure 1 for location.

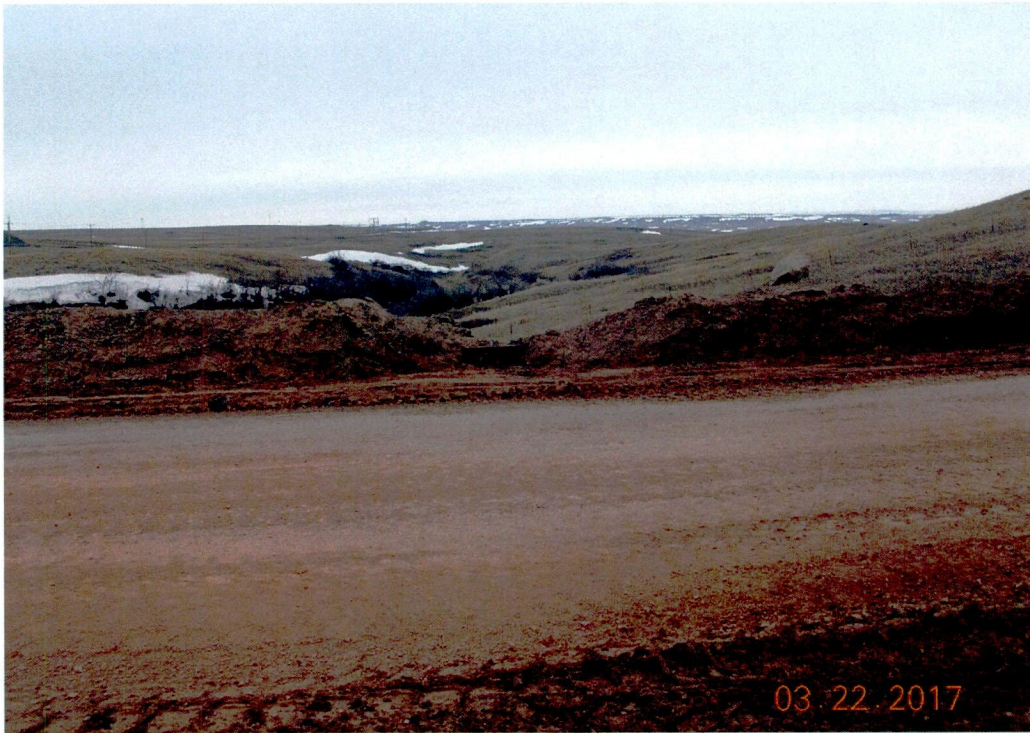
Figure 10. Haul road drainage grate culvert inlet along north haul road berm - facing north - see Figure 9 for location.

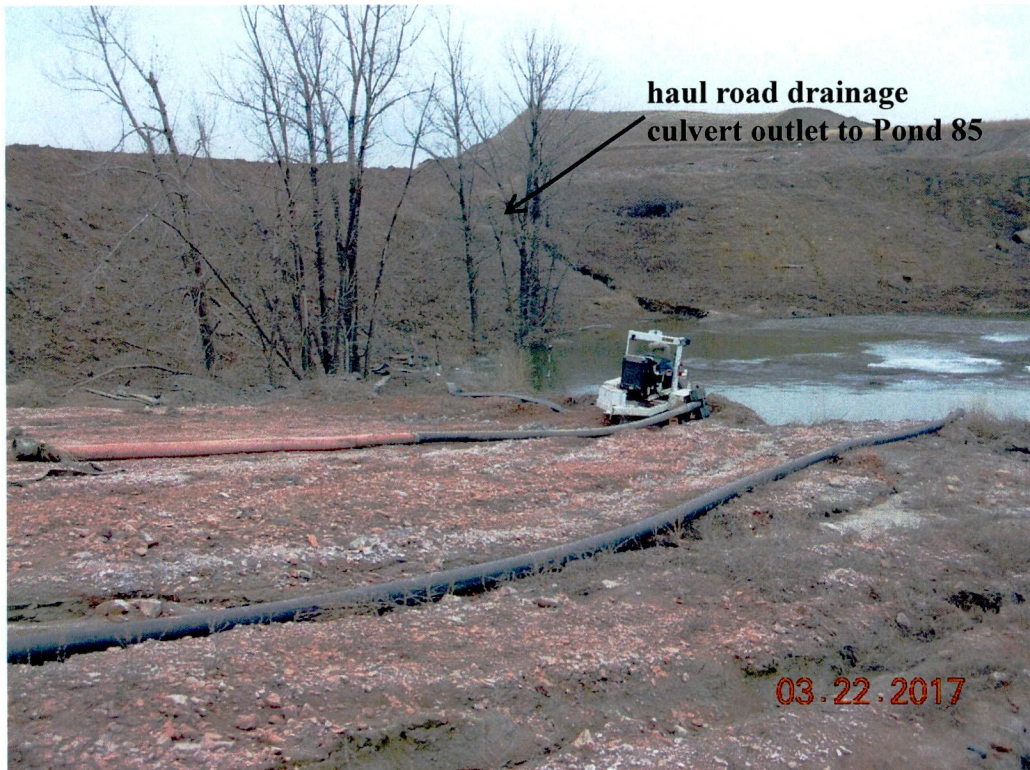
Figure 11. Haul road drainage culvert outlet to Pond 85 - see Figure 9 for location.

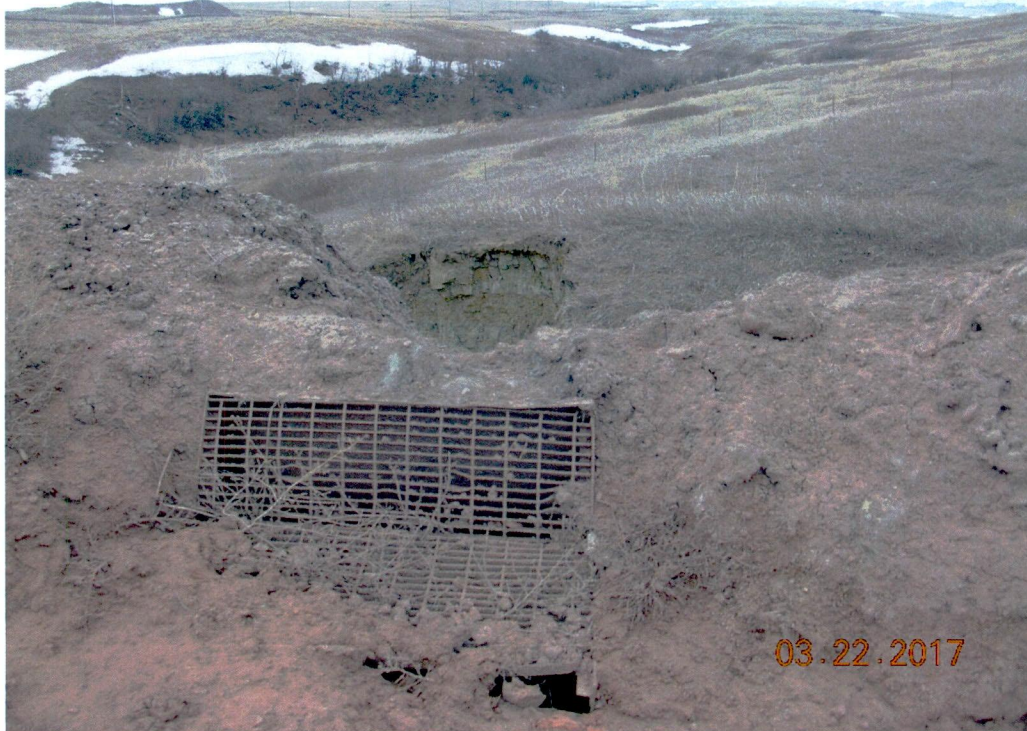
Based on the erosional gully and attendant siltation observed during the inspection on the north side of the haul road in the S $\frac{1}{2}$ SW $\frac{1}{4}$ of Section 15 in Permit KRSB-8603, Notice of Violation 1701 is being issued to Dakota Westmoreland Corporation for failure to maintain the haul road to control or prevent erosion and siltation in violation of North Dakota Administrative Code 69-05.2-24-01(2)(a).

Figure 12. Uncontrolled haul road runoff flow over or through the north haul road berm at the drainage grate location - facing north with headward extent of erosional gully in background - see Figure 9 for location.

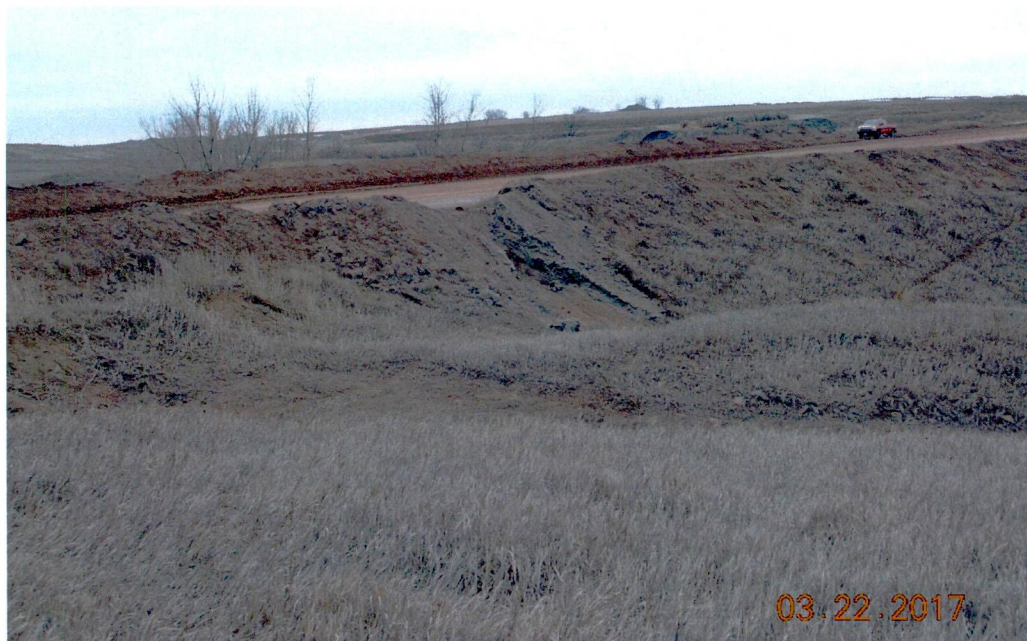
Figure 13. Uncontrolled haul road runoff flow over or through the north haul road berm at the drainage grate location as viewed from the intermittent stream's east bank - facing southwest with DWC pickup truck parked on south haul road shoulder.

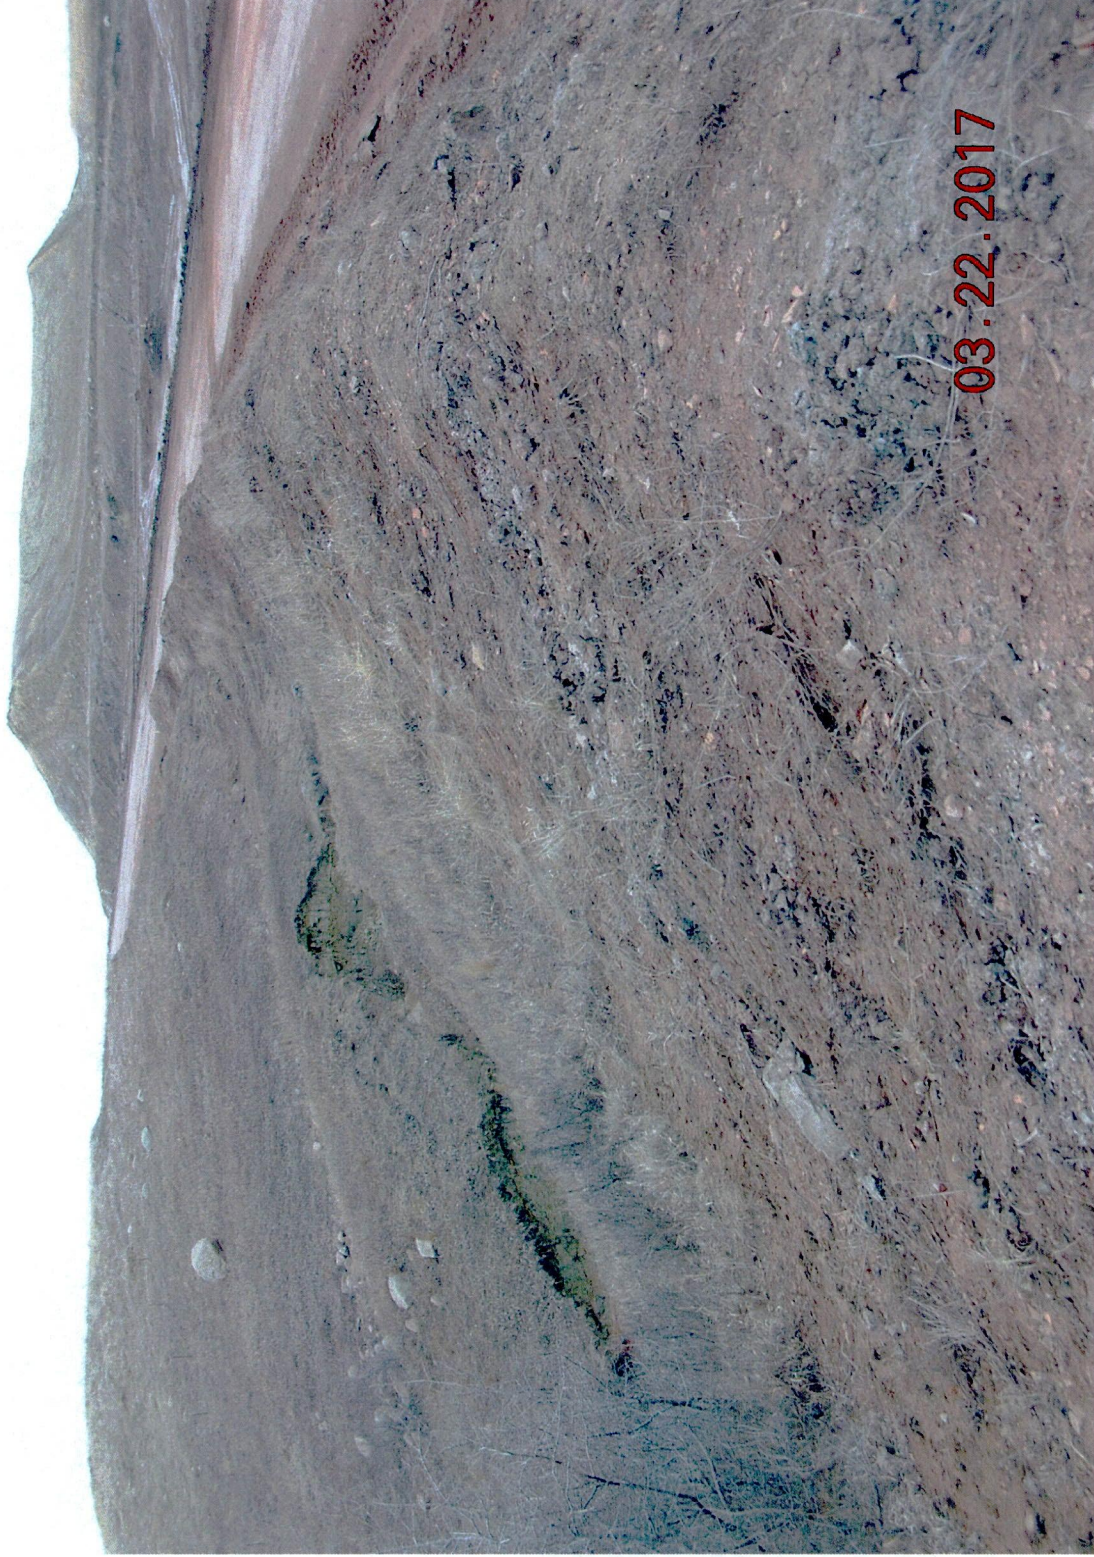
Figure 14a. North haul berm in right foreground and headward extent of erosional gully on left - facing east with subsoil stockpile 16-07-2 in right background - rotate northeast (left) with following Figure 14b.

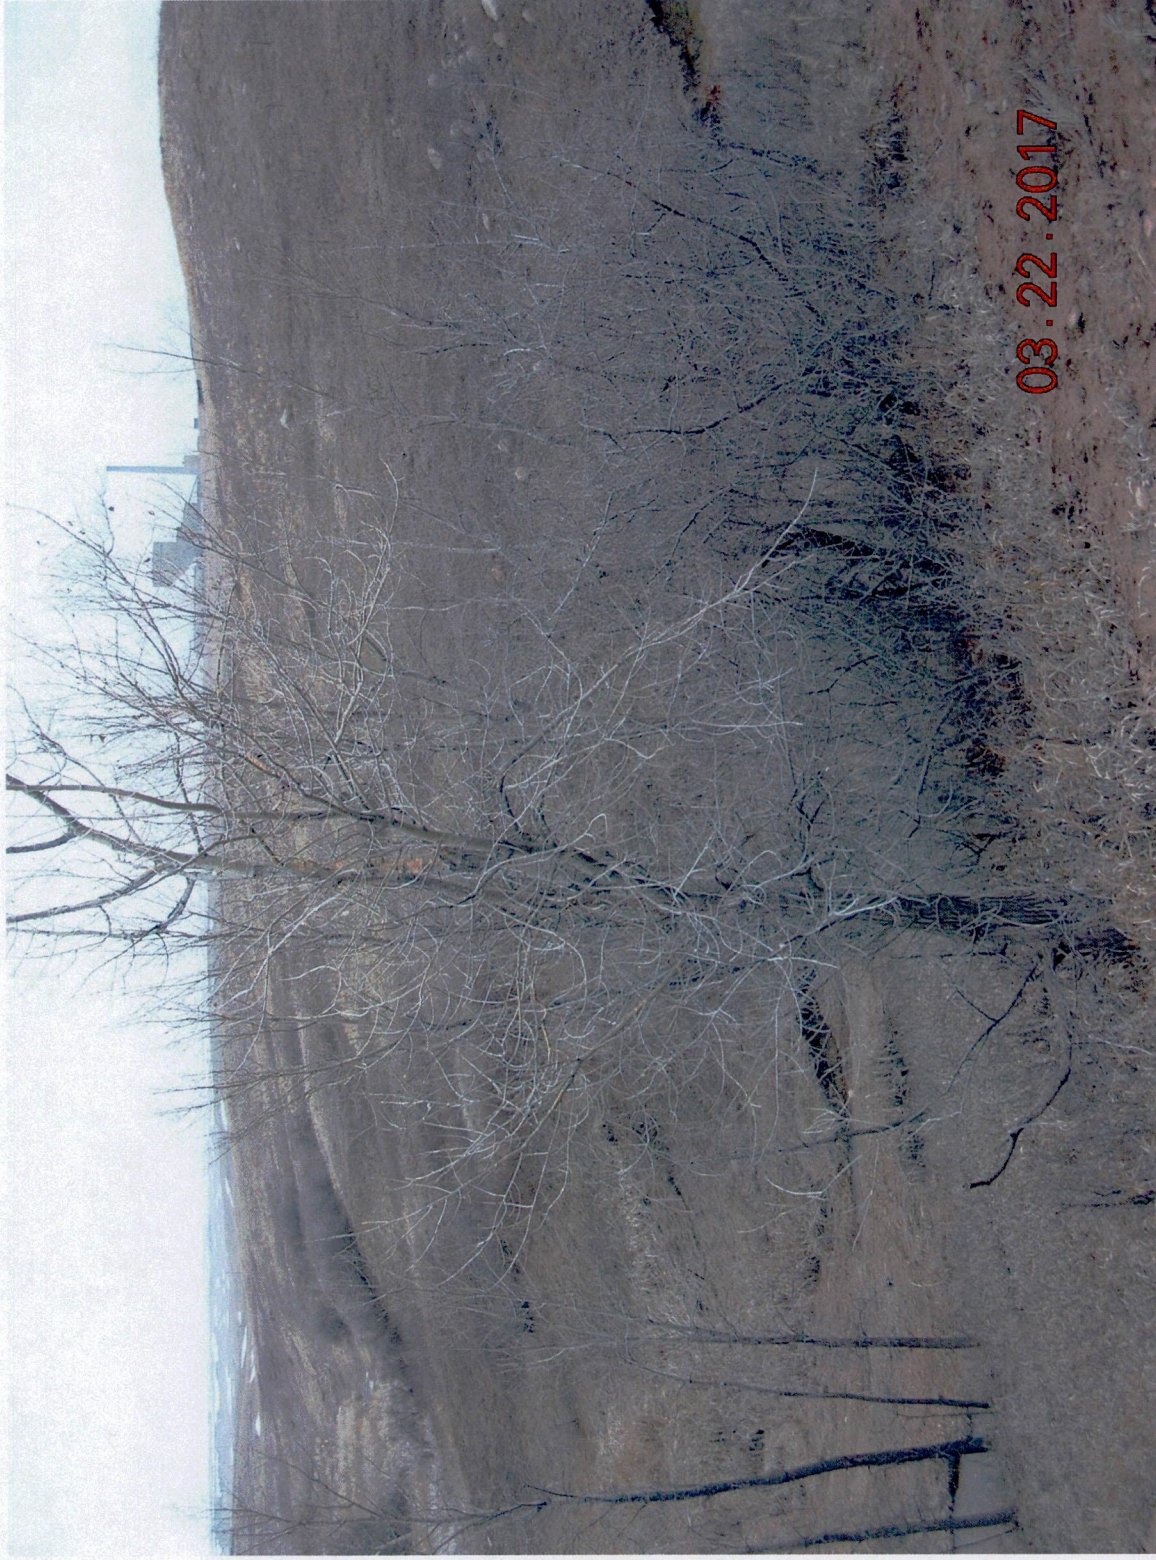
Figure 14b. Erosional gully in foreground and siltation in intermittent stream on left - facing northeast with Coyote Station in background - rotate north (left) with following Figure 14c or east (right) with preceding Figure 14a.

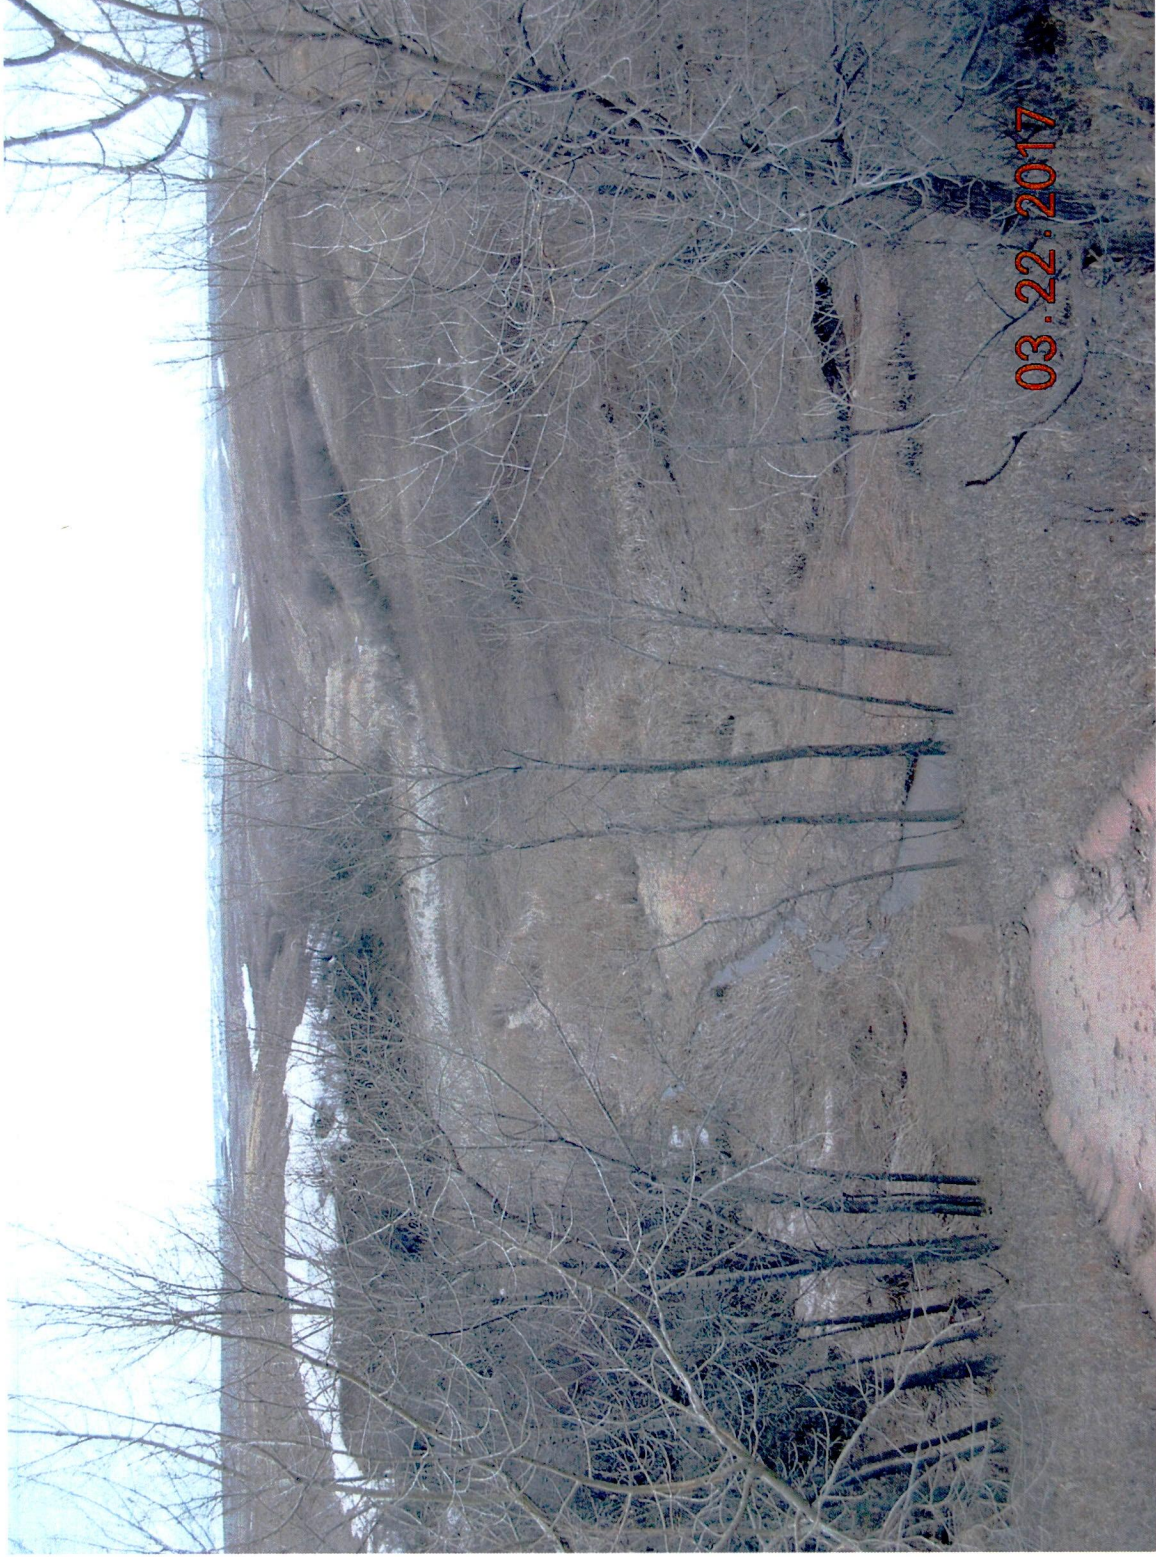
Figure 14c. Intermittent stream siltation in center - facing north with obsolete concrete drainage channel in foreground - rotate northeast (right) with preceding Figure 14b.

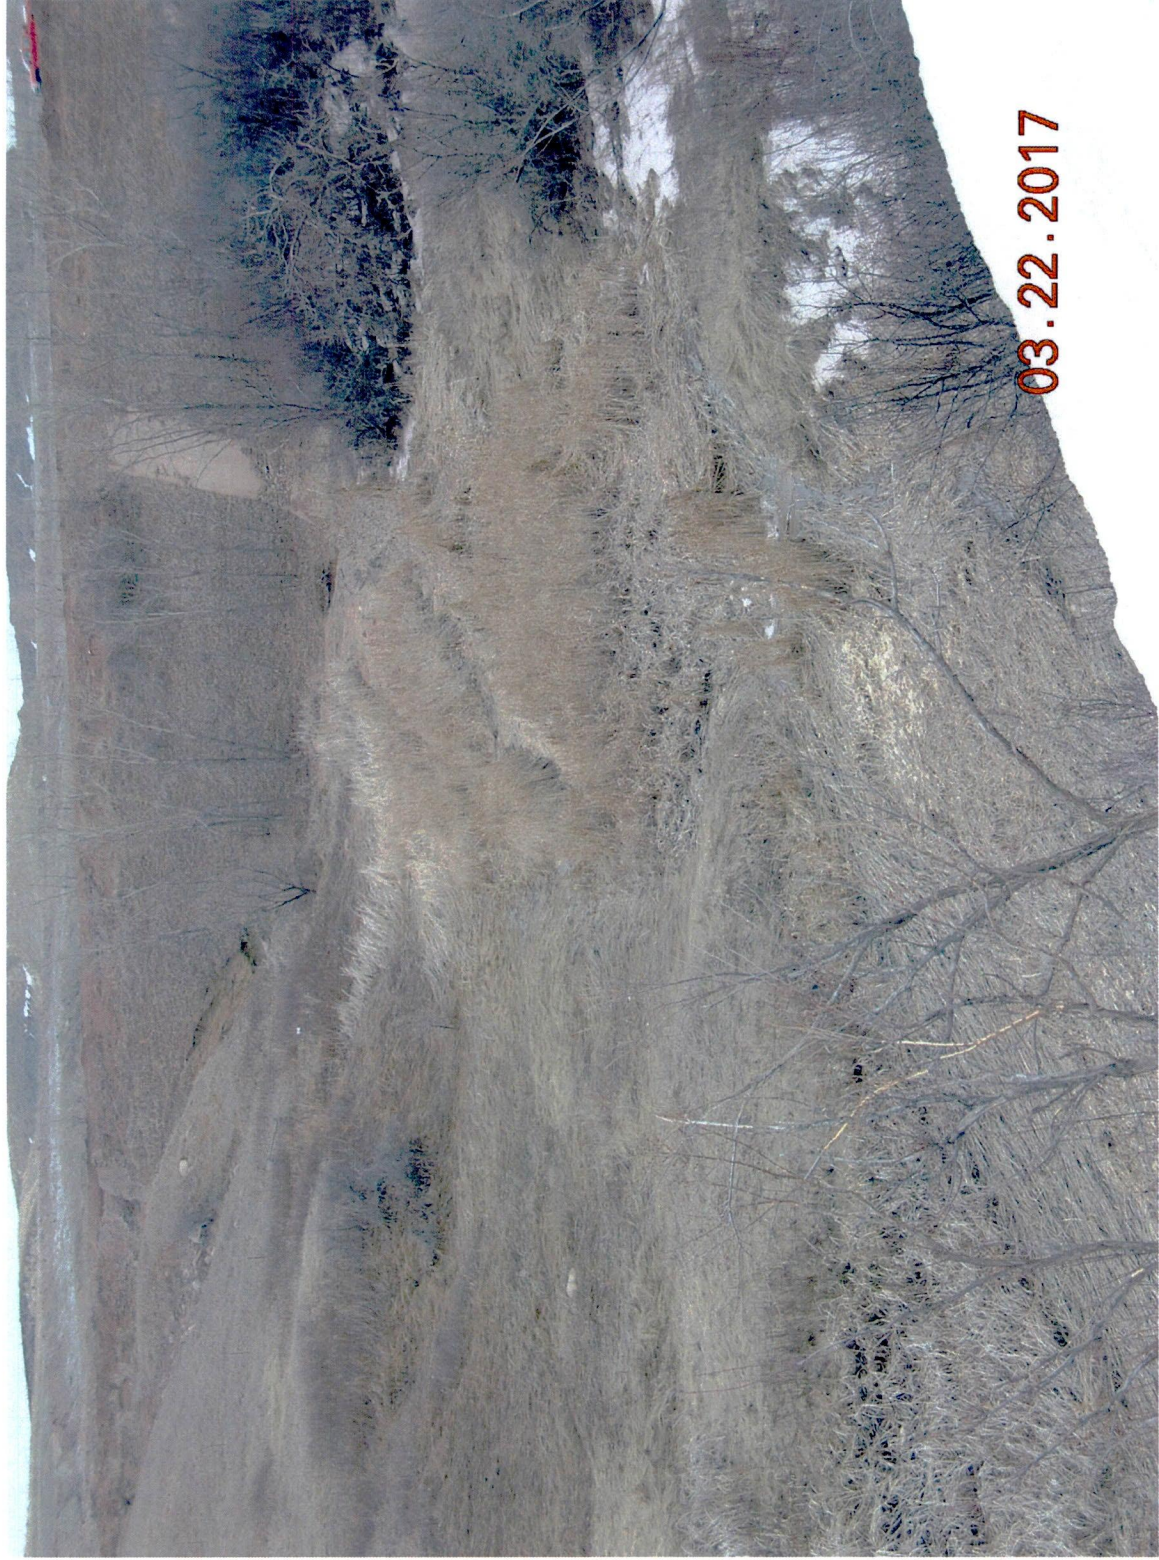
Figure 15. Overview of haul road runoff erosional gully (left background), siltation in intermittent stream (center foreground), and obsolete concrete drainage channel (center background) as viewed from the intermittent stream's west bank about 600 feet north of the haul road - facing south-southeast with DWC pickup truck parked on south haul road shoulder.
