PSC Case No. PU-17-181

Oasis Midstream Services LLC

Wild Basin Gas Plant Expansion - McKenzie County

PU-17-181 Reclamation and Vegetation Inspection Conducted 9-24-19

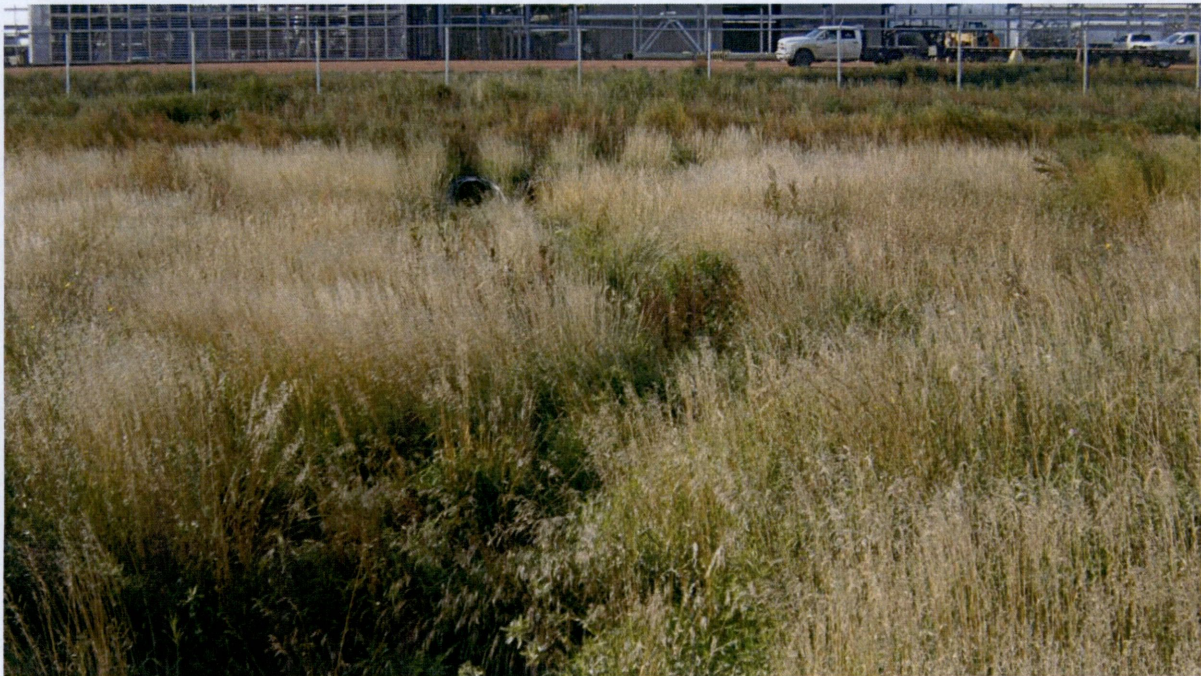
Our inspection began on the northeast side of the Wild Basin Gas Plant and proceeded around the perimeter. Vegetation is well established in all locations along the north side. There is one area (Figure 1) that has some signs of minor erosion that likely occurred some time ago. The area is now heavily vegetated, and a deeper channel has formed where the three large culverts were installed at the fence line. Because this area is well established, it is not a big concern.

Figure 1. View looking south at deeper channel where three culverts are located. Area has heavy vegetation growth.

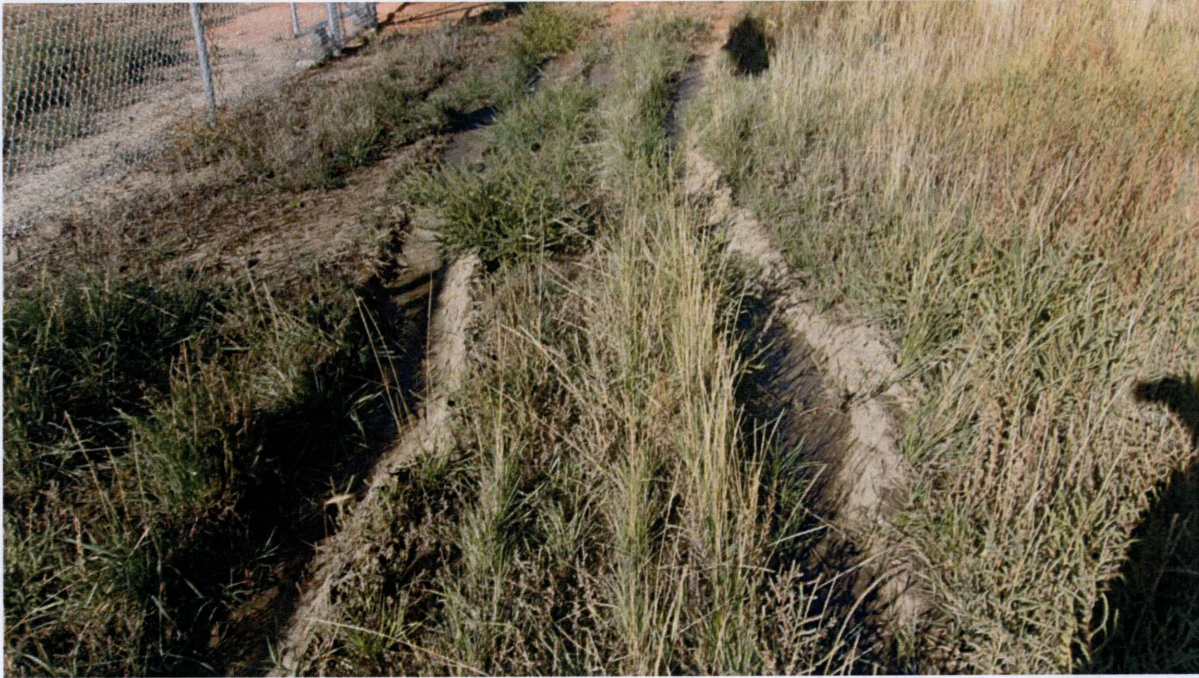
Some vehicle ruts were also noted along the fence line in certain areas that have limited vegetation growth (Figure 2). Vegetation growth in these areas may be affected by weed control that is likely occurring along the fence lines to control weeds. We then encountered a new road that was built after we began this inspection contract and was not included in the original as-built inspections conducted previously by Bartlett & West. We identified some minor erosion occurring in the road ditch as shown in Figures 3 & 4, but the adjacent areas of the property are well vegetated as shown in Figure 5.

Figure 2. View looking west at vehicle ruts along the south property fence line near the middle gate.

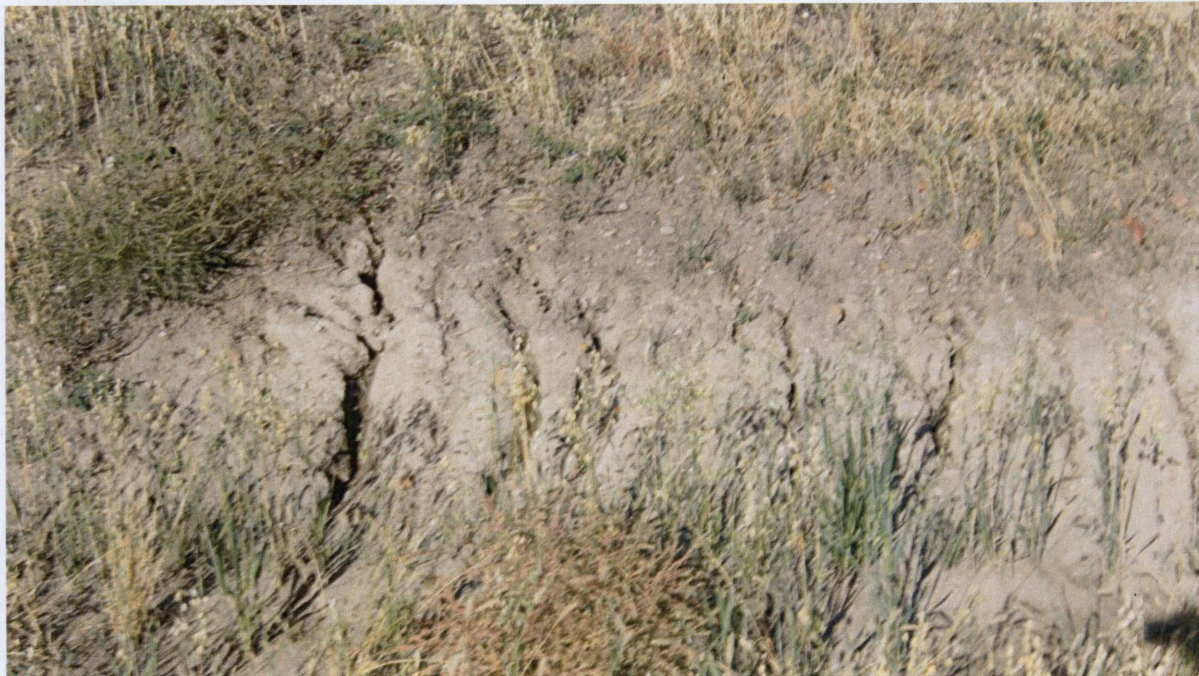
Figure 3. View looking west at the new road ditch with minor soil erosion that is occurring in the road ditch only.

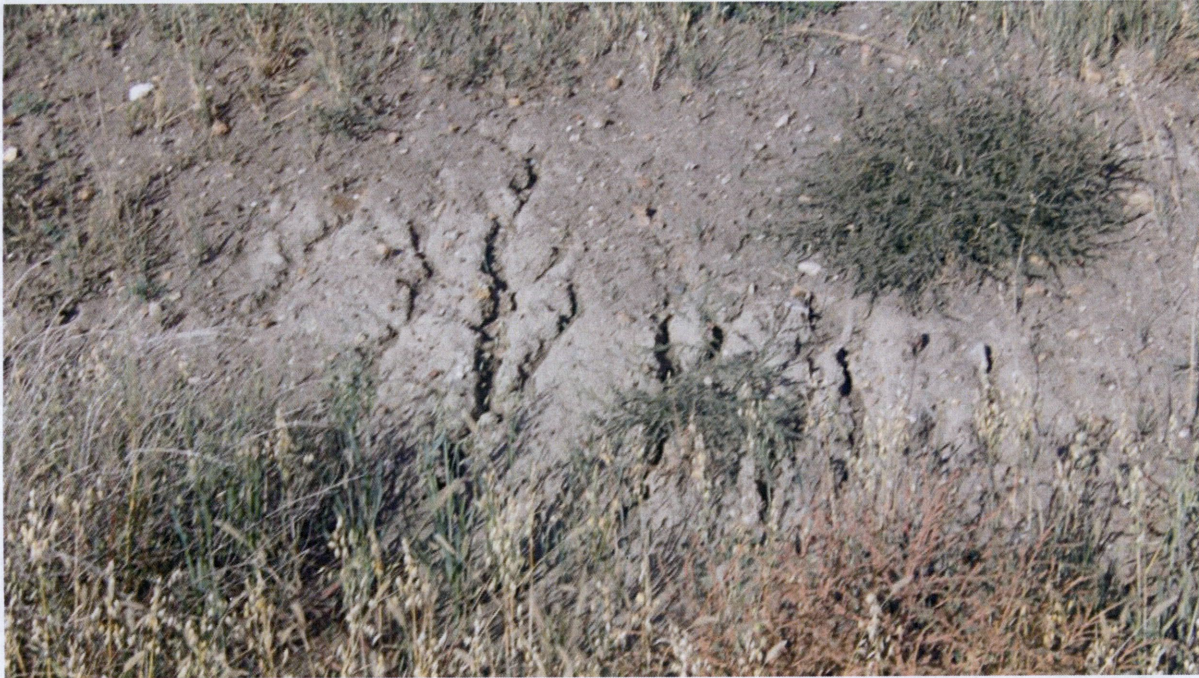
Figure 4. View looking west with good vegetation above the ditch, but some minor soil erosion occurring in the ditch.

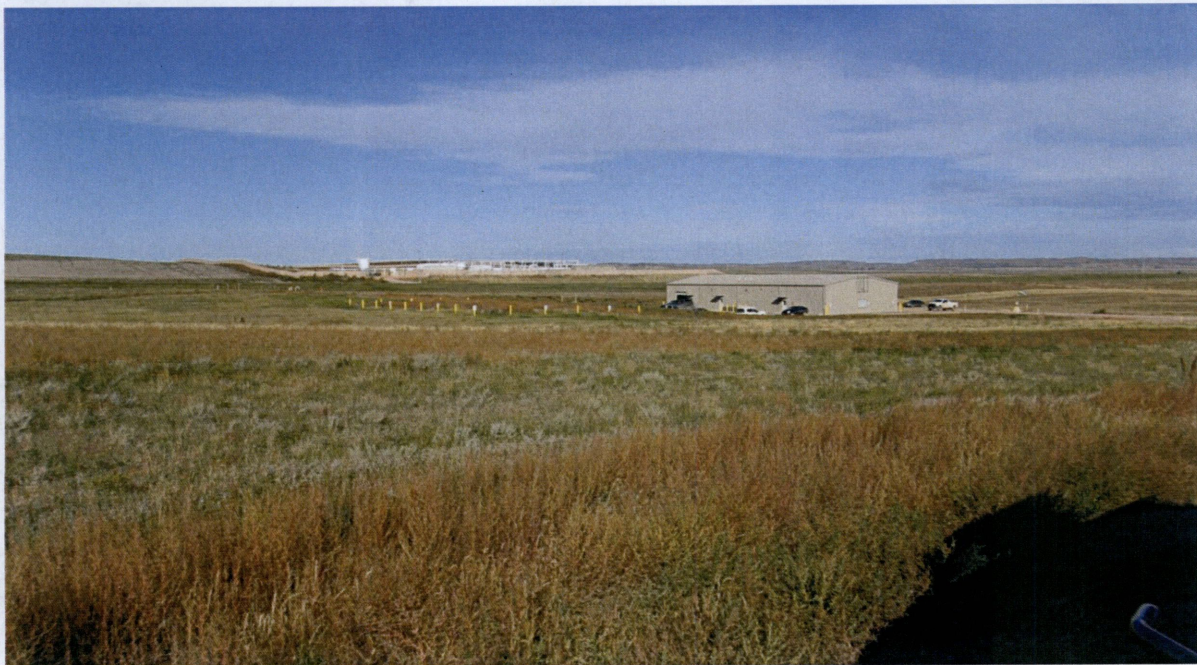
Figure 5. View looking northwest at good vegetation growth in the field areas and heavy weeds in the new road ditch.

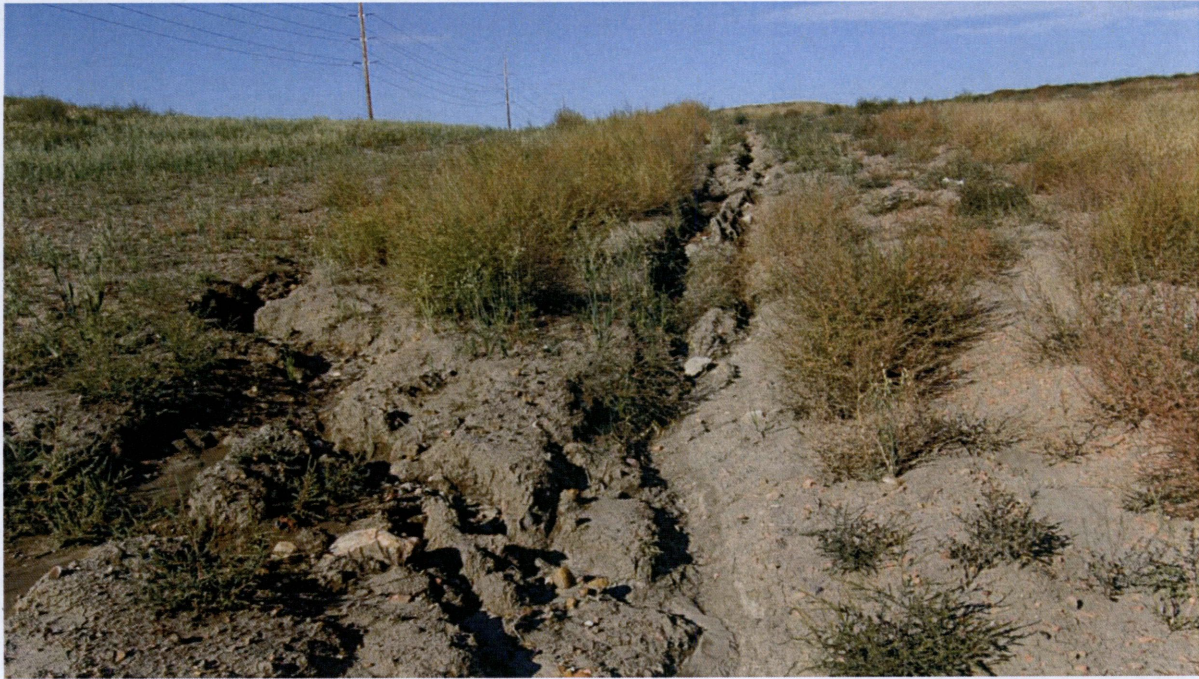
The south portion of the property has many steep slopes that have significant erosion occurring on them with limited vegetation growth. We also noticed a truck turn around that was constructed on top of a hill that has led to considerable erosion occurring in this area. The erosion has caused a significant channel to form, and likely due to no erosion control measures being implemented. These areas are shown in Figures 6-9.

Figure 6. View looking west at an area of significant erosion which starts at the truck turnaround area.

development since our last inspection. Therefore, some of these areas of concern may fall outside of the original contract scope area. Generally, the original site in our contract has been adequately reclaimed in the areas that have not seen any recent development. The areas of recent development will require some additional work including installing some erosion control measures and possibly reseeding in the more significantly eroded areas. The following pages include photographs taken during the inspection as well as a location map.

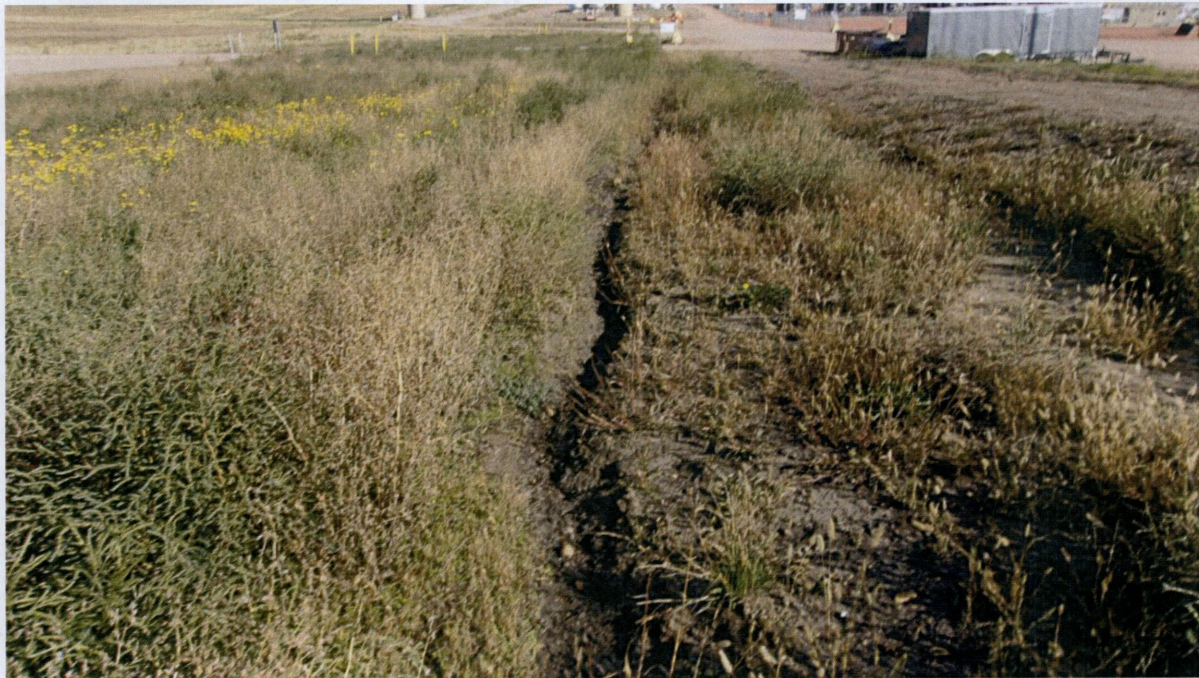
Figure 7. View looking north at an area of erosion along the west side of the truck turnaround access road.

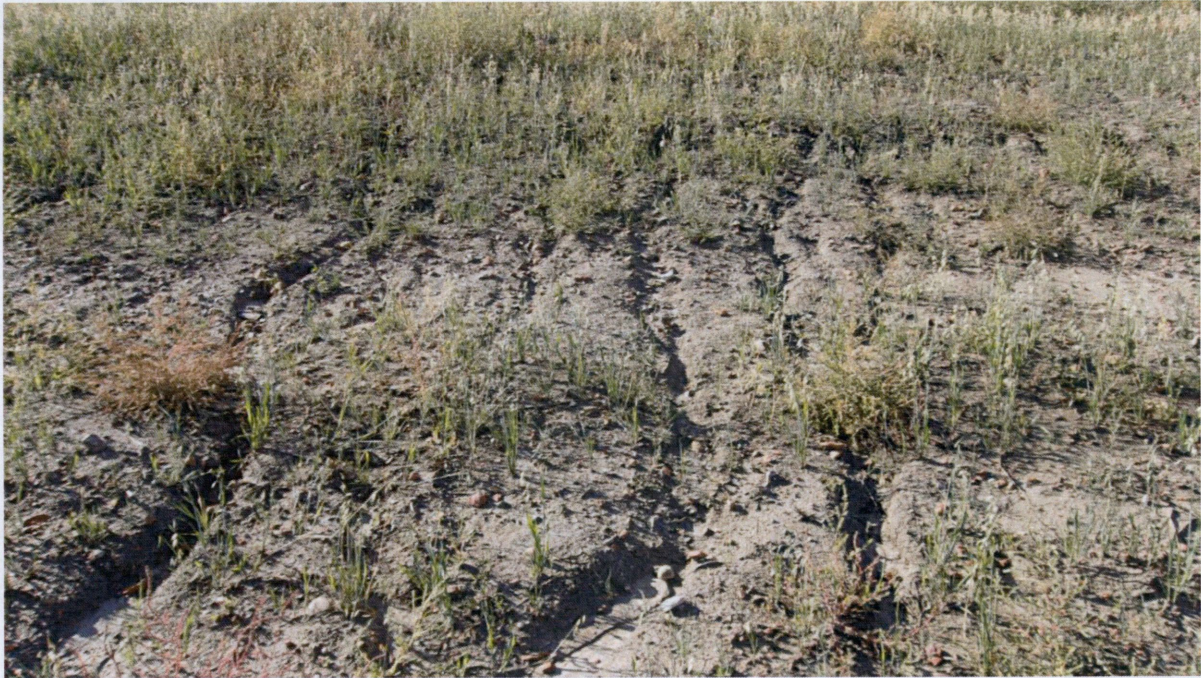
Figure 8. View looking south on the side slopes in the production area.

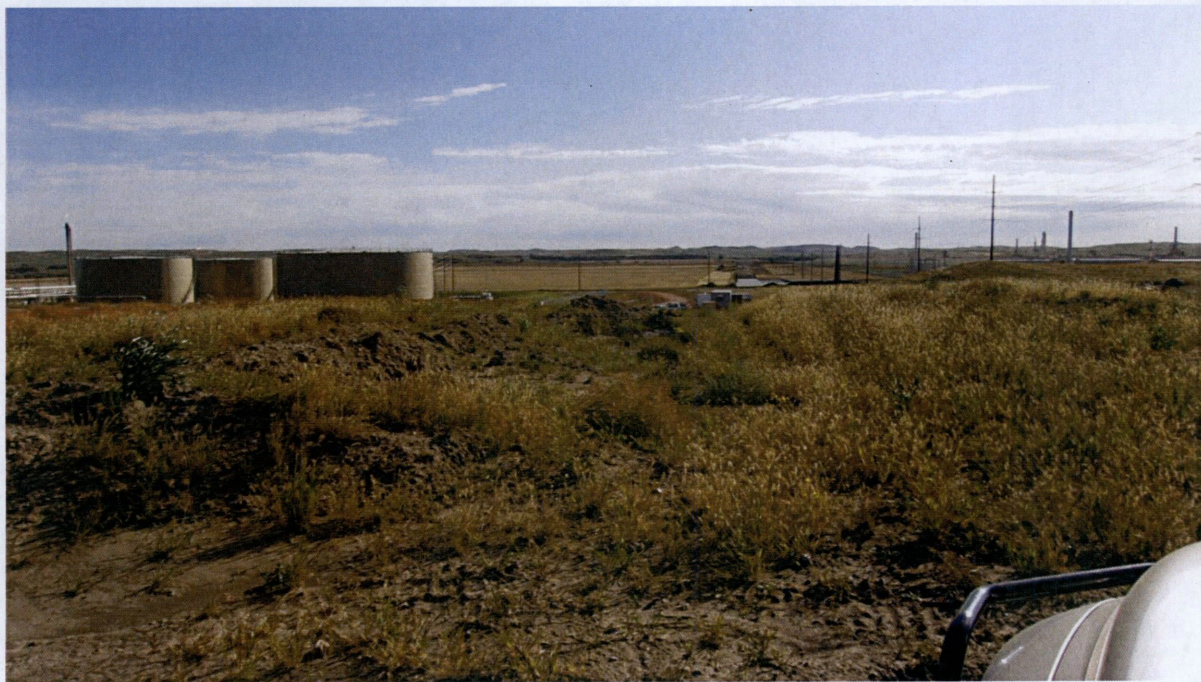
Figure 9. View of the truck turn around area that has seen limited reclamation.
