RE: Oasis Midstream Services, LLC  
Wild Basin Gas Plan  
Case No. PU-17-181

On December 28, 2021, The North Dakota Public Service Commission, submitted a Notice of Noncompliance alleging noncompliance by Oasis Midstream Services, LLC, n/k/a Rough Rider Operating, LLC. The notice outlined reclamation issues documented by the Commission's third-party inspector and filed on October 15, 2019 ("report") (<https://psc.nd.gov/database/documents/17-0181/074-010.pdf>).

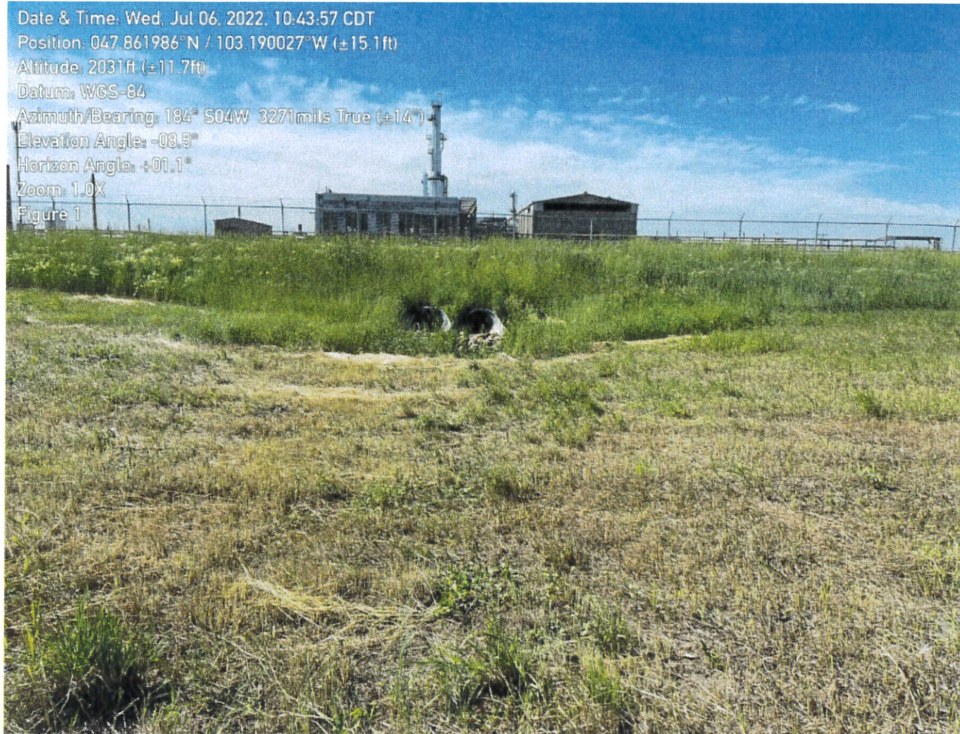
Figure 1: Erosion repaired, soil stabilized, and weed issues corrected.

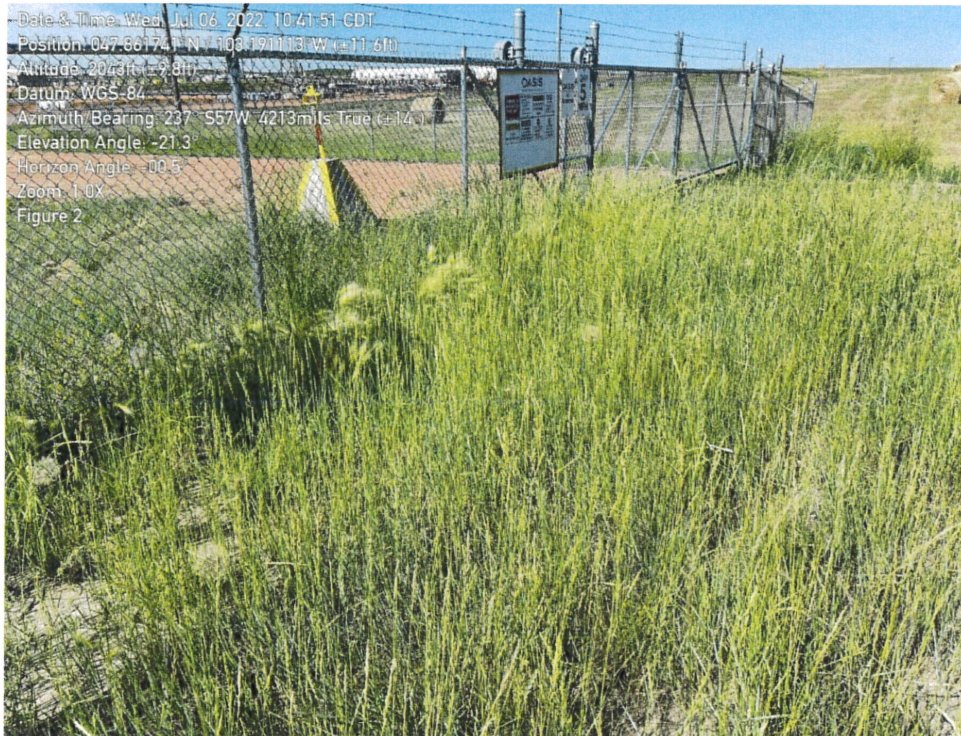
1. Vehicle ruts and unsuccessful weed control. (Figure 2)
2. Erosion in road ditch. (Figures 3-4)
3. Signification erosion and limited vegetation growth on steep slopes in the south portion of the property. Considerable erosion that has caused a signification channel to form in the area of a truck turn around on the top of a hill. (Figures 6-9)
4. Areas of recent development requiring erosion control measures and reseeding/ reclamation (Figures 10-11).

Figure 2: Weed issues corrected, ruts filled in.

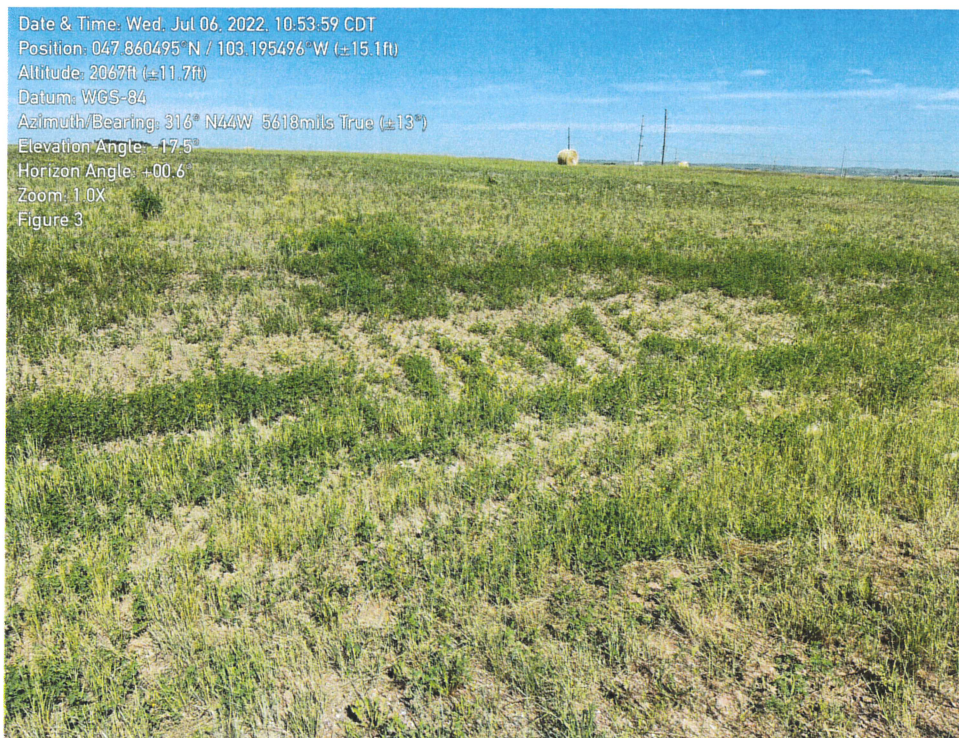
Figure 3: Road ditch stabilized.

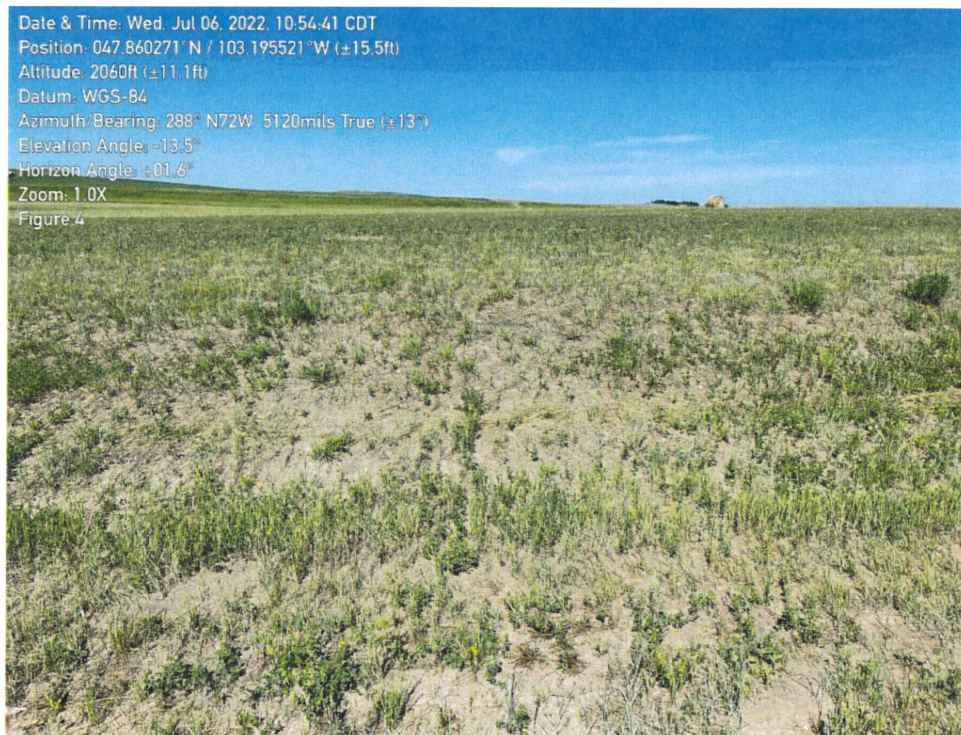
Figure 4: Road ditch stabilized.

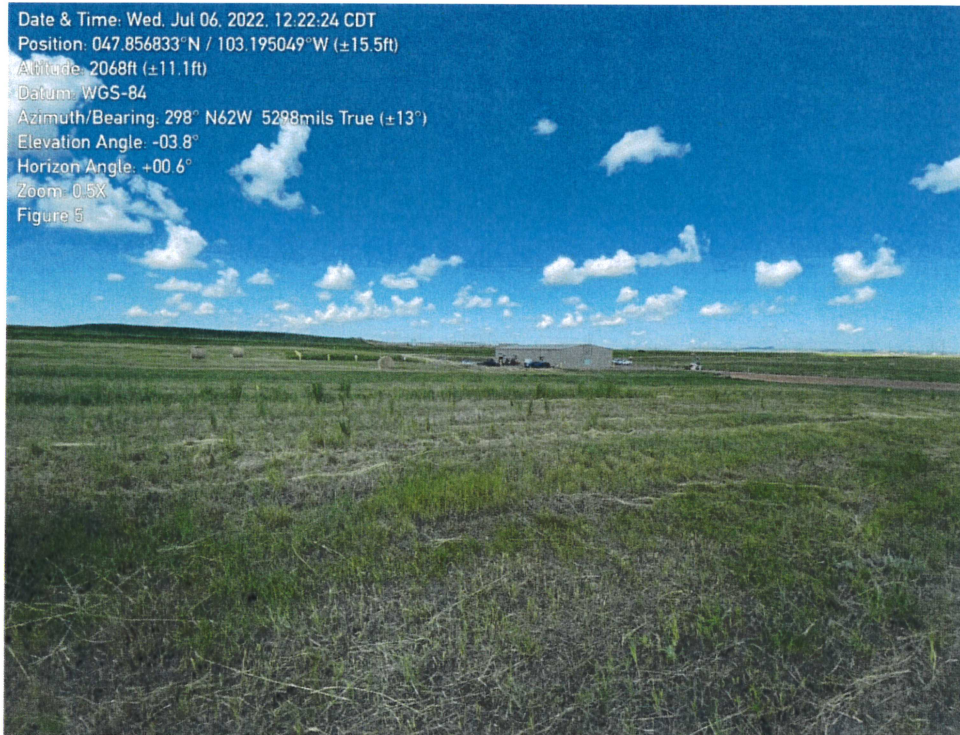
Figure 5: Weed issues in the road ditch have been corrected.

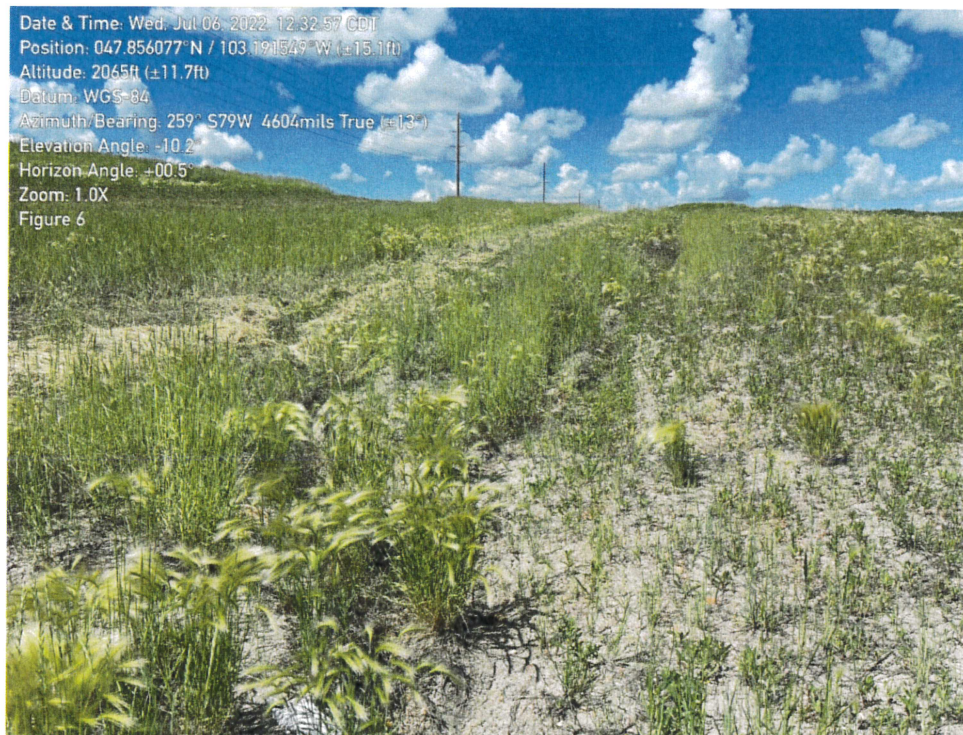
Figure 6: Minor rill erosion remains; however, vegetative cover has stabilized the soil.

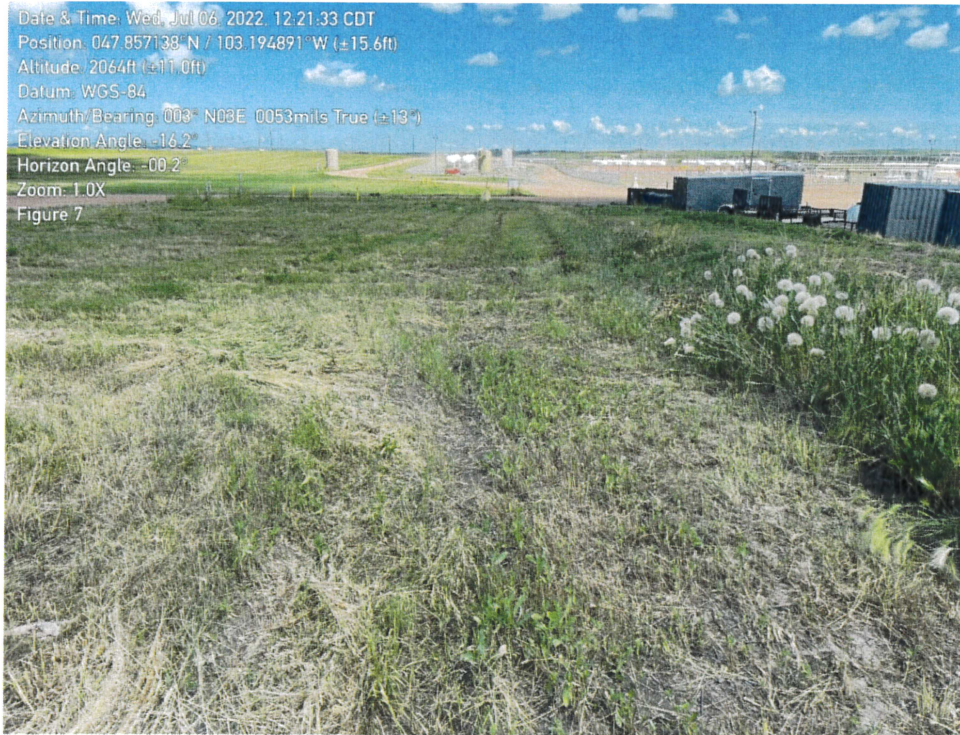
Figure 7: Erosion minimal and soil is stabilized.

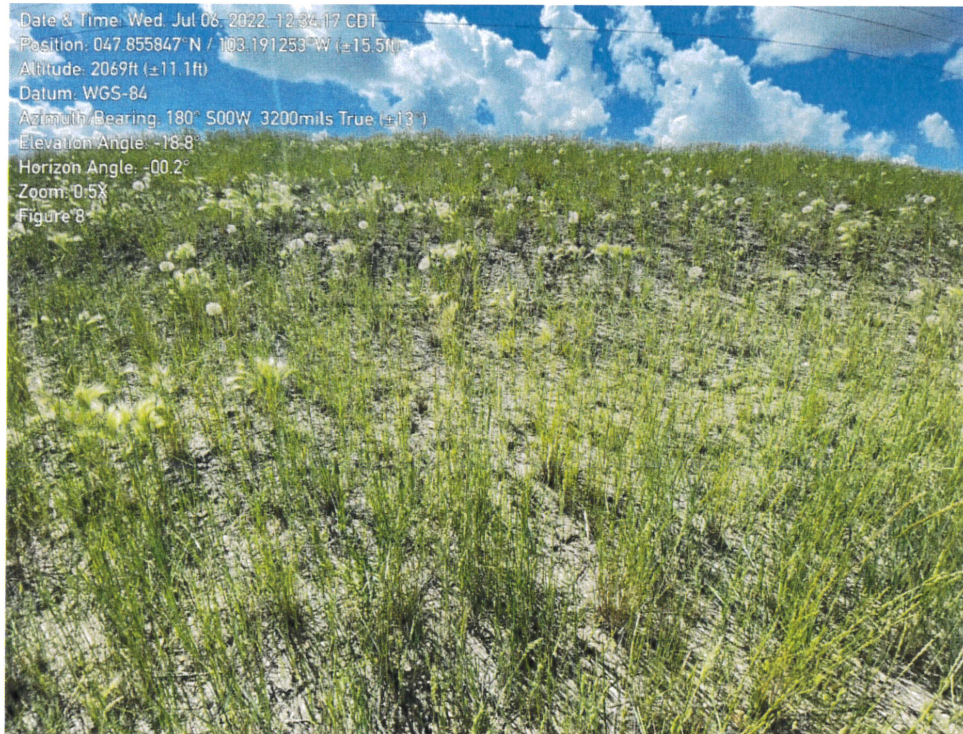
Figure 8: Southern side slopes are stabilized.

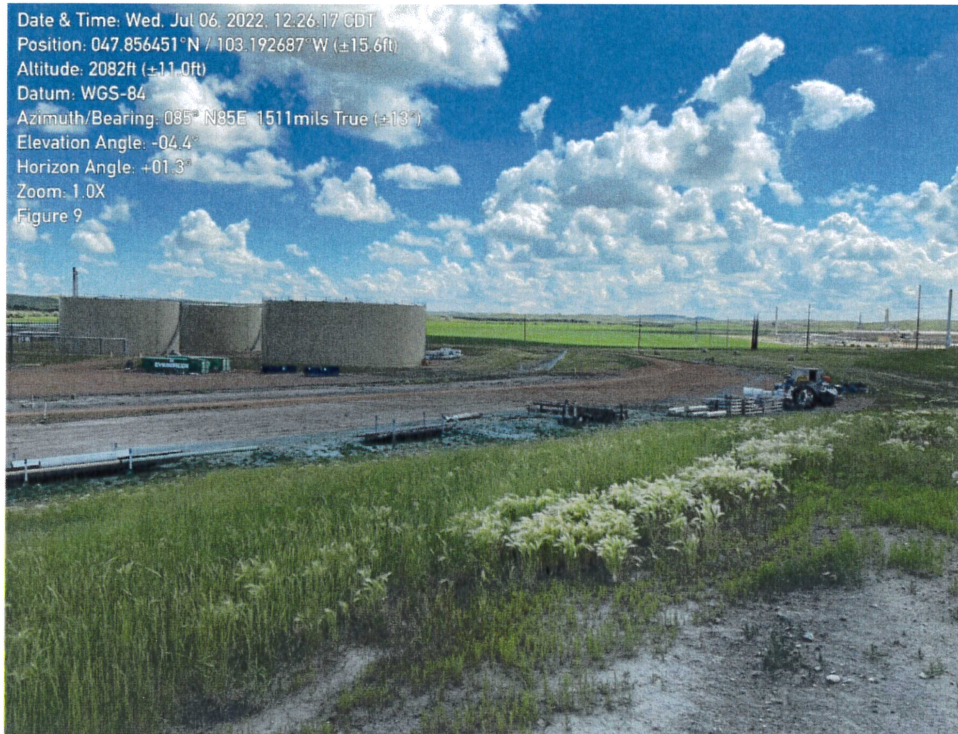
Figure 9: Truck turn around has been reclaimed.

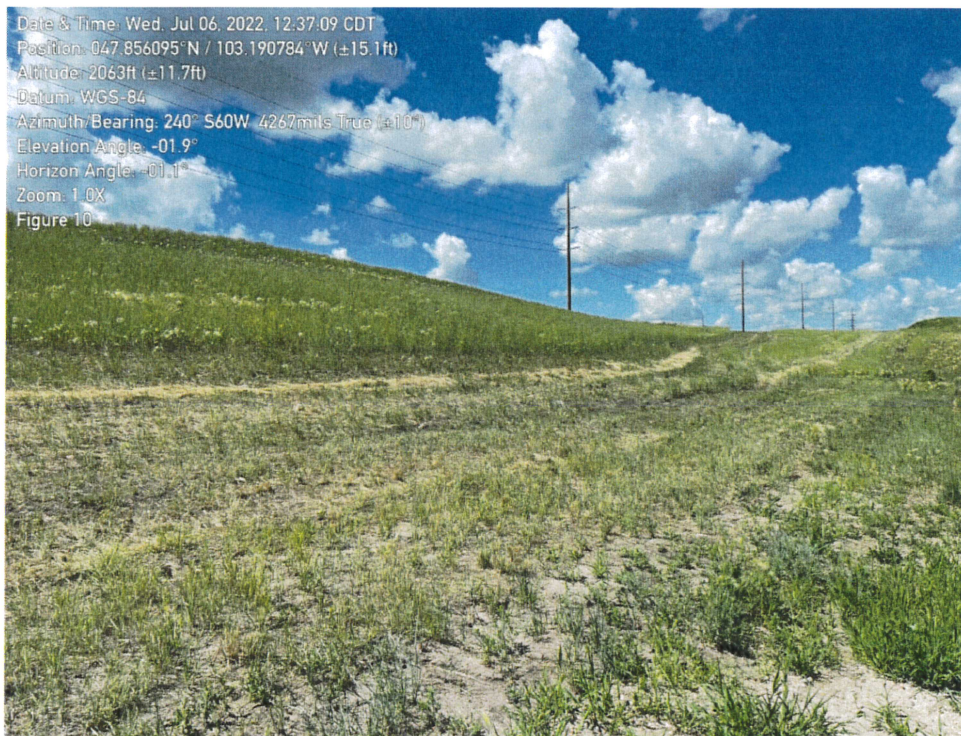
Figure 10: Southern portion of the property has been reclaimed.

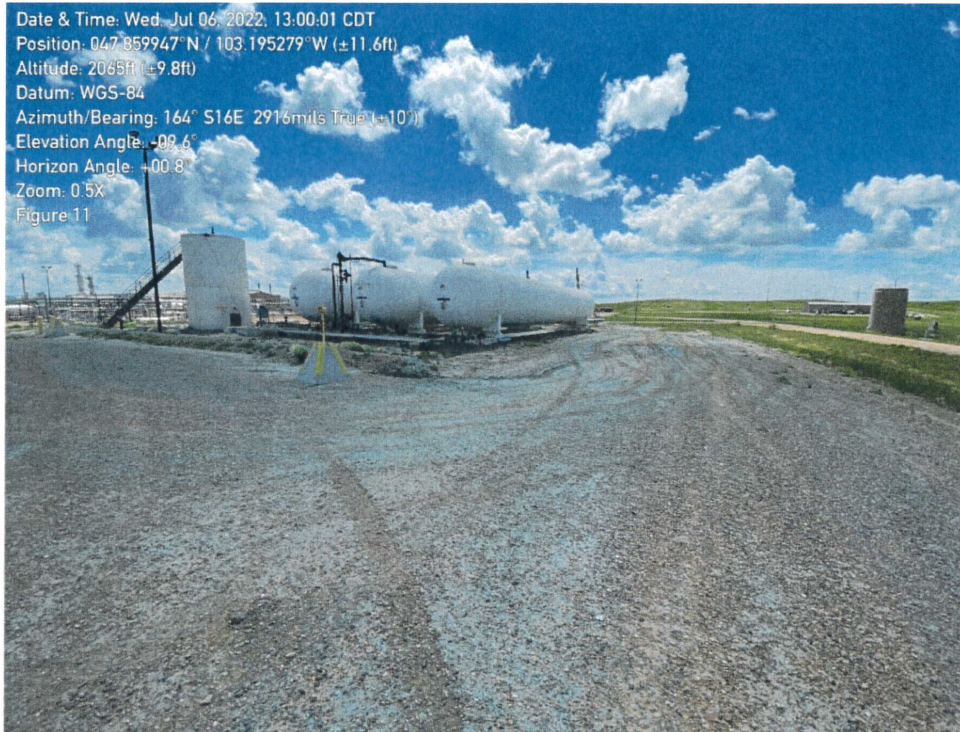
Figure 11: Additional development reclaimed.
