112 **PU-17-284** Filed: 7/3/2018 Pages: 4
Site Inspection Trip Report – Topsoil Inspection

Site/Project Location: Foxtail Wind Farm

Date of Inspection: 20 June 2018

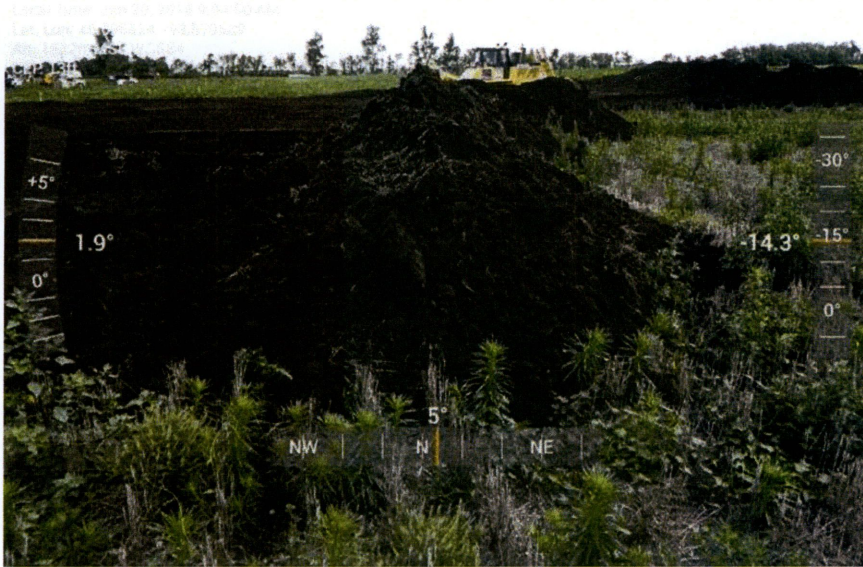
Report Photo #1 "Bulldozers Stripping Layout Yard"

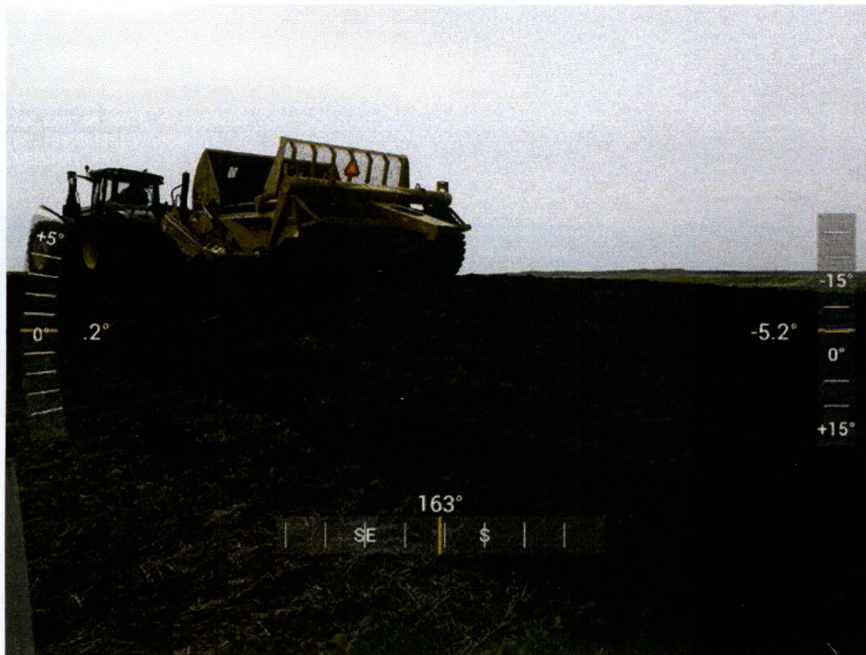
Report Photo #2 "Grader Dumping Topsoil from Access Road"

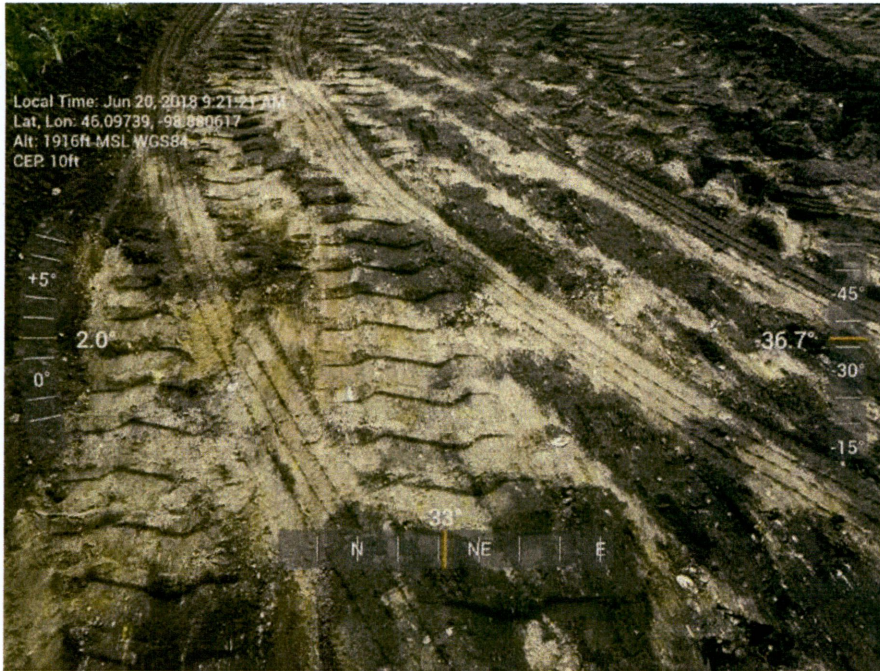
Report Photo #3 "Subsoil Showing in Layout Yard"
