**Site/Project Location:** Foxtail Wind Farm– Dickey County

**Date of Inspection:** 11 September 2018

Keitu staff visited the Foxtail Wind Farm project for a construction inspection. Inspection of construction sites focused on (1) confirming surface disturbance/work occurring within ND PSC-approved work corridor and/or route; (2) topsoil segregation occurring; (3) vegetation removal consistent with tree & scrub mitigation plan; and (4) storm water runoff and sediment control.

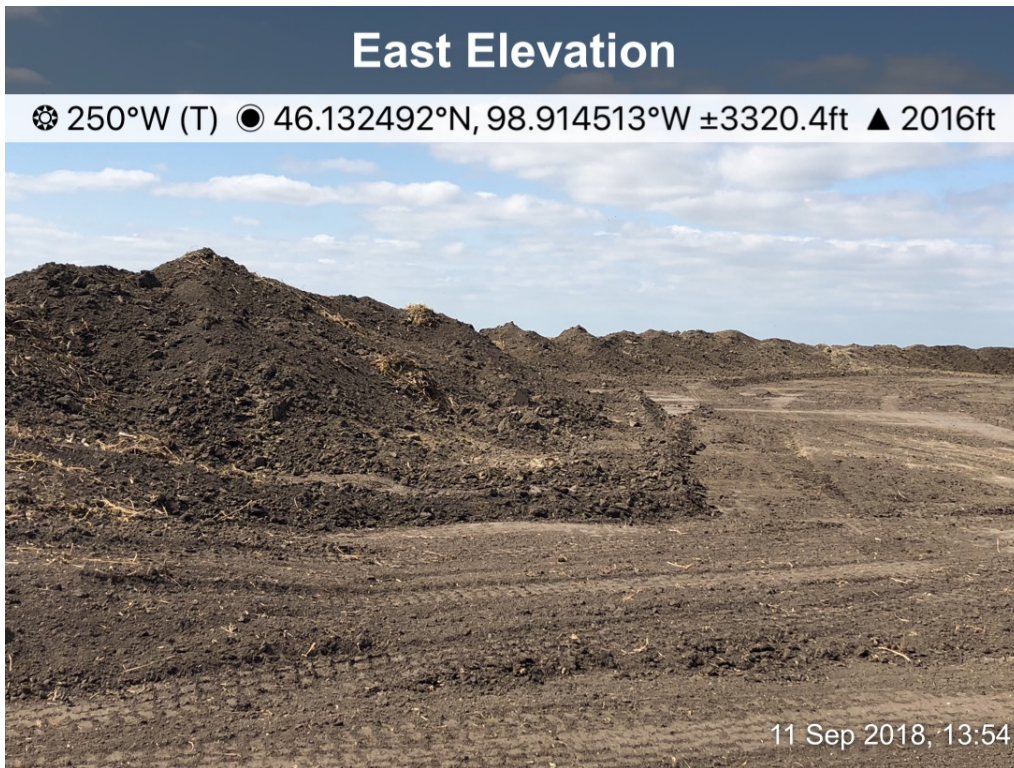
With varying topsoil depth at each site, grader operators have shown to be proficient in separating topsoil on string roads and turbine sites. Crew is beginning string road construction near turbine sites T1 and T23. Recent weather conditions and cattle have damaged silt fences between sites T-40 and T-49. Peter Nelson, Project Manager of Wanzek Construction stated this area will be fixed within 24 hours (9-11-2018) and that Wanzek Construction employs a crew to routinely check and remediate issues with silt fences. All roads and turbine sites inspected showed adequate segregation of topsoil and subsoil with topsoil being used as an outer berm for string roads and turbine sites.

**Report Photo #1 "Topsoil Segregation- Site T-21"**

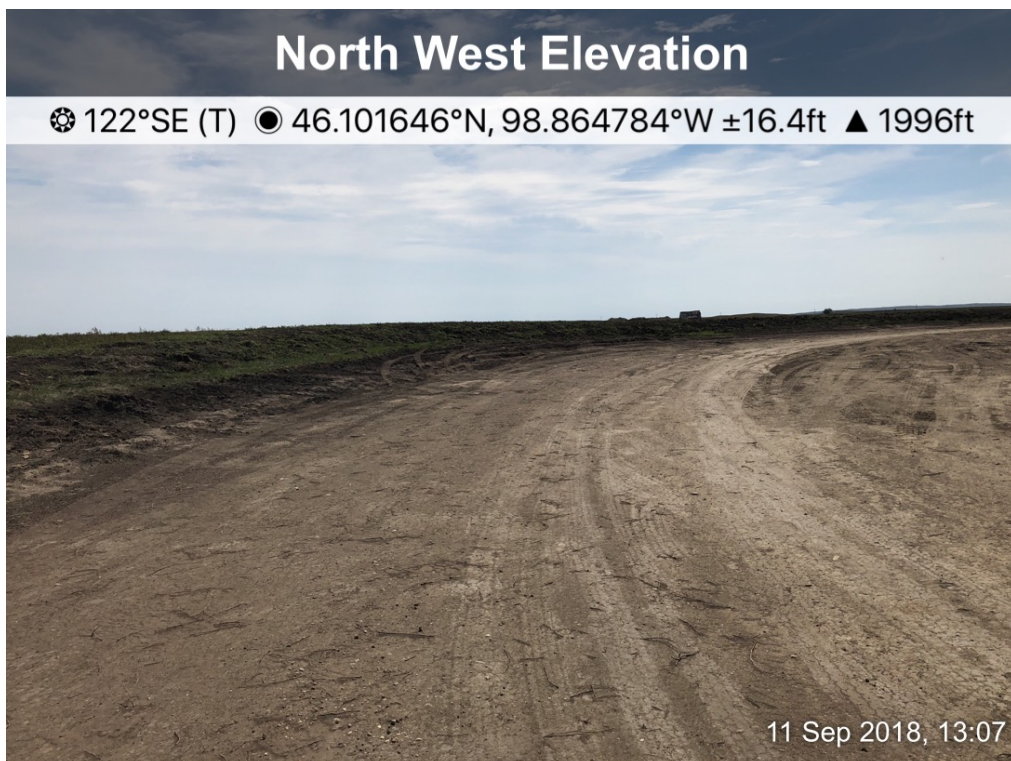
**Report Photo #2 "String Road between Sites T-40 and T-46"**

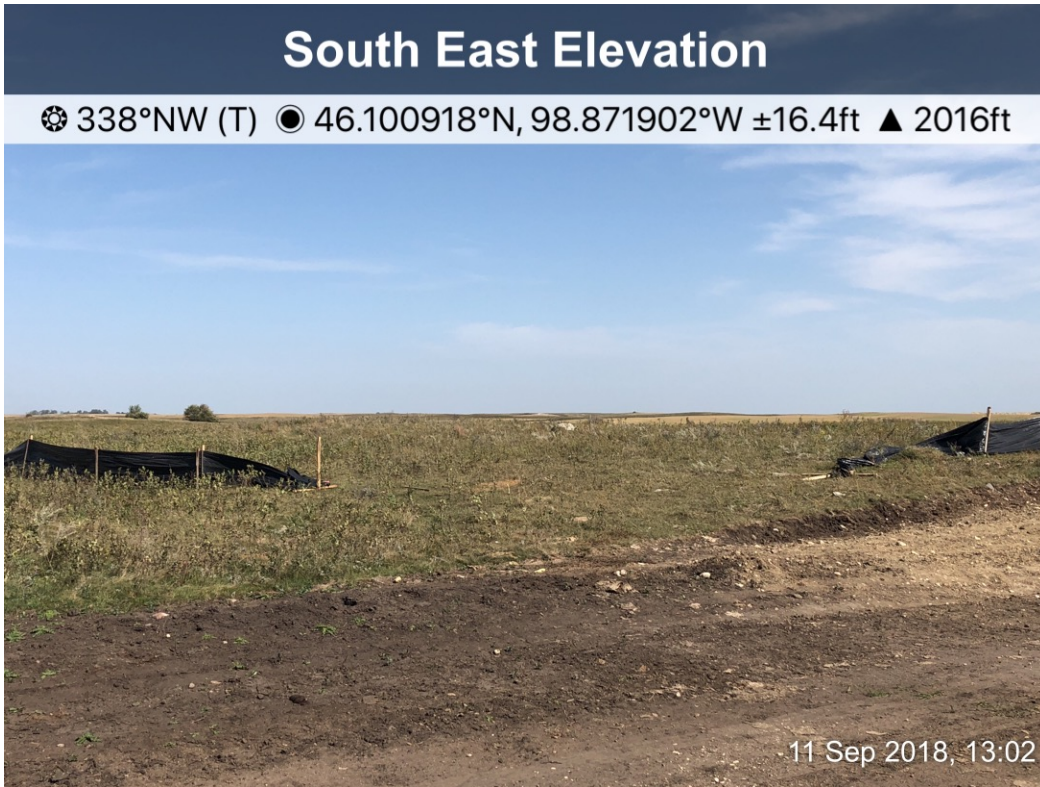
Silt fence damages between sites T-40 and T-49. Peter Nelson stated this issue will be fixed within 24 hours (9-11-2018).

**Report Photo #3 "Sediment Fence Down Between Sites T-40 and T-45"**

Damaged silt fences must be repaired or replaced within 24 hours to prevent sediment runoff from storm water. All erosion control devices will be routinely monitored for damage caused by weather and cattle.
