Site/Project Location: Foxtail Wind Farm– Dickey County

Date of Inspection: 26 June 2019

Keitu staff visited the Foxtail Wind Farm project for a construction inspection. Inspection of construction sites focused on (1) confirming surface disturbance/work occurring within ND PSC-approved work corridor and/or route; (2) topsoil segregation occurring; (3) vegetation removal consistent with tree & scrub mitigation plan; and (4) storm water runoff and sediment control.

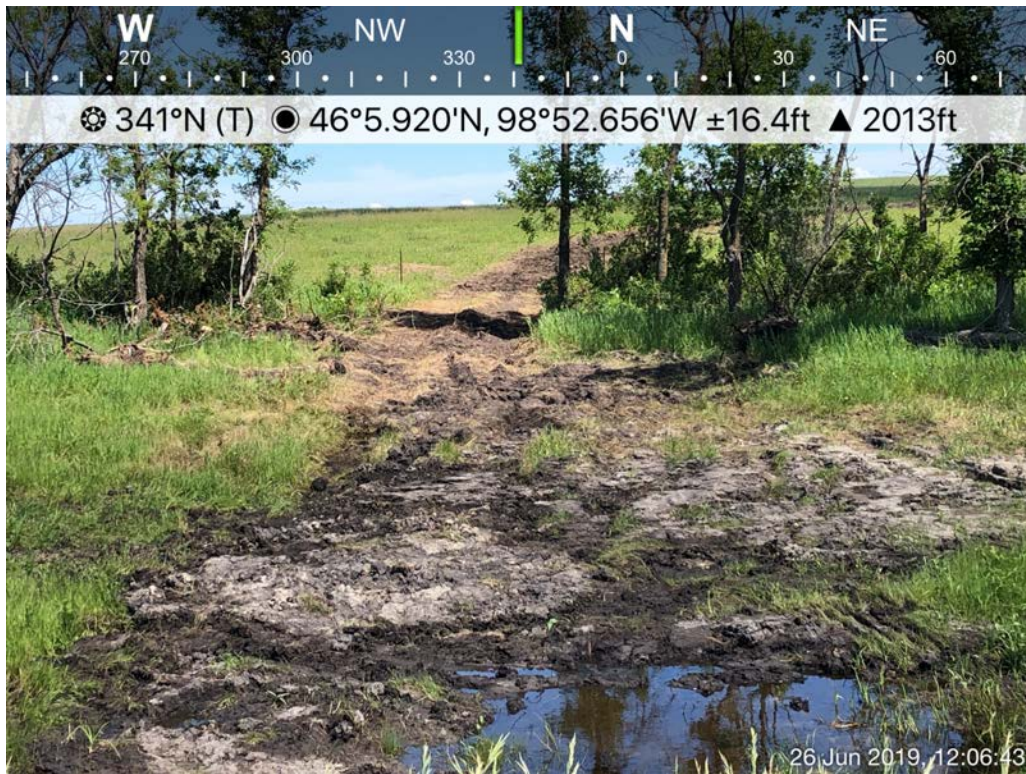
There were a small number of trees removed where underground cables were trenched through single row shelterbelts for turbine sites and the substation. The number of trees removed was very minimal; however, a tree and shrub mitigation plan was not found in the records for the Project on the PSC website. Vegetation was emerging through the erosion control blankets at the substation where dirt work was completed.

Report Photo #1 "Underground cable trench on North side of 91st St towards T45"

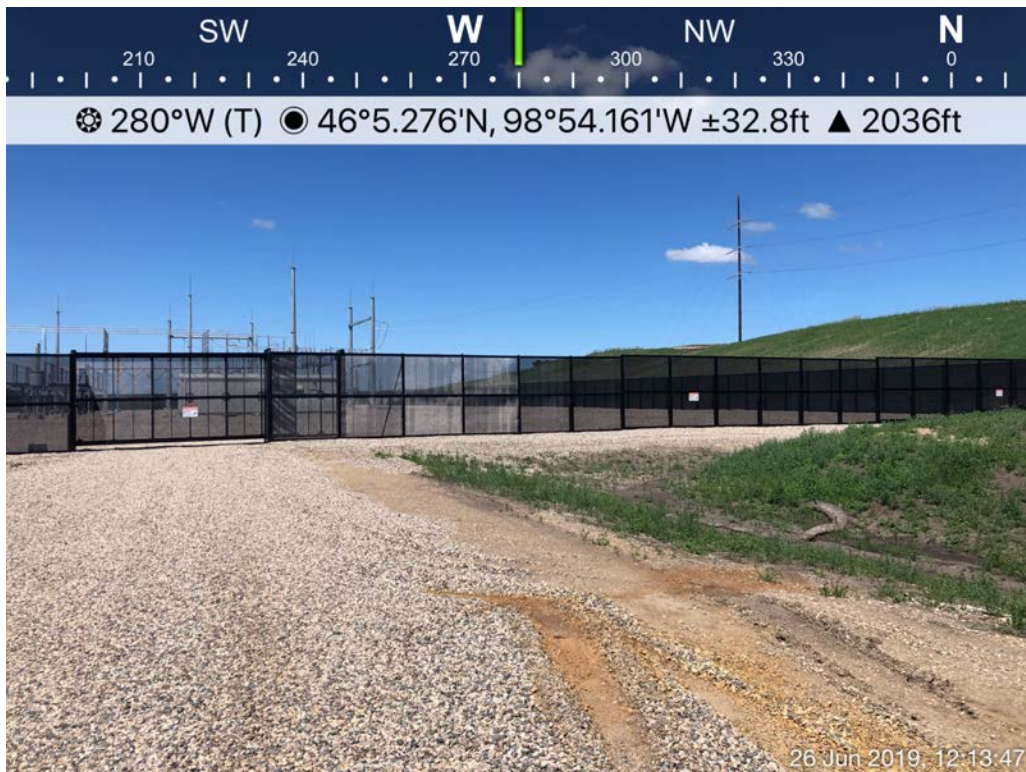
Report Photo #2 "Substation with vegetation emerging through erosion blanket on North side"

Erosion control and stormwater BMPs should continue to be routinely evaluated and replaced or repaired as necessary and pad sites smoothed out once construction on the sites is completed.

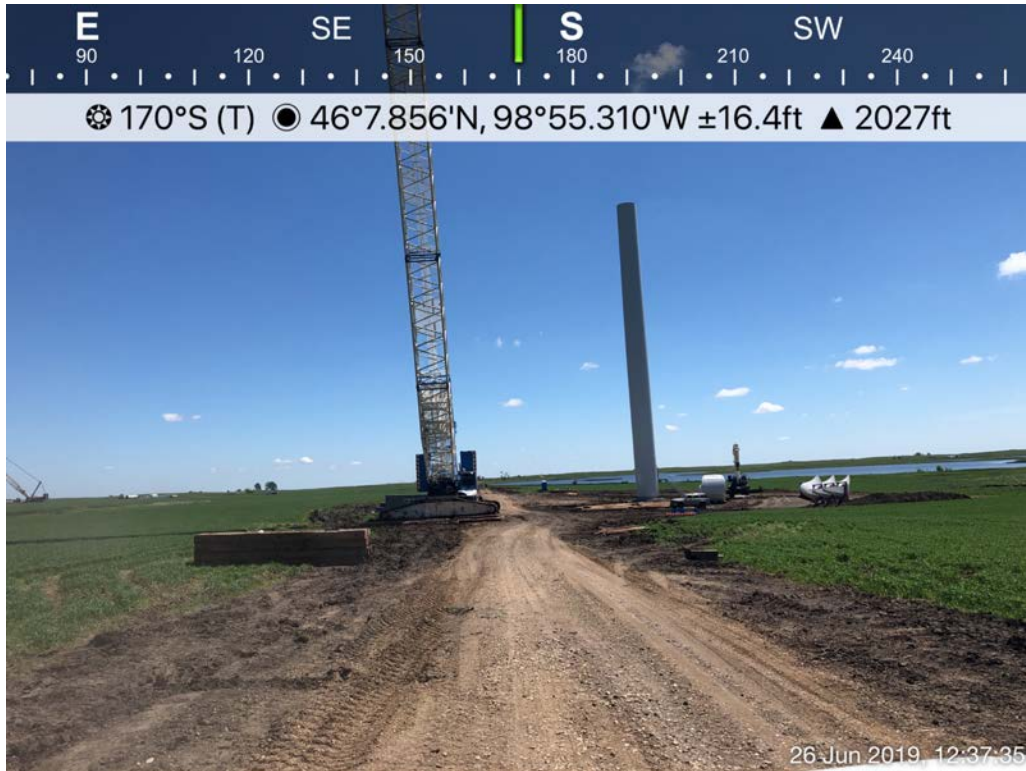
Report Photo #3 “Constructed turbine tower with turbine blades and components on site T7”

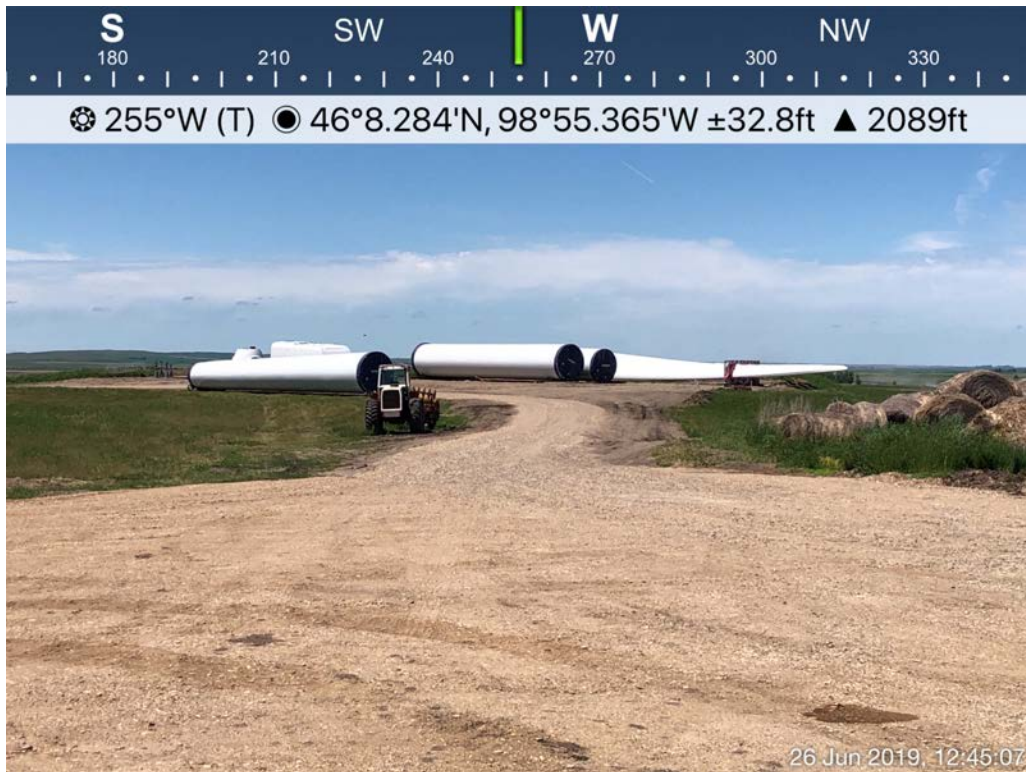
Report Photo #4 “Turbine components on site T5 ready for construction of tower”

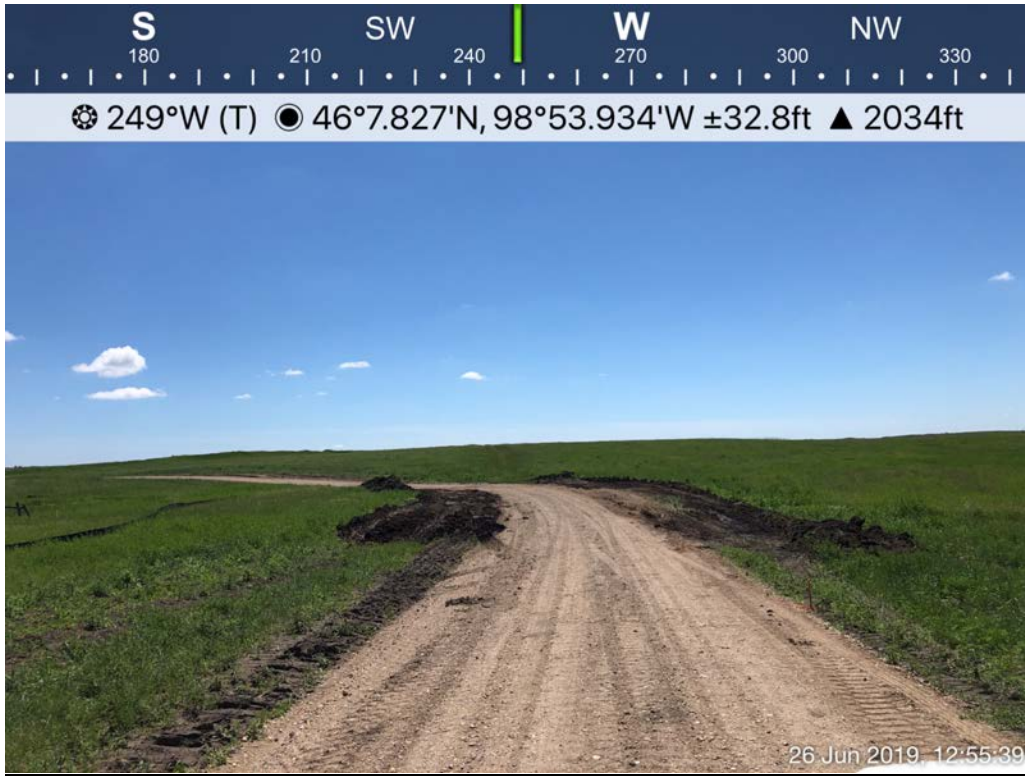
The majority of construction involving the stripping of topsoil was completed in 2018, with the exception of some curves on string roads. In these circumstances, the topsoil was stripped appropriately and piled on the side of the string road to be replaced when turbine construction is completed. Erosion control and stormwater management devices were in good condition, working effectively, and checked routinely.

Report Photo #5 "String road to site T14 widened on curve for haul trucks"
