Reclamation and Revegetation Inspection Report

Foxtail Wind Farm

Foxtail Wind, LLC

ND PSC Case No. PU-17-284

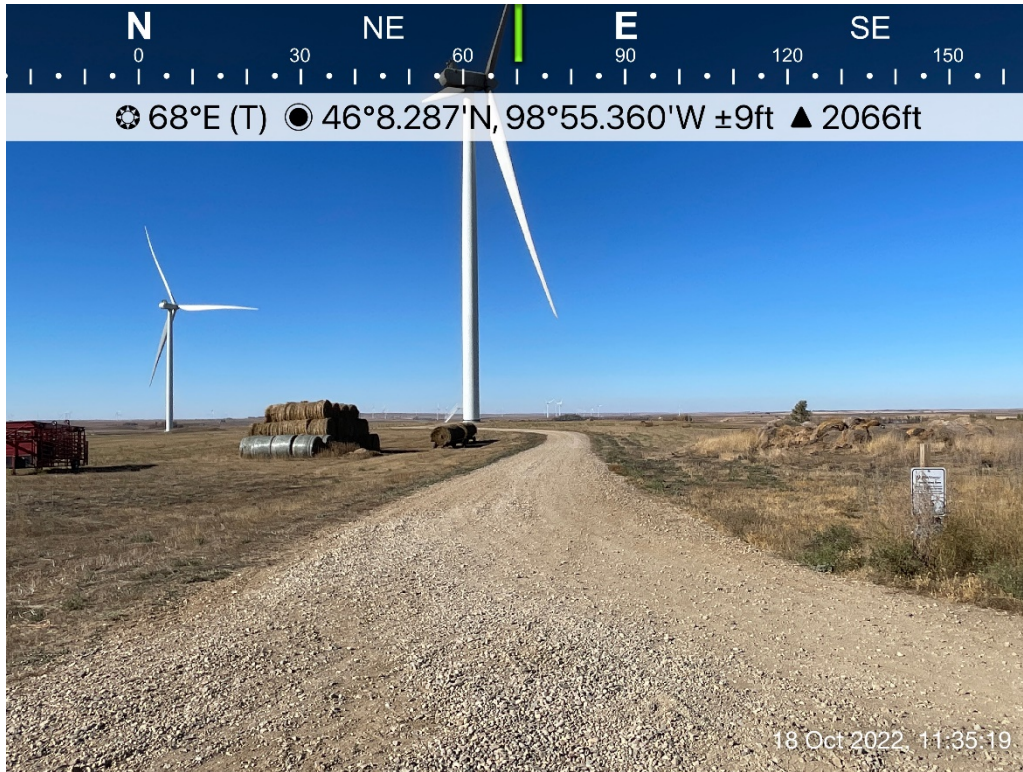
Report Photo #1: Access Road through Pastureland and Turbine Site T-5

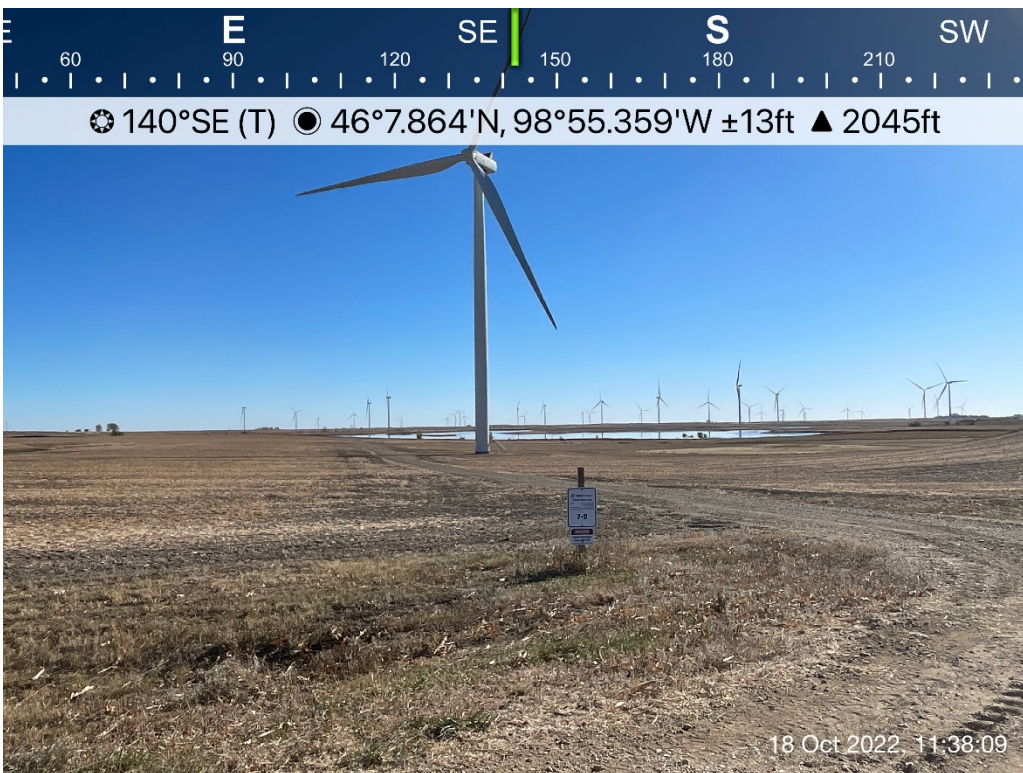
Report Photo #2: Access Road through Cropland and Turbine Site T-7

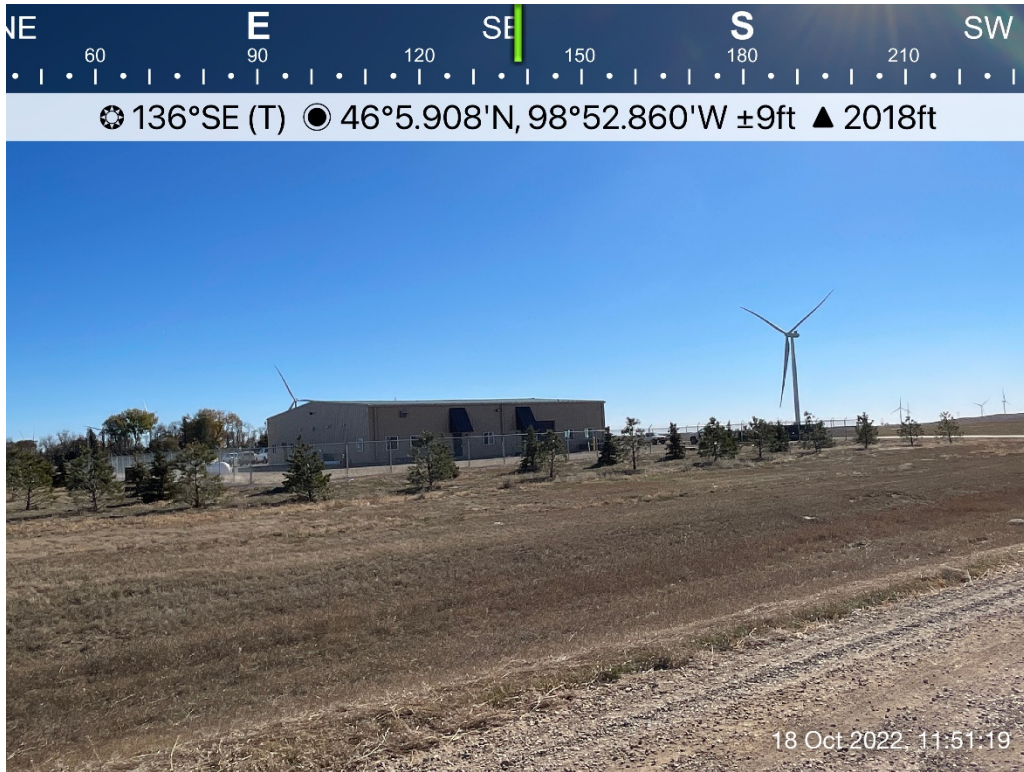
Report Photo #3: O&M Building and Tree Plantings

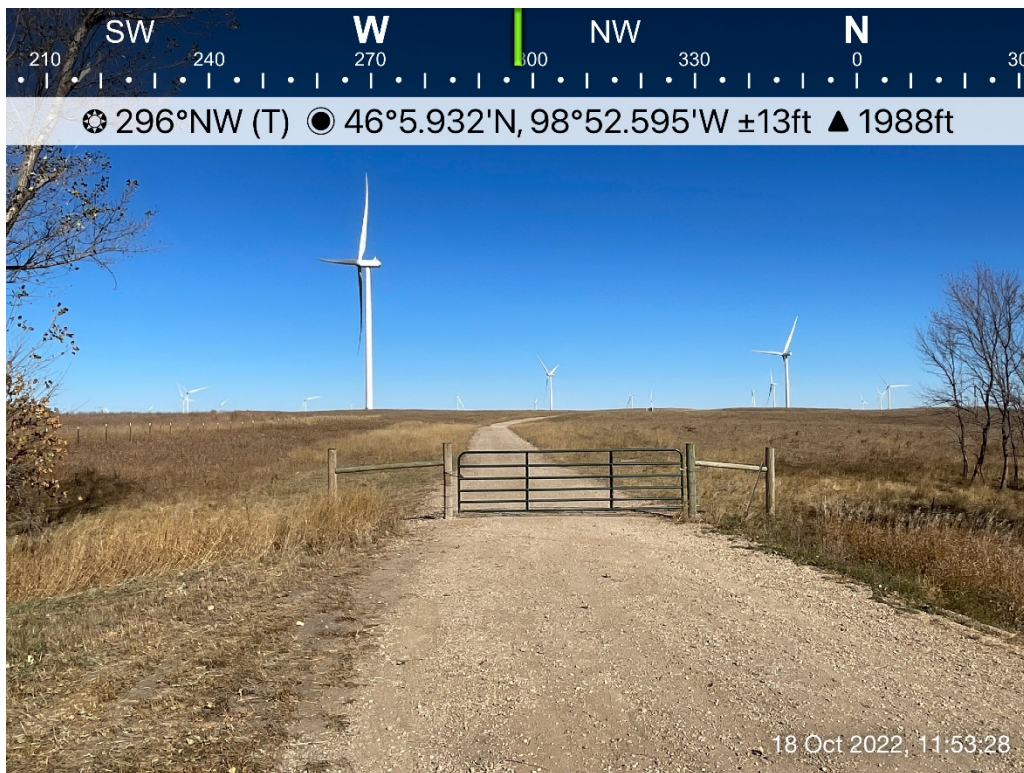
Report Photo #4: Access Road to Turbines T-51 to T-53 and Gate where Trees were Removed

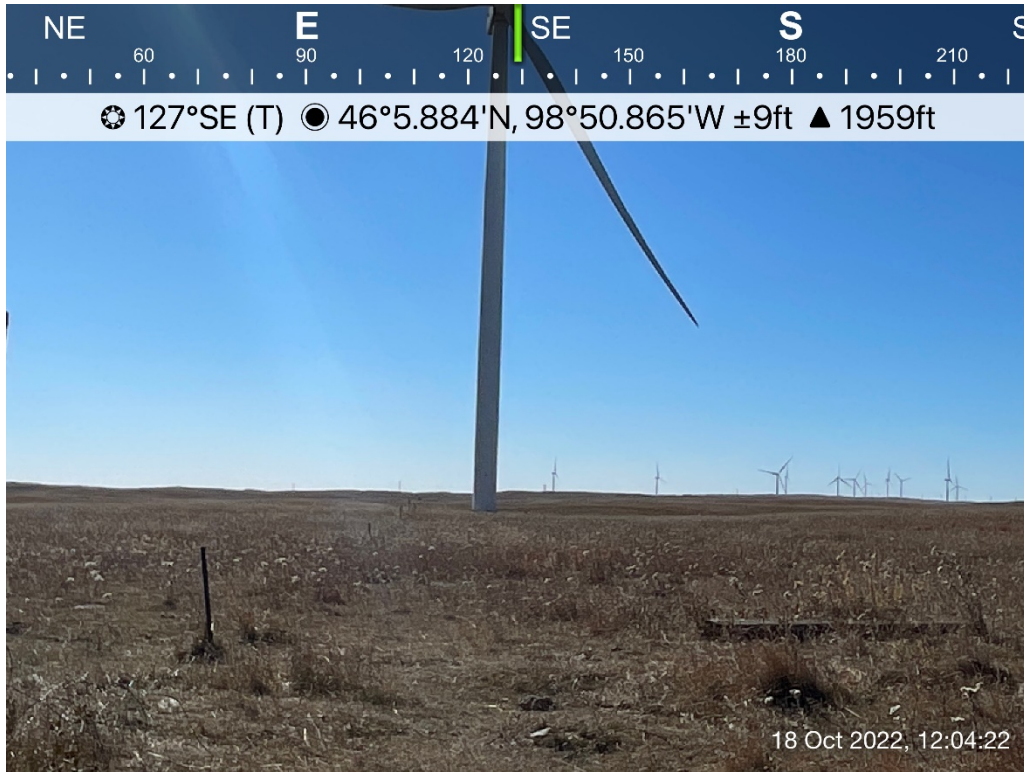
Report Photo #5: Turbine Site T-56 in Pastureland

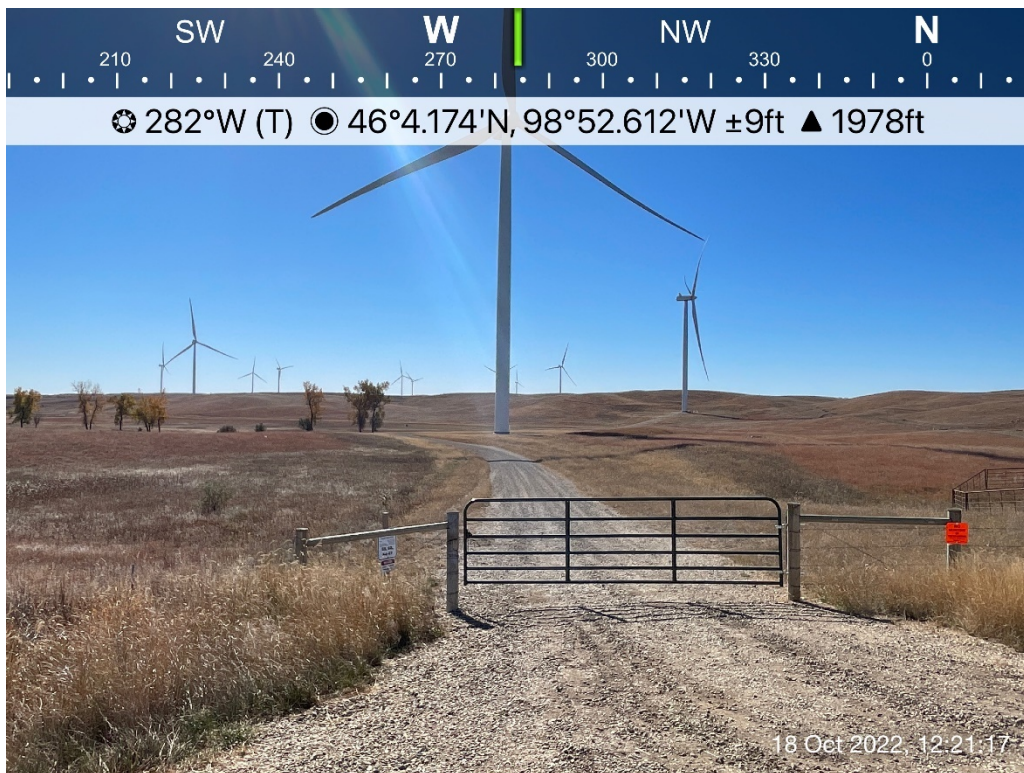
Report Photo #6: Access Road through Pastureland and Turbine Sites T-64 to T-67
