Andeavor NGL Pipeline Project Topsoil Inspection Report PU-18-72

Prepared for:
**North Dakota
Public Service Commission**

WENCK Associates, Inc.
301 1st Street NE, Suite 202
Mandan, ND 58554
Phone: 701-751-3370
Fax: 763-479-4242

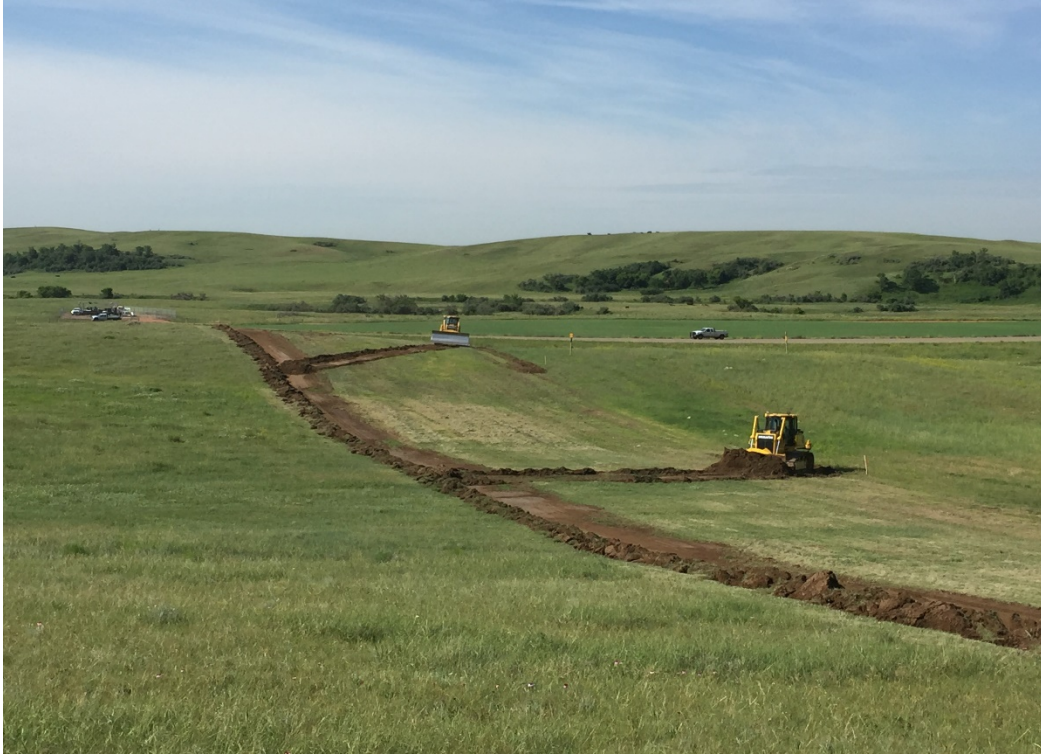
Photo 1. Facing: South. Location: 47.80797, -103.170188. Start of topsoil stripping by Jones Contractors on the North Segment. You can see where the dozer scraped a line in the ground for the topsoil pile to be placed, to stay in the ROW.

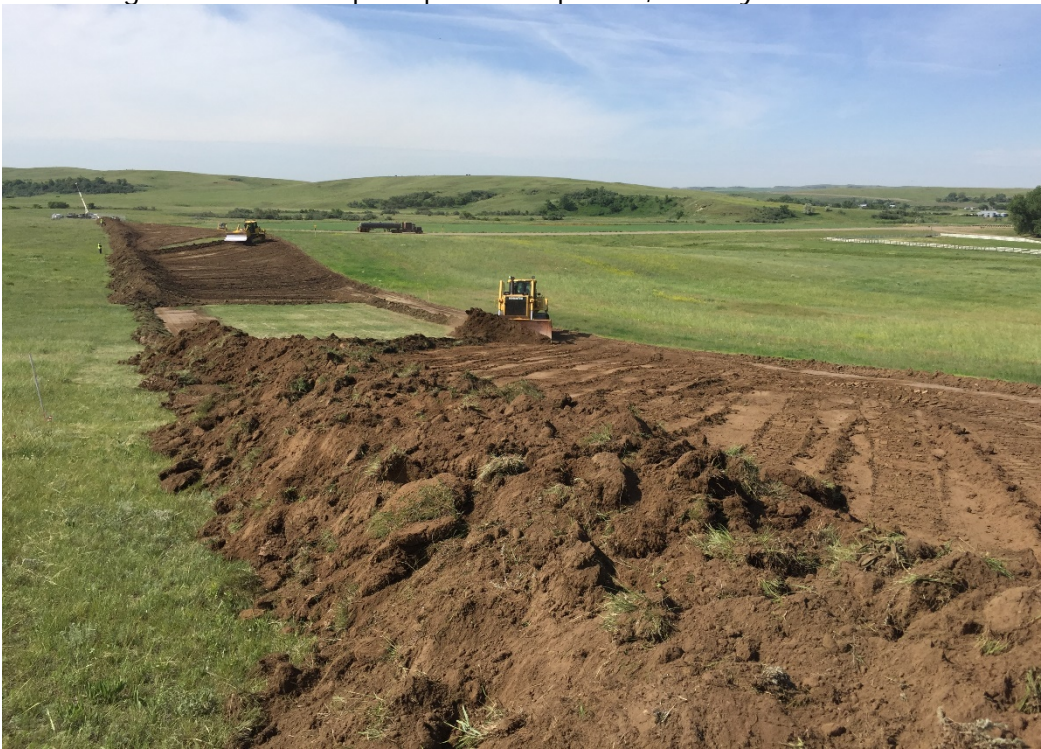
Photo 2. Facing: South. Location: 47.80799, -103.170348. Start of topsoil stripping. Topsoil stockpile being created. Spotters ensuring stockpile remain in ROW.

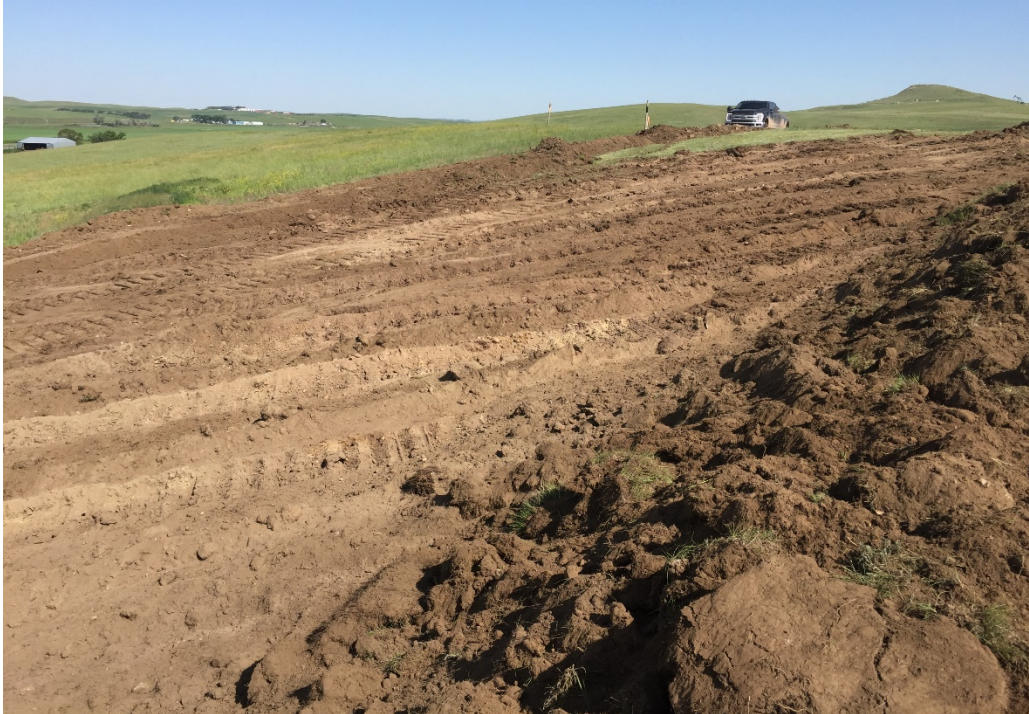
Photo 3. Facing: Northwest. Location: 47.80796, -103.17023. Topsoil stripped to depth of around 8 in. Subsoil reached with small amount of topsoil remaining will be leveled by final pass of grader.

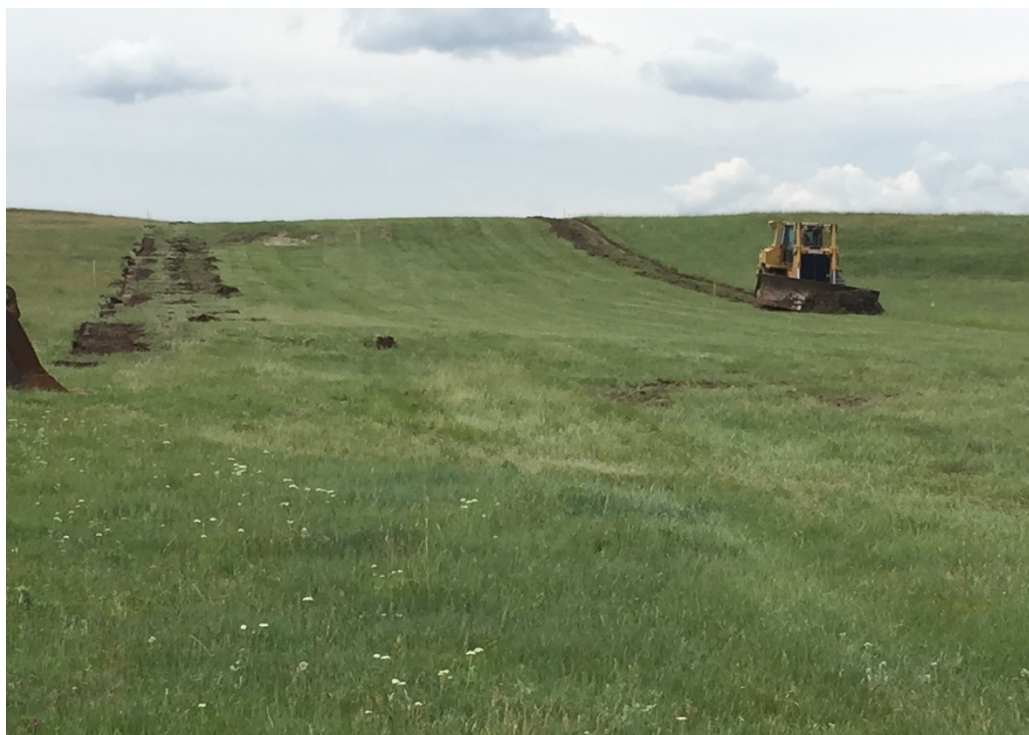
Photo 4. Facing: South. Location: 47.151114, -103.214176. Dozer marking edge of ROW for start of topsoil stripping by Jomax on the South Segment.

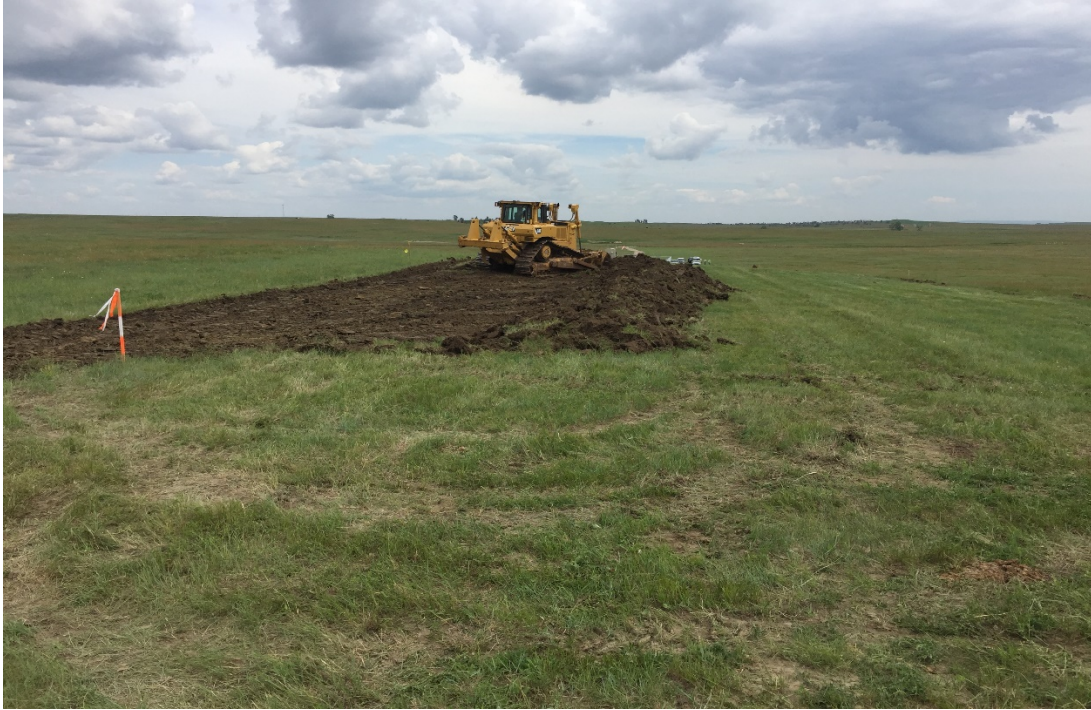
Photo 5. Facing: North. Location: 47.149225, -103.21515. Start of topsoil stripping on South Segment. West half of ROW stripped first.

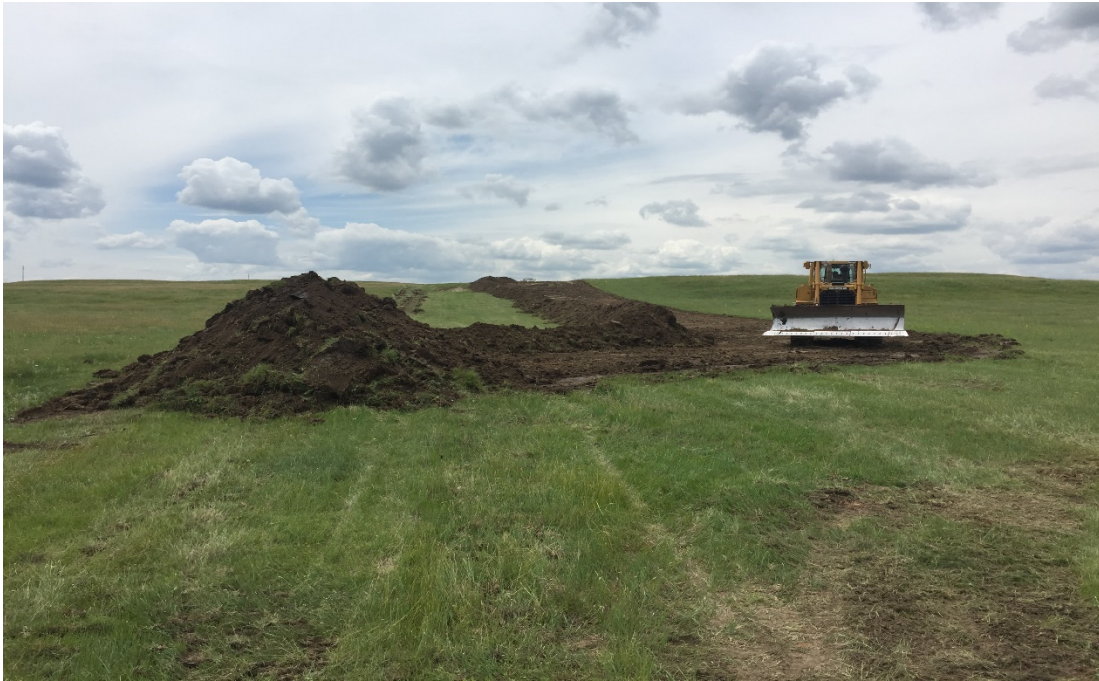
Photo 6. Facing: South. Location: 47.150877, -103.214334. West half of ROW stripped. Final topsoil stockpile location on east end of ROW.

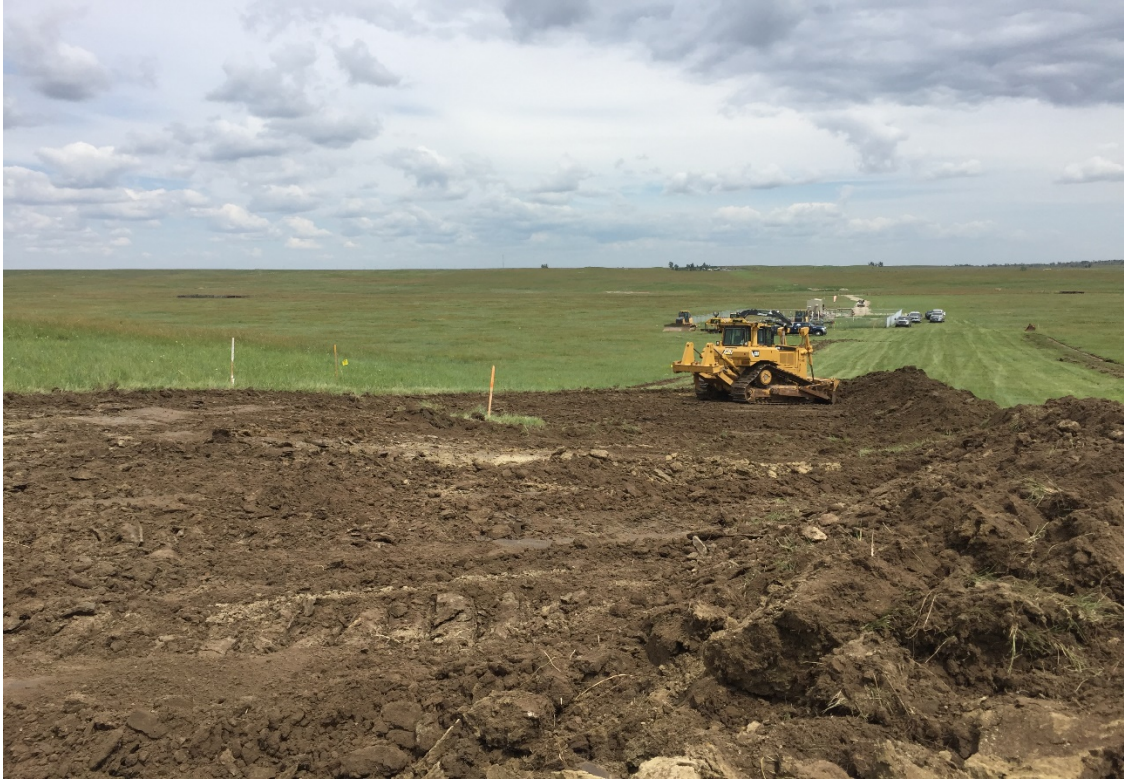
Photo 7. Facing: North. Location: 47.149667, -103.214934. Subsoil beginning to show at current grade. Depth of around 8 inches.

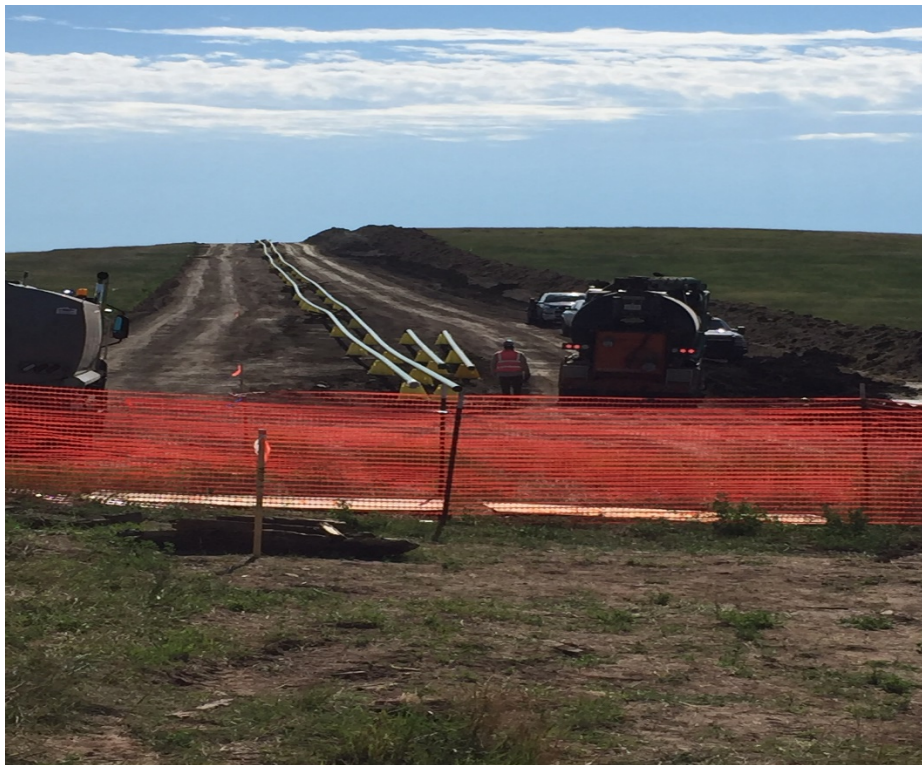
The next topsoil inspection was conducted on 12 July 2018. This inspection focused on the 6 in. Transfer Segment line running from Belfield to the Fryburg Rail Terminal. Wenck staff met with Scott Staehnke on location to observe topsoil removal by Jones Contractors. Topsoil removal was completed at this location prior to arrival and looked adequate. Mr. Staehnke mentioned that initial topsoil removal on the first day of construction was around 8 inches but needed to be deeper in some areas. This site contained a hilltop which can complicate topsoil removal. Topsoil was pushed to the south side of the ROW and then another pass was made into the subsoil to create a level surface for installing the pipe. The subsoil pile was stored next to the topsoil and the two piles slightly came in contact with each other (**Appendix A, Photo 9**). Mr. Staehnke is aware of this and noted that the machine operators who spread the excavated soil will pull from the pile starting with the subsoil during backfilling. After all the subsoil is graded, another pass with the grader will be completed to spread the bit of soil where the sub and topsoil were contacting each other. Then the topsoil will be placed over the disturbed subsoils. This will help ensure that any subsoil/topsoil mix is located above the subsoil layer while still being buried beneath all the unmixed topsoil (**Appendix A, Photos 8-9**).

During site inspections, there were several locations where the subsoil pile was observed touching the topsoil pile, and locations where subsoil was mixed slightly with the topsoil. On hilltops, subsoil is removed in order to create a level surface to operate and install pipe. Subsoil stockpiles were created and touched topsoil stockpiles. This will result in slight mixing of the sub and topsoil at the points of contact. The final pass taken by graders during topsoil stripping inevitably disturb a small amount of subsoil. Both of these types of mixing are minimal and were known to occur by the contractors. The mixed soils are located on the surface of the stockpile and will be the first layer spread when replacing the soils. As a result, any mixed soils will be covered with a majority of the topsoil.

Photo 8. Facing: East. Location: 46.8596, -103.23127. Two stockpile mounds visible at hilltop at the Transfer Segment. Topsoil on outside (right) with the subsoil pile touching.

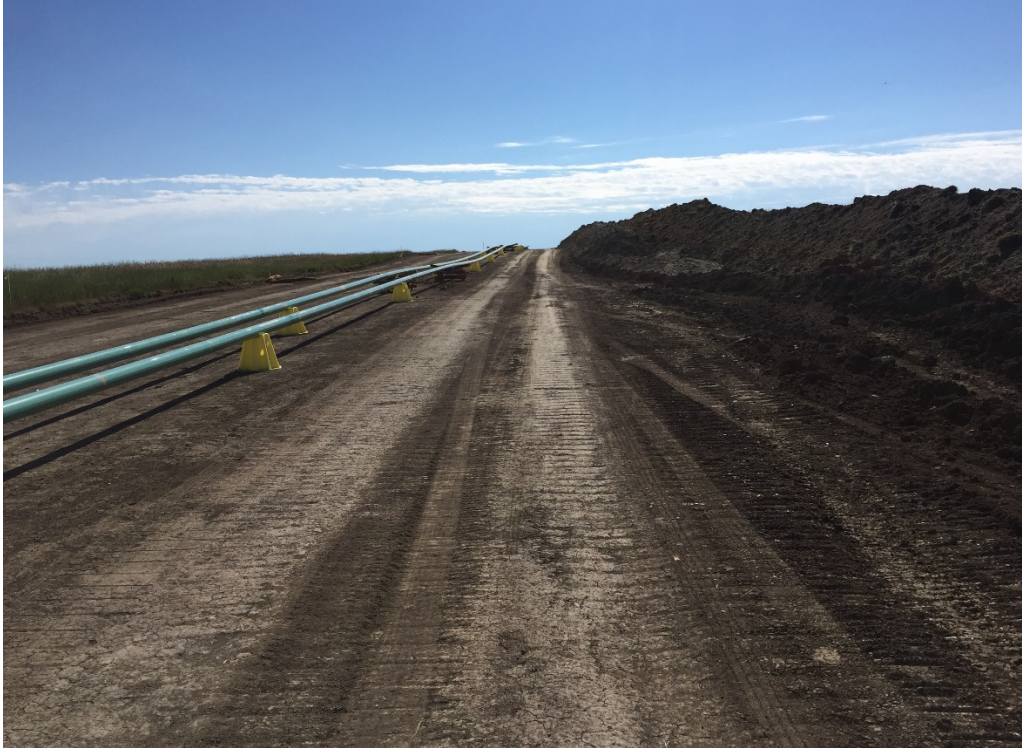
Photo 9. Facing: East. Location: 46.85963, -103.22839. Closer view of subsoil and topsoil stockpiles.

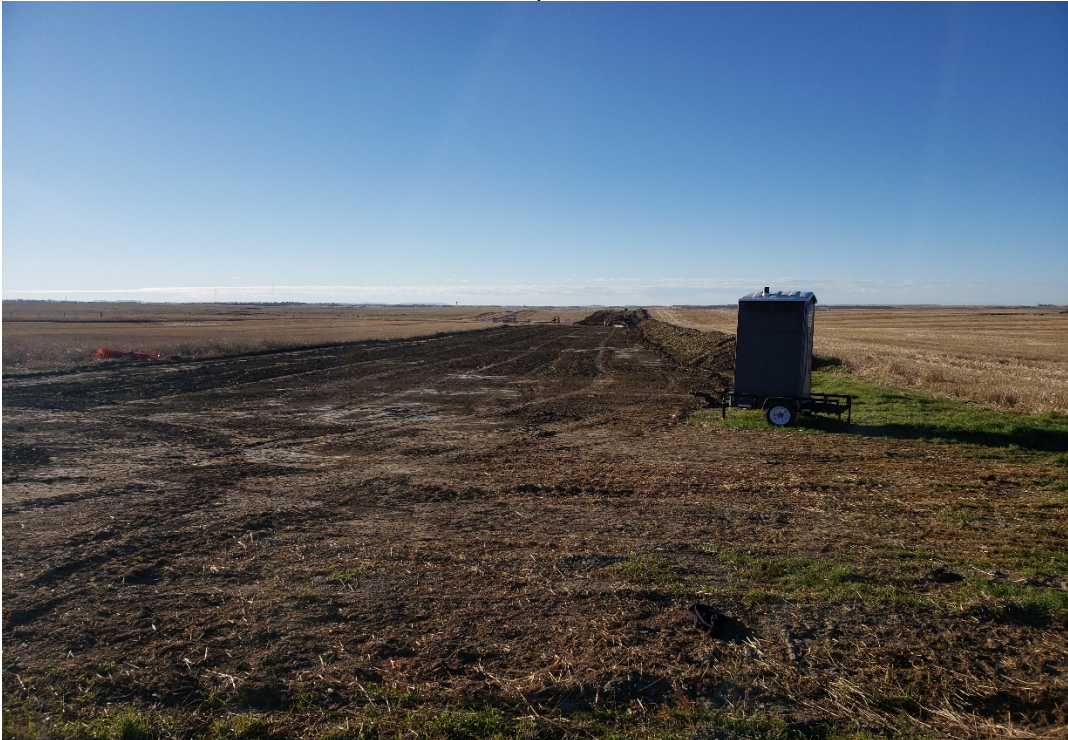
Photo 10. Facing: South. Location: 46.94859, -103.21168. Topsoil stripping on the South Segment. Stockpile stored on west side of ROW.

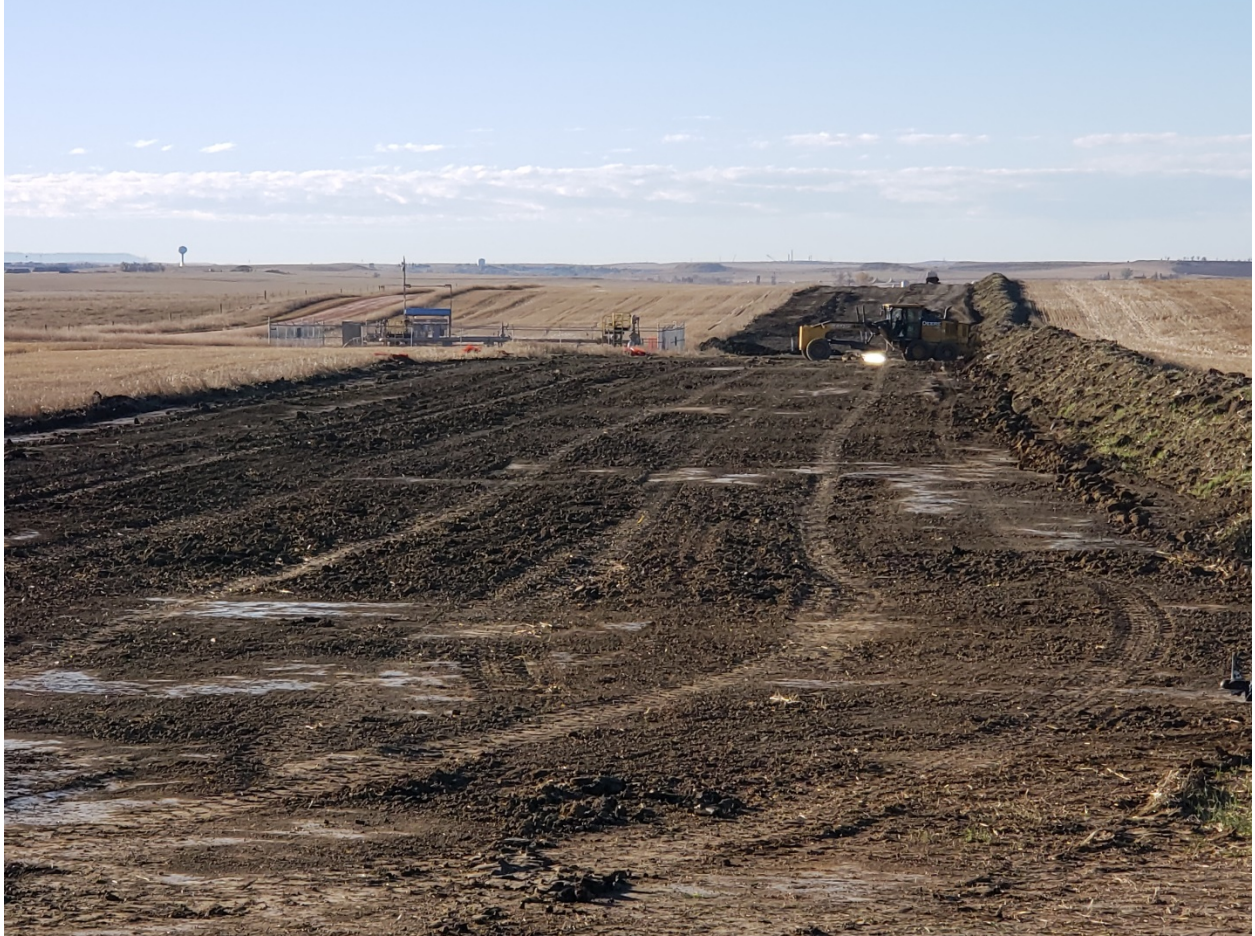
Photo 11. Facing: South. Location: 46.94859, -103.21168. Topsoil stripping on South Segment. Grader making last pass to level ROW.
