Andeavor Y Grade Hub Reclamation Inspection Report PU-18-72

Prepared for:
**North Dakota
Public Service Commission**

WENCK Associates, Inc.
3303 Fiechtner Driver
Fargo, ND 58103
Phone: 701-297-9600
Fax: 701-297-9601

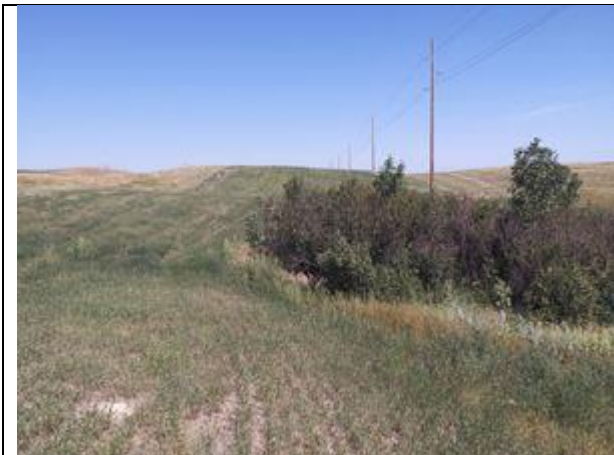
Observation Point: 32
Date Taken: 08/19/2020 12:30 PM
Direction Photo is Taken: North
Spread: North Segment

Photo Description: Land usage is hay land. Location of centerline as built does not match in field conditions. Centerline goes through shrubs, still extant.

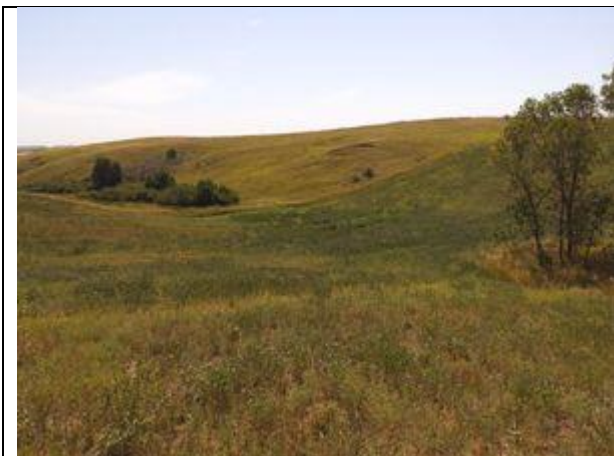
Observation Point: 33
Date Taken: 08/19/2020 12:45 PM
Direction Photo is Taken: Southeast
Spread: North Segment
Photo Description: Land usage is hay land. Gap in treed area naturally exists, evidenced by Google earth historical imagery. However, location of centerline as built does not match in field conditions. Centerline goes through trees, still extant. Evidence of cleared woody debris adjacent ROW at east side.
Latitude: 47.72814379
Longitude: -103.19632177
