Enclosures: Construction Inspection PU-18-280 (2 hardcopies)

Site/Project Location: Emmons and Logan Counties, ND

Date of Inspection: 5 November 2019

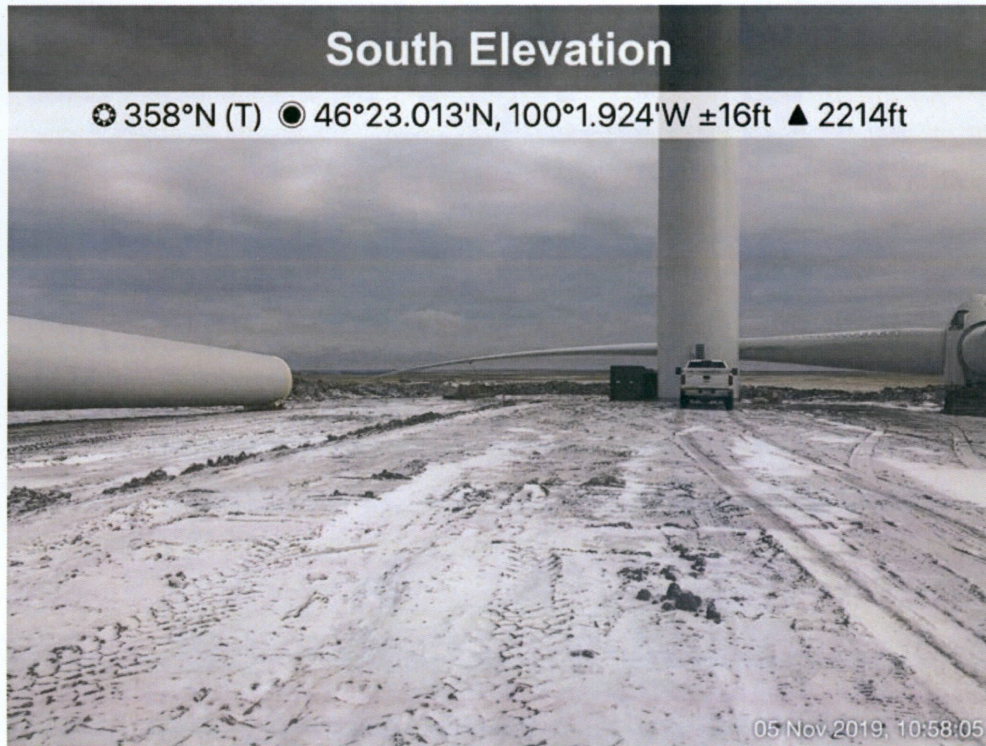
Report Photo #1 "Turbine Materials at Site 56"

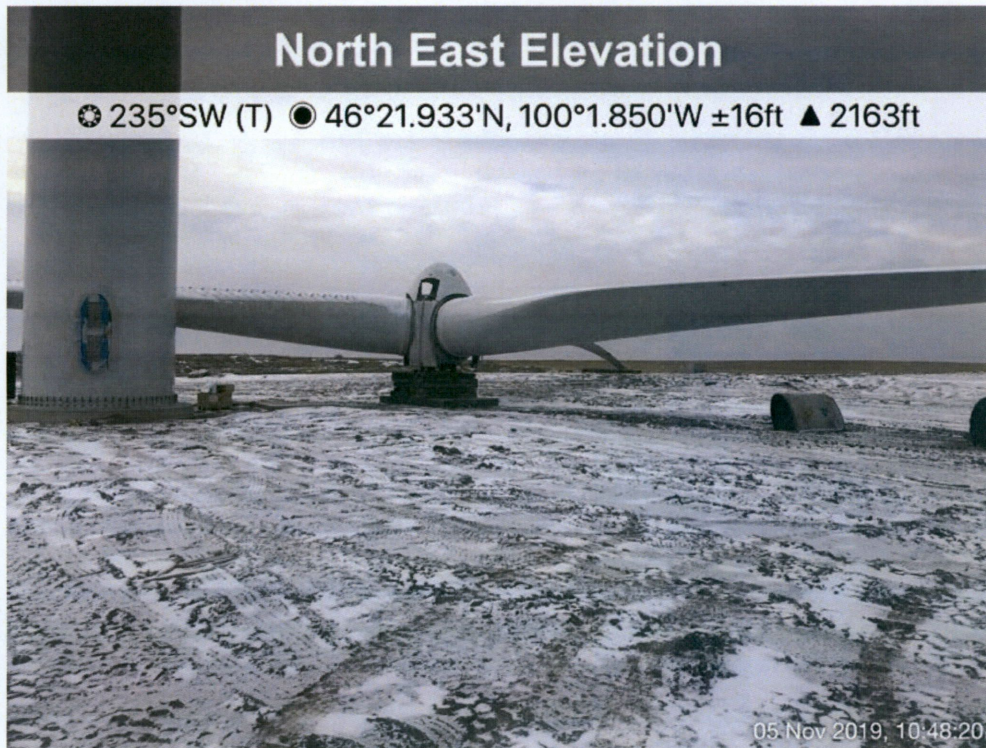
Report Photo #2 "Tower Up and Turbine Components Ready to Install at Site 51"

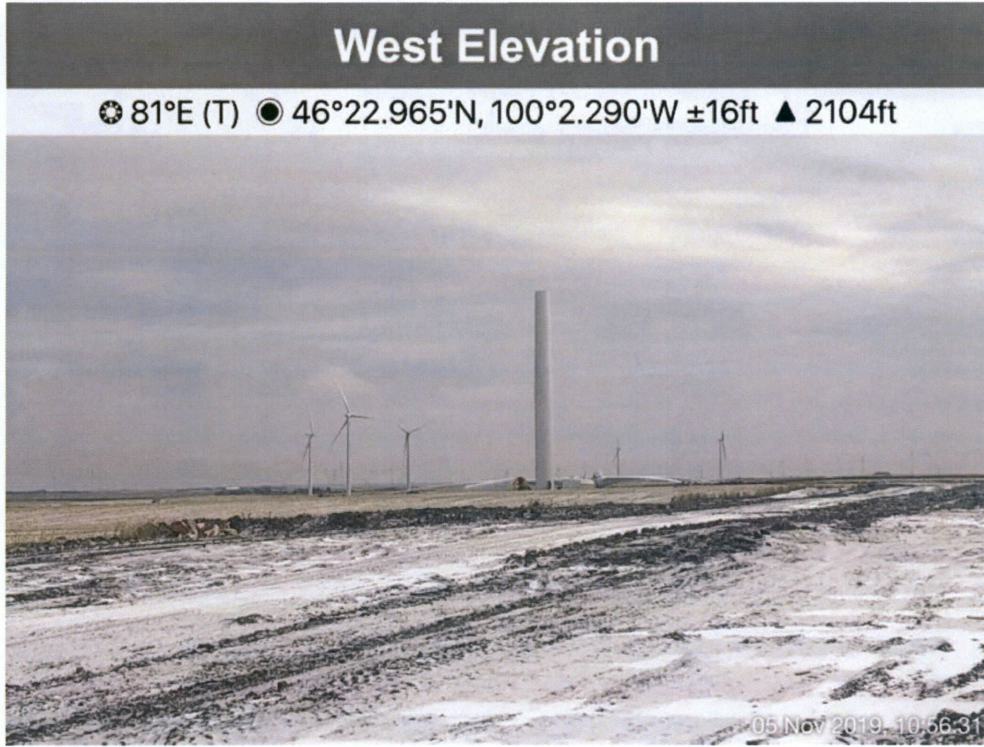
Report Photo #3 View of Wind Turbines near Completion

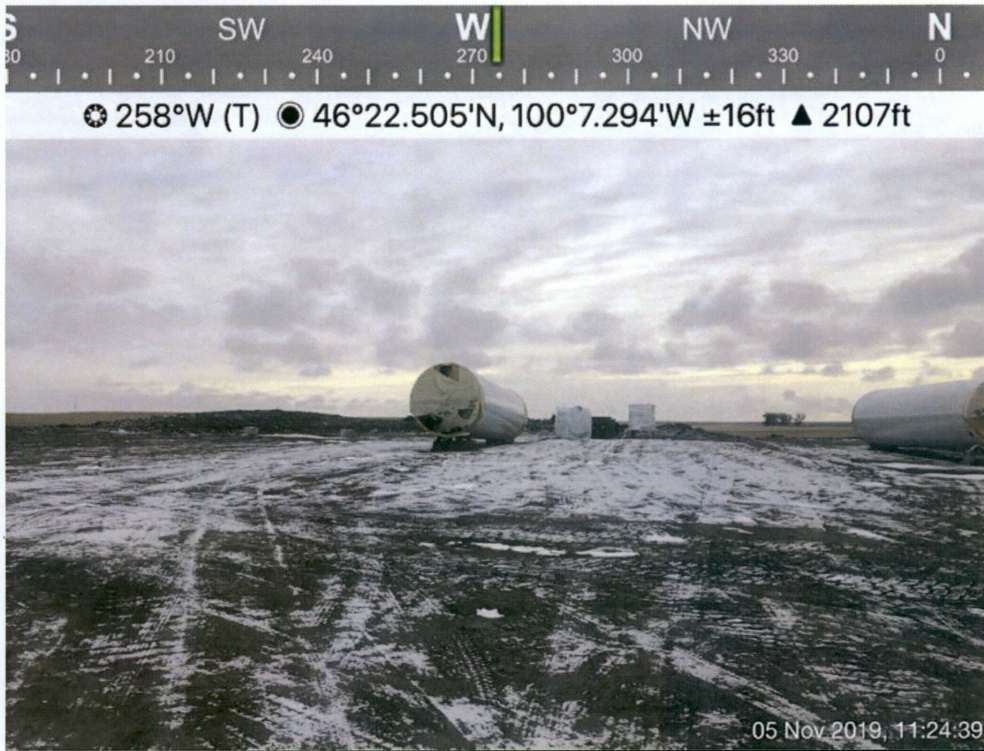
Report Photo #4 "Turbine Construction at Site 18"

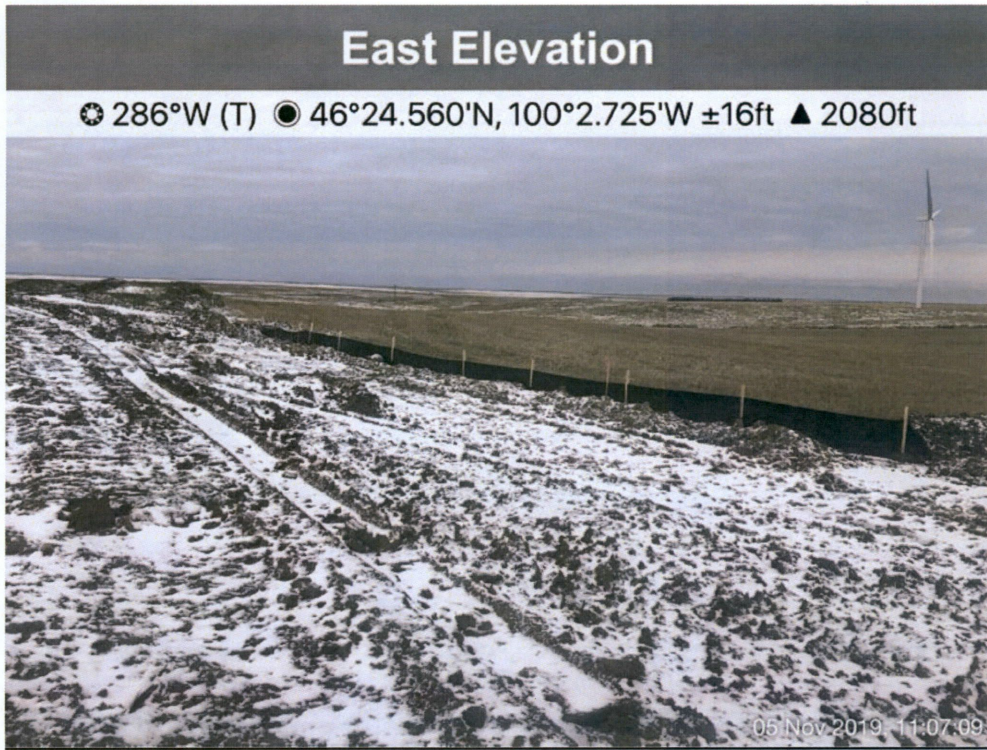
During the inspection, stripped topsoil was noted along string roads and at turbine sites. Topsoil was appropriately segregated from the subsoil with it being piled along the opposite side of string roads and in separate piles at turbine sites. Erosion control and stormwater management BMPs were in good condition. At the time of the inspection, the ground was frozen.

Report Photo #5 "Sediment Fence in Place near Site 39"

Erosion control and stormwater BMPs should continue to be routinely evaluated and replaced or repaired as necessary and pad sites smoothed out once construction on the sites is completed. Topsoil piles will be used to revegetate areas not used for permanent roads or turbine pads.

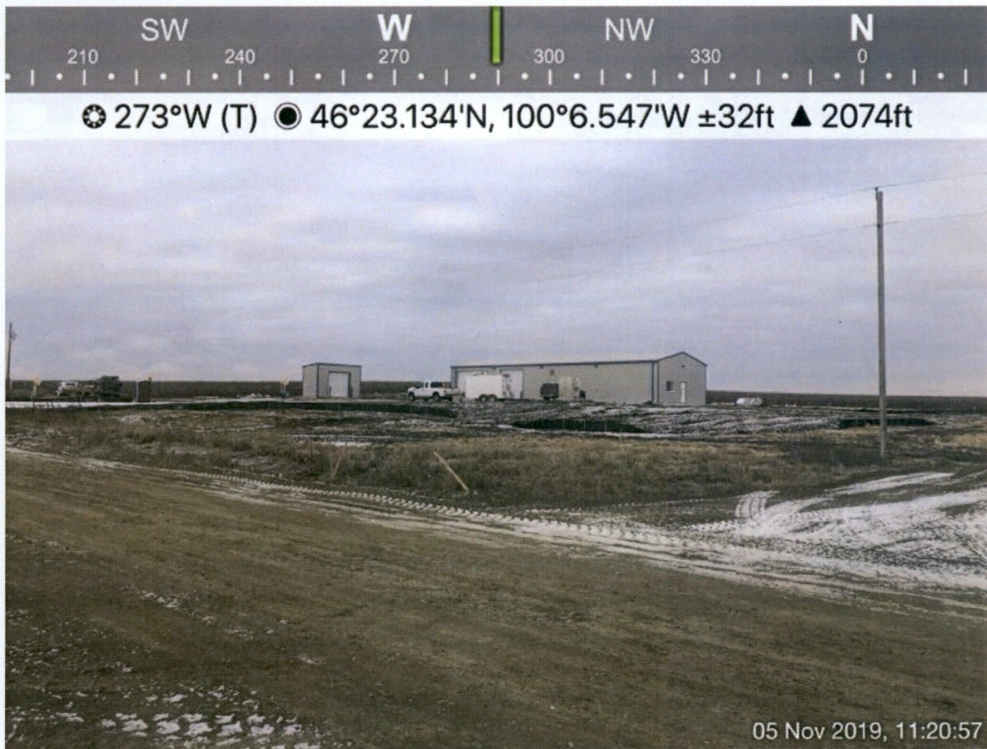
Report Photo #6 "Newly Constructed Operations and Maintenance Building"
