Site/Project Location: Emmons-Logan Wind Energy Center

Dates of Inspection: May 16 & 29, 2019

Keitu staff visited the Emmons-Logan Wind Energy project for a topsoil inspection. These inspections are for both the Wind Energy Center and the Transmission Line since it is the same construction crew removing topsoil for both projects. Inspections of the construction sites are focused on (1) confirming surface disturbance/work occurring within North Dakota PSC-approved work corridor and/or route; (2) topsoil segregation occurring; (3) vegetation removal consistent with Tree & Shrub Mitigation Plan.

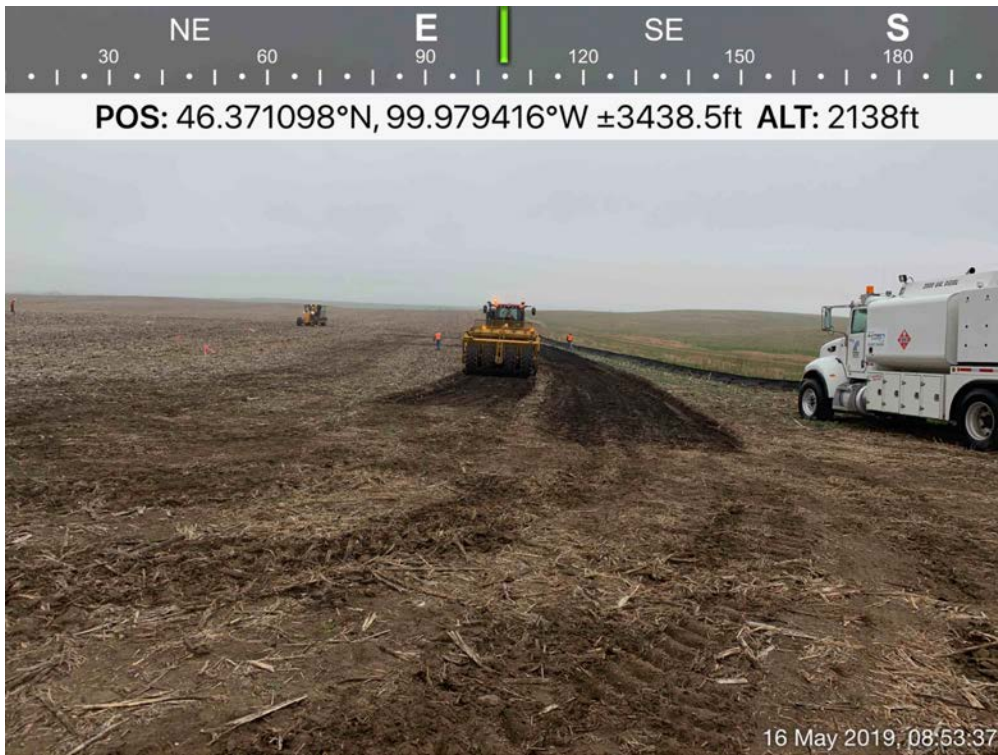
Grader stripped the topsoil for the laydown yard, adjacent to 72nd Ave SE. Grader operator was informed topsoil depth was 4-6 inches deep in the area where the laydown yard was located. The grader operator removed topsoil to a depth where subsoil appeared and bulldozers were going to level the remaining drift rows of topsoil after completing topsoil removal of the laydown yard. The area of the laydown yard was previously a cultivated field. Topsoil depth at the laydown yard was not deeper than 12 inches. The operator was careful to remove topsoil to a depth where subsoil started to appear. All topsoil removed from laydown yard was placed on the west side of the site. The operators of the grader demonstrated a proper understanding of the rules and regulations for topsoil removal.

Report Photo #1 "Stripping Layout Yard"

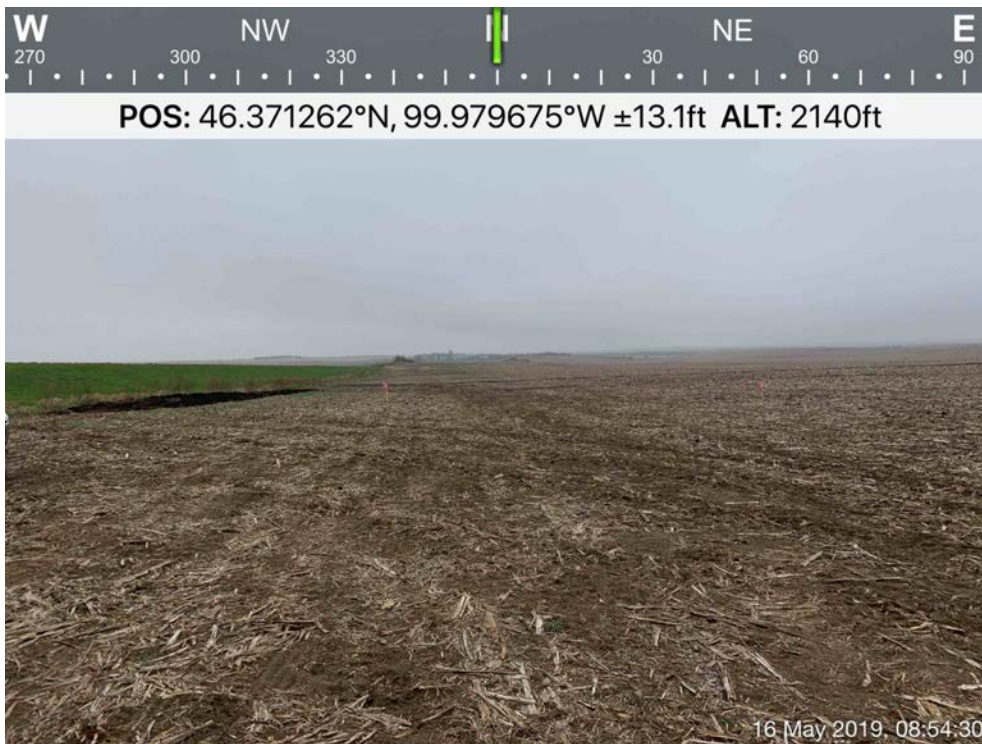
Report Photo #2 "Start of Topsoil Pile"
