**Site/Project Location:** Emmons-Logan Wind Energy Center

**Dates of Inspection:** May 16 & 29, 2019

Keitu staff visited the Emmons-Logan Wind Energy project for a topsoil inspection. These inspections are for both the Wind Energy Center and the Transmission Line since it is the same construction crew removing topsoil for both projects. Inspections of the construction sites are focused on (1) confirming surface disturbance/work occurring within North Dakota PSC-approved work corridor and/or route; (2) topsoil segregation occurring; (3) vegetation removal consistent with Tree & Shrub Mitigation Plan.

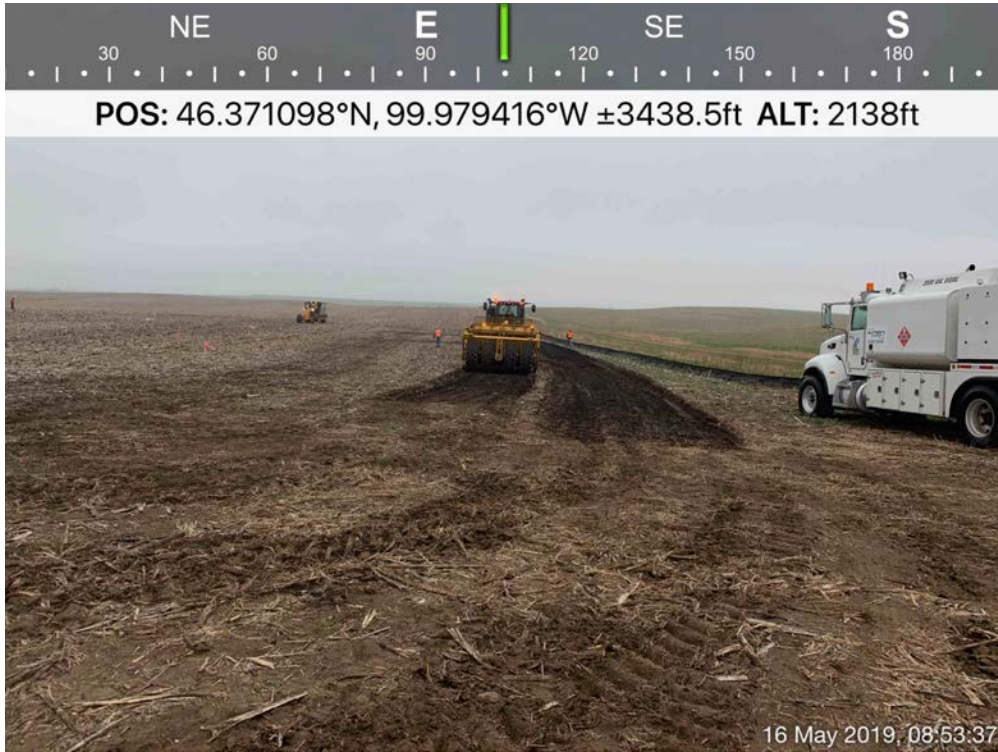
Grader stripped the topsoil for the laydown yard, adjacent to 72<sup>nd</sup> Ave SE. Grader operator was informed topsoil depth was 4-6 inches deep in the area where the laydown yard was located. The grader operator removed topsoil to a depth where subsoil appeared and bulldozers were going to level the remaining drift rows of topsoil after completing topsoil removal of the laydown yard. The area of the laydown yard was previously a cultivated field. Topsoil depth at the laydown yard was not deeper than 12 inches. The operator was careful to remove topsoil to a depth where subsoil started to appear. All topsoil removed from laydown yard was placed on the west side of the site. The operators of the grader demonstrated a proper understanding of the rules and regulations for topsoil removal.

**Report Photo #1 "Stripping Layout Yard"**

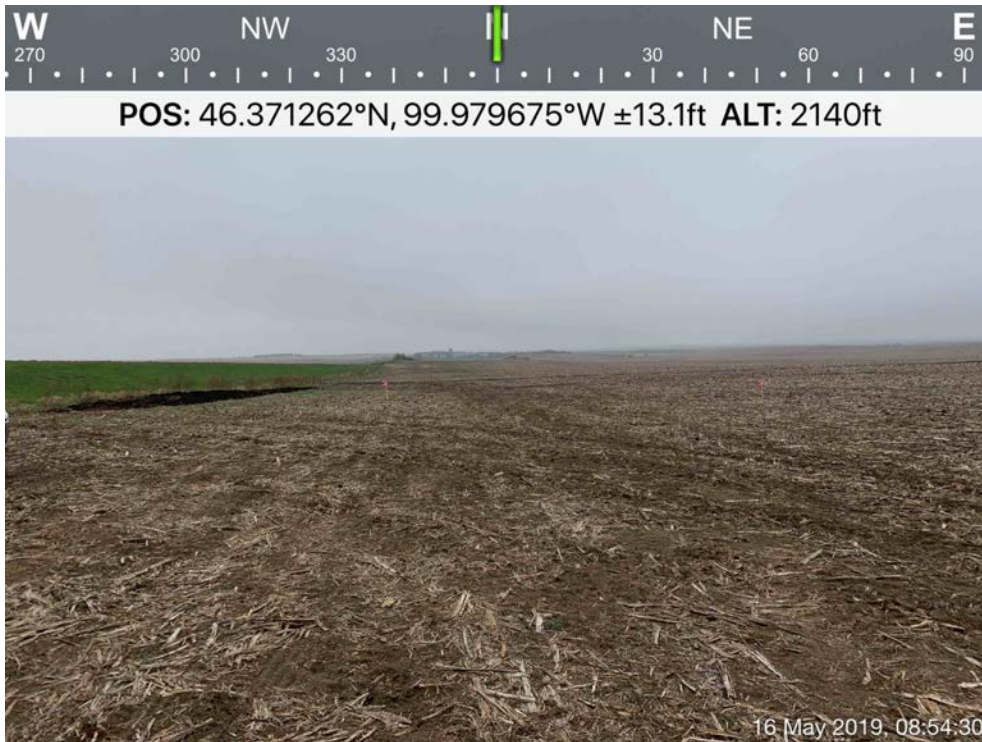
**Report Photo #2 "Start of Topsoil Pile"**

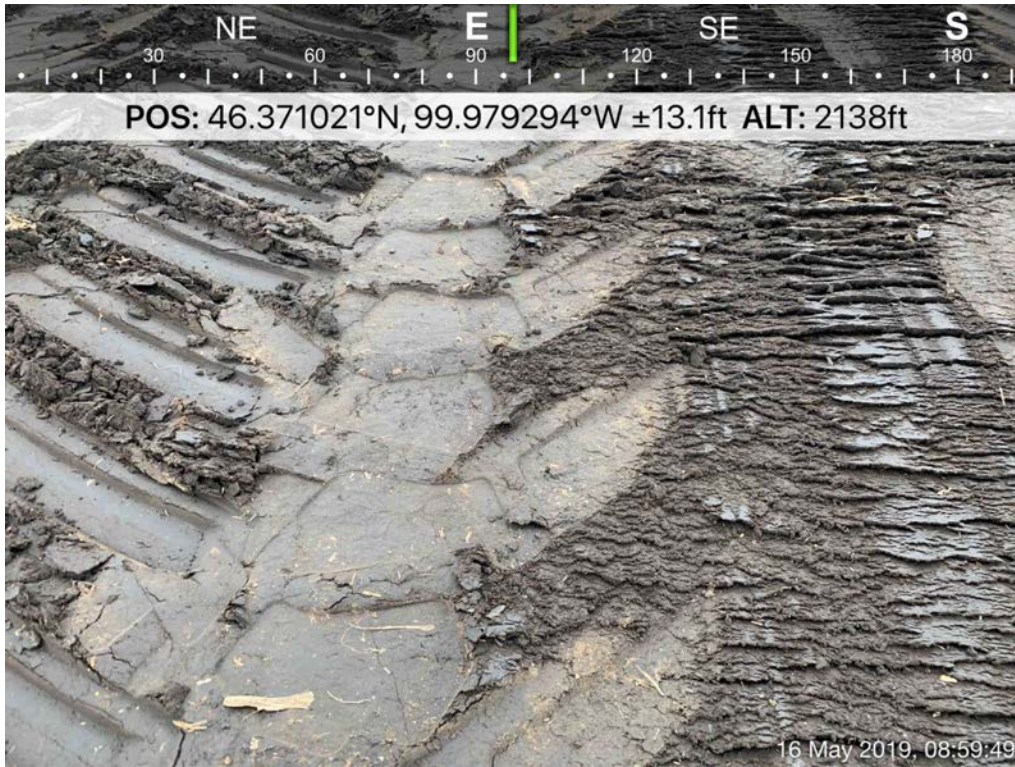
**Report Photo #3 "Subsoil Showing in Laydown Yard"**

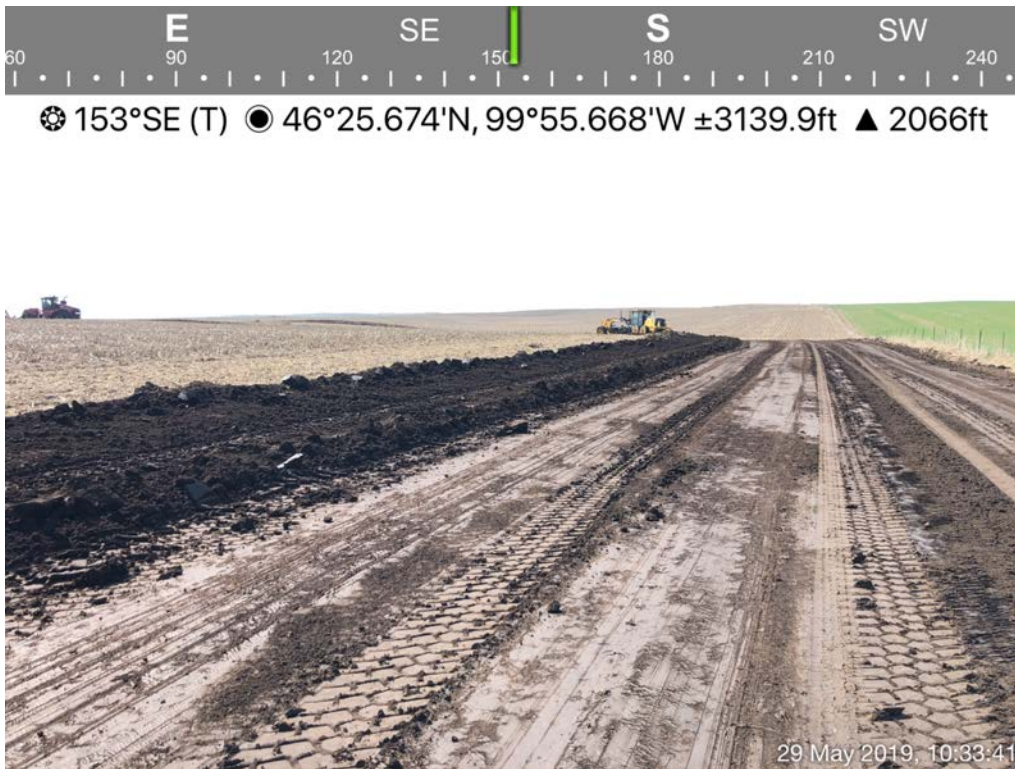
A grader and bulldozer were used on the construction site to strip topsoil for an access road from 68<sup>th</sup> St SE to the pad area for the where a wind turbine will be constructed. The grader and bulldozer operators were the same individuals that had performed the topsoil stripping at the laydown yard during the initial inspection and demonstrated an adequate understanding of the rules and regulations for topsoil removal and proficiency to perform the task properly. The bulldozer was used to strip the topsoil for the access road while the grader was

simultaneously stripping topsoil for the turbine pad. The access road was constructed on fairly level ground and subsoil was reached at depths between 8-12 inches. The turbine pad was located in mostly flat area of the field with exception of a small portion of a moderate sloping hillside. Subsoil on the pad location was reached at a depth of 6-8 inches for the majority of the site, and the portion located on the hillslope was noticeably shallower with subsoil being reached at depths between 3-4 inches. Topsoil depth was less than 12 inches for both the access road and turbine pad. The grader and bulldozer operators piled the topsoil in a row to one side of the road and the outer edges of the turbine pad. Both equipment operators confirmed that the topsoil piles would be segregated from other surface material until construction was completed and the topsoil would be returned to pre-construction condition.

**Report Photo #4 "Access Road with Topsoil Piled to the Side"**
