**Site/Project Location:** Emmons and Logan Counties, ND

**Date of Inspection:** 8 August 2019

Keitu staff visited the Emmons Logan Wind Farm project for a construction inspection. Inspection of construction sites focused on (1) confirming surface disturbance/work occurring within ND PSC-approved work corridor and/or route; (2) topsoil segregation occurring; (3) vegetation removal consistent with tree & scrub mitigation plan; and (4) storm water runoff and sediment control.

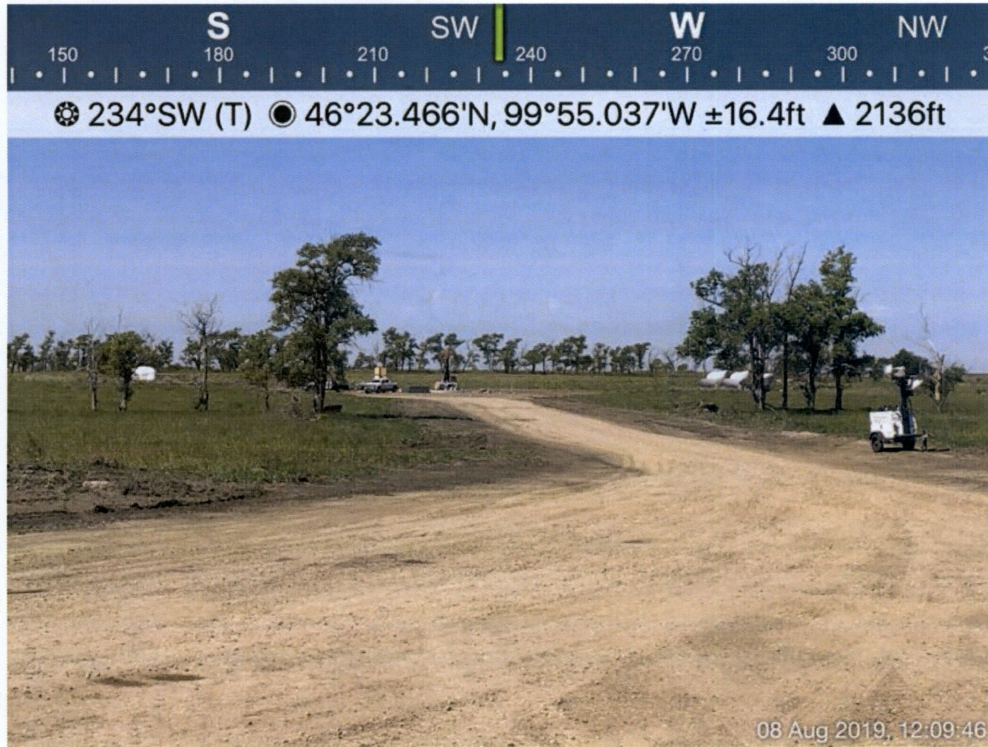
There were locations where trees were removed where underground cables were trenched through single row shelterbelts and string roads were constructed to turbine sites. The number of trees removed was very minimal. Nextera Energy will follow the tree and shrub mitigation plan submitted as part of their Application for Certificate of Site Compatibility. In several locations, string roads to turbine sites were constructed through agricultural fields currently in crop production.

**Report Photo #1 "Trees removed from single row shelter belt for road"**

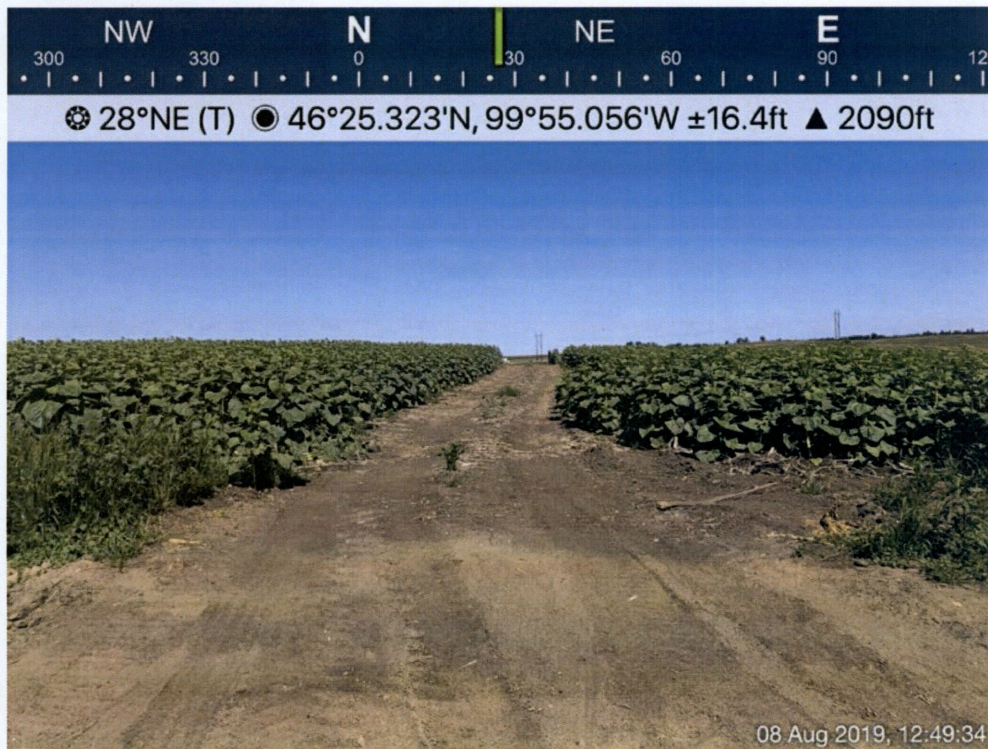
**Report Photo #2 "String road through crop field"**

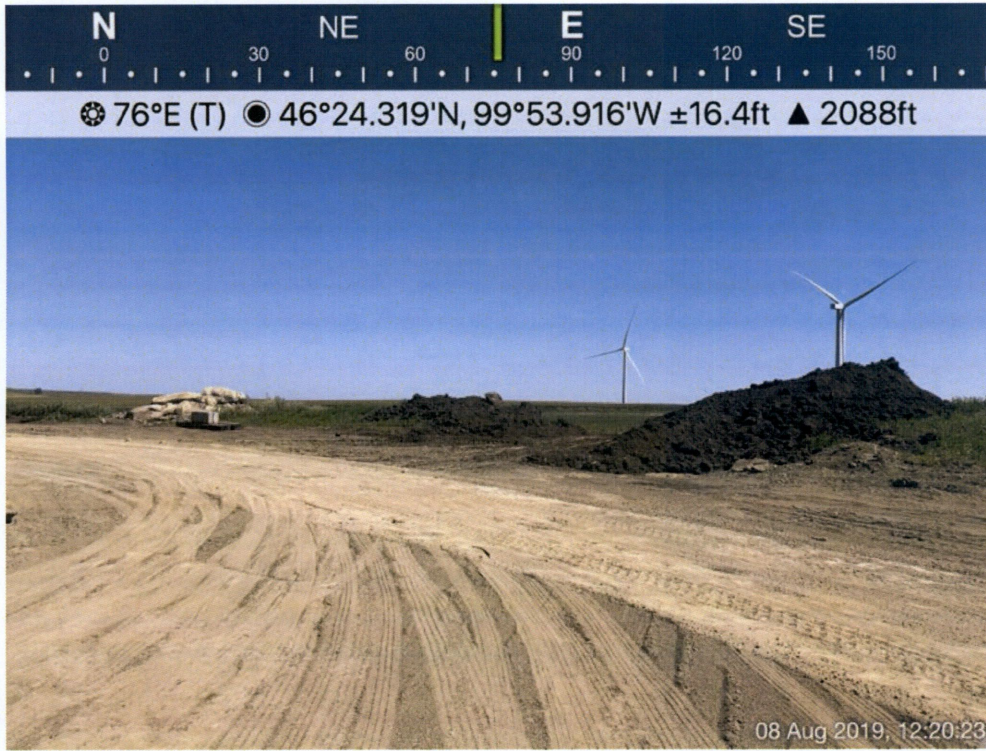
During the inspection, stripped topsoil was noted along string roads and at turbine sites. Topsoil was appropriately segregated from the subsoil with it being piled along the opposite side of string roads and in separate piles at turbine sites. Erosion control and stormwater management BMPs were in good conditional and working effectively.

**Report Photo #3 "Topsoil piles segregated from subsoil"**

Erosion control and stormwater BMPs should continue to be routinely evaluated and replaced or repaired as necessary and pad sites smoothed out once construction on the sites is completed. Topsoil piles will be used to revegetate areas not used for permanent roads or turbine pads.

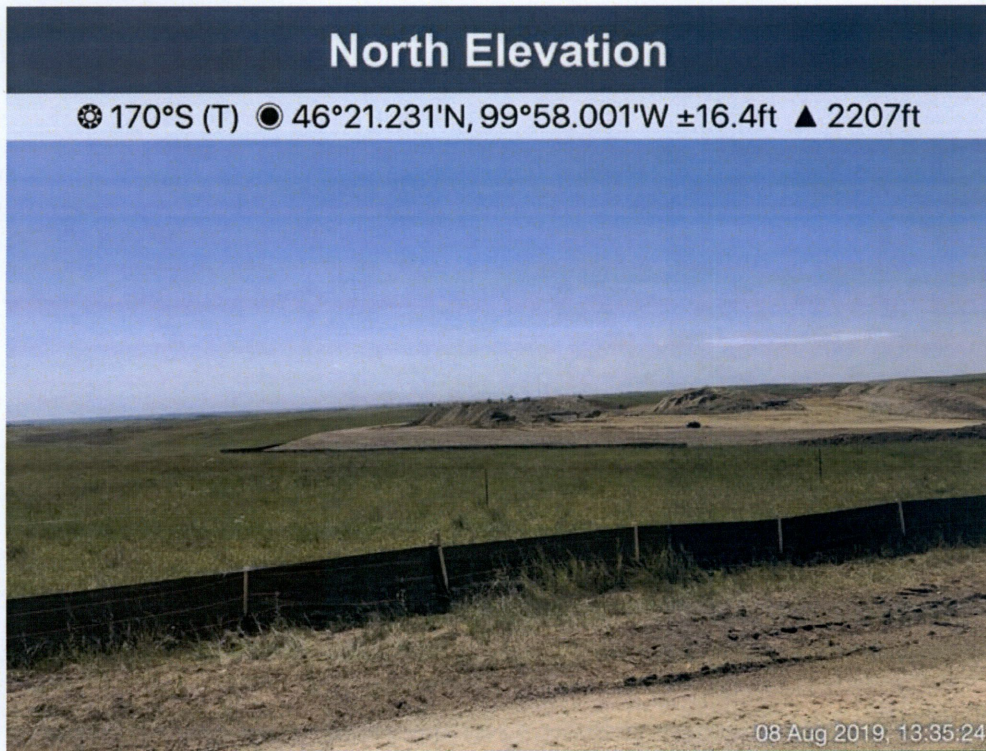
**Report Photo #4 "Turbine site 87 with silt fences for stormwater management"**

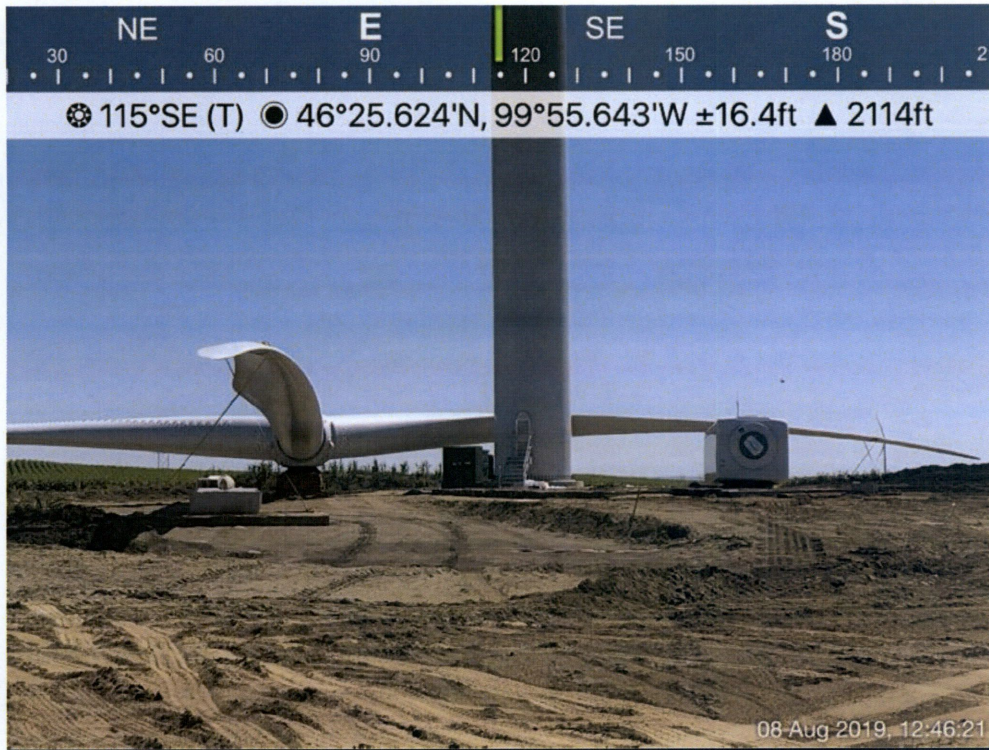
**Report Photo #5 "Turbine site 72 with construction in-progress"**

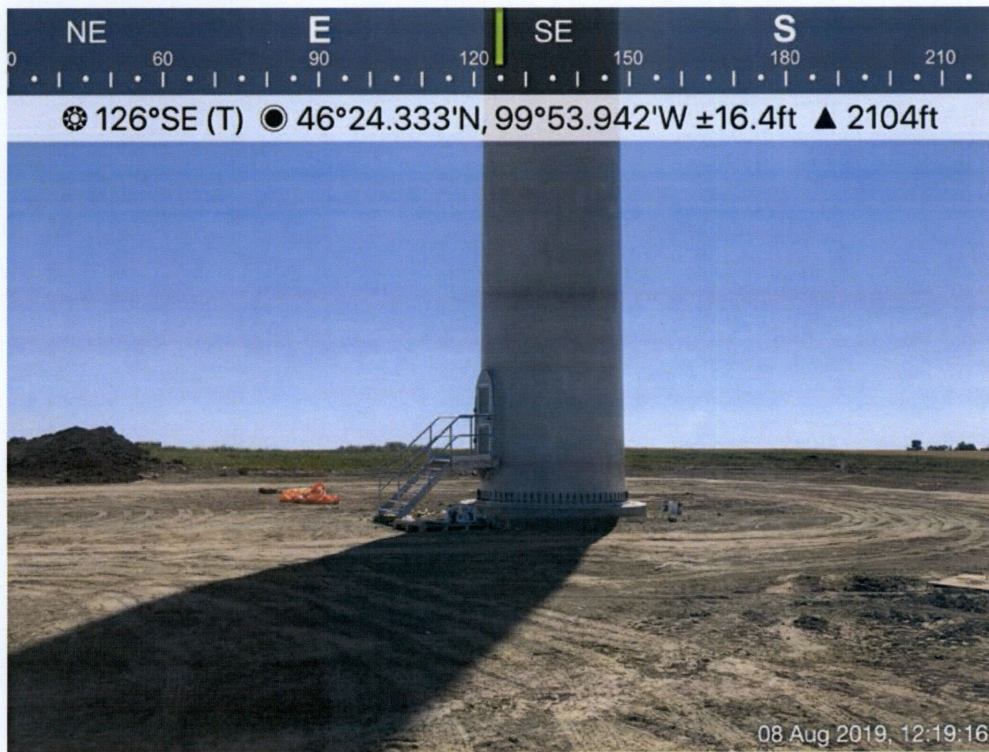
**Report Photo #5 "Turbine site 110 with construction completed"**

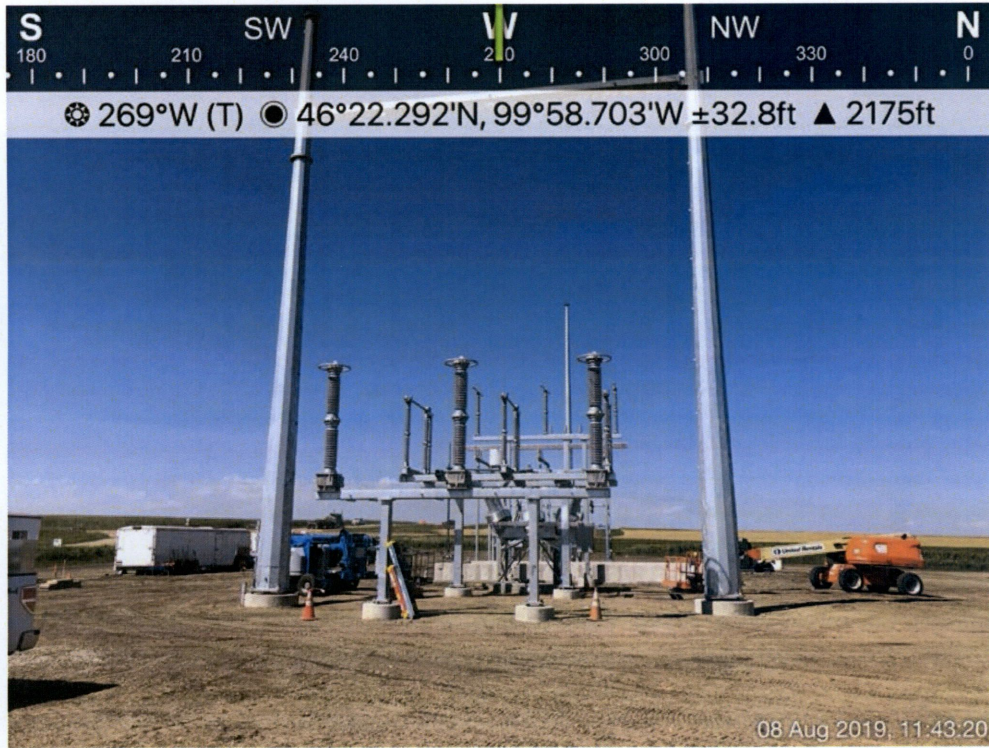
**Report Photo #1 "Substation under construction"**

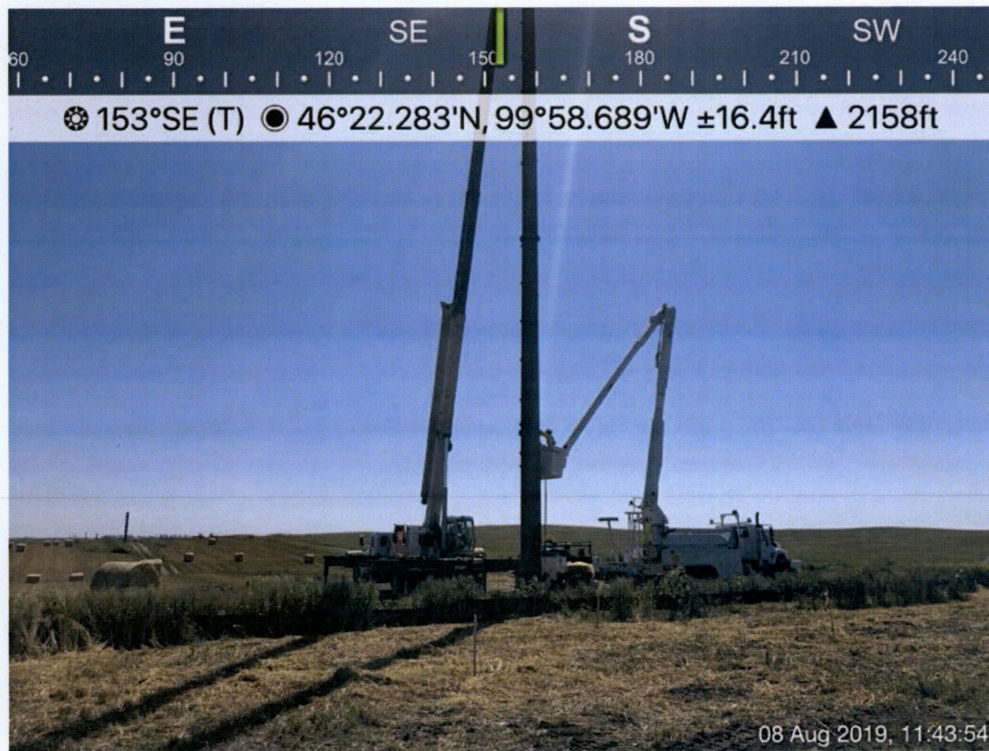
**Report Photo #2 "Transmission structure under construction"**

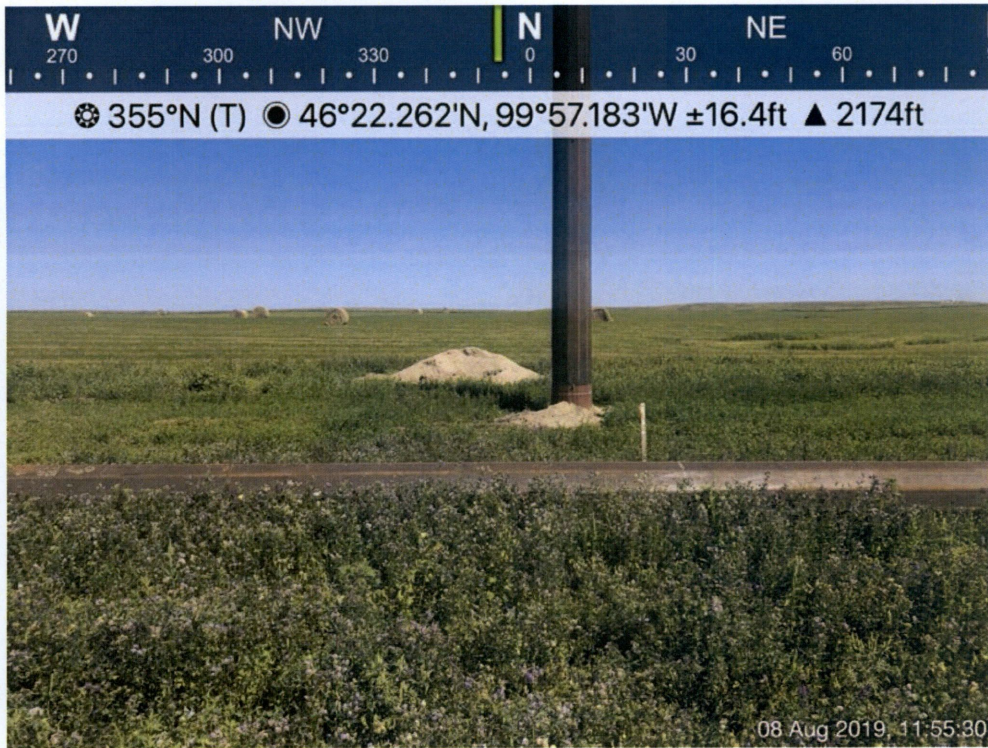
During the inspection, stripped topsoil was noted along access roads and at the structure locations. Topsoil was appropriately segregated from the subsoil with it being piled along the opposite side of access roads and in separate piles at structure sites. Erosion control and stormwater management BMPs were in good conditional and working effectively.

**Report Photo #3 "Topsoil piles segregated from subsoil next to transmission structure"**

Erosion control and stormwater BMPs should continue to be routinely evaluated and replaced or repaired as necessary and pad sites smoothed out once construction on the sites is completed. Topsoil piles will be used to revegetate areas not used for permanent roads.

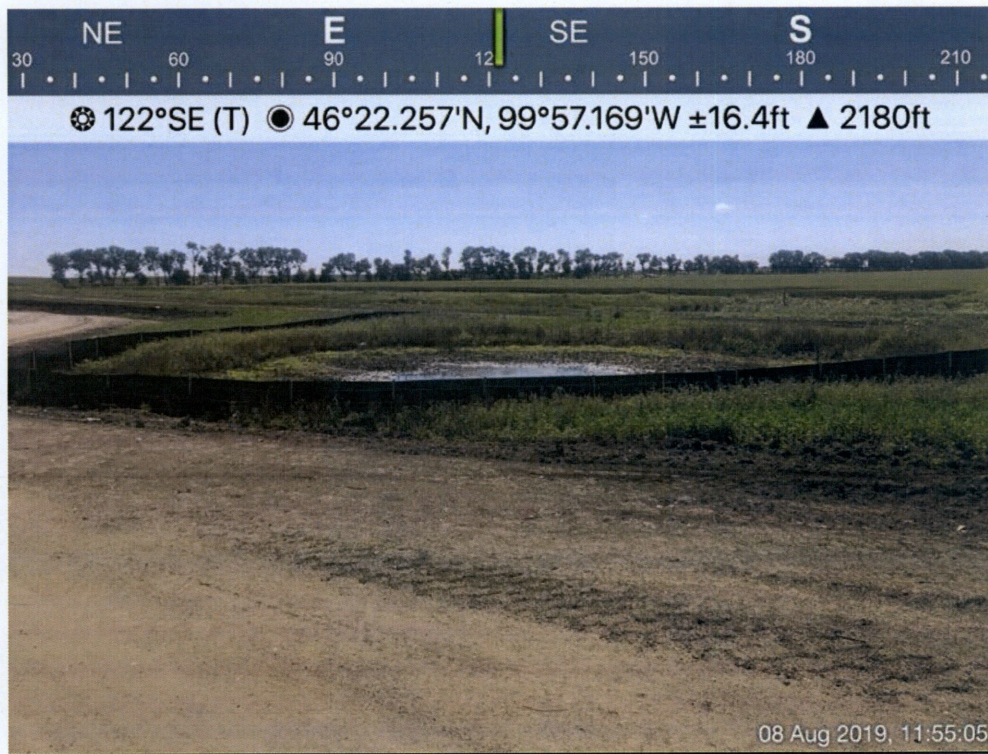
**Report Photo #4 "Silt fence for stormwater management"**

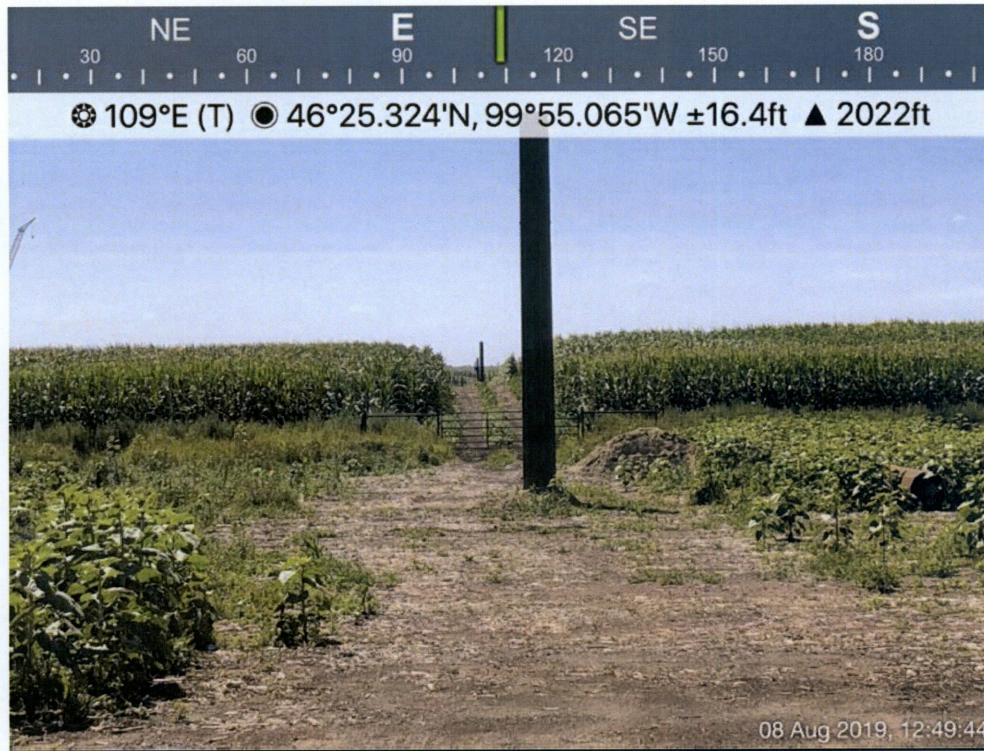
**Report Photo #5 "Transmission structure running through crop field"**
