Site/Project Location: Emmons and Logan Counties, ND

Date of Inspection: 5 November 2019

Keitu staff visited the Emmons Logan Wind Farm project for a construction inspection. Inspection of construction sites focused on (1) confirming surface disturbance/work occurring within ND PSC-approved work corridor and/or route; (2) topsoil segregation occurring; (3) vegetation removal consistent with tree & scrub mitigation plan; and (4) storm water runoff and sediment control.

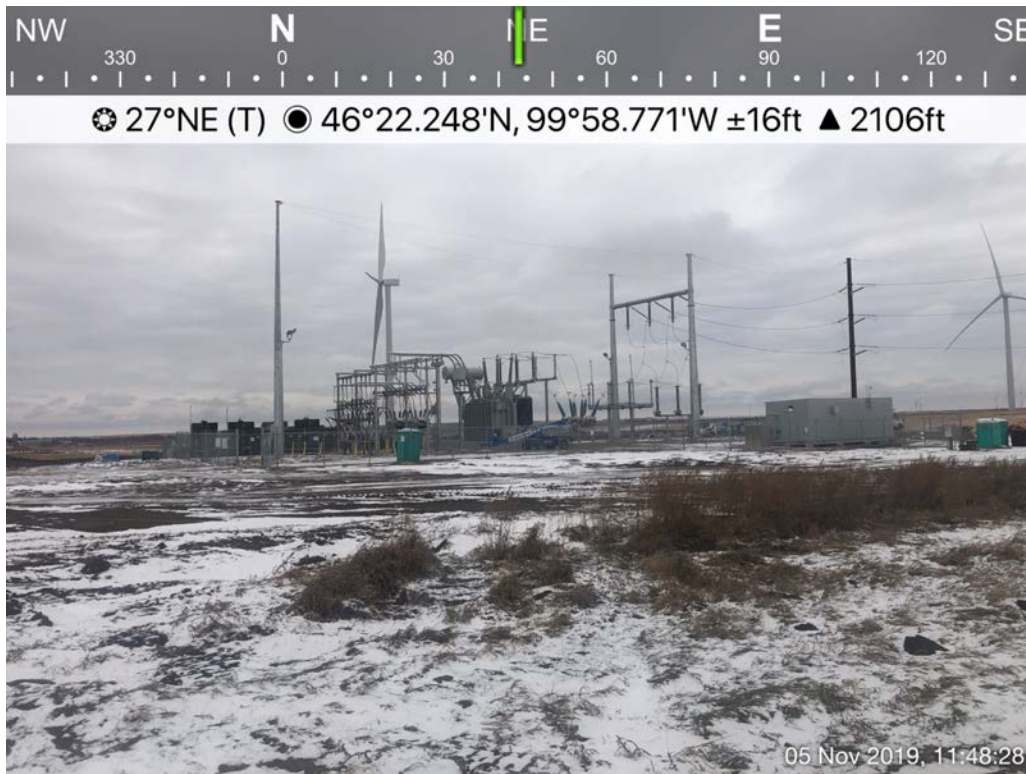
Report Photo #1 "Collection Line on North side of 72nd St SE"

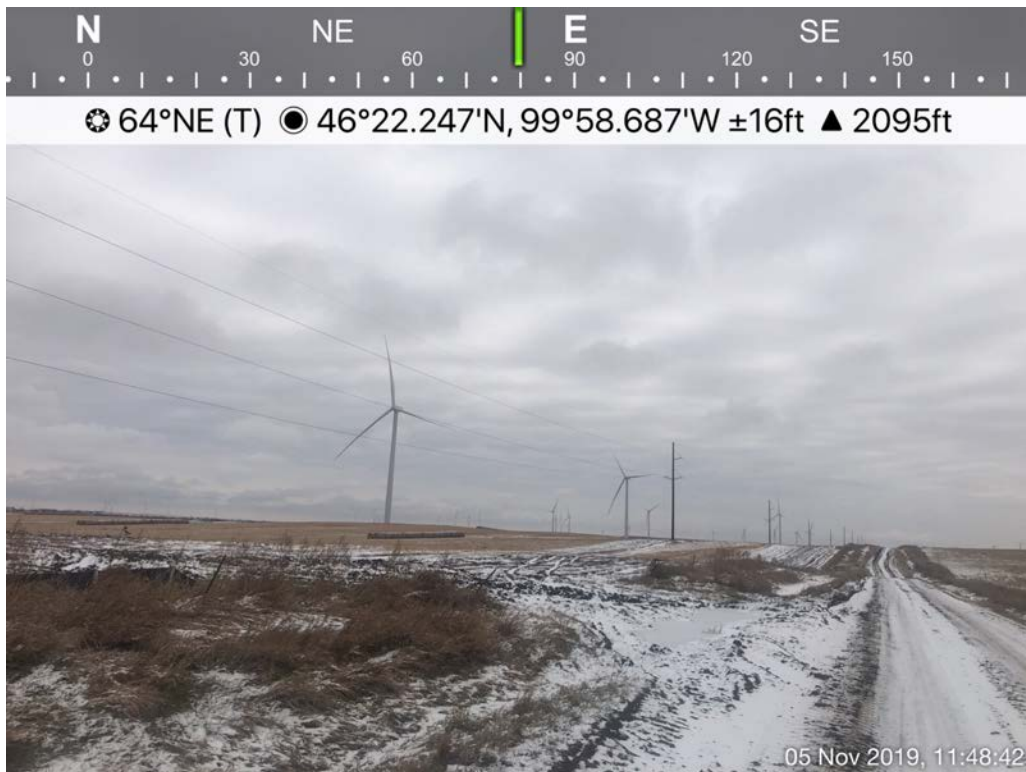
Report Photo #2 "Transmission Line Corridor and Structures on North side of 72nd Ave SE"

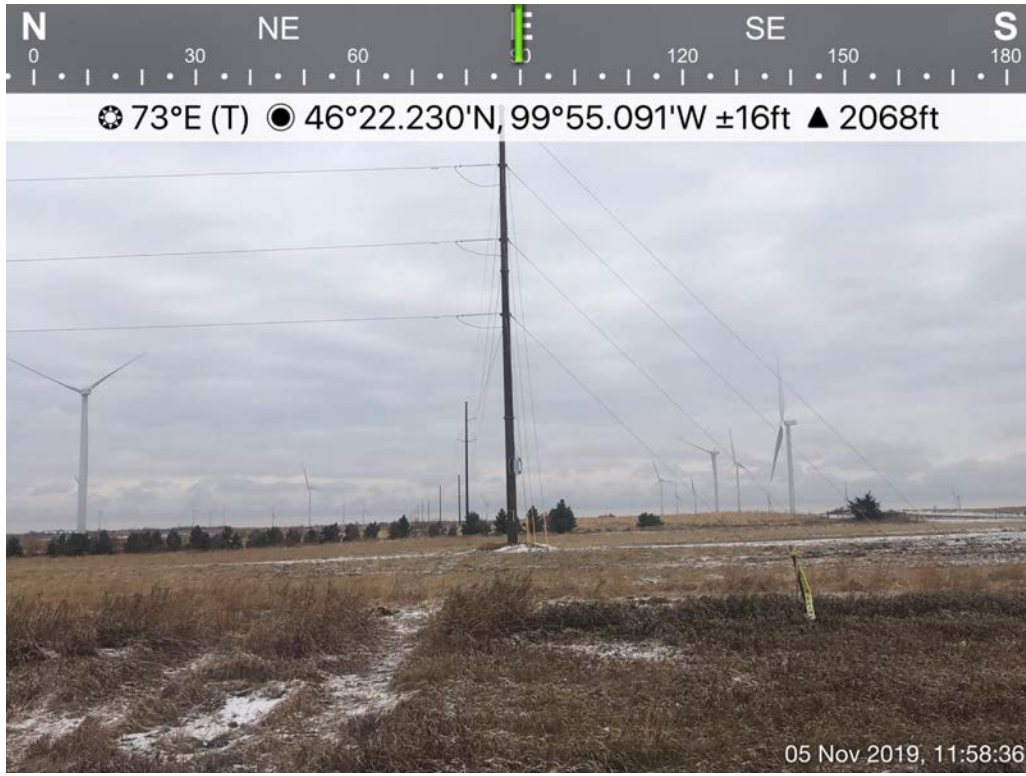
Report Photo #3 "Transmission Line Structures Running North-South along West Side of 24th Ave SE"

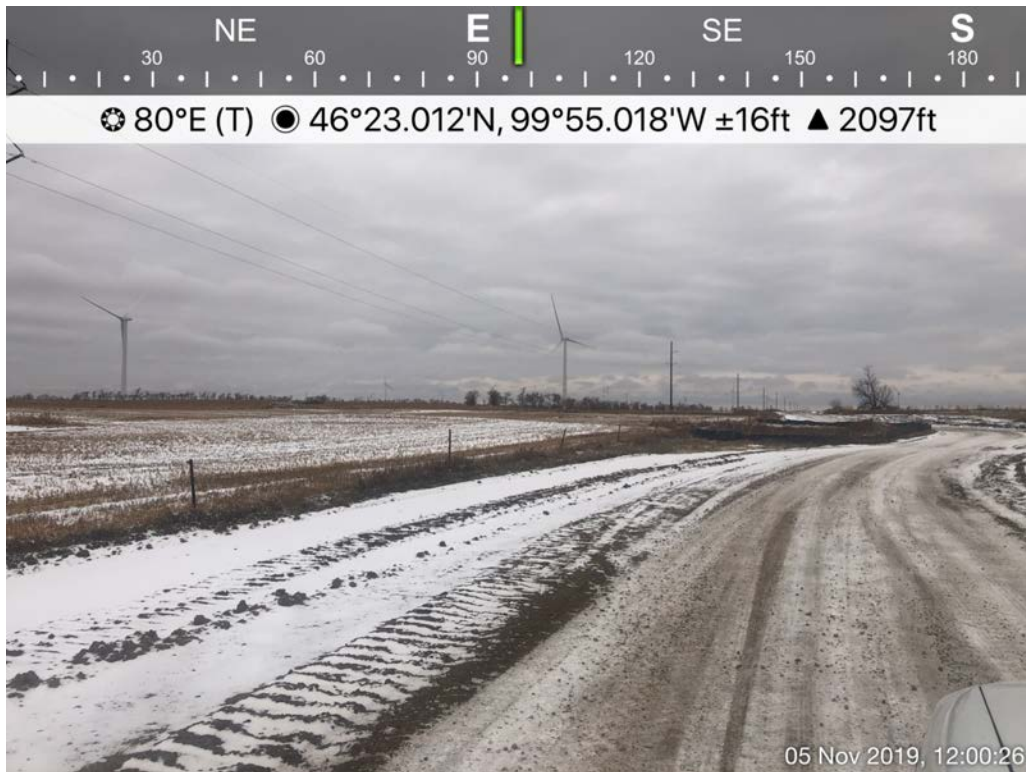
Report Photo #4 "Silt fence and 24th Ave SE Avoiding Wetland Area"

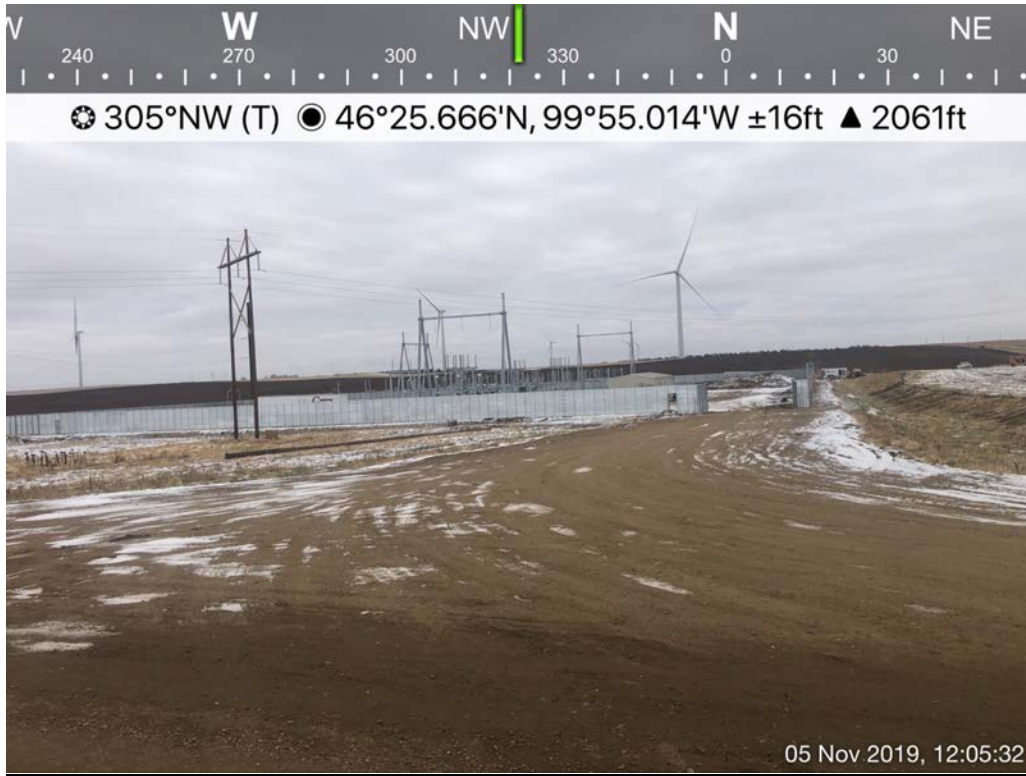
Report Photo #5 "Substation Construction near Completion"
