Site/Project Location: Aurora Wind Farm

Date of Inspection: 21 October 2019

Keitu staff visited the Aurora Wind Transmission Project for a start of project topsoil inspection for the transmission line portion of the wind farm project. Inspection of construction sites to focus on (1) confirming surface disturbance/work occurring within ND PSC-approved work corridor and/or route; (2) topsoil segregation occurring; (3) vegetation removal consistent with tree & scrub mitigation plan.

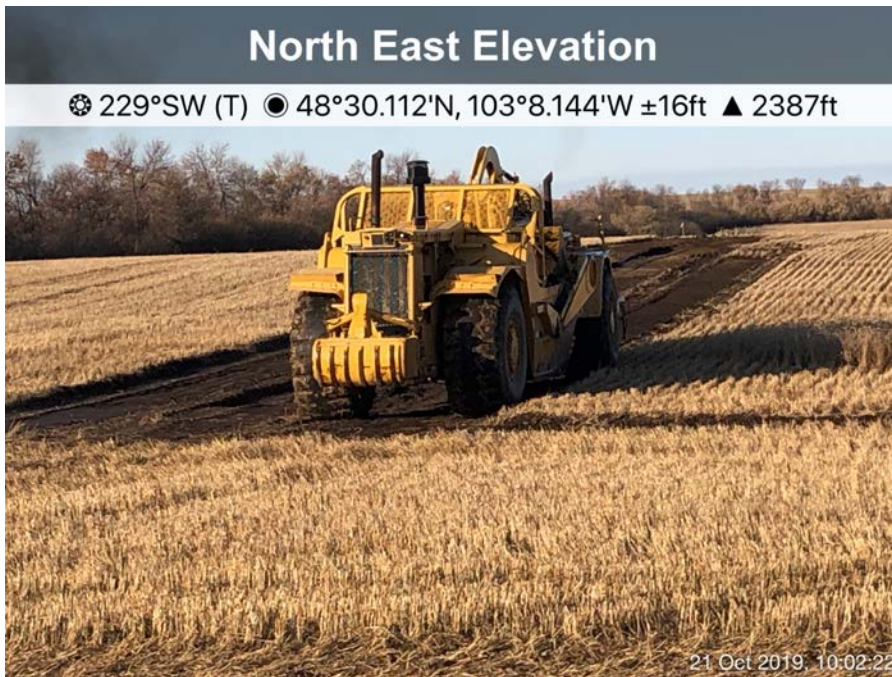
A grader started stripping topsoil on the south and east sides of the laydown yard which was located in a recently harvested crop field. Topsoil depth varied from 8-12 inches deep in the areas stripped during the inspection. The low lying areas on the northwest side of the substation had significantly deeper topsoil depth of 12 inches or more. The grader removed topsoil and relocated it to the southern border of the substation to be used as a perimeter berm. The topsoil was pushed into piles to be picked up with a grader and used as a perimeter berm.

Report Photo #1 “Grader Stripping Topsoil”

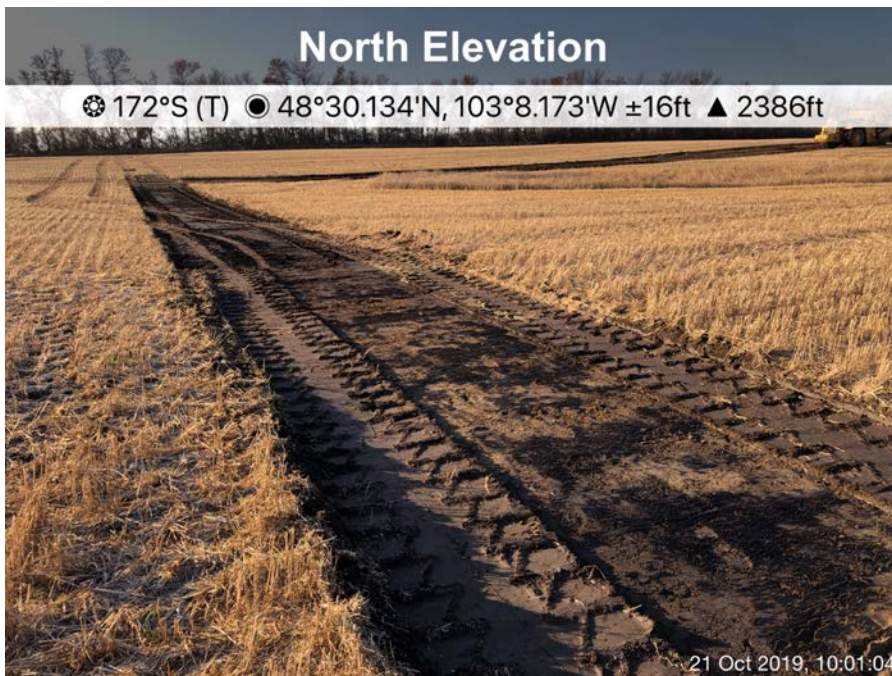
The grader operator demonstrated proper understanding of the rules and regulation for topsoil removal and removed the topsoil to a depth where the subsoil started to appear. The soil was saturated due to the high amount of precipitation in September and early October. The bulldozer operator made multiple passes over the same ground to remove the wet topsoil in increments to smoothly strip the topsoil layer at proper depths across the varying contours of the field.

Report Photo #2 “Subsoil Showing After Topsoil Removal”

Topsoil segregation was noted to be acceptable at this time in the areas observed. Equipment operator was reminded to strip soil, where it existed, down to a maximum of 12 inches or to the depth where subsoil appeared. Equipment operators have demonstrated proficiency in topsoil removal and segregation in compliance with the Commission's Order.

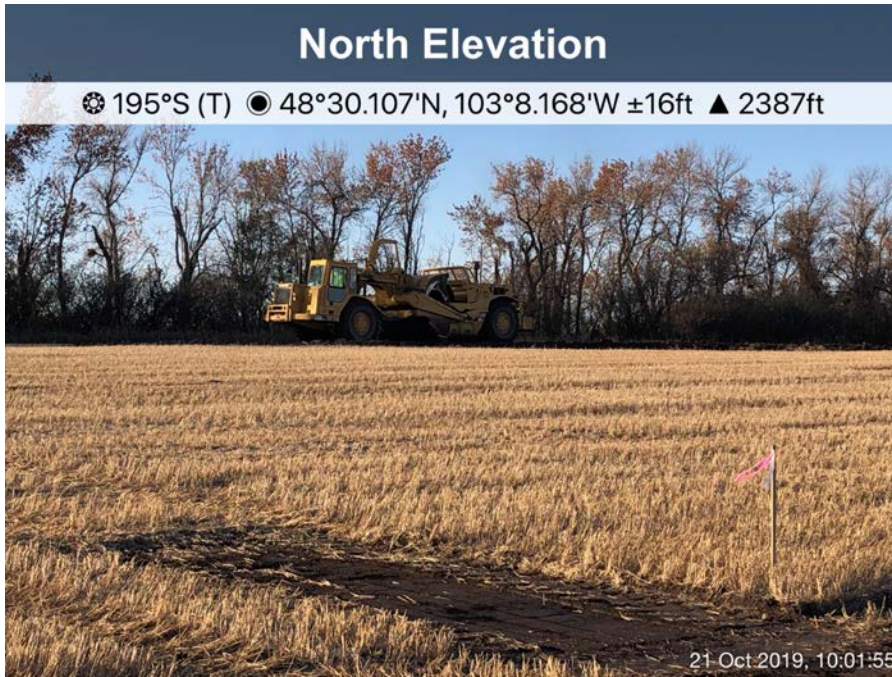
Report Photo #3 "Grader Relocating Stripped Topsoil for Perimeter Berm"
