Site/Project Location: Emmons and Logan Counties, ND

Date of Inspection: 10 June 2020

Keitu staff visited the Aurora Wind Transmission project for a construction inspection. Inspection of construction sites focused on (1) confirming surface disturbance/work occurring within ND PSC-approved work corridor and/or route; (2) topsoil segregation occurring; (3) vegetation removal consistent with tree & scrub mitigation plan; and (4) storm water runoff and sediment control.

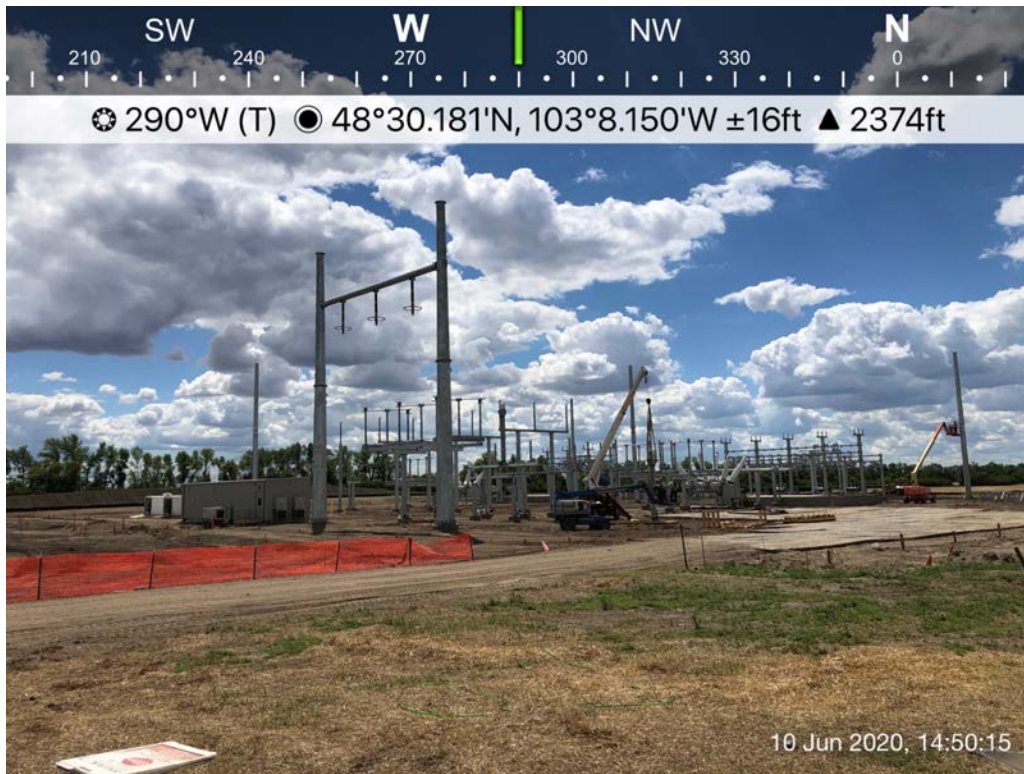
Report Photo #1 "Substation with ongoing construction"

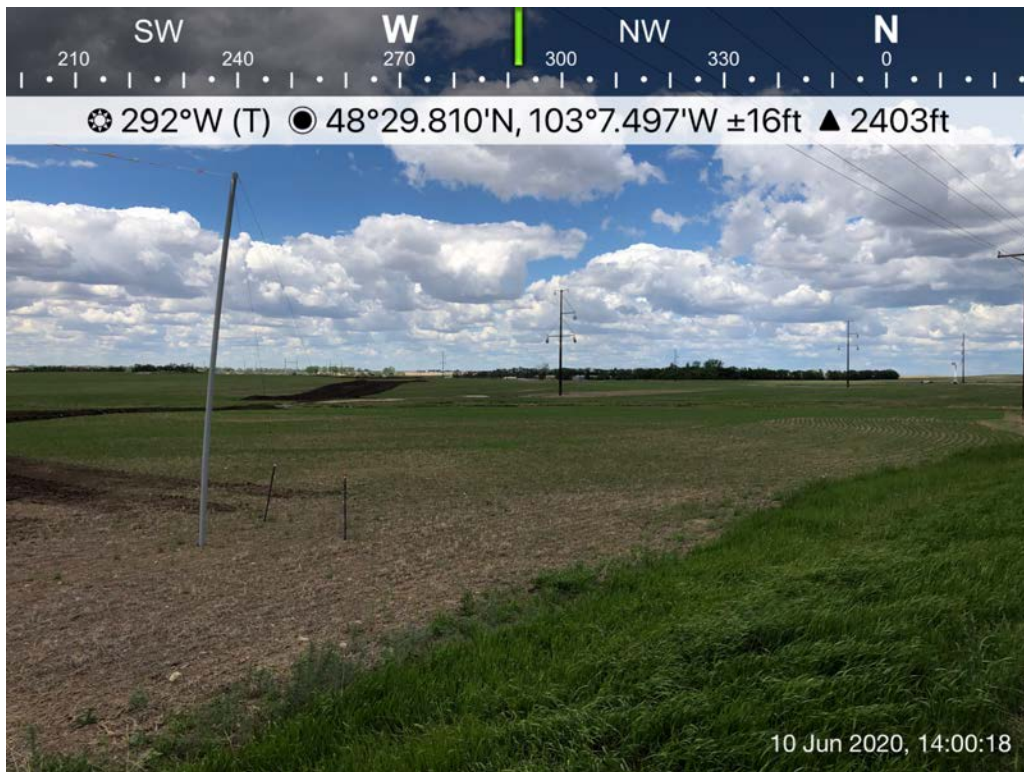
Report Photo #2 "Transmission structures with construction completed"

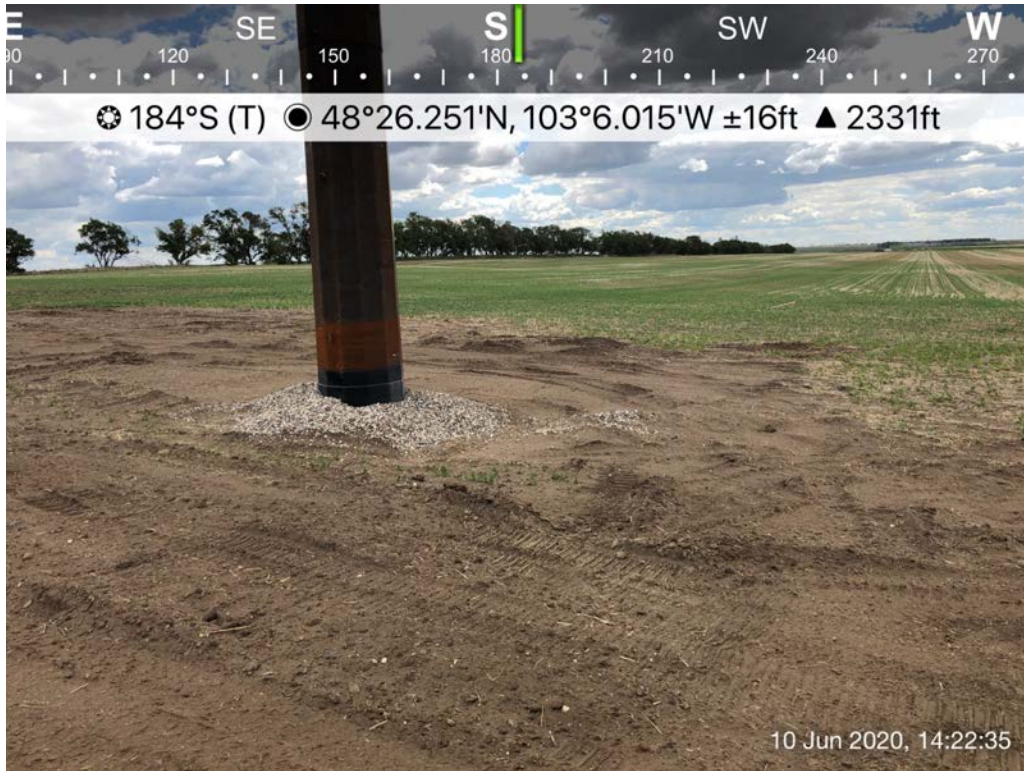
Report Photo #3 “Base of completed structure”

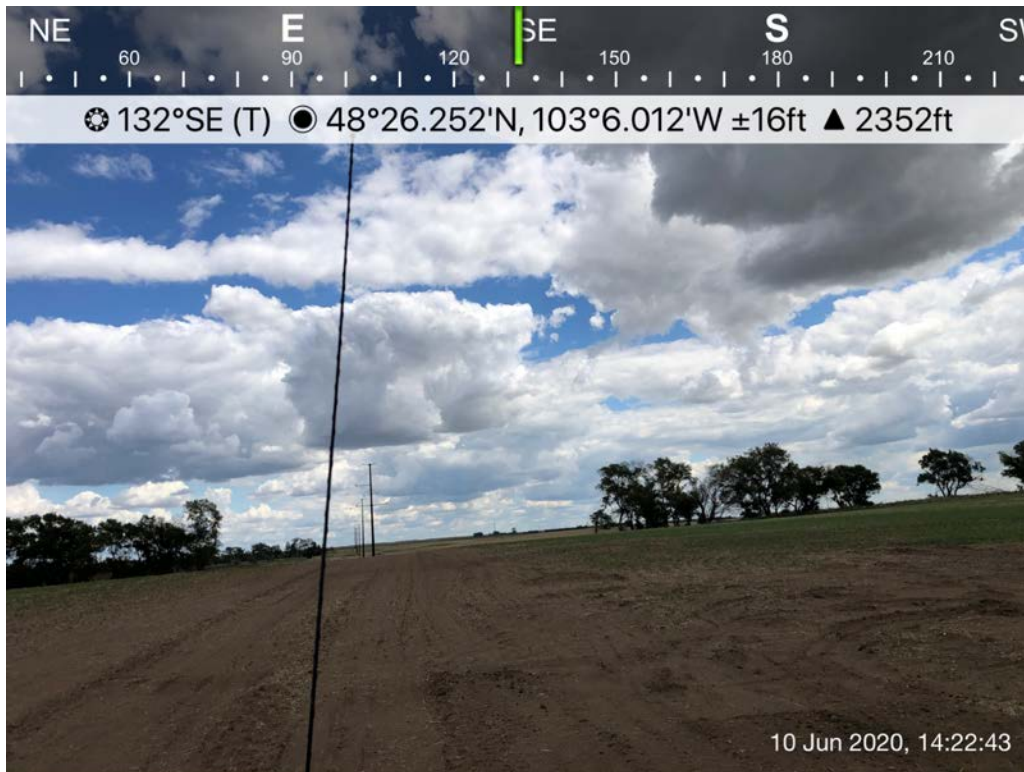
There were locations where trees were removed from single row shelterbelts for string roads to turbine sites. The number of trees removed was minimal. Enel Green Power will follow the tree and shrub mitigation plan submitted as part of their Application for Certificate of Site Compatibility. There are locations where access roads for the transmission line were constructed through agricultural fields currently in crop production.

Report Photo #4 “Area with trees removed for transmission line”
