Reclamation and Revegetation Inspection Report

Aurora Wind Project
Aurora Wind Project, LLC

ND PSC Case No. PU-18-351

September 2022

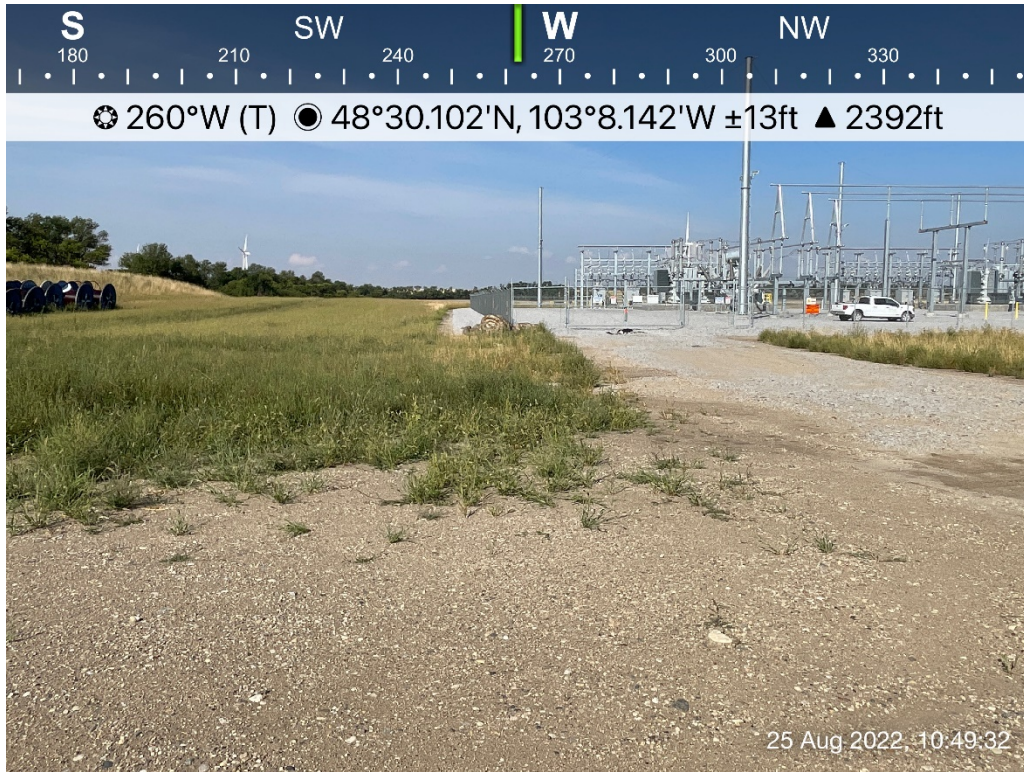
Report Photo #1: Established Vegetation at Substation

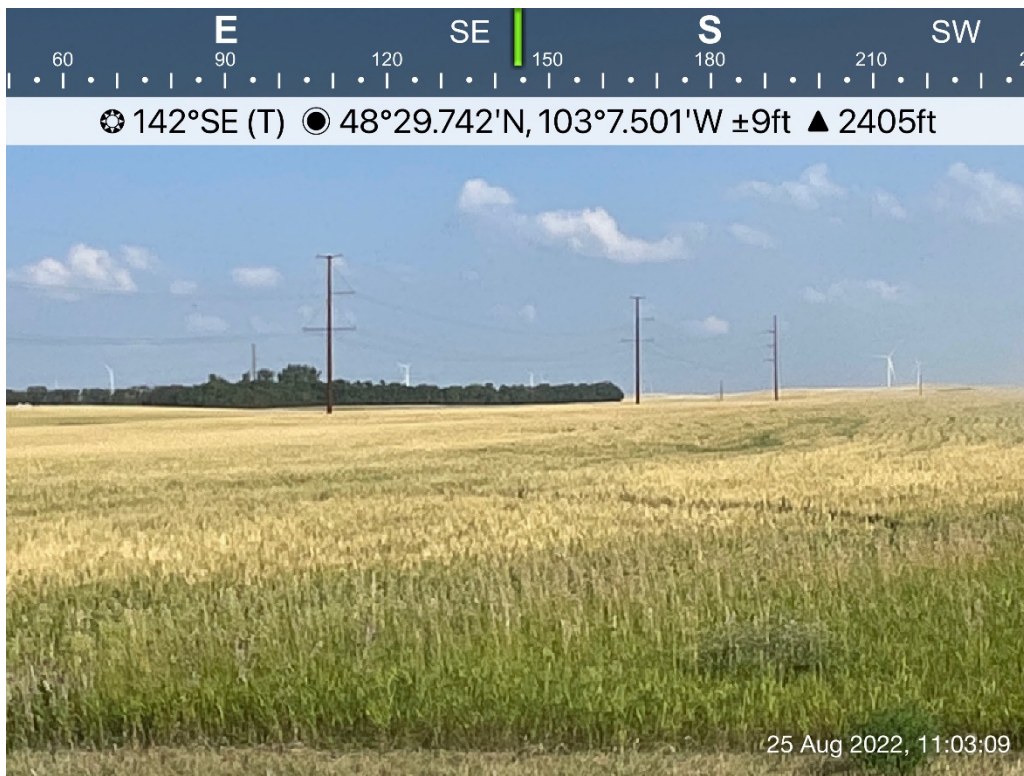
Report Photo #2: Transmission Poles in Wheat Field

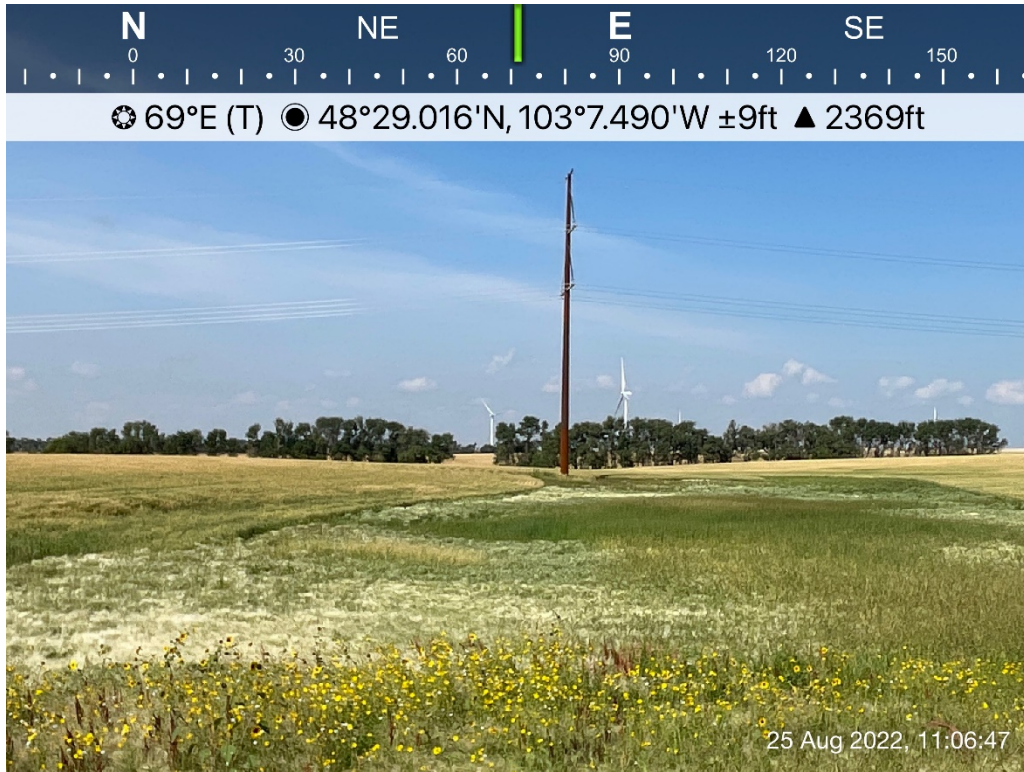
Report Photo #3: Transmission Pole near Wetland

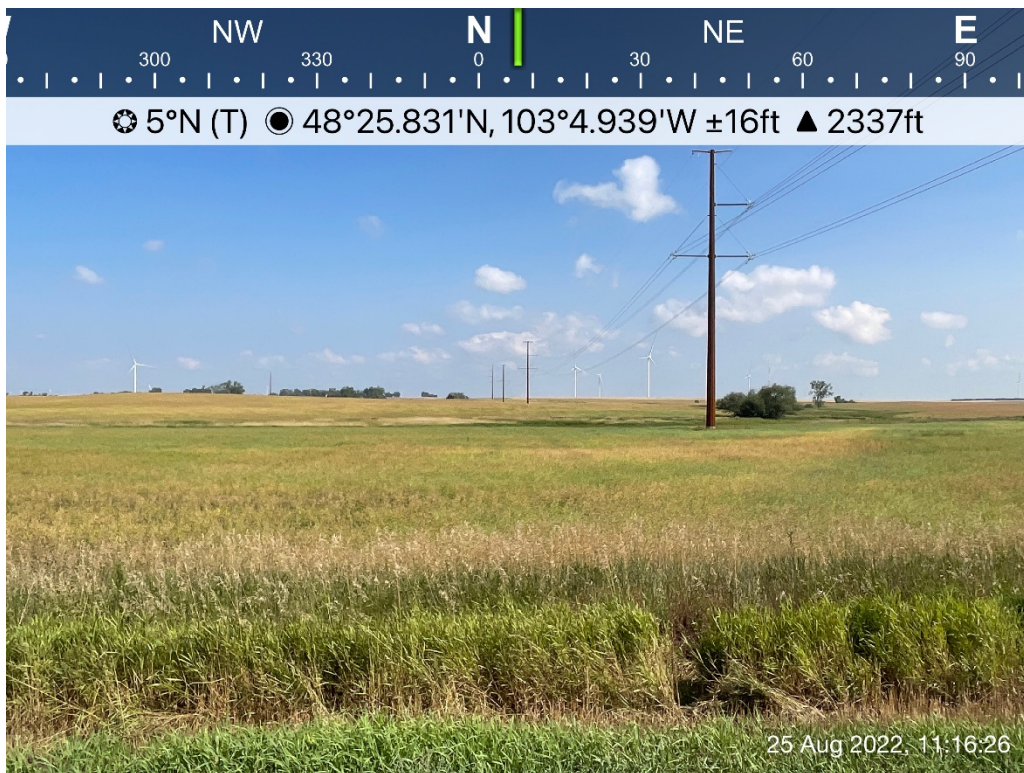
Report Photo #4: Transmission Poles through Cropland
