Site/Project Location: Aurora Wind Farm

Date of Inspection: 8 October 2019

Keitu staff visited the Aurora Wind Project for a start of project topsoil inspection for the wind turbine construction portion of the wind farm project. Inspection of construction sites to focus on (1) confirming surface disturbance/work occurring within ND PSC-approved work corridor and/or route; (2) topsoil segregation occurring; (3) vegetation removal consistent with tree & scrub mitigation plan.

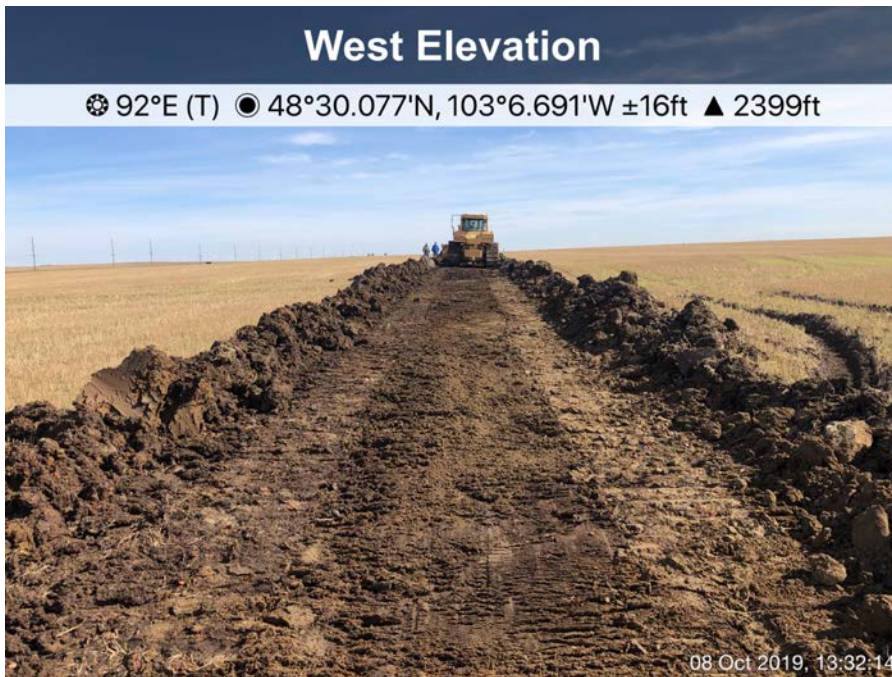
A bulldozer started stripping topsoil on the south side of the laydown yard which was located in a recently harvested crop field. Topsoil depth varied from 6-10 inches deep on the south side of the laydown yard. The low lying areas on the north side of the yard had significantly deeper topsoil depth of 12 inches or more. The dozer pushed the topsoil into piles to be picked up with a grader and used as a perimeter berm for the laydown yard. After the topsoil was stripped and placed into piles, graders moved the topsoil piles and created a perimeter berm on the east and south sides of the laydown yard.

The bulldozer operator demonstrated proper understanding of the rules and regulation for topsoil removal and removed the topsoil to a depth where the subsoil started to appear. The soil was saturated due to the high amount of precipitation in September and early October. The bulldozer operator made multiple passes over the same ground to remove the wet topsoil in increments to smoothly strip the topsoil layer at proper depths across the varying contours of the field.

Report Photo #1 "Bulldozer Stripping Layout Yard"

Topsoil segregation was noted to be acceptable at this time in the areas observed. Equipment operator was reminded to strip soil, where it existed, down to a maximum of 12 inches or to the depth where subsoil appeared. Equipment operators have demonstrated proficiency in topsoil removal and segregation in compliance with the Commission's Order.

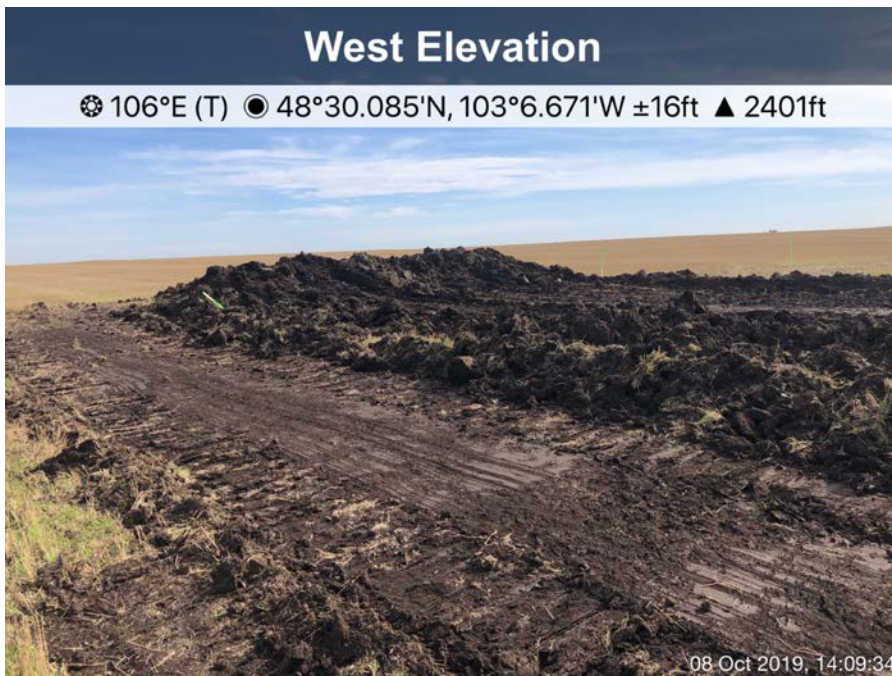
Report Photo #2 "Topsoil Pile to be Used for Perimeter Berm"

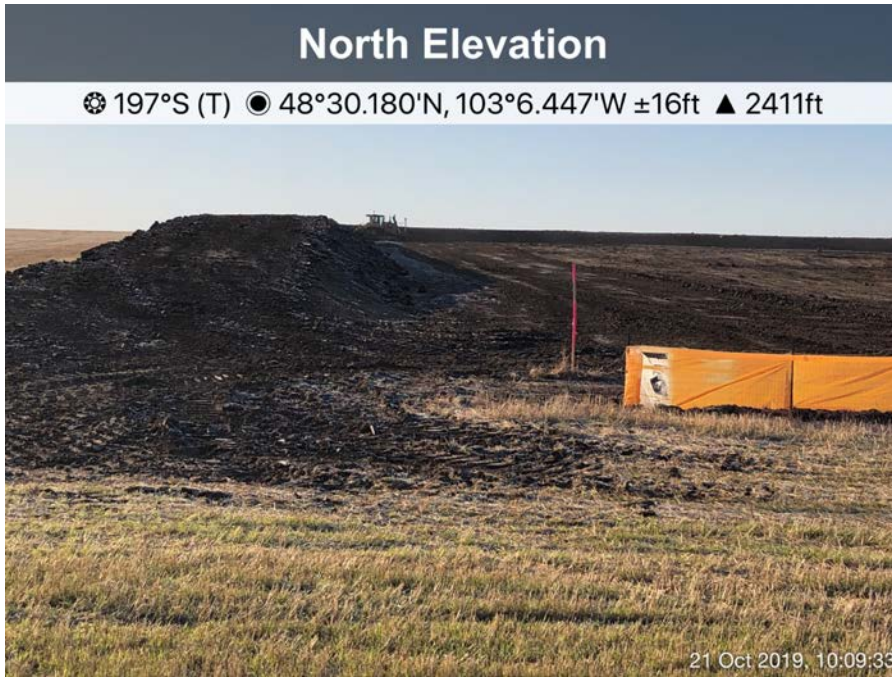
Report Photo #3 "Topsoil Berm at Laydown Yard"
