Site/Project Location: Emmons and Logan Counties, ND

Date of Inspection: 10 June 2020

Keitu staff visited the Aurora Wind Turbine project for a construction inspection. Inspection of construction sites focused on (1) confirming surface disturbance/work occurring within ND PSC-approved work corridor and/or route; (2) topsoil segregation occurring; (3) vegetation removal consistent with tree & scrub mitigation plan; and (4) storm water runoff and sediment control.

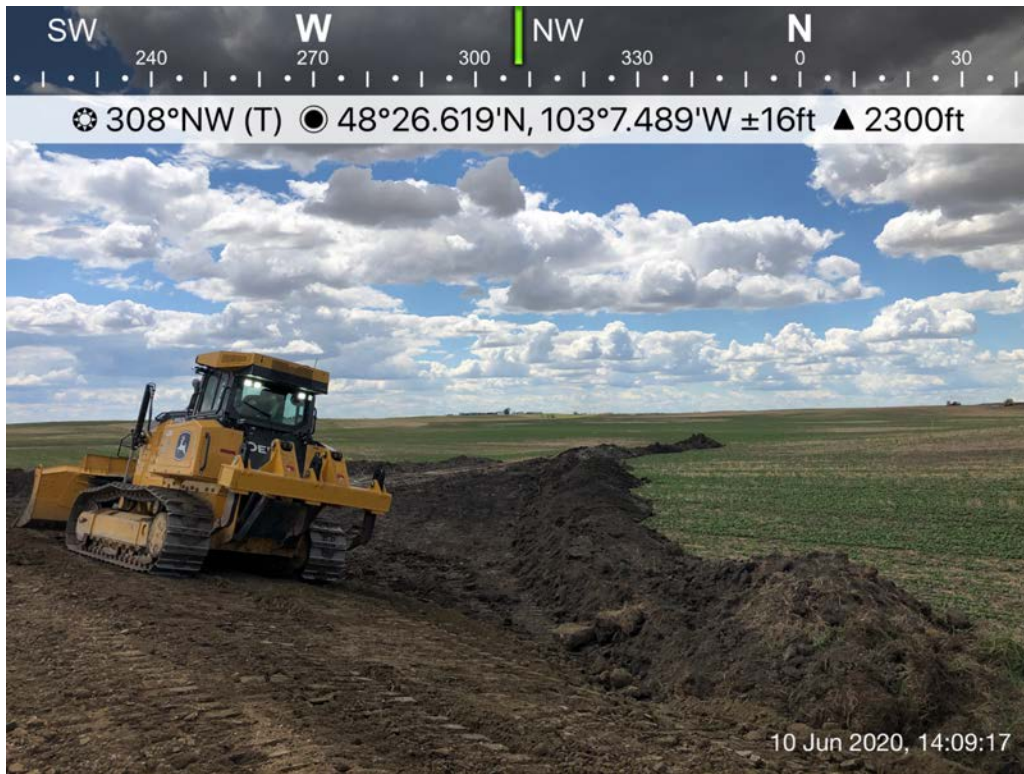
Report Photo #1 "Topsoil being stripped for string road"

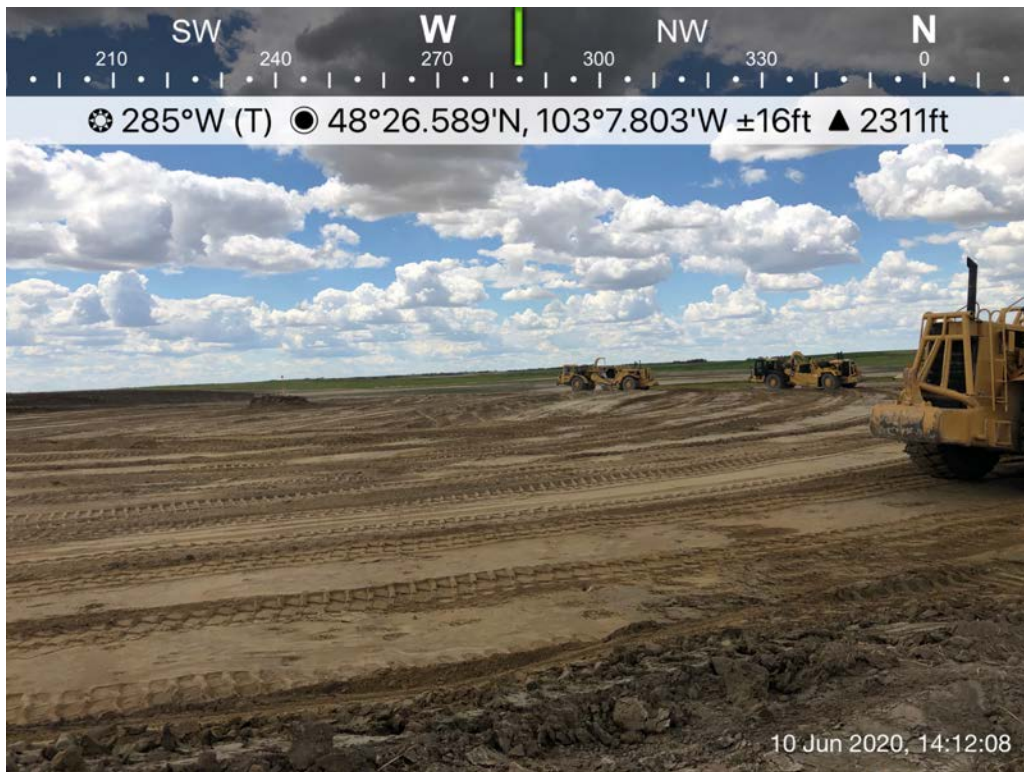
Report Photo #2 "Dirt work being conducted on turbine pad T-18"
