**Site/Project Location:** Emmons and Logan Counties, ND

**Date of Inspection:** 10 June 2020

Keitu staff visited the Aurora Wind Turbine project for a construction inspection. Inspection of construction sites focused on (1) confirming surface disturbance/work occurring within ND PSC-approved work corridor and/or route; (2) topsoil segregation occurring; (3) vegetation removal consistent with tree & scrub mitigation plan; and (4) storm water runoff and sediment control.

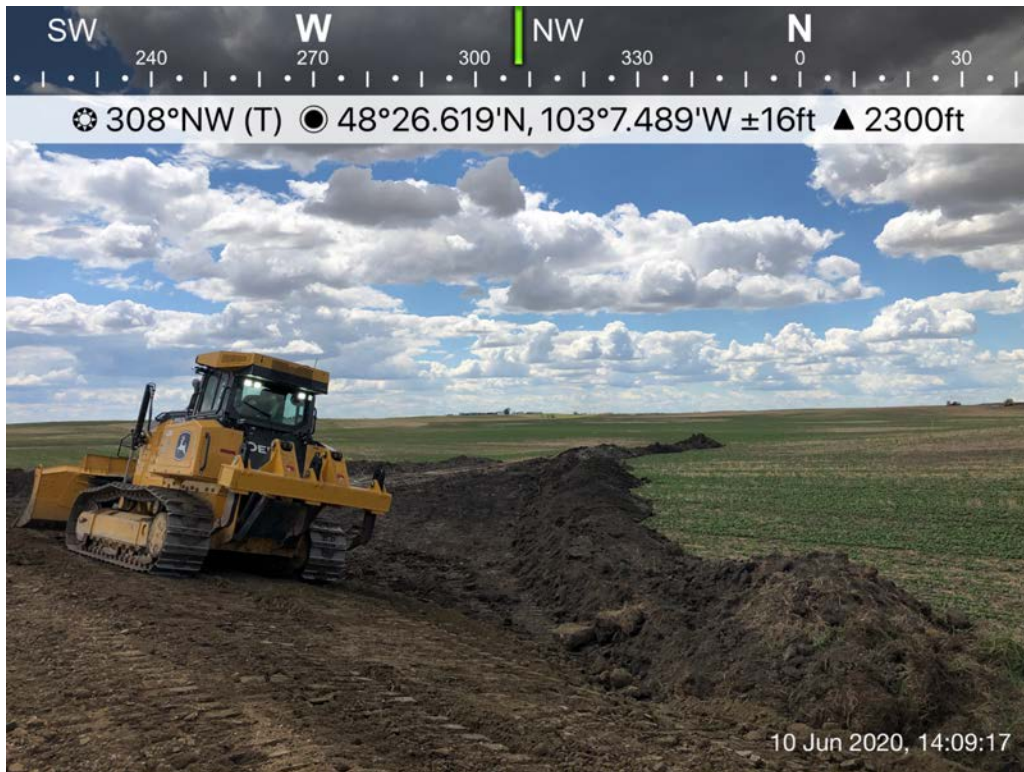
**Report Photo #1 "Topsoil being stripped for string road"**

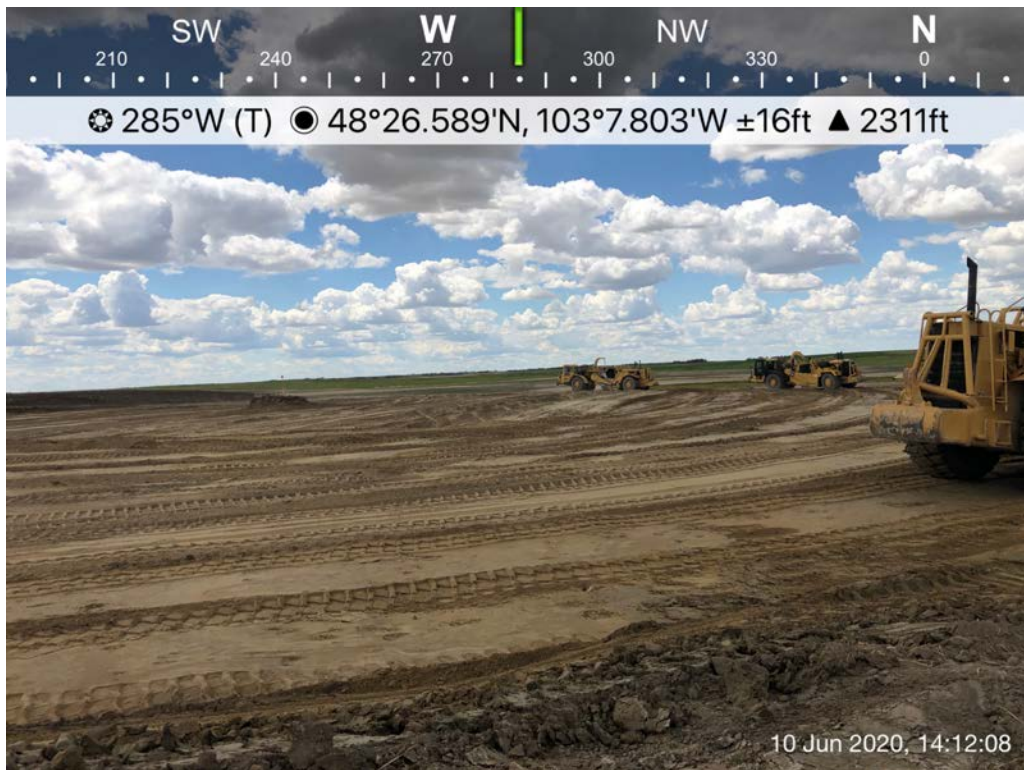
**Report Photo #2 "Dirt work being conducted on turbine pad T-18"**

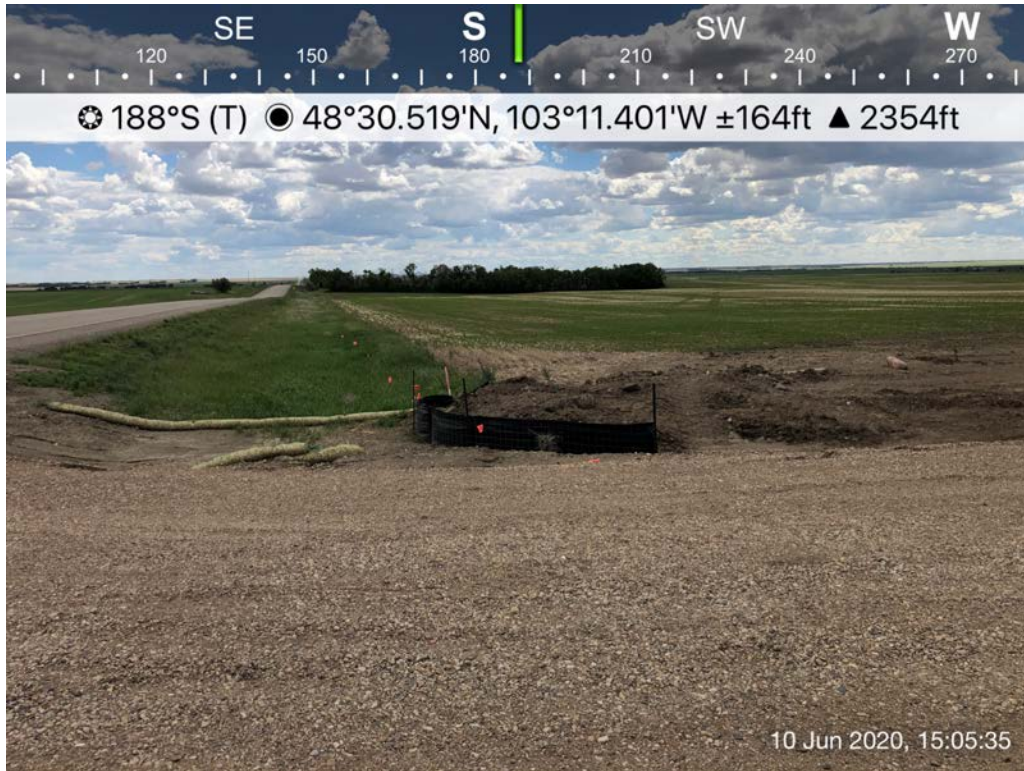
**Report Photo #3 "Silt fence near turbine pad T-51"**
