170 **PU-18-352** Filed: 11/12/2020 Pages: 5
Construction Inspection Report

Keitu Engineers & Consultants, Inc.

Site/Project Location: Aurora Wind Farm

Date of Inspection: 21 October 2020

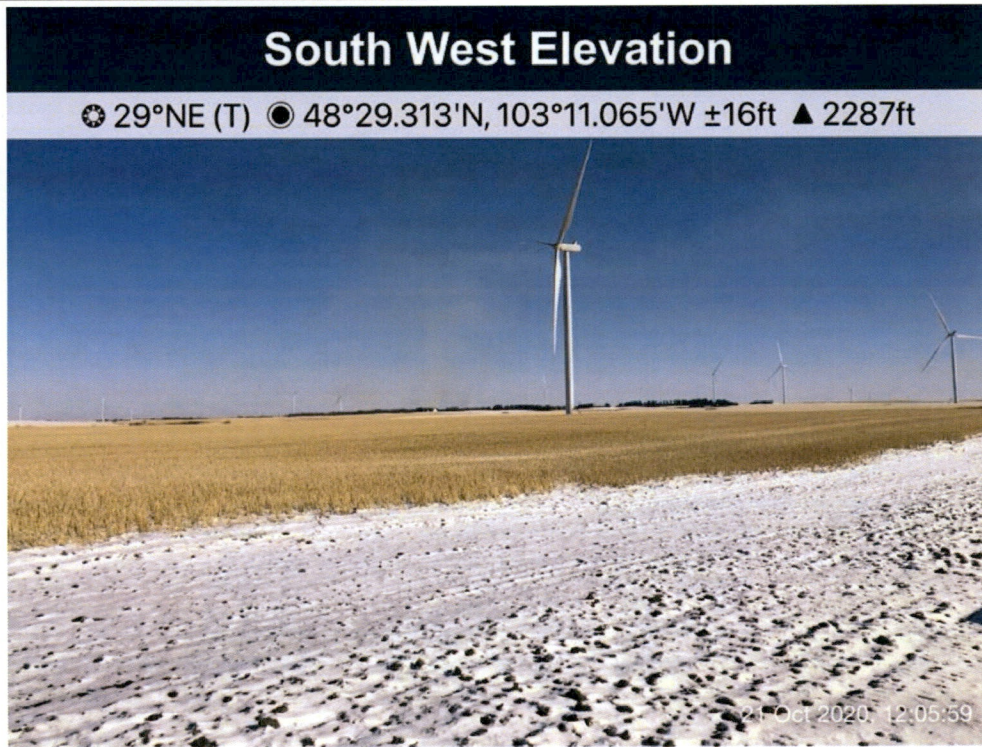
Report Photo #1 "Overview of Wind Turbines"

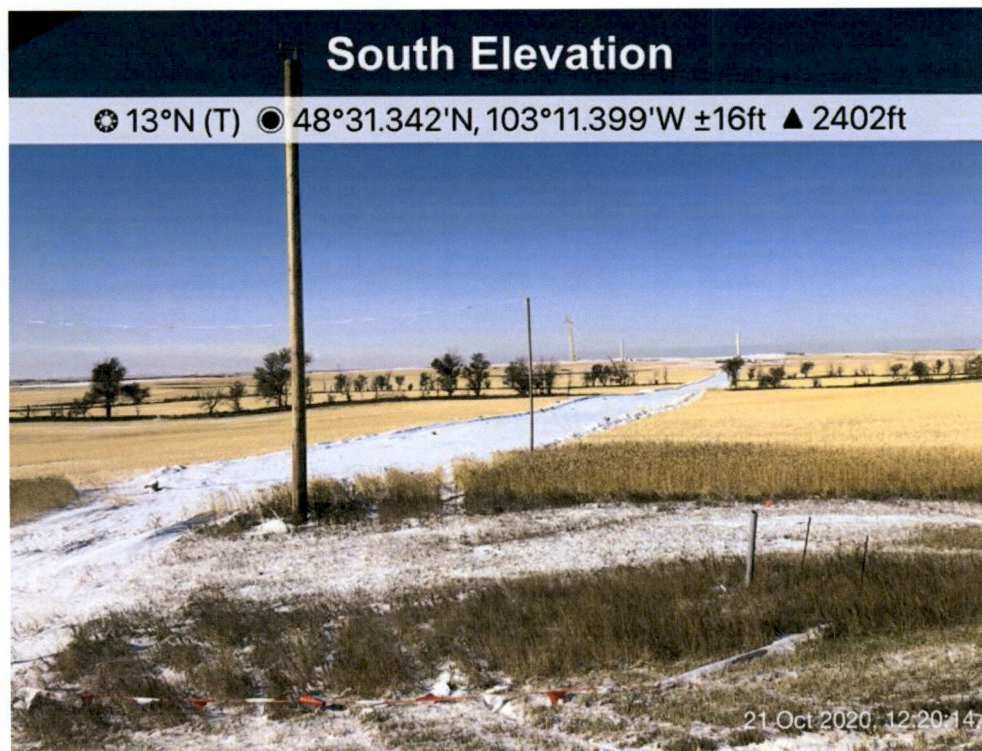
There were locations where trees were removed from single row shelterbelts for string roads and collection lines to turbine sites. The number of trees removed was minimal. Enel Green Power will follow the tree and shrub mitigation plan submitted as part of their Application for Certificate of Site Compatibility. In several locations, string roads to turbine sites were constructed through agricultural fields currently in crop production.

Report Photo #2 "Collection Line and Removed Trees"

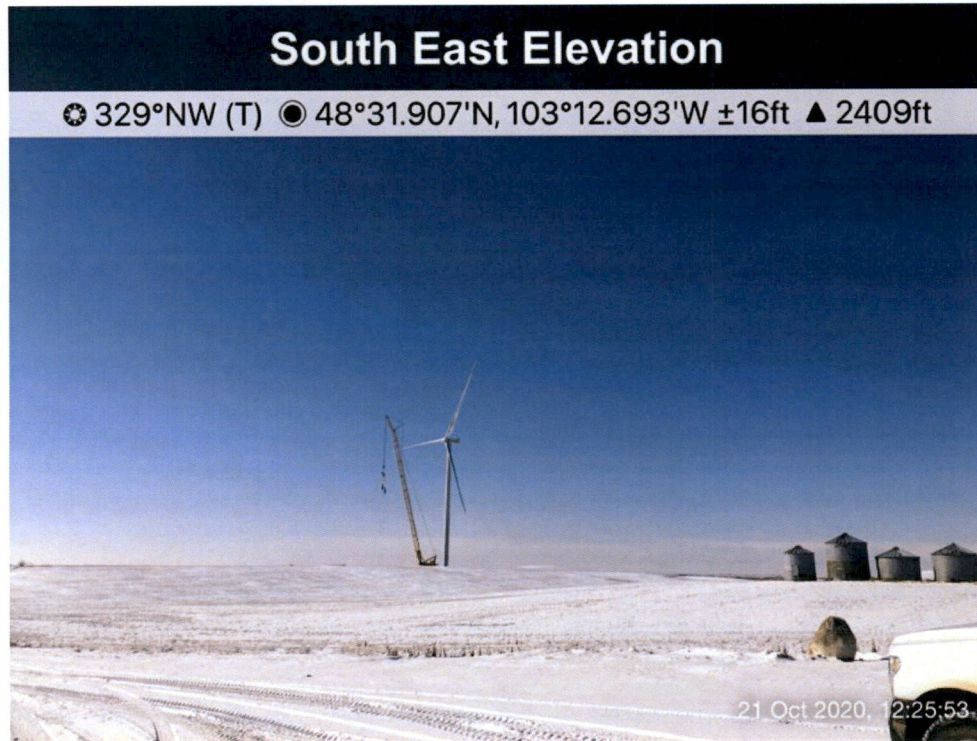
Report Photo #3 "Wind Turbine Nearing Completion"

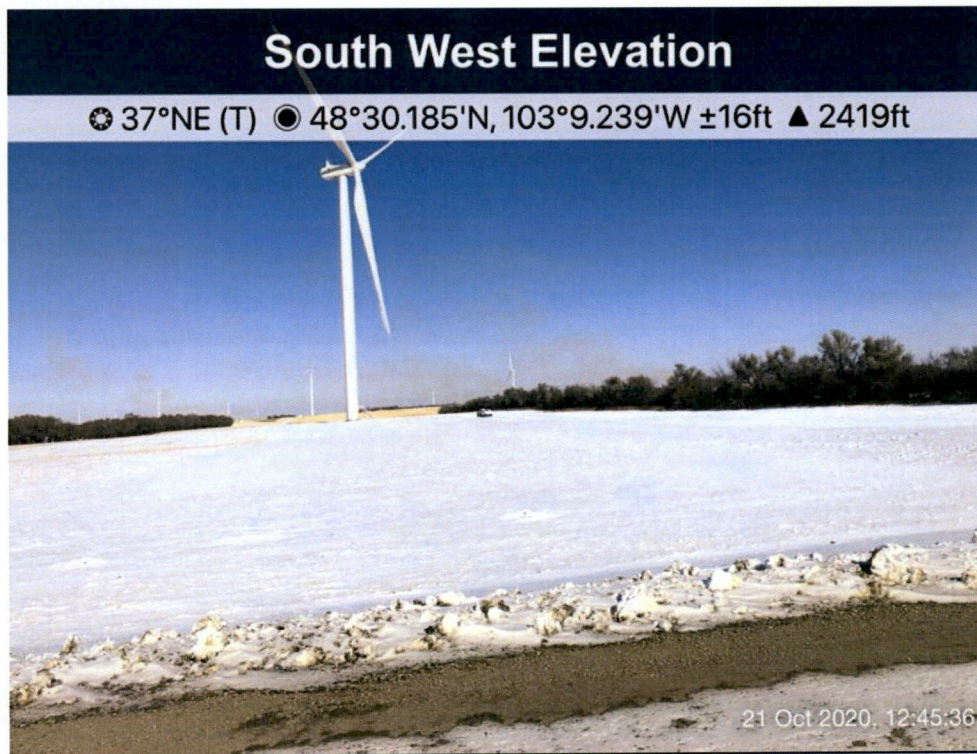
Report Photo #4 "Overview of Completed Turbines"
