# Reclamation and Revegetation Inspection Report

Aurora Wind Project

ND PSC Case No. PU-18-352

September 2022

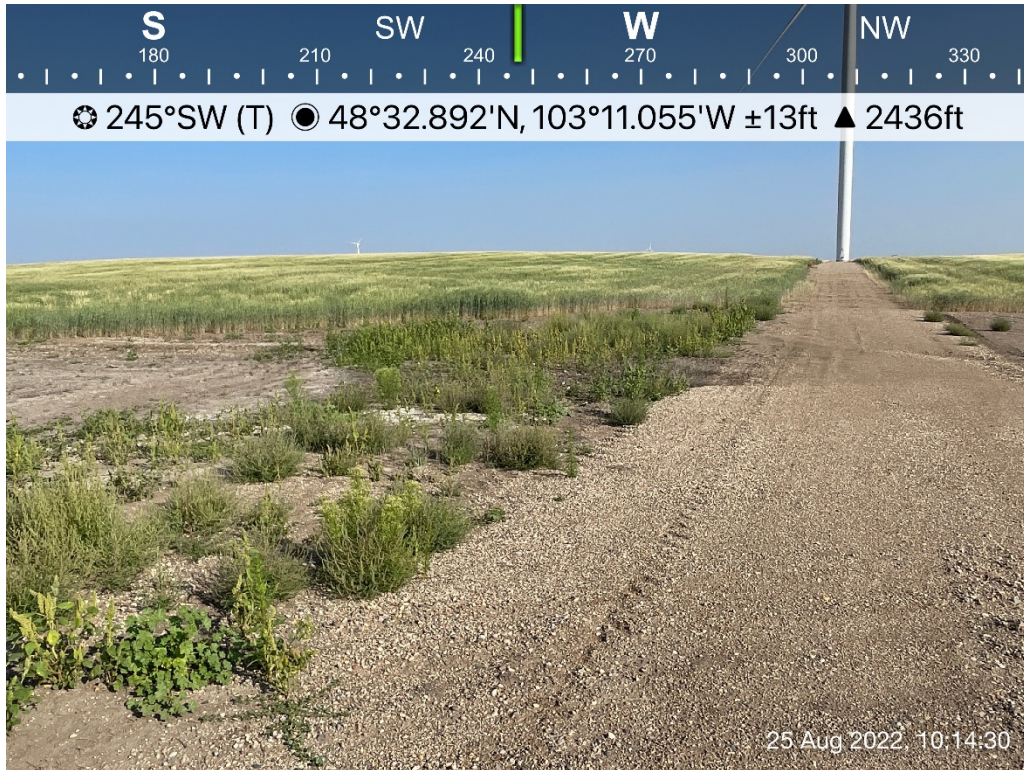
**Report Photo #1:** Wetland Area Near Access Road and Wheat Fields in Production

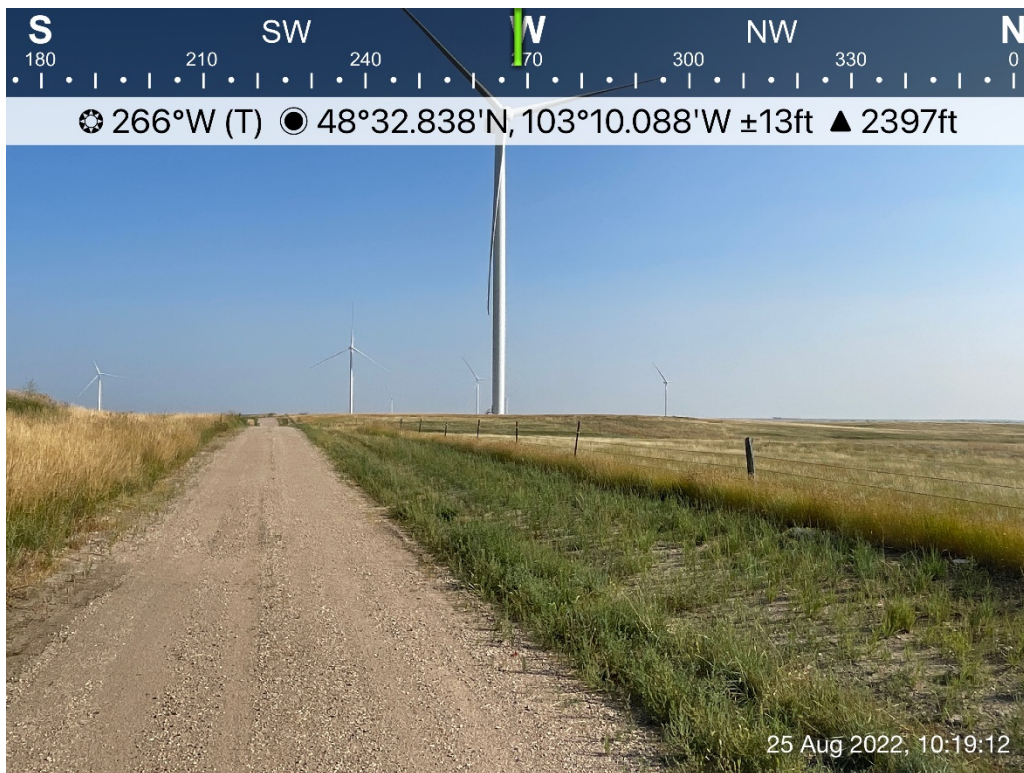
**Report Photo #2:** Grasses in Different Stages of Establishment along Access Road

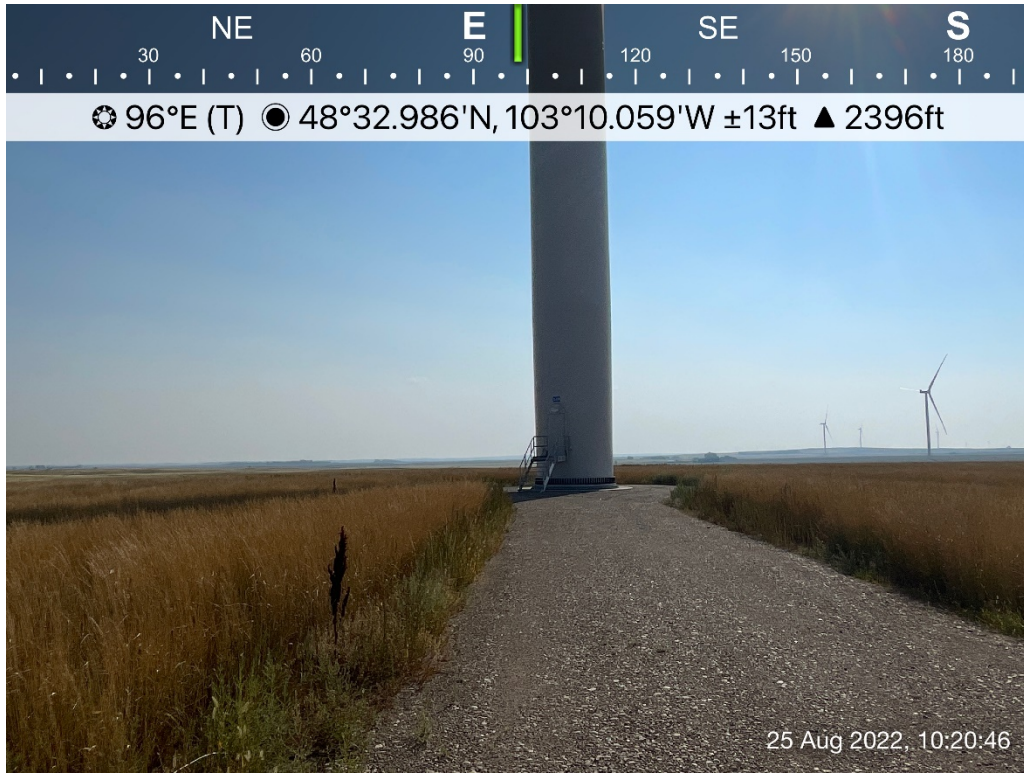
**Report Photo #3:** Established Grasses along Access Road and Turbine Site

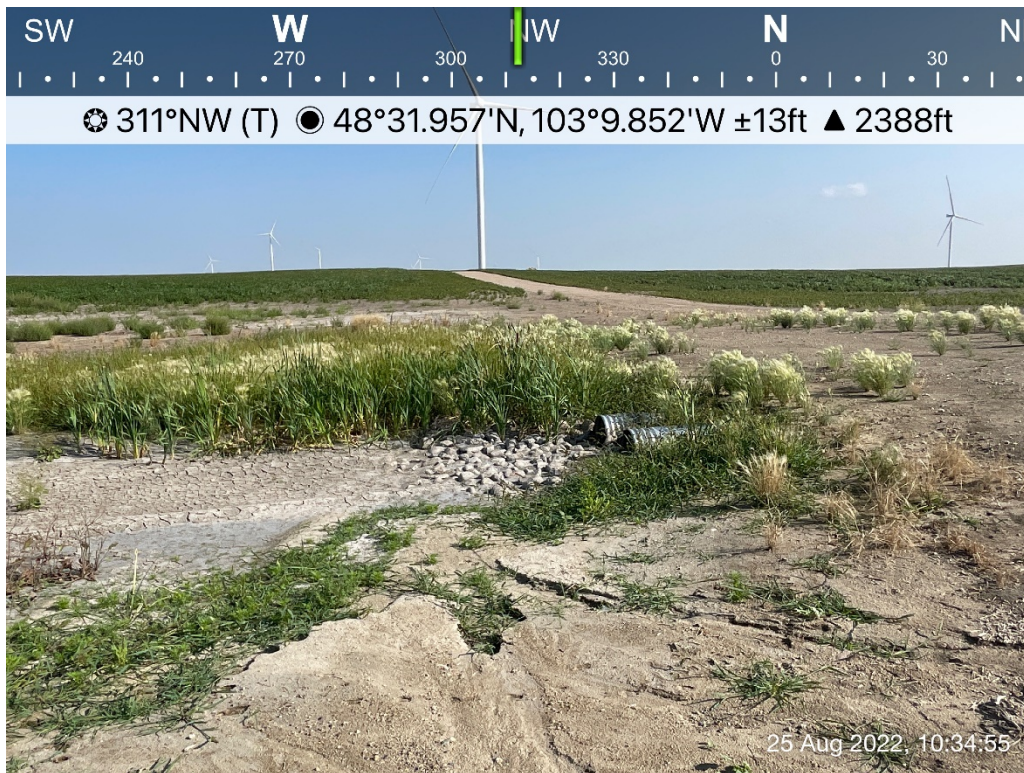
**Report Photo #4:** Culvert under Access Road and Wetland Area

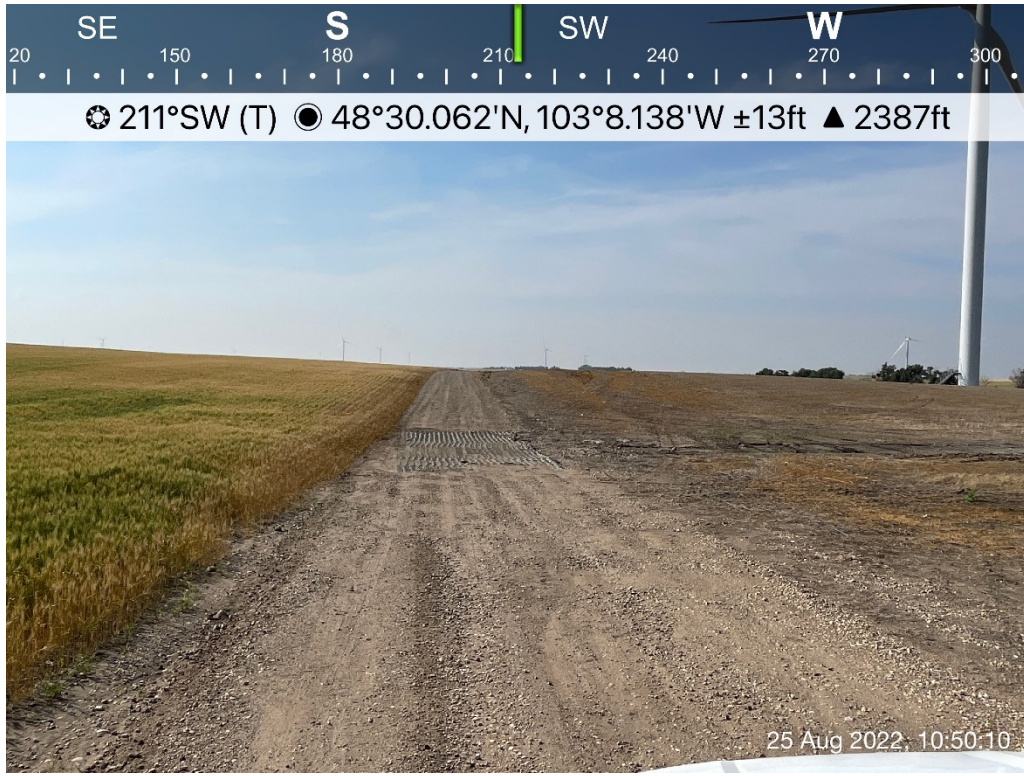
**Report Photo #5:** Wheat Field and Wetland Area along Access Road

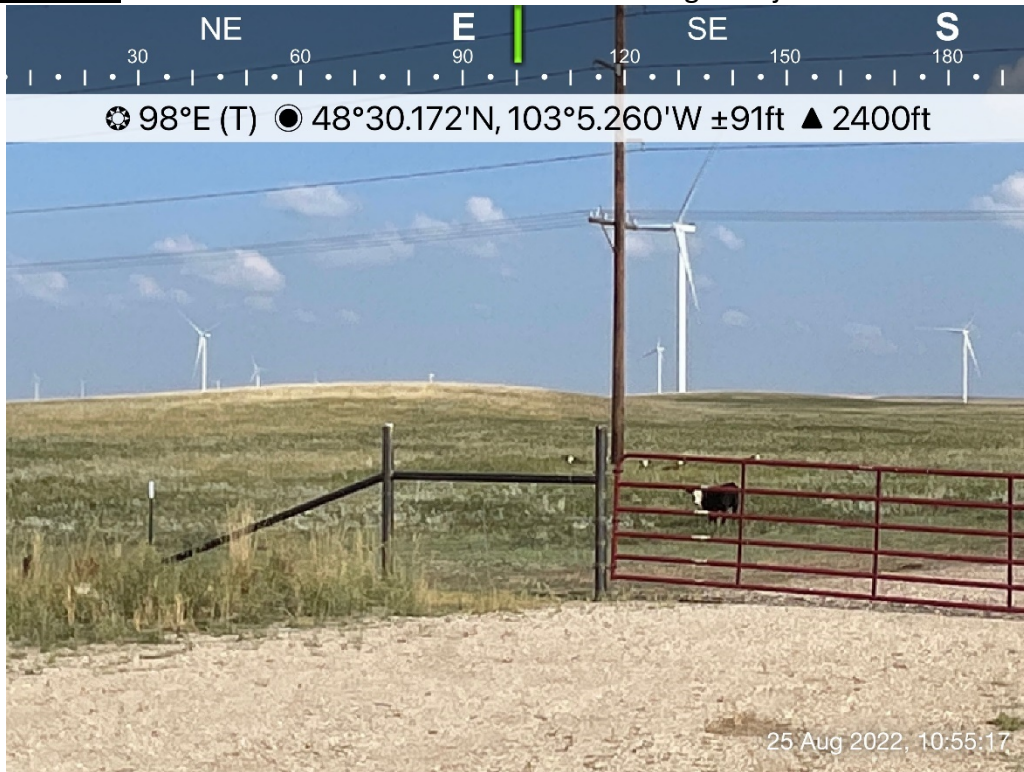
**Report Photo #6:** Overview of Turbine Sites and Cows Grazing in Adjacent Pastureland
