Re: Case No. PU-18-383

This letter is in response to the ND One-Call Complaint Case No. PU-18-383 received on December 7th, 2018 concerning excavation activity that occurred on 9/11/18 and 9/17/18, 2018 located at approximately LaMoure and Ransom counties in ND. Alleged Violation: Excavator failed to conduct the excavation in a careful and prudent manner to avoid damage of underground facilities. Other: Did not try to find line (pothole).

3 **PU-18-383** Filed: 12/17/2018 Pages: 3  
Response to North Dakota One-Call Complaint

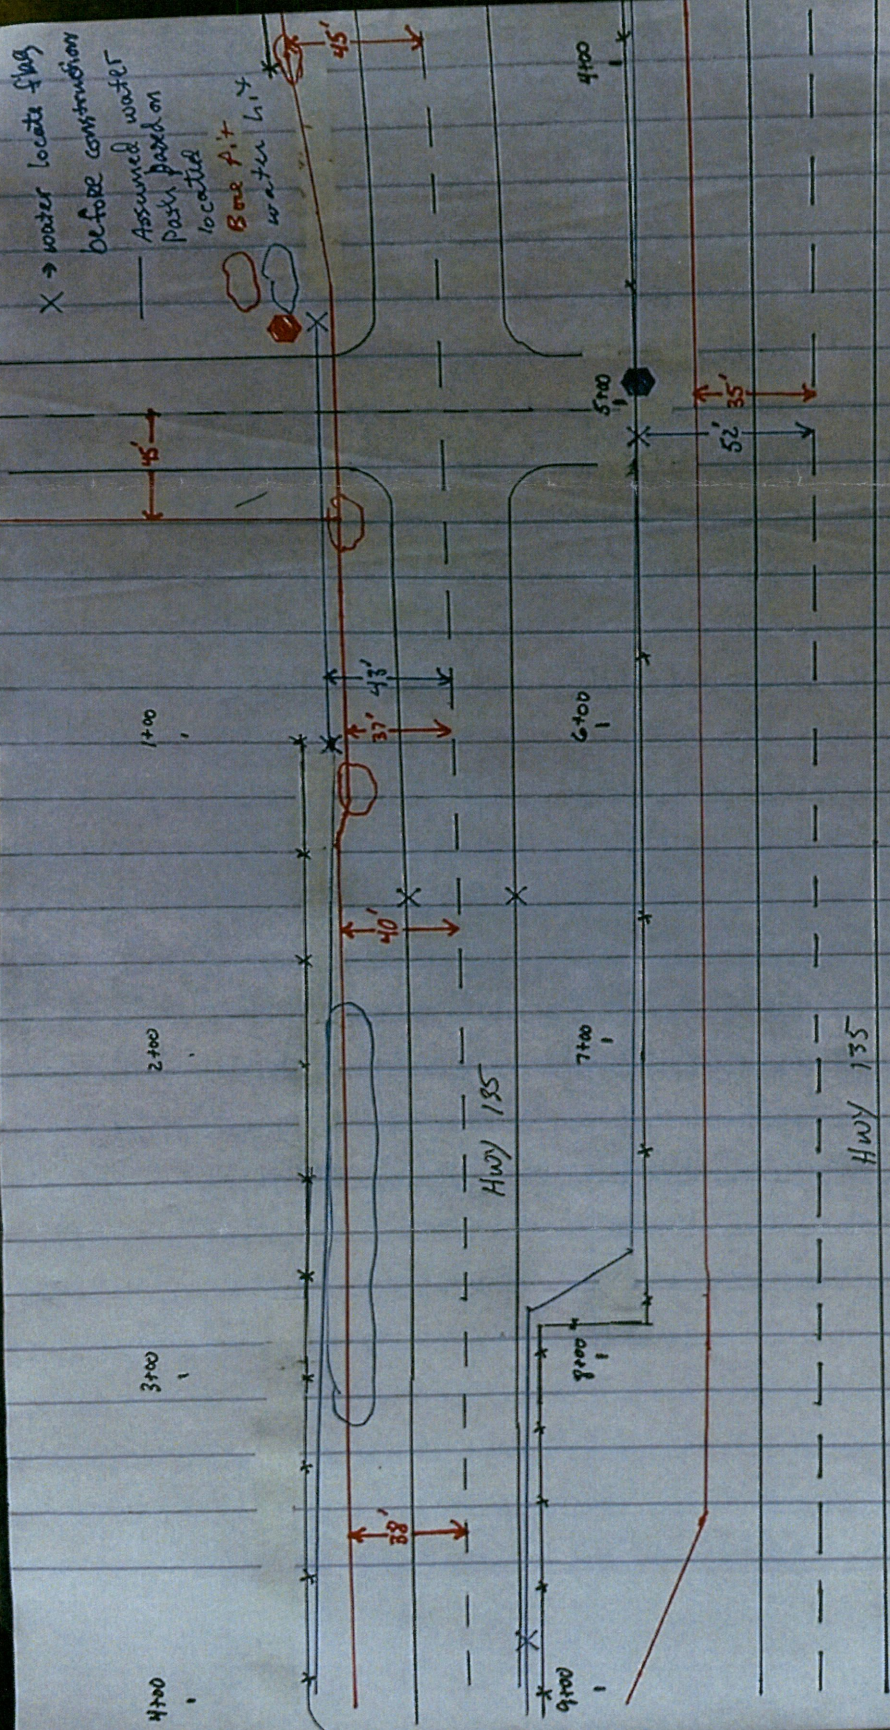
9/17/18 Investigation: MP crew was plowing paralleling the Barnes Rural water line maintaining approximately 10-foot clearance from the marked water line when the damage occurred. It was discovered after the hit that MP had plowed on top of the mislocated line for 710 feet, but damage occurred in only one section. See attached drawing and statement by KLJ Engineer.

The red line is the existing fiber location as placed on 9.17.18 by MP next level. There was NOT any water flags in the area where SE water was shown to be. Drawing a line between the only close flags, the water was shown to be around 10' away from where they were actually shown to be. Plowing started at Sta 1+21, veered slightly South, then was brought back towards the road. The water line was found to be only 3' 4" in the impact area. There is A reel end vault/ped to go at STA 9+50 on the fence line across from an approach.
