Public Service Commission
State of North Dakota

Re: ND One-Call Excavation Notice System: North Dakota Century Code Chapter 49-23

Enclosed is a copy of a ND One-Call Complaint, with attachments, against Northern Improvement Company, received by the North Dakota Public Service Commission on November 13, 2018, from Scott MacLean at Montana Dakota Utilities, of Dickinson, ND, Case Number PU-18-388. The location of the damage identified in the complaint is approximately the southeast corner of the intersection of 3rd St E and 5th Ave E in Dickinson, ND.

ND ONE-CALL COMPLAINT

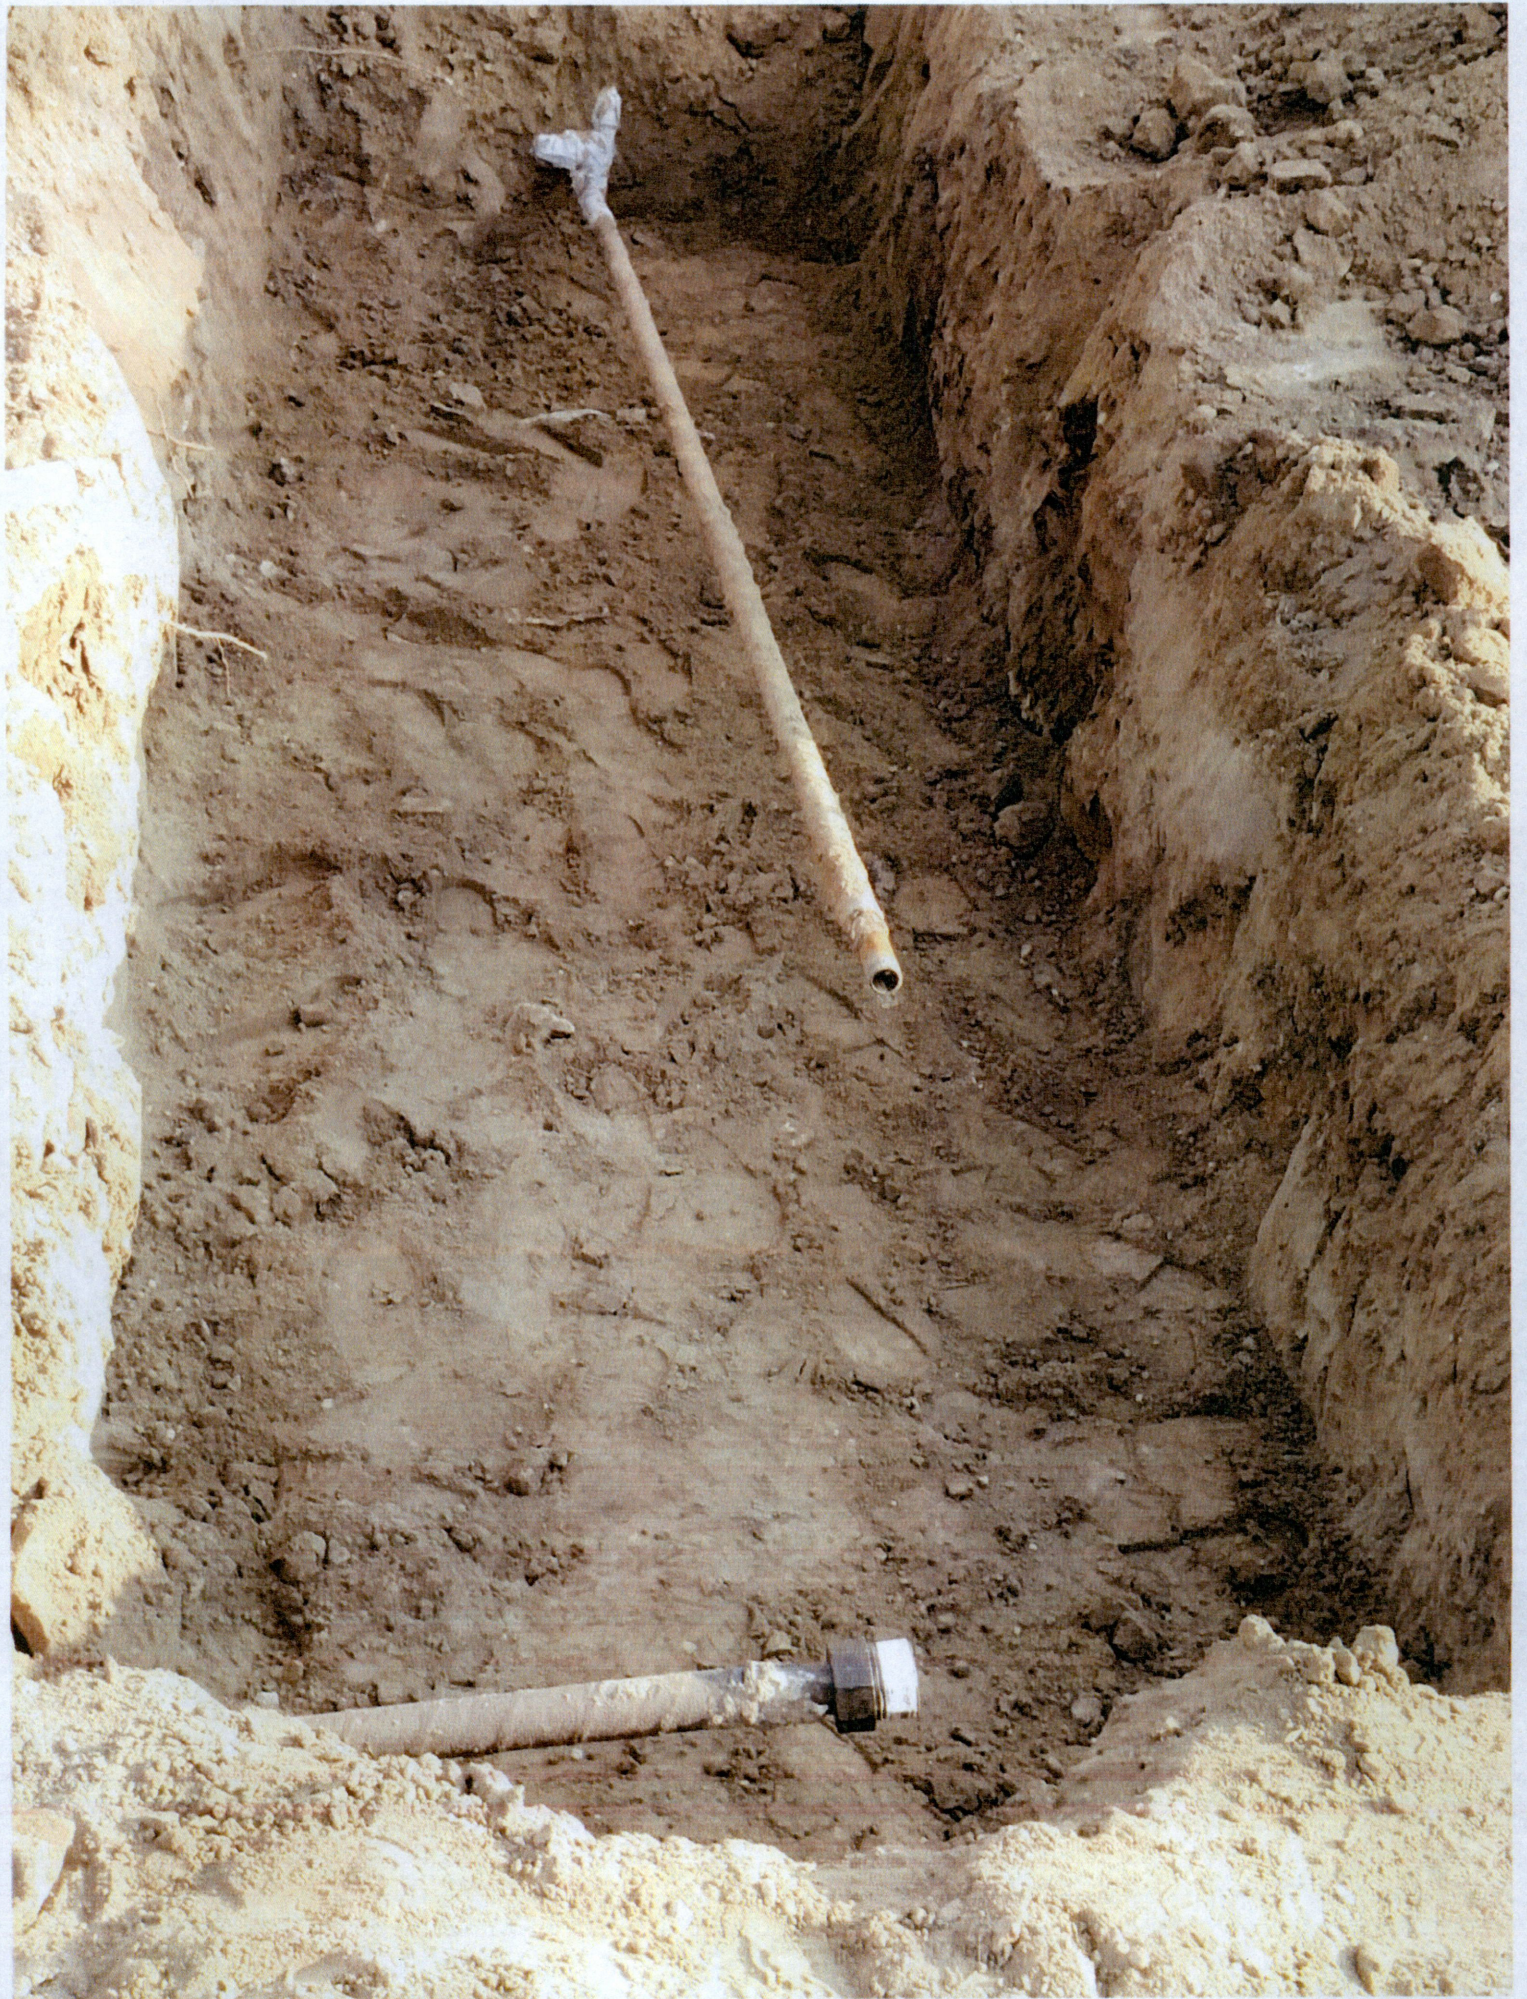
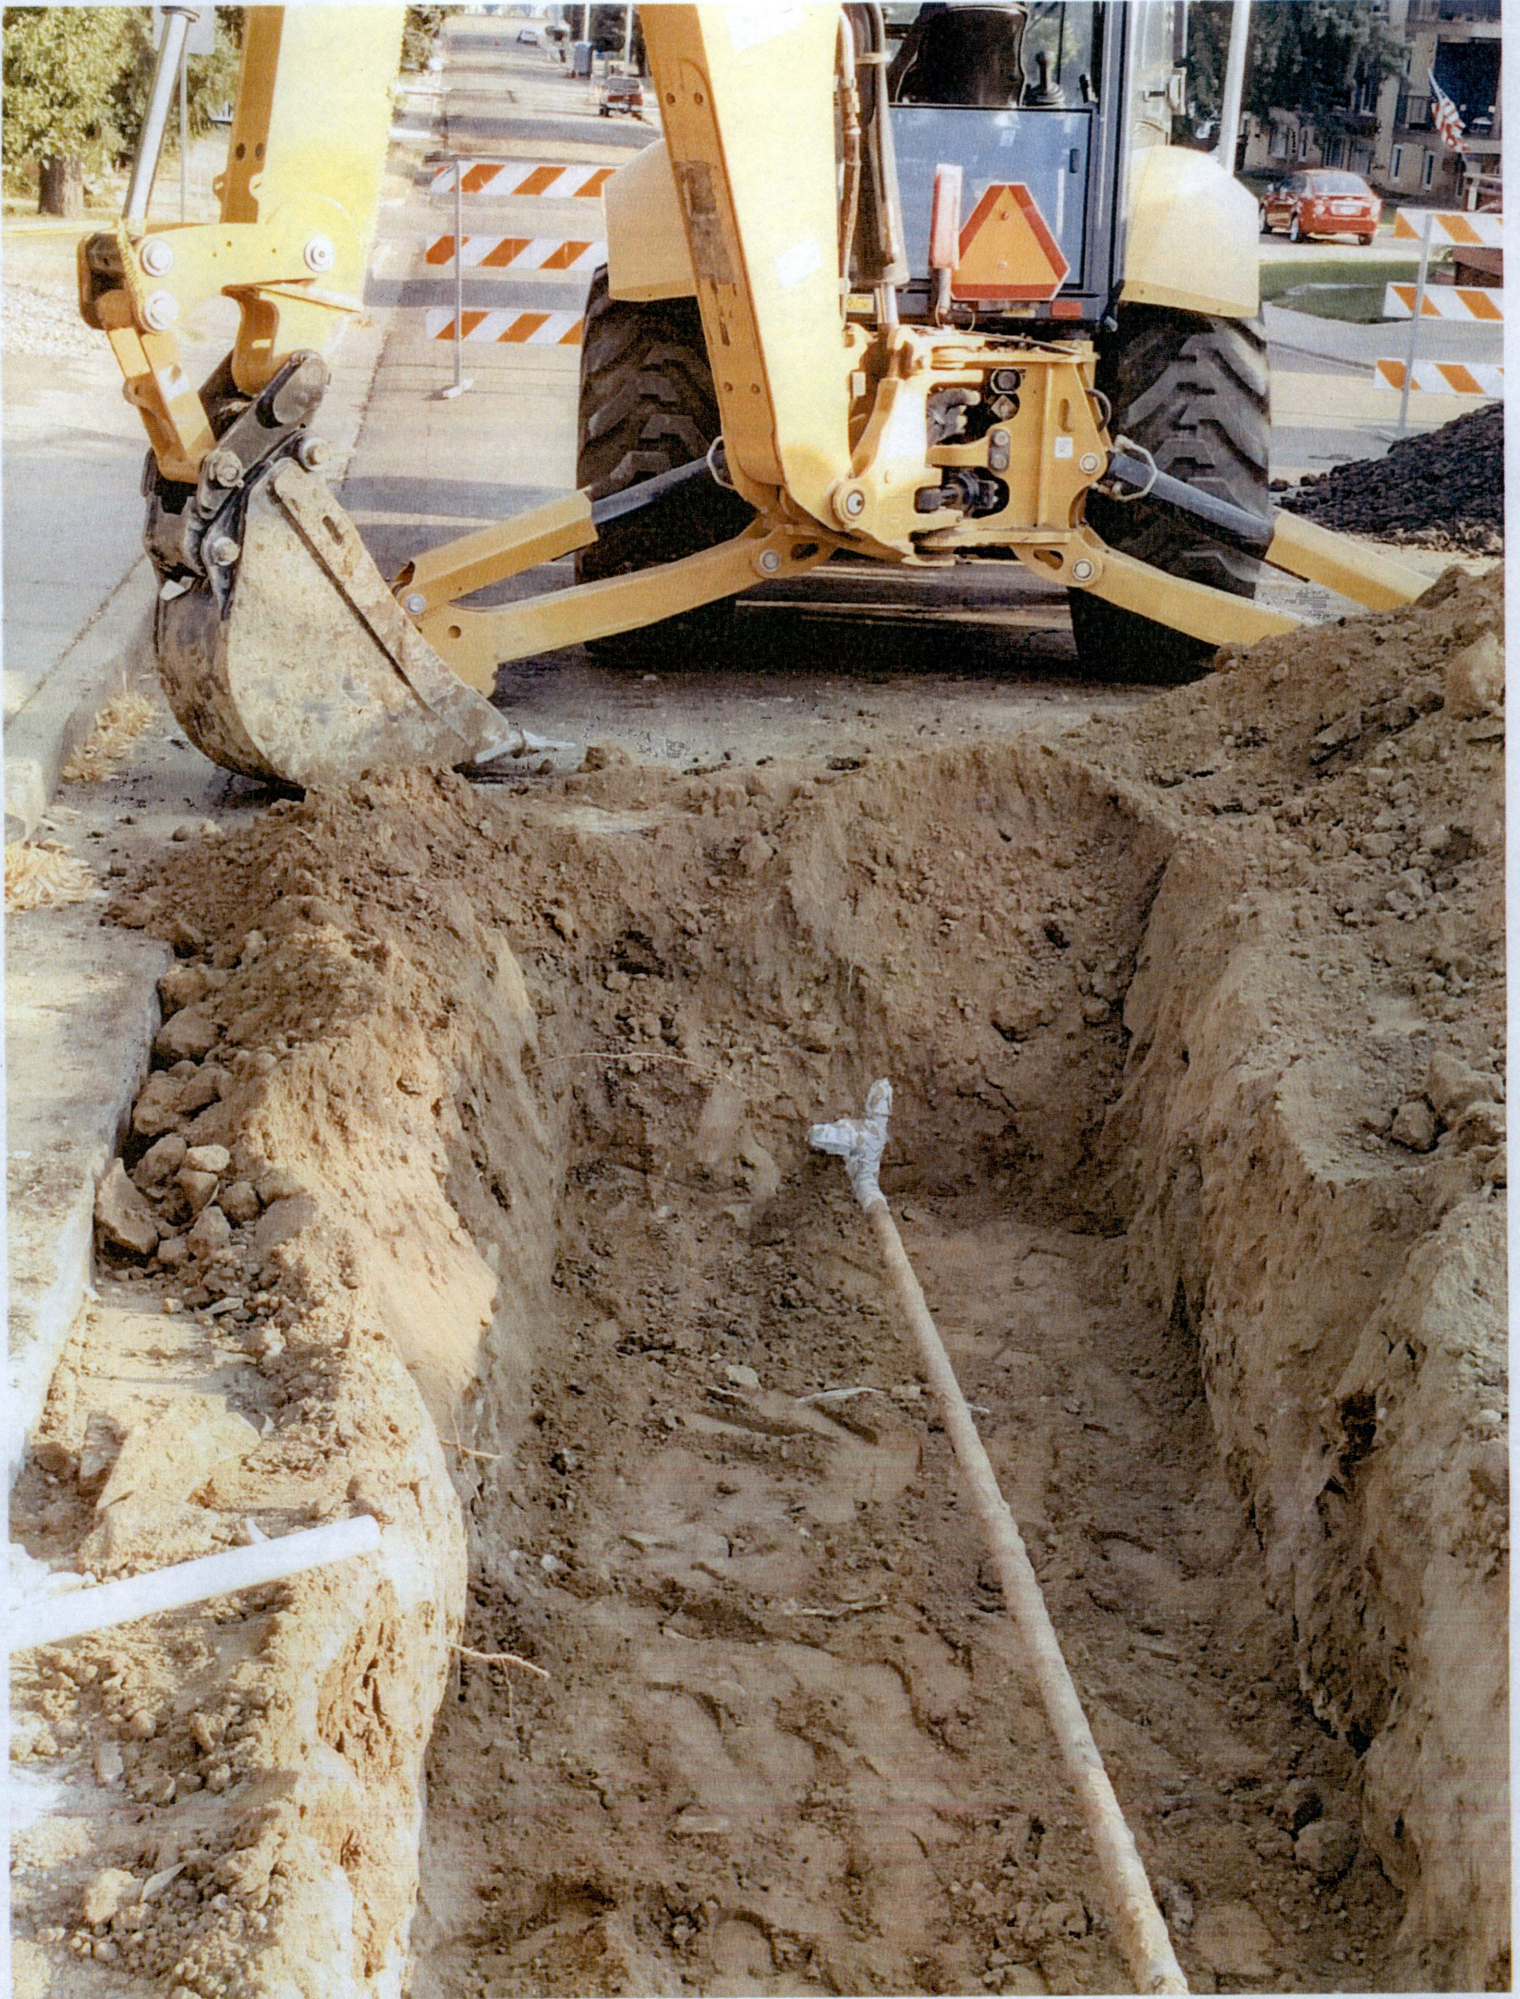
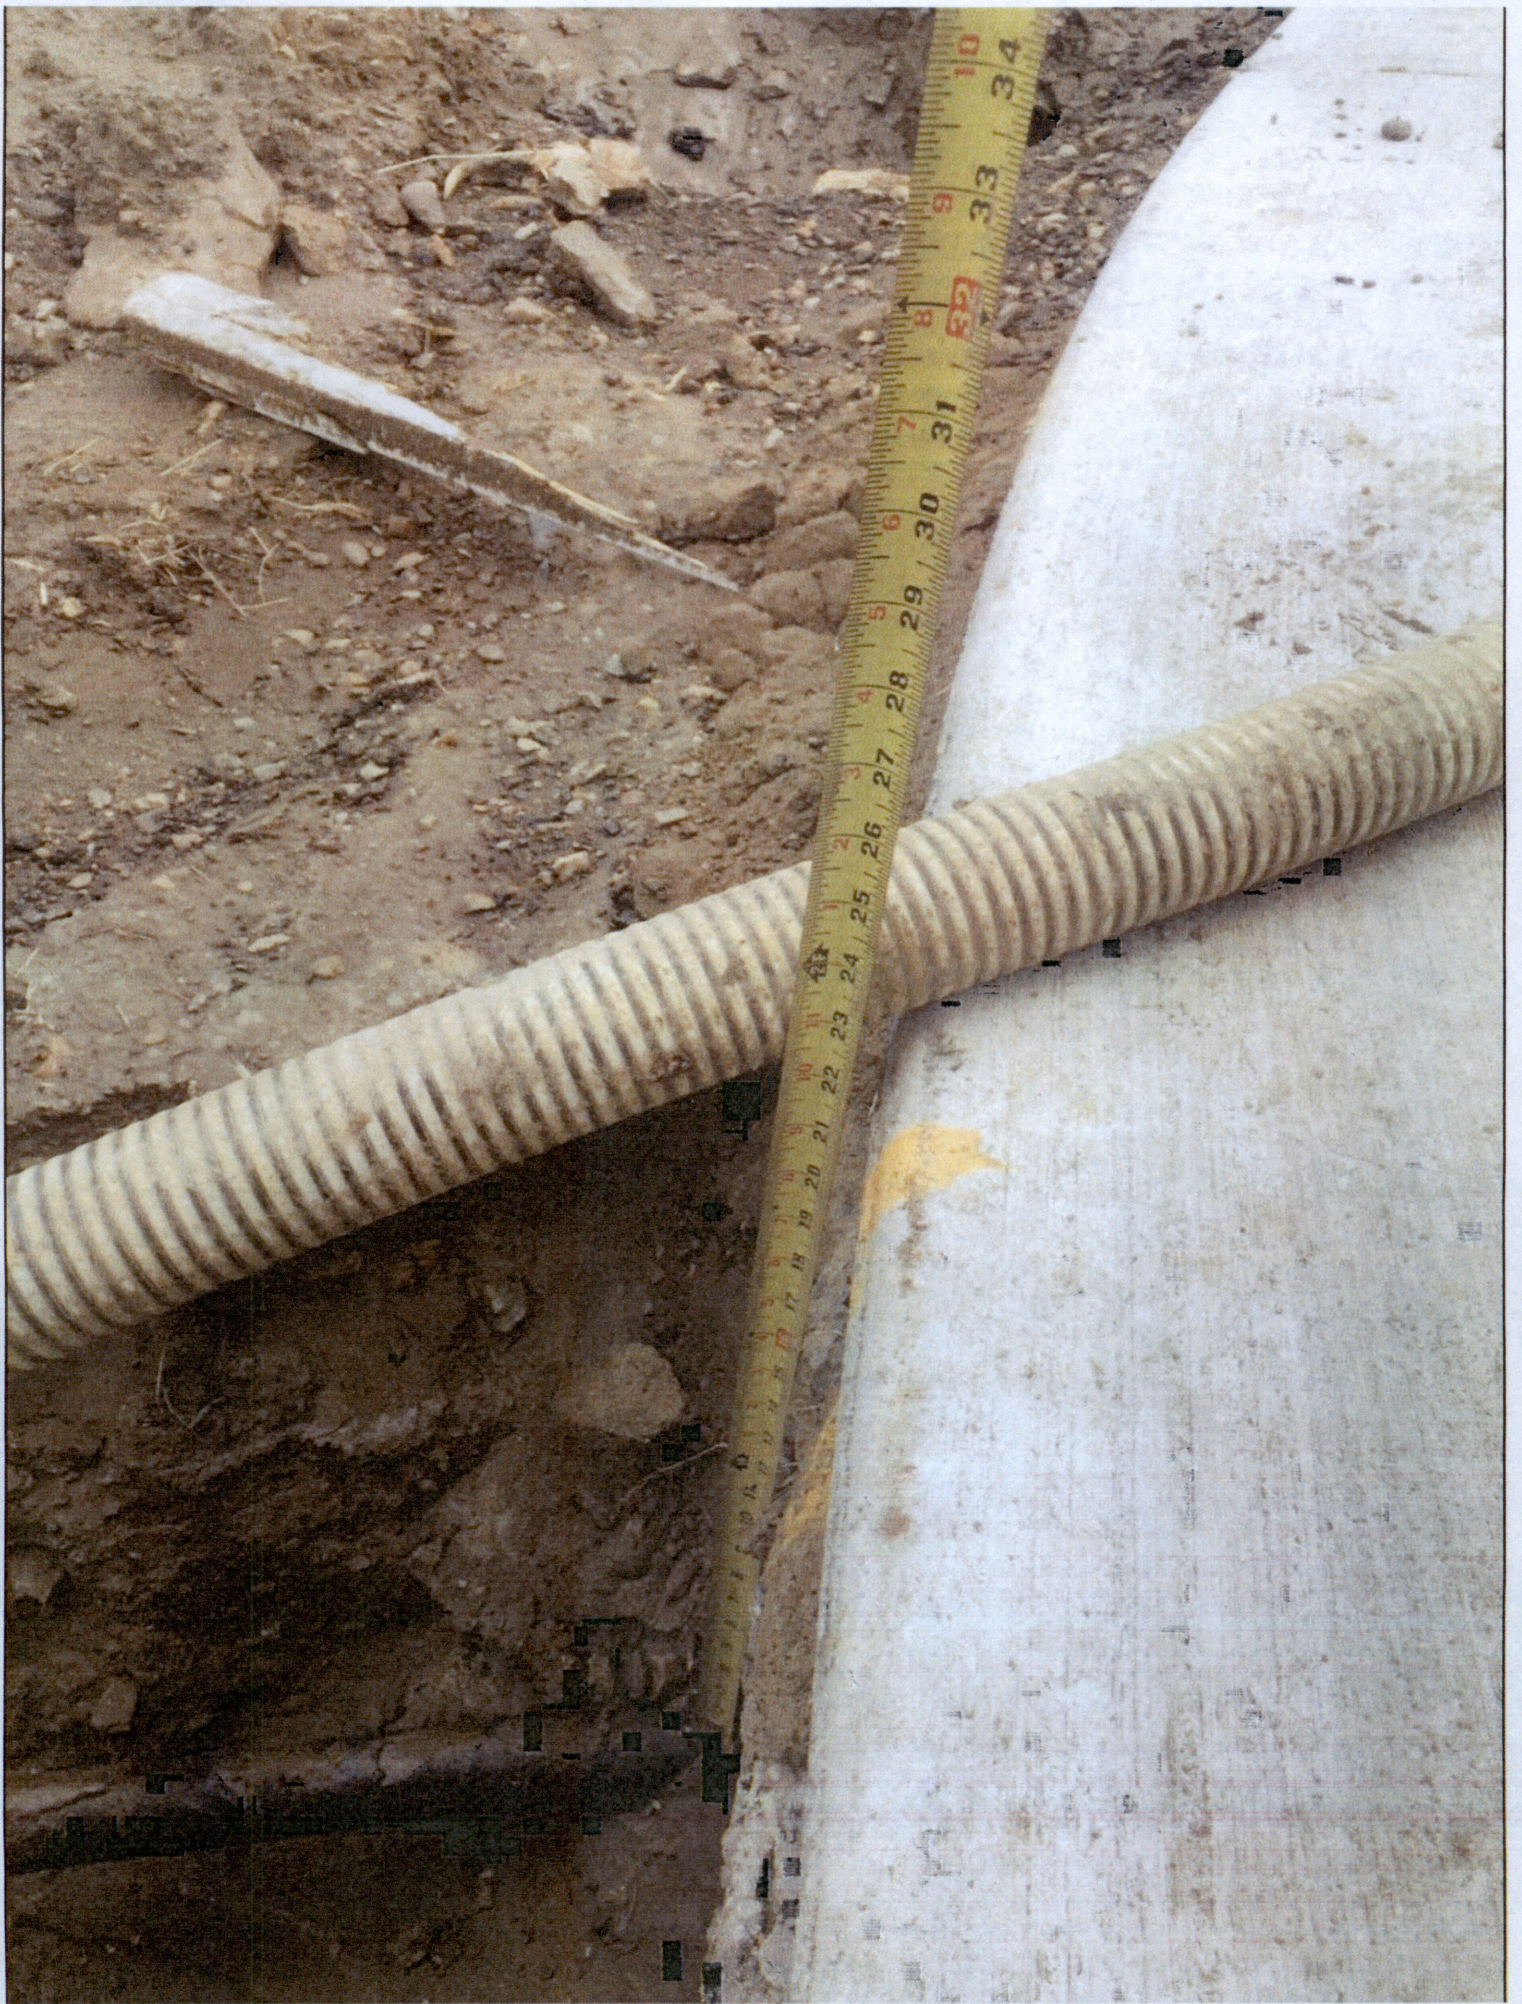
Northern Improvement was excavating (large trackhoe) asphalt in intersection and installing concrete handicap approaches on the corners at a depth of almost 2' without exposing steel gas distribution line. Fire and Police were on scene until MDU - Gas Crew could get gas shut down. Gas was clearly marked and exactly where gas was. There are supporting documents along with pictures to support claim. E.L.M. locating would also be able to provide pictures of the finished locate. There was no attempt to hand dig or hydrovac gas facility. Trackhoe pulled apart pipe at two 90's and distribution line had to be rerouted from under the new handicap approach because of the damage.

Description of Leak: excavator ripped apart 1.25 dresser 90
Method of Repair: Replaced portion of gas main
Date Repaired: 8/1/2017 S.O. #: MDUG-20170731-23908 Date of follow up (if required): _____
If a DOT Reportable Leak: _____ Date and Time of Telephone report: _____
To whom was leak reported: _____
