Initial Topsoil Inspection

To: Adam Renfandt, CFA
From: Matt Retka, Wenck Associates, Inc.
Date: May 24, 2019
Subject: PU-18-399, Demicks Lake Pipeline Initial Topsoil Inspection

PU-18-399 CONSTRUCTION INSPECTION

Initial Topsoil Removal Photographs

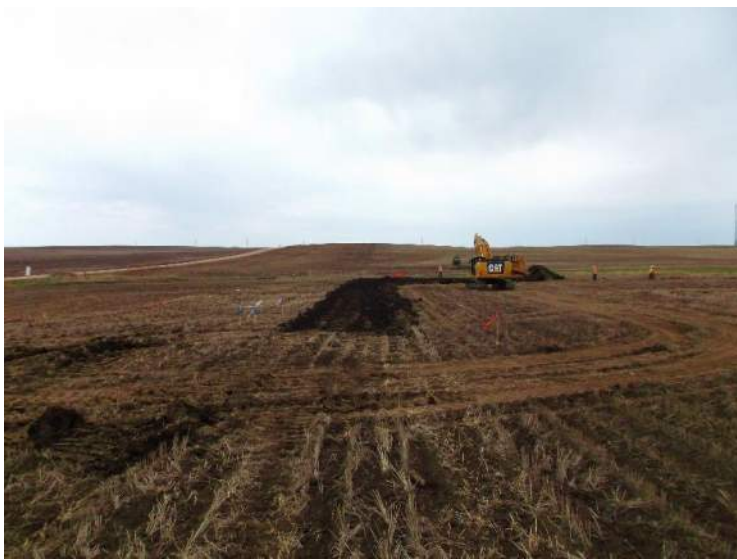
Observation Point: 1

Photo Description: Start of topsoil stripping on ROW by Jomax contractors on Station 12+00 of Spread 1.

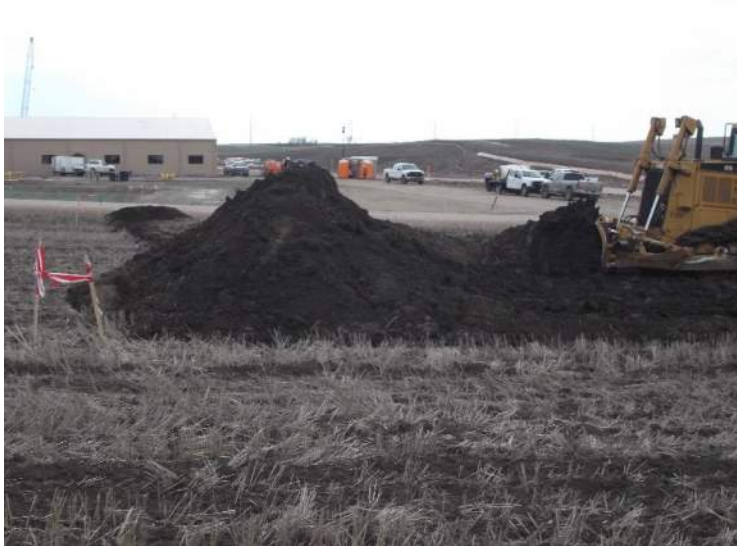
Observation Point: 2

Photo Description: Topsoil stockpile creation at Station 10+00 Spread 1.

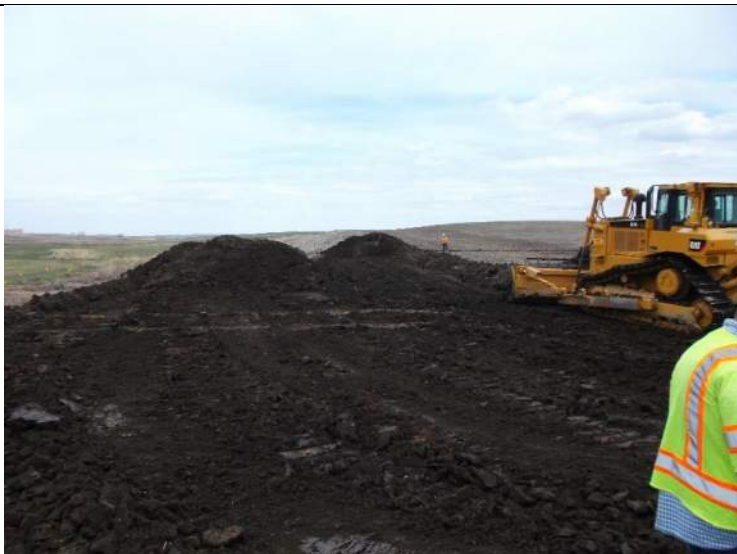
Observation Point: 3

Photo Description: Station 12+00 of Spread 1. Topsoil stockpile and spotter in background ensuring topsoil remains within ROW.

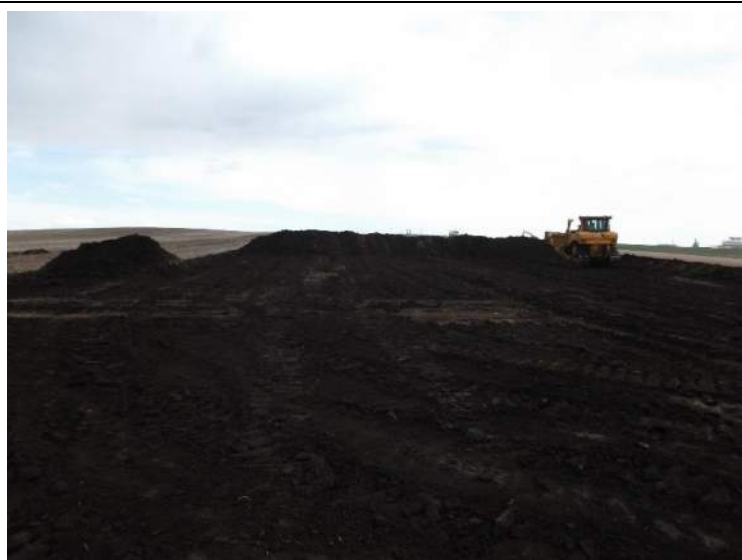
Observation Point: 4a

Photo Description: Station 10+00 Spread 1. Topsoil stripped width of ROW.

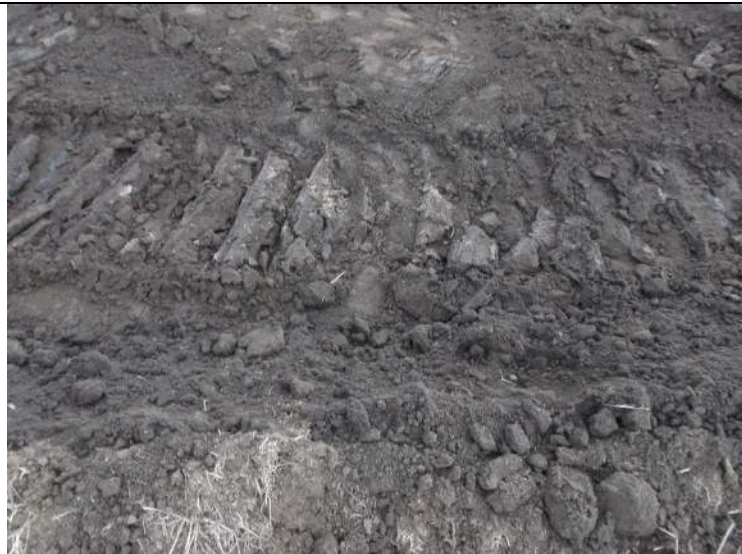
Observation Point: 4b

Photo Description: Westside of ROW. Topsoil stripped to subsoil. Topsoil depth at approximately 10 inches.

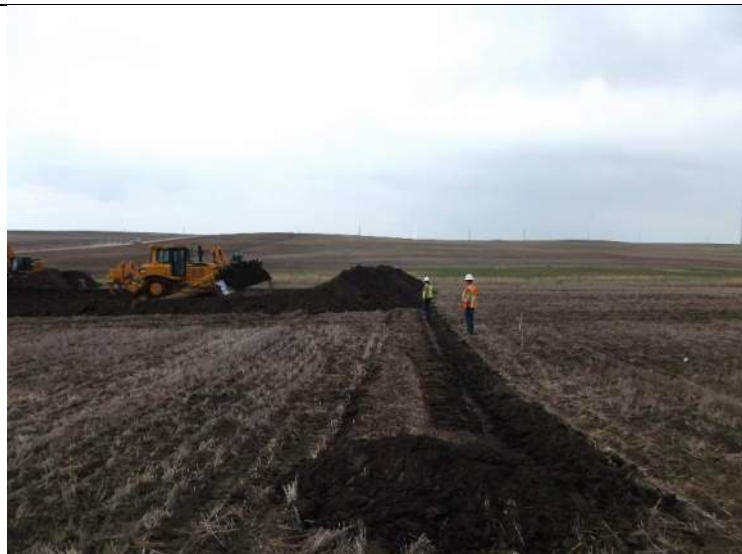
Observation Point: 5

Photo Description: Station 12+00 Spread 1. Topsoil stockpile line. Spotter ensuring ROW containment of topsoil.

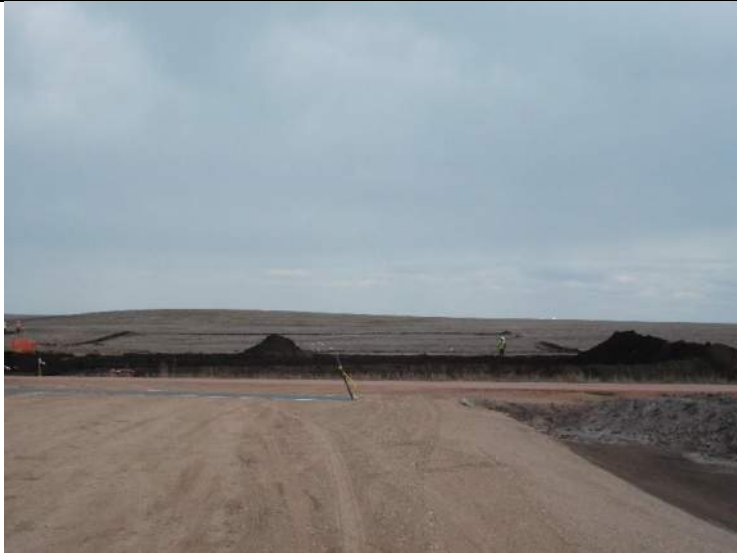
Observation Point: 6

Photo Description: Station 10+00 Spread 1 as seen from Station 08+00. South of sectional road running West to East.

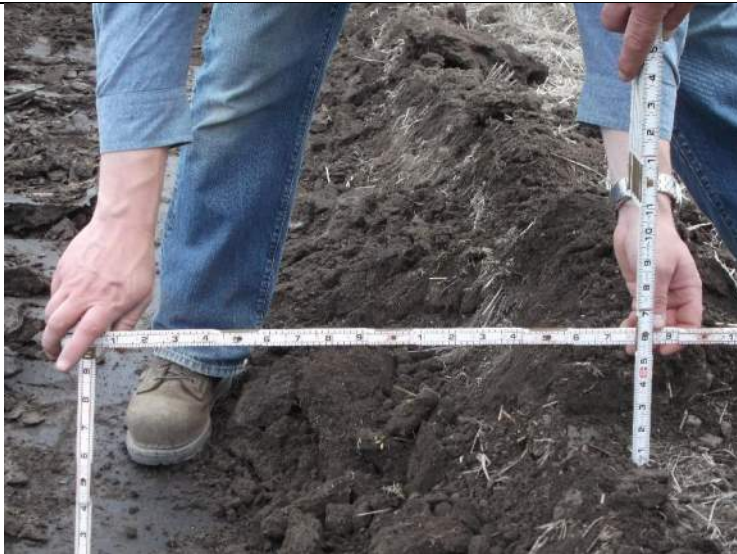
Observation Point: 7

Photo Description: After final cut of topsoil to subsoil (claypan). Field measurement shows approximately 7 inches to claypan at this location of Station 12+00 Spread 1.

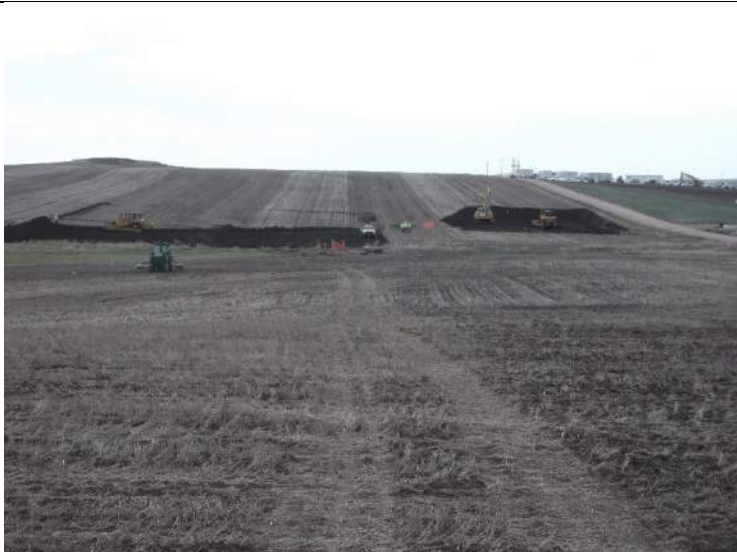
Observation Point: 8

Photo Description: West along ROW overlooking Stations 10+00 and 12+00 of Spread 1. East of Station 12+00 is the outline of Station 11+00.

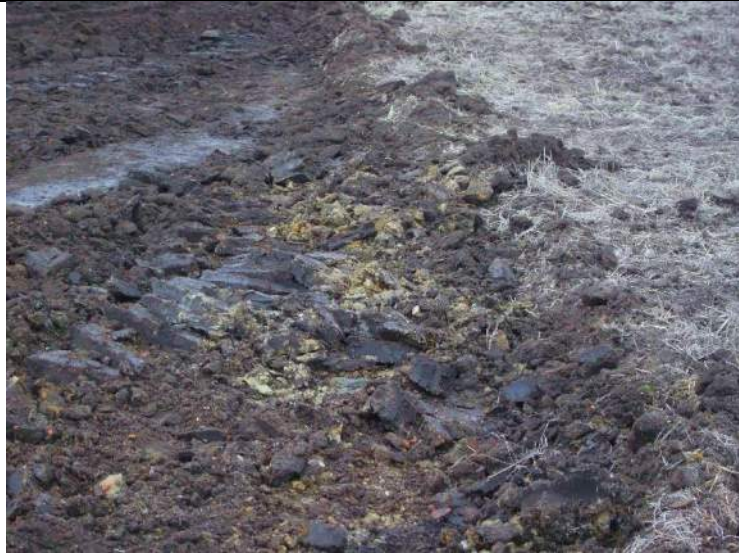
Observation Point: 9

Topsoil was stockpiled north and east of the Right of Way (ROW). Topsoil depth was in an approximate range of 7-12 inches to a subsoil clay pan or calcareous soil horizon. Portions of a potential buried quarter section road revealing scoria deposits was un-earthed at station 13+00. Topsoil stripping was terminated at that location. Observation of color changes during stripping unveiled a calcareous subsoil at Station 22+00. Topsoil stripping was terminated with very little subsoil deposited in the topsoil stockpile area at that location. Construction of a road approach was observed at station 10+00. Fill was obtained using subsoil from surrounding work area (see Attachment A and B).

Photo Description: Potential old road that has been exposed during topsoil stripping. Scoria and other road material were found along the quarter section line of the SE and SW quarters of S17, T151N, R96W. Topsoil stripping was terminated at that location.

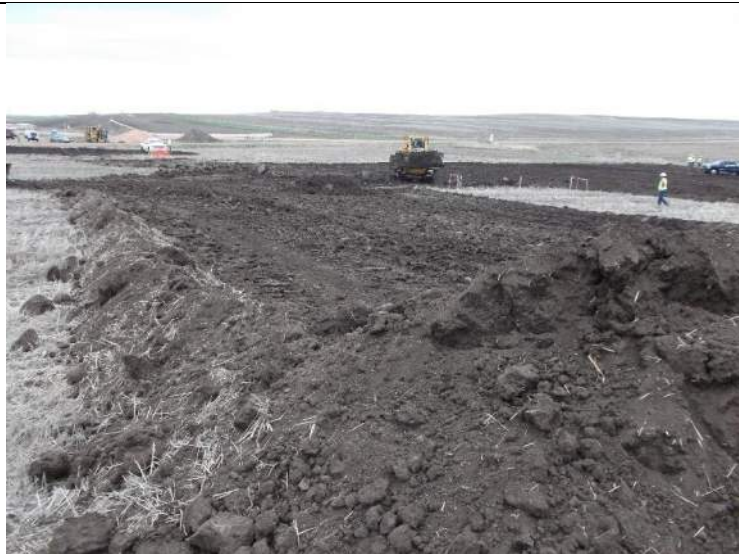
Observation Point: 10

Photo Description: Topsoil stripping and stockpile at Station 11+00 Spread 1.

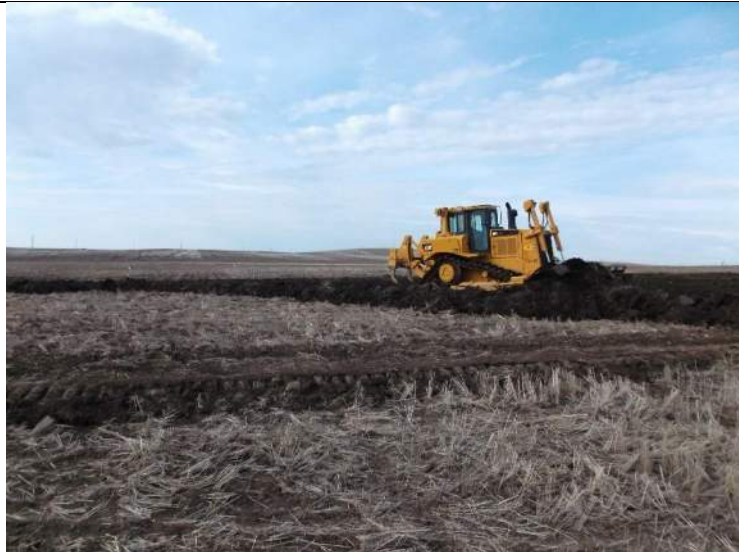
Observation Point: 11

Photo Description: Topsoil stripping by Jomax. Starting Station 16+00 Spread 1.

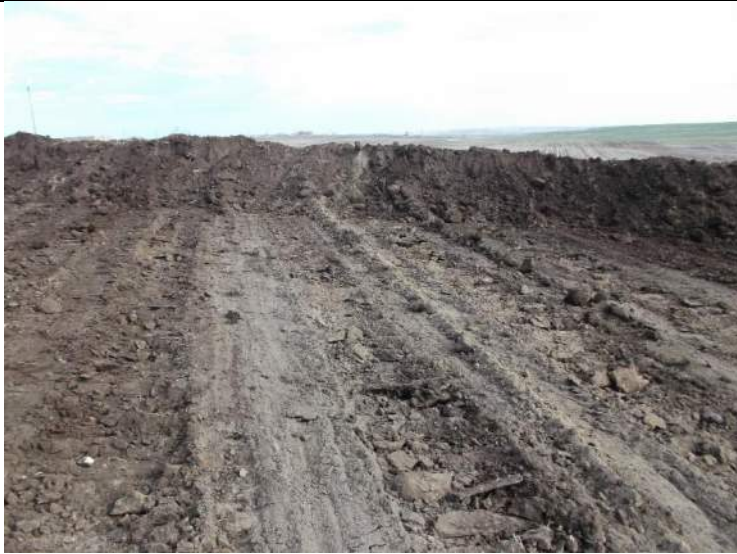
Observation Point: 12

Photo Description: Observation of color change of a calcareous subsoil. Stripping terminated at correct depth. Very small amount entered topsoil stockpile, as to be expected in some cases.
Station 18+00 Spread 1

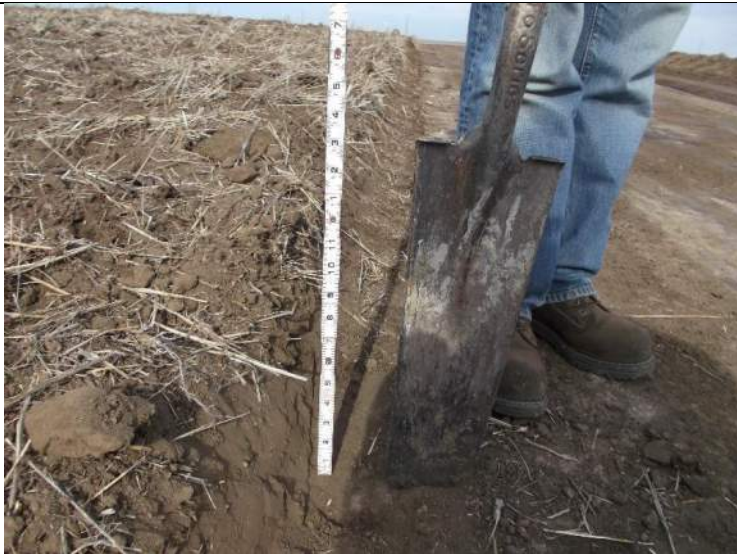
Observation Point: 13

Photo Description: Approximate topsoil stripped at shoulder slope of hill along southside of ROW. Cut by motor grader which resulted in very steep angle of ROW depression allowinf accurate measurement of stripping depth. Zahl/Cabb soil.
Station 22+00 Spread 1.

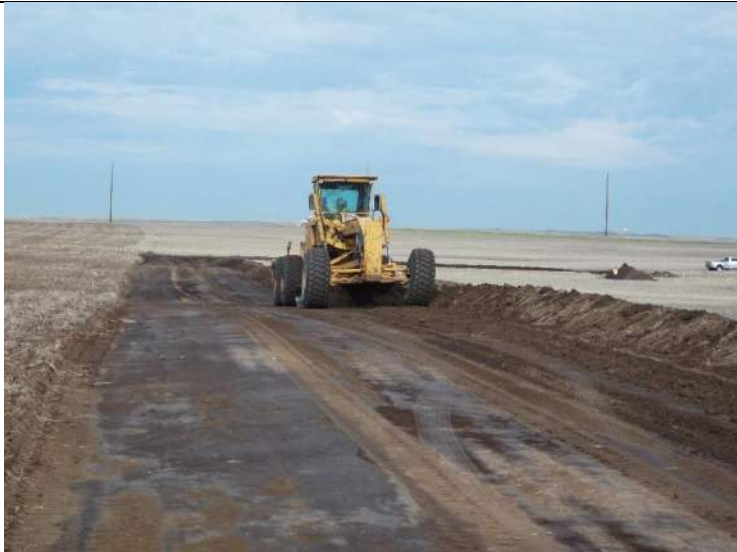
Observation Point: 14

Photo Description: Motor grader at work smoothing subsoil/topsoil transition along ROW.
Station 28+00 Spread 1.

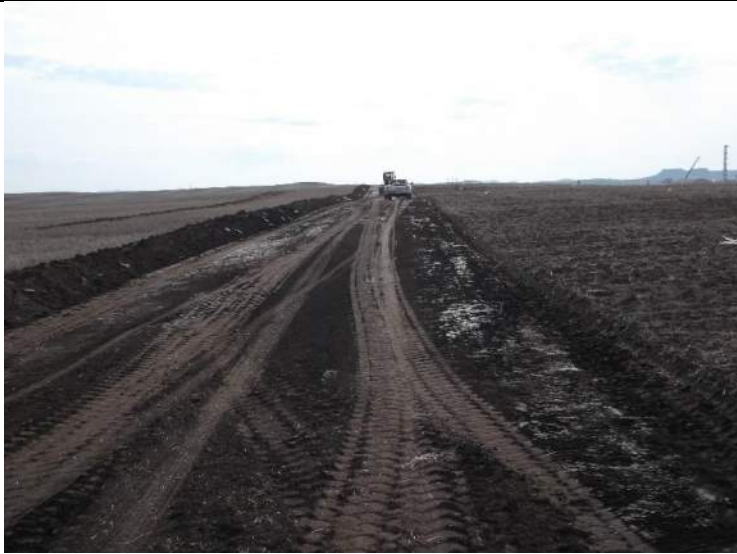
Observation Point: 15

Photo Description: Motor grader initial stripping of ROW. From Station 30+00 Spread 1.

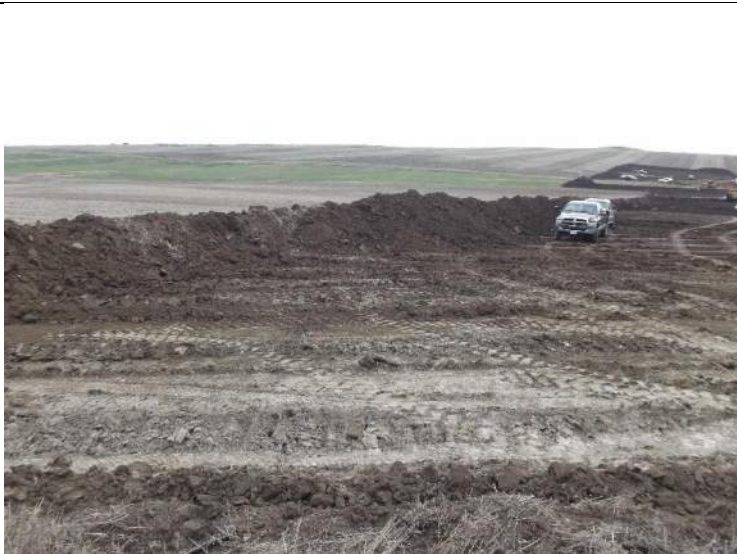
Observation Point: 16

Photo Description: Topsoil stockpile and ROW. Station 18+00 Spread 1. Topsoil mostly stripped awaiting motor grader.

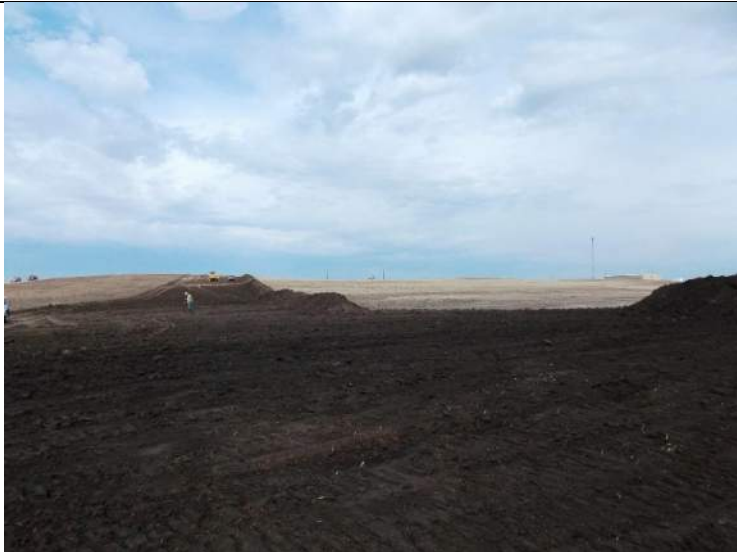
Observation Point: 17

Photo Description: Topsoil stripped at Station 16+00 Spread 1. Awaiting motor grader finishing.

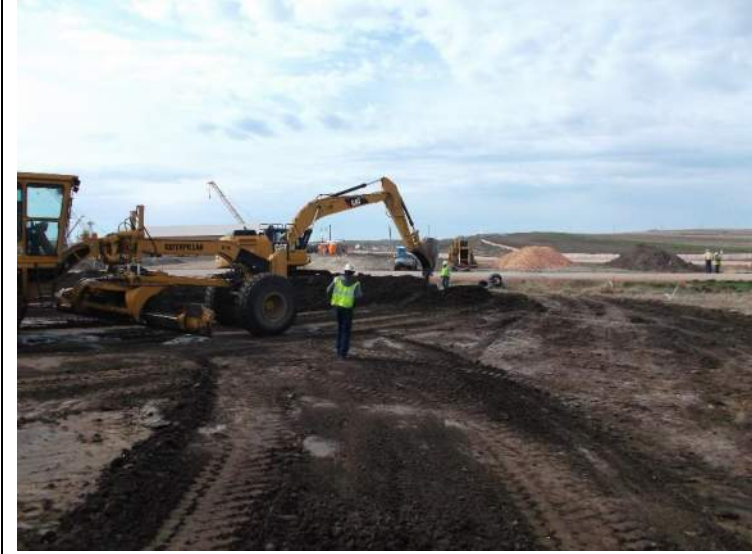
Observation Point: 18

Photo Description: Creation of road approach for Station 10+00 Spread 1. Motor grader pushing subsoil. Backhoe placing subsoil over culvert.
