Demicks Lake NGL Pipeline Project Topsoil Inspection Report PU-18-399

Prepared for:
**North Dakota
Public Service Commission**

WENCK Associates, Inc.
301 1st Street NE, Suite 202
Mandan, ND 58554
Phone: 701-751-3370
Fax: 763-479-4242

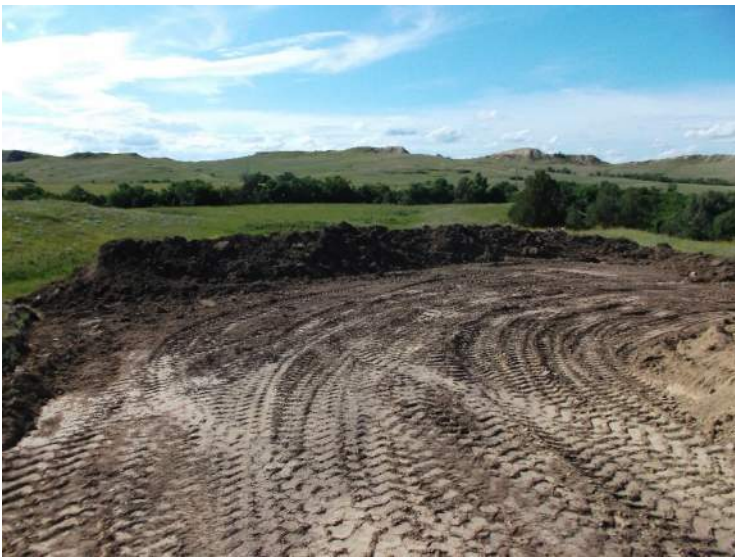
Observation Point: 101a

Photo Description: Topsoil stockpile segregated from subsoil stockpile.

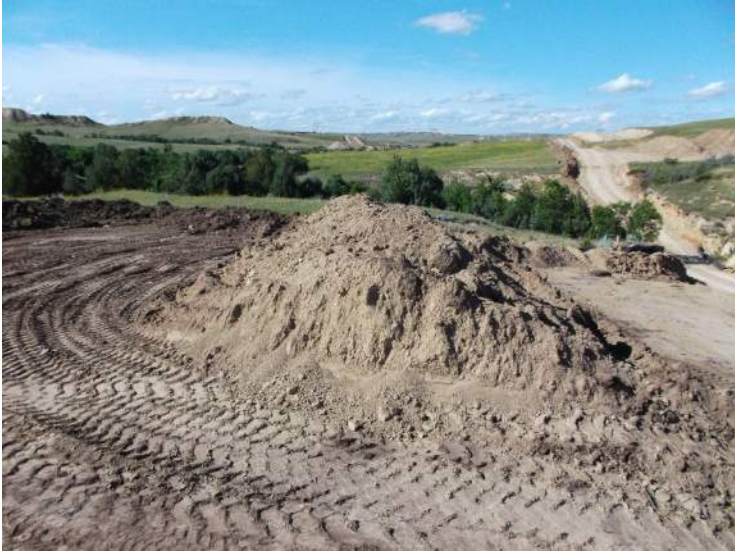
Observation Point: 101b

Photo Description: Subsoil stockpile generated from necessary grading along workspace within ROW.

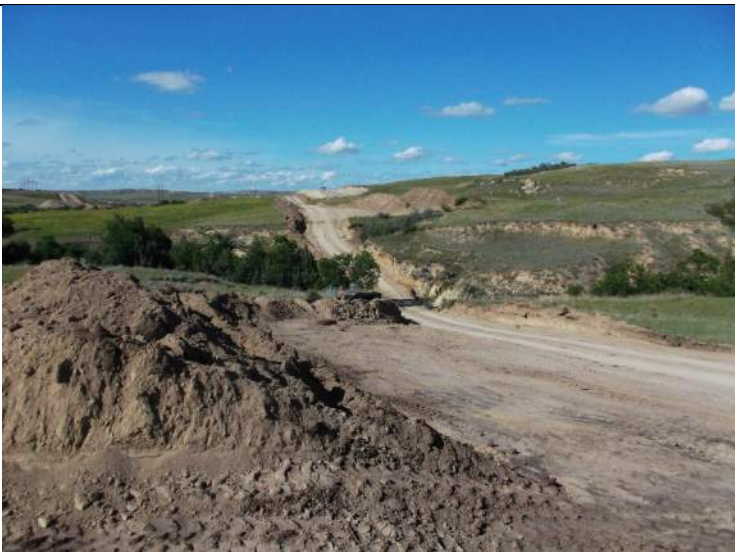
Observation Point: 101c

Photo Description: View of ROW which crosses stream S-13 and proposed for open-cut.

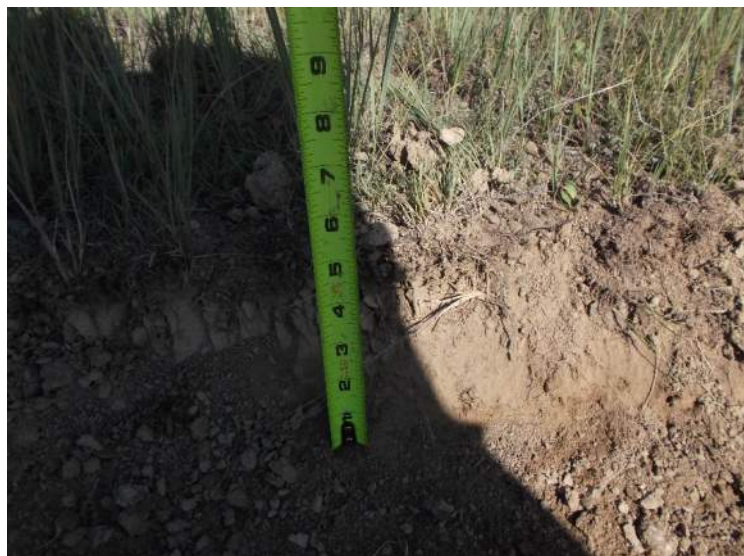
Observation Point: 102

Photo Description: Naturally calcareous topsoil at hill summit. Approximately 4-5 inches stripped.

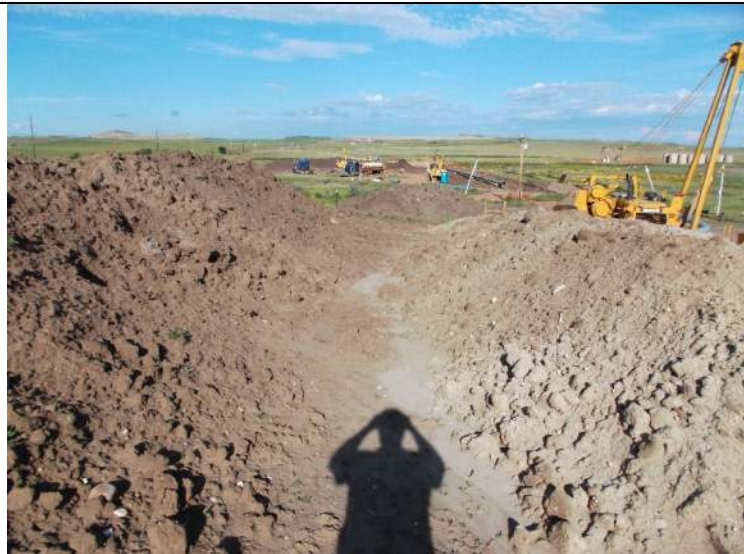
Observation Point: 103

Photo Description: Topsoil and subsoil stockpiles segregated properly.

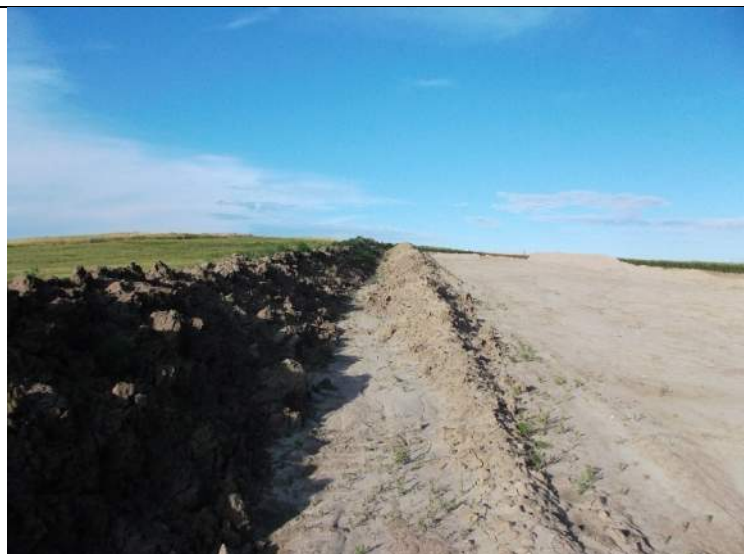
Observation Point: 110

Photo Description: Topsoil and subsoil segregated properly.

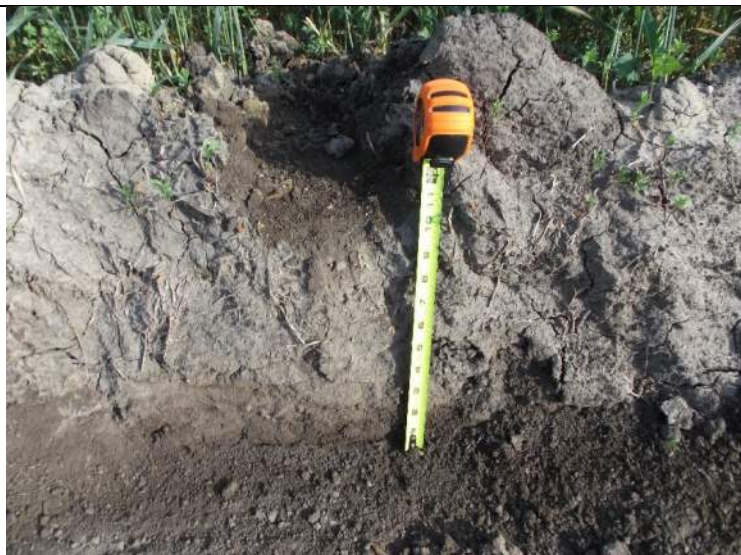
**Observation Point: 113**

Photo Description: Approximately 9-10 inches of topsoil stripped from backslope.

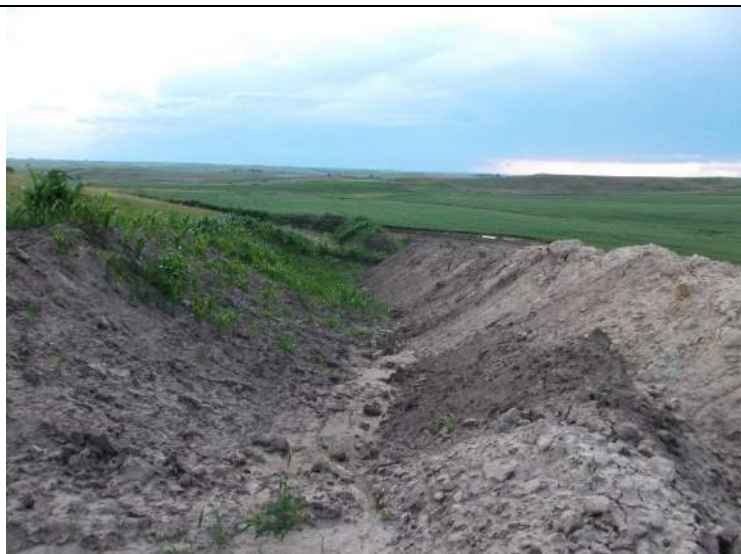
**Observation Point: 115**

Photo Description: Topsoil and subsoil stockpiles segregated correctly.

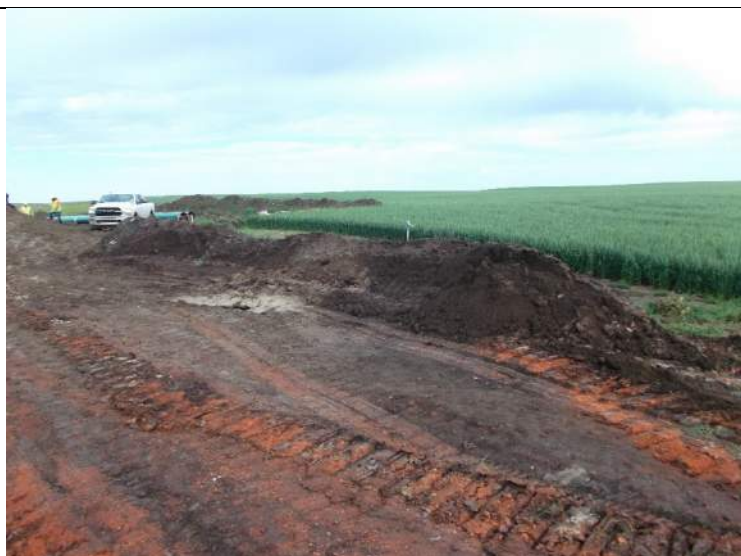
**Observation Point: 117a**

Photo Description: Topsoil stockpile. Row stripped correctly to color change and scoria deposit.

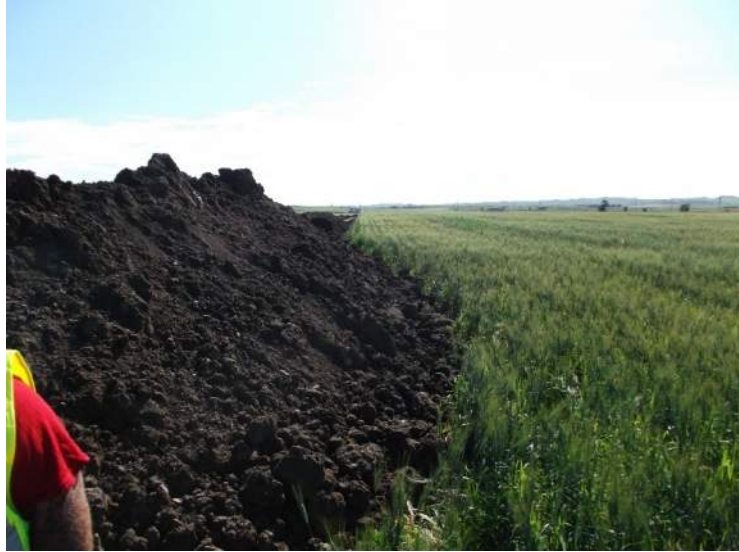
**Observation Point: 124**

Photo Description: Subsoil spilled on crop within ROW boundary. Brought to the attention of Alen Kitchens, QCS Assistant Chief Inspector. Discussed that crop would work as a barrier to limit topsoil and subsoil mixing. Backhoe will gather subsoil only on top of crop vegetation to minimize mixing with in-situ topsoil during replacement.

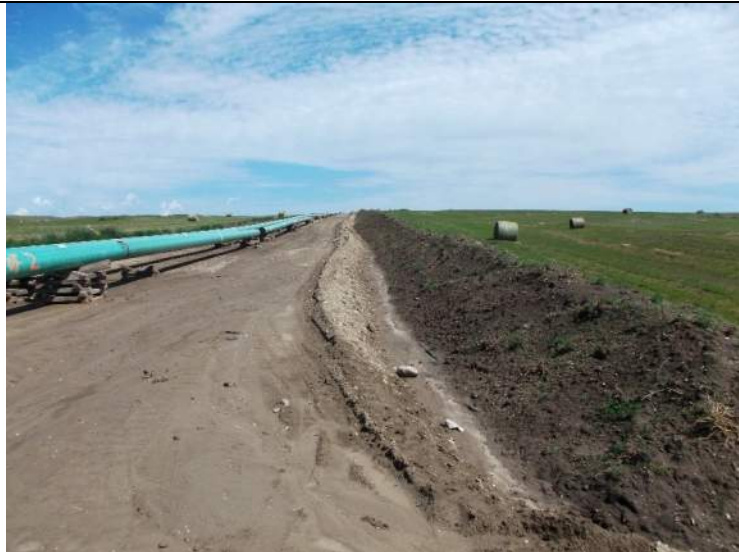
**Observation Point: 129**

Photo Description: Topsoil and subsoil properly segregated.

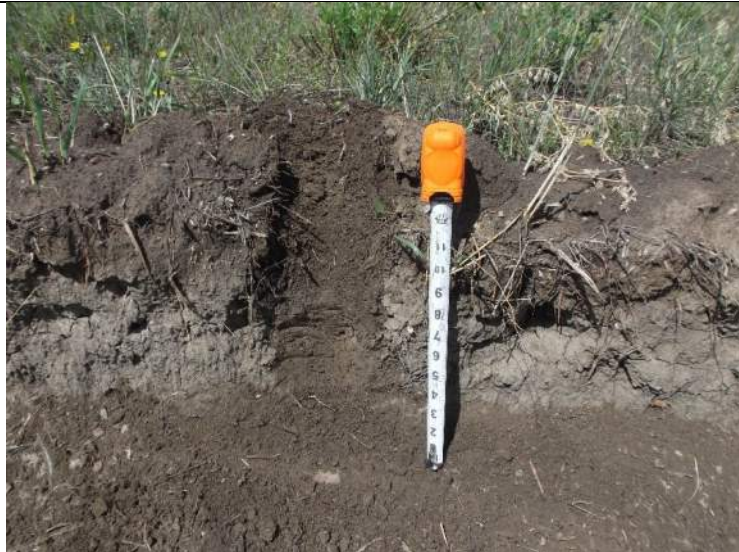
**Observation Point: 130**

Photo Description: Approximately 8 inches of topsoil stripped from backslope correctly. Soil profile revealed no effervescence. ROW surface revealed moderate effervescence.

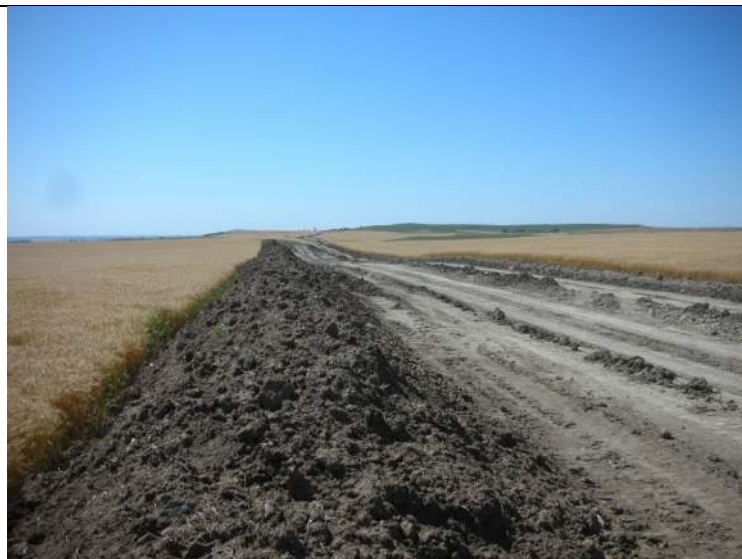
**Observation Point: 2761sw**

Photo Description: Overlooking buried trench and appropriately stockpiled topsoil.

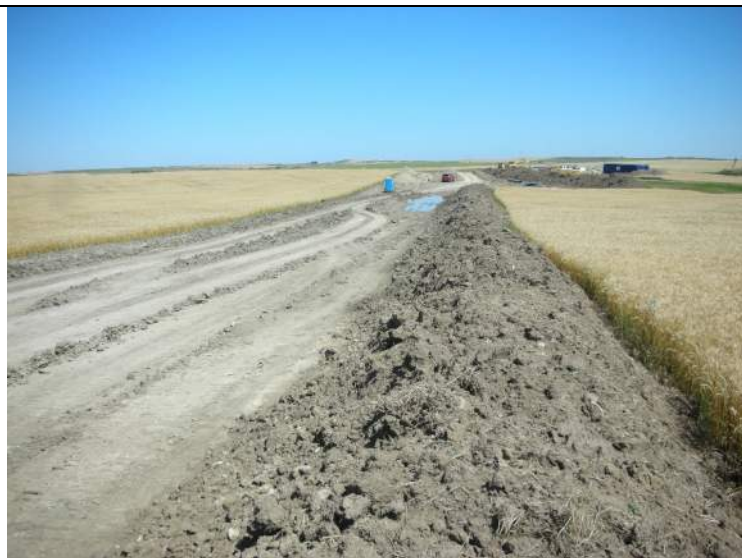
**Observation Point: 2762ne**

Photo Description: Overlooking buried trench and appropriately stockpiled topsoil.

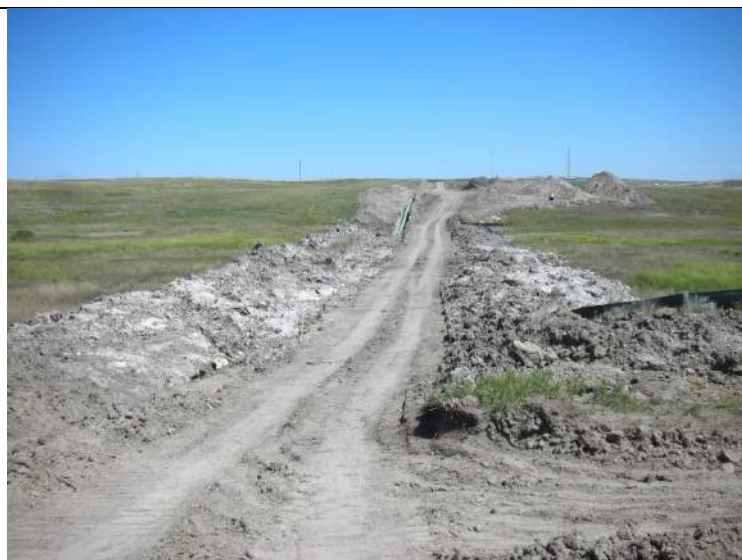
**Observation Point: 2765e**

Photo Description: Open cut through saline wetland. Discussed potential lack of topsoil and subsoil segregation during trenching with Mr. Kitchens.

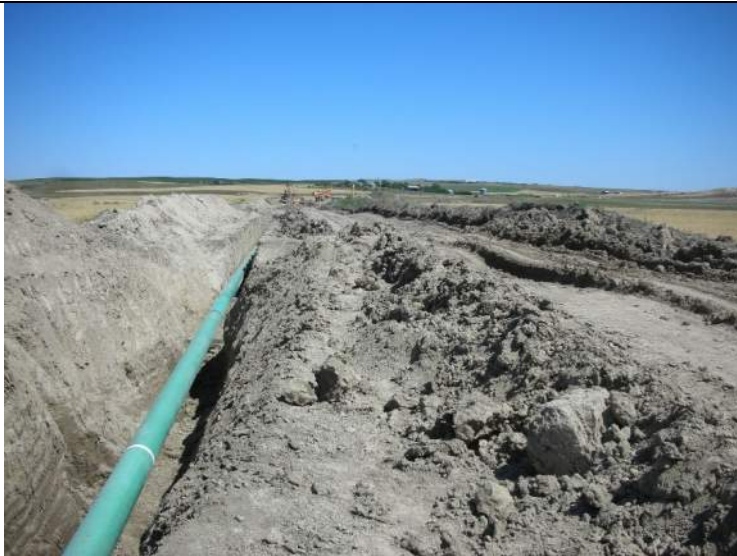
**Observation Point: 2767e**

Photo Description: Overlooking trench and appropriately segregated topsoil and subsoil stockpiles.

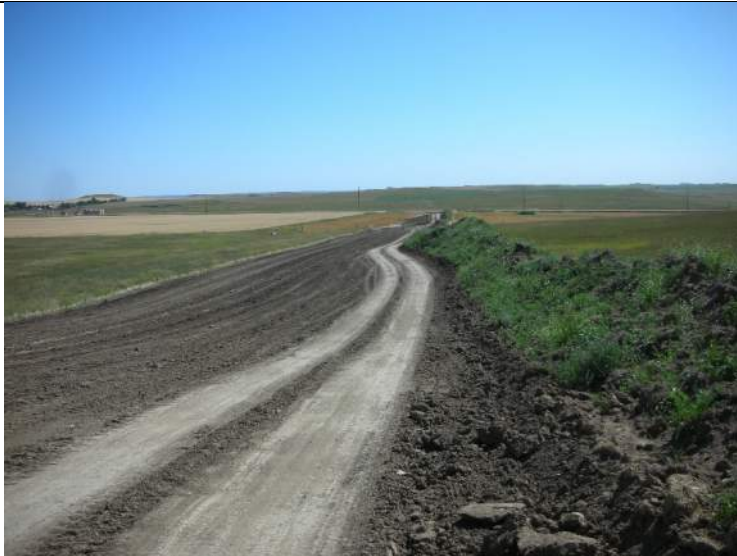
**Observation Point: 2778s**

Photo Description: Overlooking trench and backfilled ROW. Awaiting topsoil redistribution by H2.

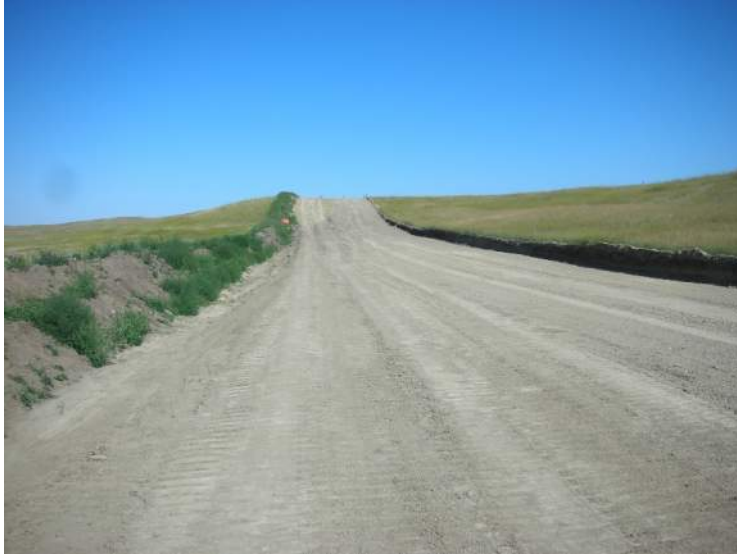
Observation Point: 2780e

Photo Description: Appropriate topsoil segregation and trench backfill.
