# Demicks Lake NGL Pipeline Project Construction Inspection Report PU-18-399

*Prepared for:*  
**North Dakota  
Public Service Commission**

**WENCK Associates, Inc.**  
301 1st Street NE, Suite 202  
Mandan, ND 58554  
Phone: 701-751-3370  
Fax: 763-479-4242

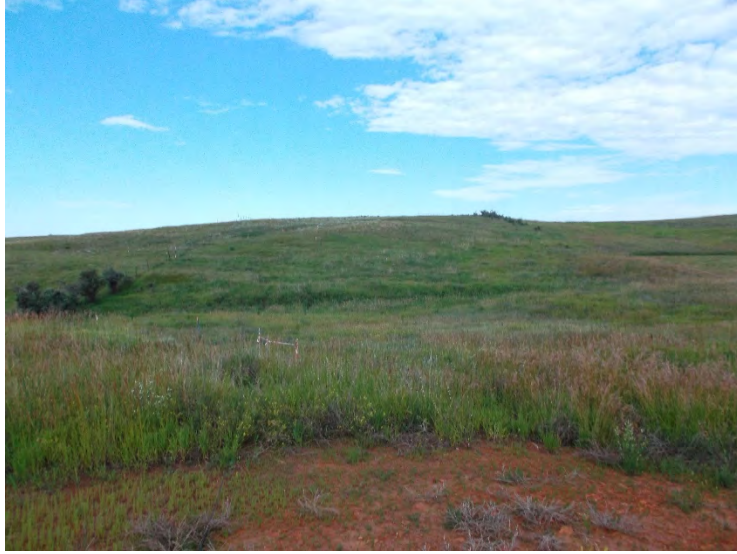
**Observation Point: 119**

from mining activities will also be bored under (**Appendix A, Observation Points 119-121**).

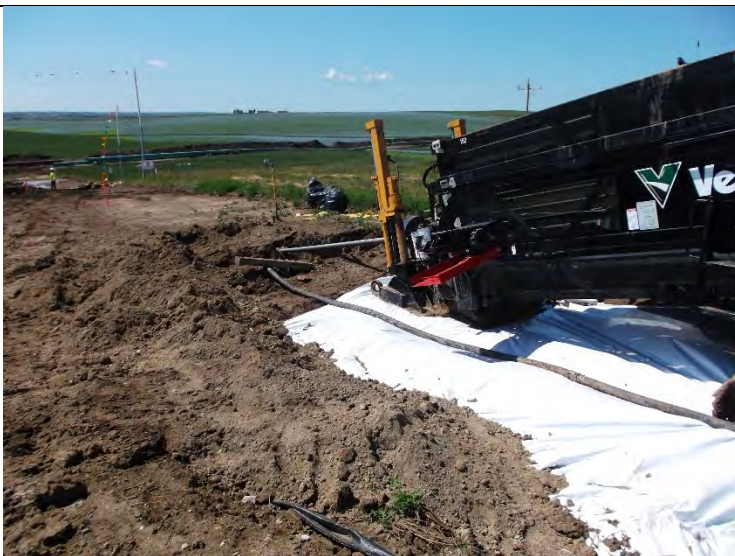
**Observation Point: 131**

Photo Description: Jomax crew boring under undeveloped sectional line. White mat placed to mitigate against potential machine fluid spills or leaks.

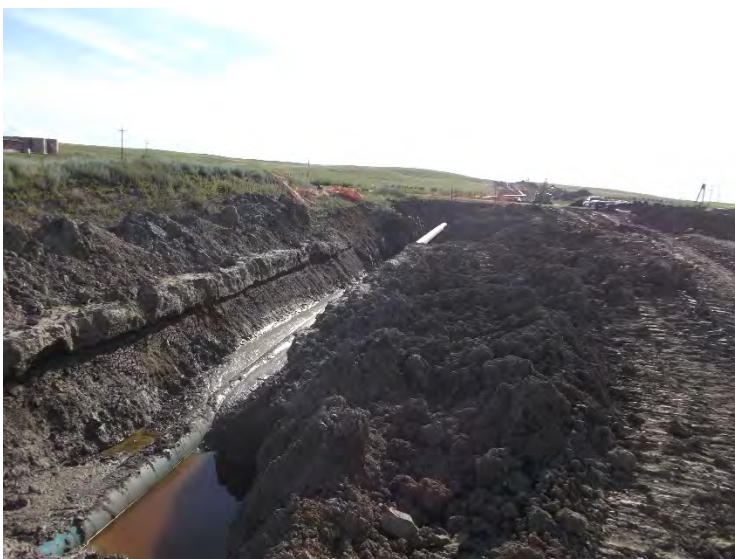
**Observation Point: 104**

Photo Description: Pipe bored under access road. Trench seemed to hazardous to conduct accurate measurement of pipe depth. Visual estimation of pipe depth was 48-inches or deeper.

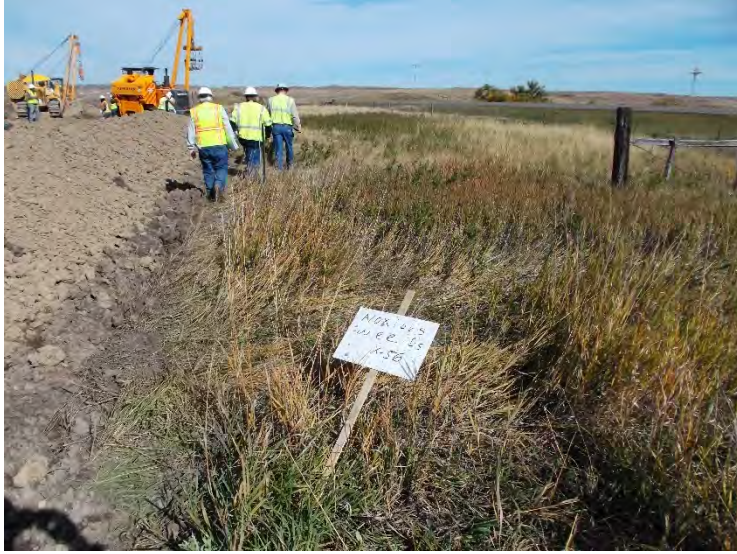
**Observation Point: 198**

On 8 October 2019, Mr. Hackley visited Spread 3 of the Project. Noxious weeds (X-56) was clearly marked adjacent to ROW (**Appendix A, Observation Point 198**). Pipe in trench measurements were appropriate or deeper than required. Trench wall profiles showed that topsoil had been stripped appropriately (**Appendix A, Observation Point 199**). Jomax contractors were observed installing pipe into trenches. Pipe was also observed strung and awaiting trench to be dug for installation (**Appendix A, Observation Point 200 and 205**). A potentially geologically unstable area located at Milepost 56.4 slated for HDD was observed. Guideline stakes were present marking the proposed path of the HDD, which had not been completed at the time of the inspection (**Appendix A, Observation Point 204**).
