Demicks Lake NGL Pipeline Project Construction Inspection Report PU-18-399

Prepared for:
**North Dakota
Public Service Commission**

WENCK Associates, Inc.
301 1st Street NE, Suite 202
Mandan, ND 58554
Phone: 701-751-3370
Fax: 763-479-4242

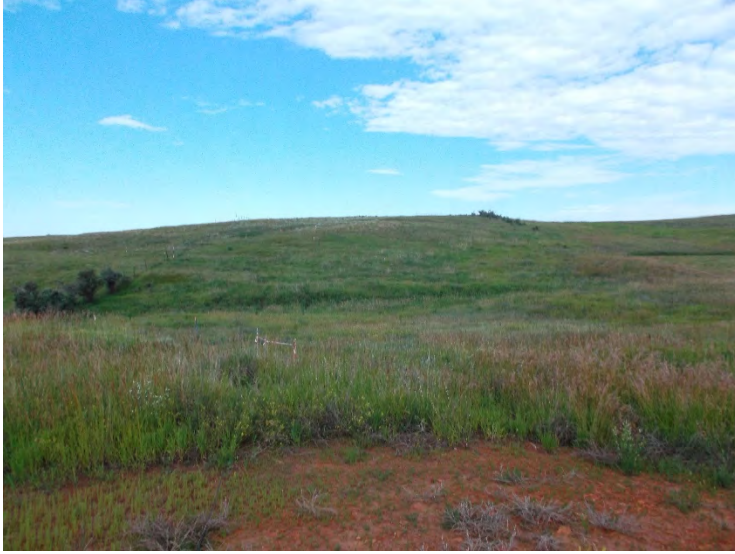
Observation Point: 119

from mining activities will also be bored under (**Appendix A, Observation Points 119-121**).

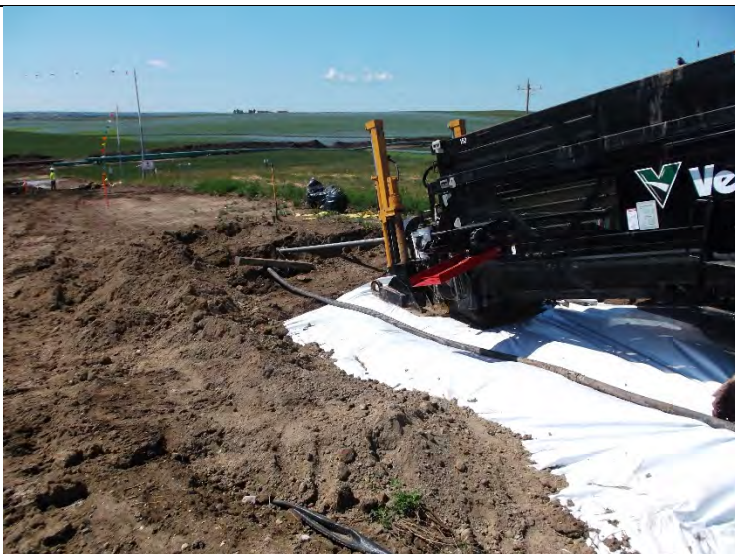
Observation Point: 131

Photo Description: Jomax crew boring under undeveloped sectional line. White mat placed to mitigate against potential machine fluid spills or leaks.

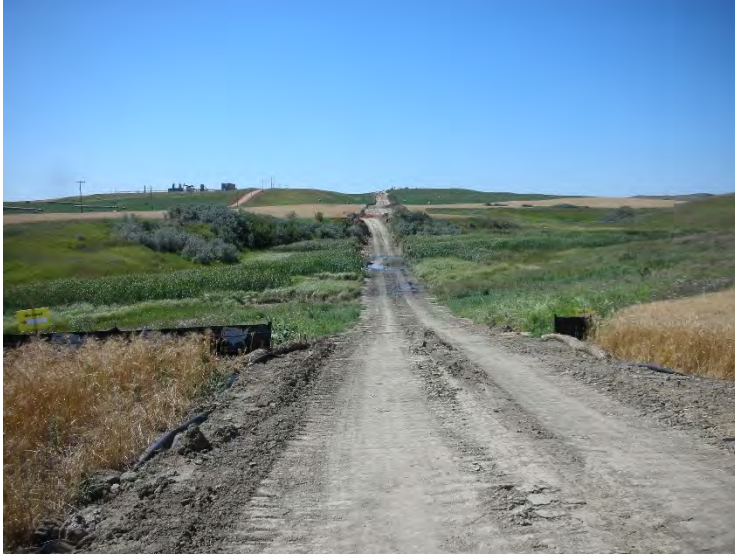
Observation Point: 2770w

Photo Description: Overlooking wetland (W-25). Silt fences installed. HDD used under wetland feature.

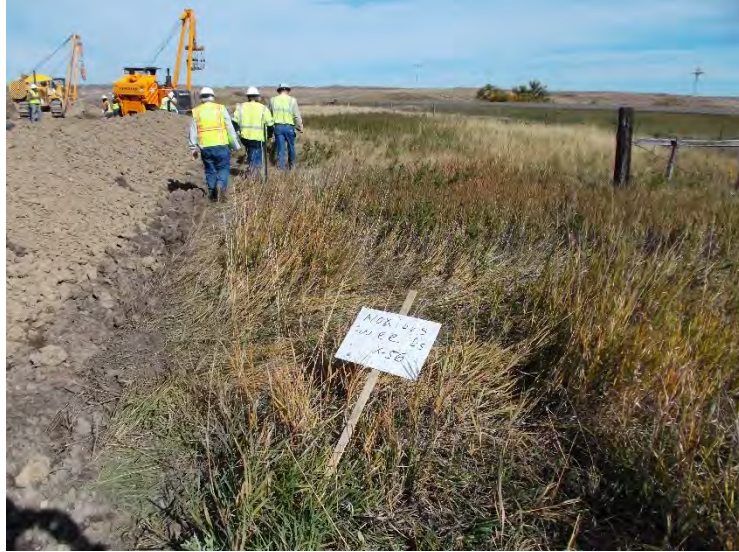
**Observation Point: 198**

On 8 October 2019, Mr. Hackley visited Spread 3 of the Project. Noxious weeds (X-56) was clearly marked adjacent to ROW (**Appendix A, Observation Point 198**). Pipe in trench measurements were appropriate or deeper than required. Trench wall profiles showed that topsoil had been stripped appropriately (**Appendix A, Observation Point 199**). Jomax contractors were observed installing pipe into trenches. Pipe was also observed strung and awaiting trench to be dug for installation (**Appendix A, Observation Point 200 and 205**). A potentially geologically unstable area located at Milepost 56.4 slated for HDD was observed. Guideline stakes were present marking the proposed path of the HDD, which had not been completed at the time of the inspection (**Appendix A, Observation Point 204**).
