PU-18-399

Demicks Lake, 20-inch NGL
Pipeline

Reclamation Inspection Report

September 2021

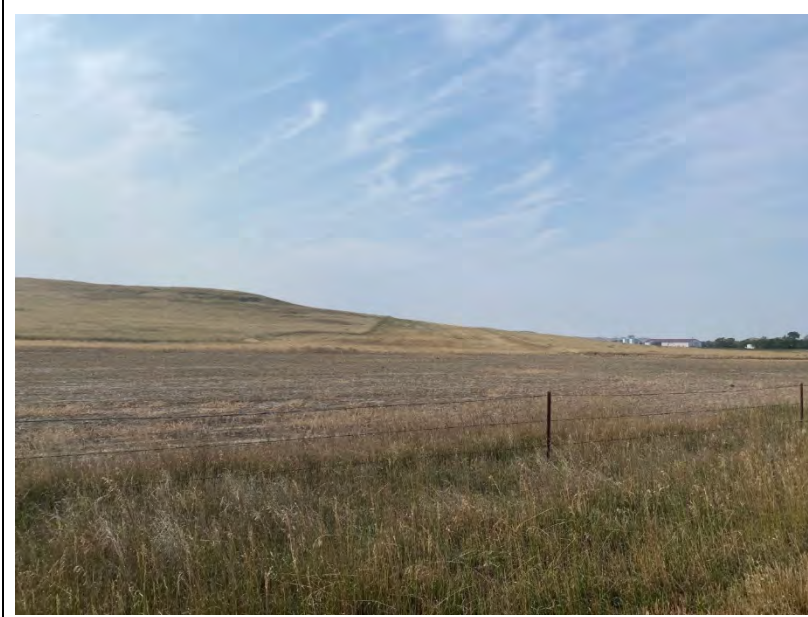
Observation Point: 9060001
Date Taken: September 6, 2021
Direction Photo is Taken:
Southwest

Photo Description: Photos from road show recovery of plant communities match surrounding croplands and ditch communities. Primary species include: western wheat grass, cut wheat and brome (*Bromus inermis*). ROW through ditch, crop field and grassland. Community types match surrounding lands.

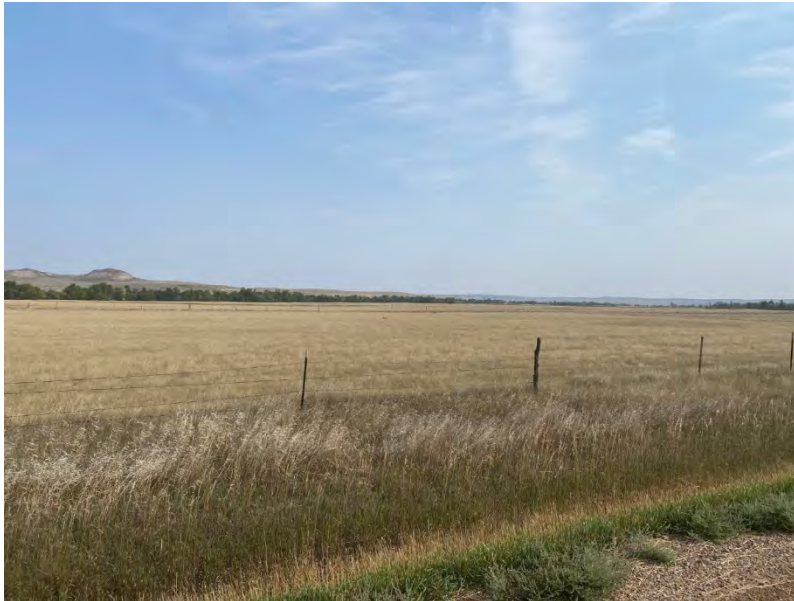
Observation Point: 9060001
Date Taken: September 6, 2021
Direction Photo is Taken:
Northeast

Photo Description: Photos from the road show recovery of plant communities to match surrounding croplands and ditch communities. Primary species include: western wheat grass, cut wheat and brome. Northeast of the road crossing there are no observable change in plant community species and surrounding lands. Vegetation consistent along ROW, through ditch, and crop field. Community types match surrounding lands.

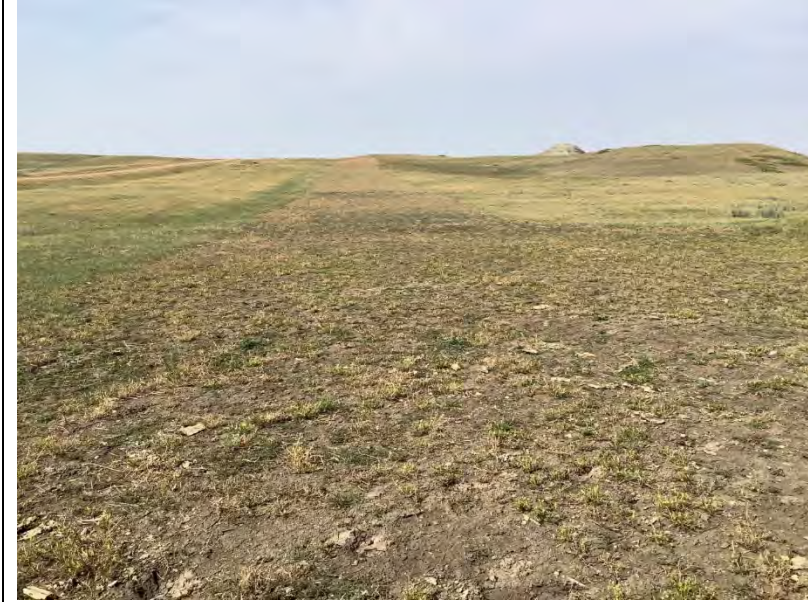
Observation Point: 9060004
Date Taken: September 6, 2021
Direction Photo is Taken: West

Photo Description: Swale with natural vegetation. Vegetative community is slowly recovering due to drought conditions. Not enough native plants in ROW to conclude the area will recover to match surrounding pasture. Species include western wheatgrass, gray thistle, yellow sweet clover, curly-cup gumweed, and hairy golden aster.

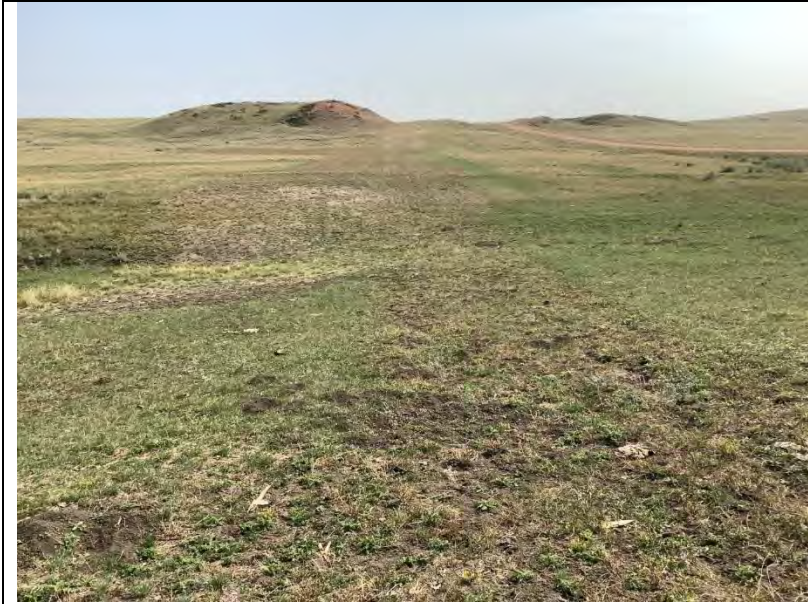
Observation Point: 9060005
Date Taken: September 6, 2021
Direction Photo is Taken: East

Photo Description: Field drain crossing where tree/vegetation matches surrounding community

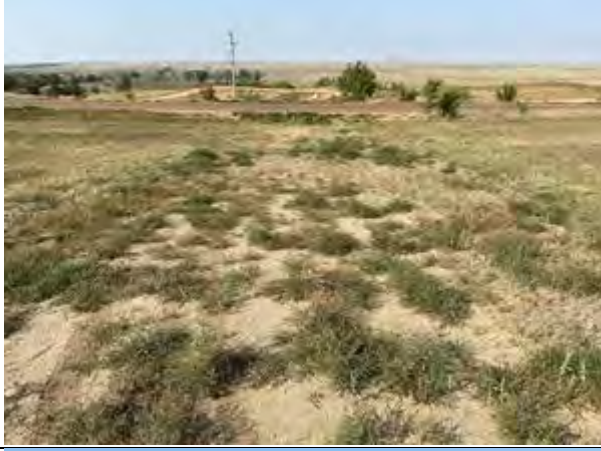
<p>Observation Point: 9090022 Date Taken: September 9, 2021 4:35 PM Direction Photo is Taken: North</p> <p>Photo Description: Access road is poorly reclaimed, and sparsely vegetated with weeds. Follow-up work is recommended.</p> <p>Latitude: 47.7899376832219 Longitude: -103.357598182638</p>

The access road at **Observation Point 9090022** was observed to lack seeded vegetation. Stantec could not determine if topsoil was properly replaced at this location and Stantec recommends the PSC inquire about this area with ONEOK. Adding topsoil or soil biological amendmets could be possible methods to improve the organic matter content and improve vegetative restoration here.

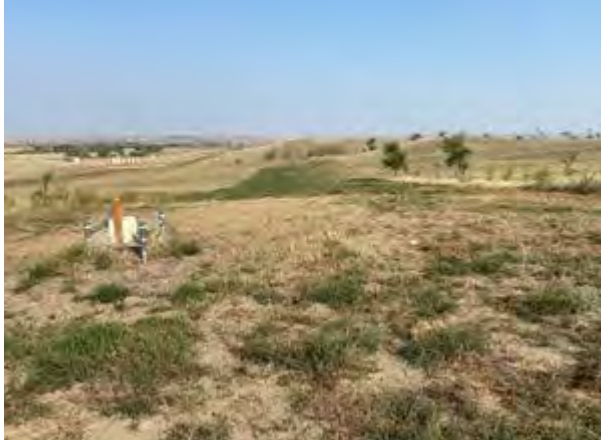
<p>Observation Point: 9090023 Date Taken: September 9, 2021 4:38 PM Direction Photo is Taken: East</p> <p>Photo Description: Vegetation recolonizing the hillside ROW. There were little desired grasses, with kochia and prickly Russian thistle dominant. The ROW does not match surrounding area.</p> <p>Latitude: 47.7895699841017 Longitude: -103.35689066498</p>

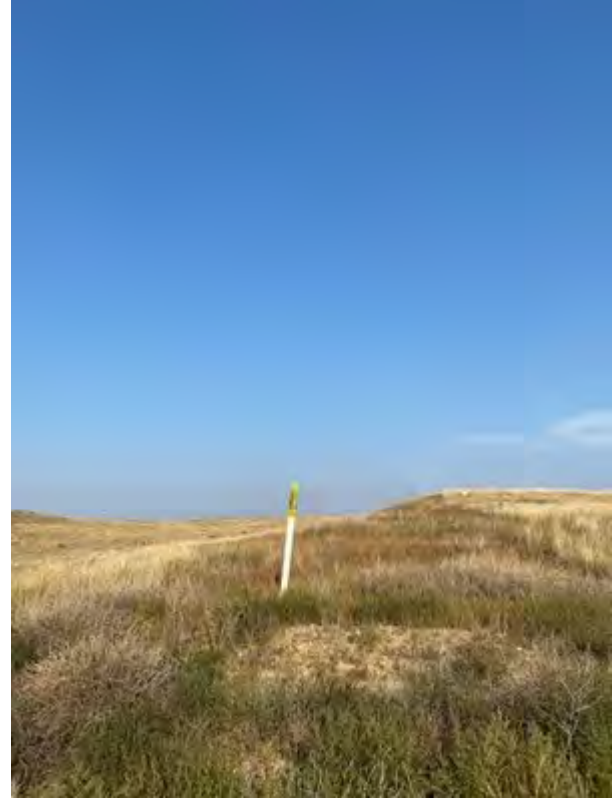
<p>Observation Point: 9090033 Date Taken: September 9, 2021 6:04 PM Direction Photo is Taken: East</p> <p>Photo Description: Crested wheatgrass dominant in surrounding area. ROW contains mostly kochia and prickly Russian thistle.</p> <p>Latitude: 47.8551307277698 Longitude: -103.261942386018</p>

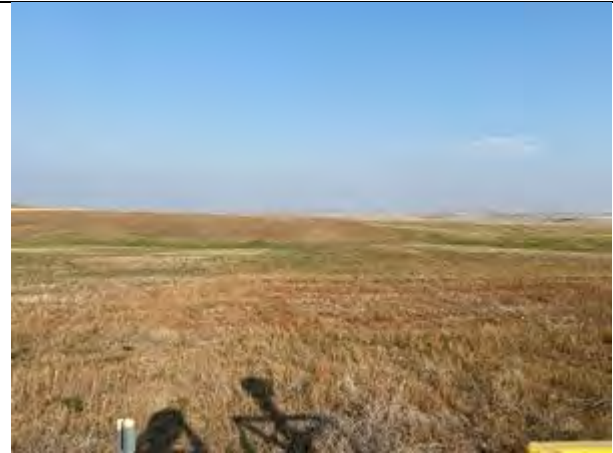
<p>Observation Point: 9090034 Date Taken: September 9, 2021 6:16 PM Direction Photo is Taken: East</p> <p>Photo Description: Historic land use is presumably cropland but existing condition land-use in ROW is difficult to ascertain. Short, dry veg visible with crested wheatgrass in adjacent areas. Grass coming in somewhat, but appears stressed from drought.</p> <p>Latitude: 47.8533300191241 Longitude: -103.240598489013</p>
