**In re: Belle Fourche Pipeline Company  
8-inch Wilson-Bowline Pipeline Conversion Project  
Case No. PU-18-404  
Our File No. 013084-000013**

# Report of Geohazard Evaluation Wilson to Bowline Pipeline Segments West Central North Dakota

Tetra Tech Project No. 117-0533085

October 27, 2020

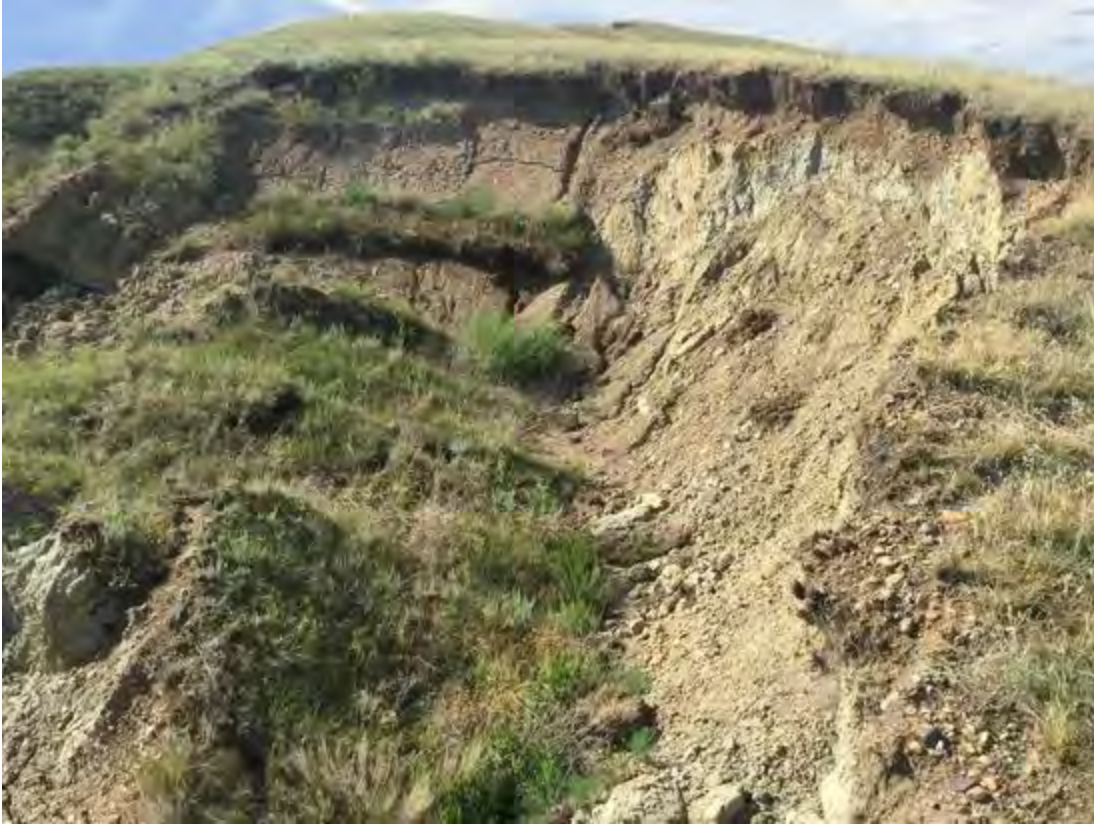
**Photo #2**

**Description:** Multiple slumps near the unnamed creek were observed associated with movement of the large slide mass.

**Photo Type:** Slope movement evidence | **Photo Bearing:** 322 degrees  
**Photo Description:** Large slide mass between existing pipeline.

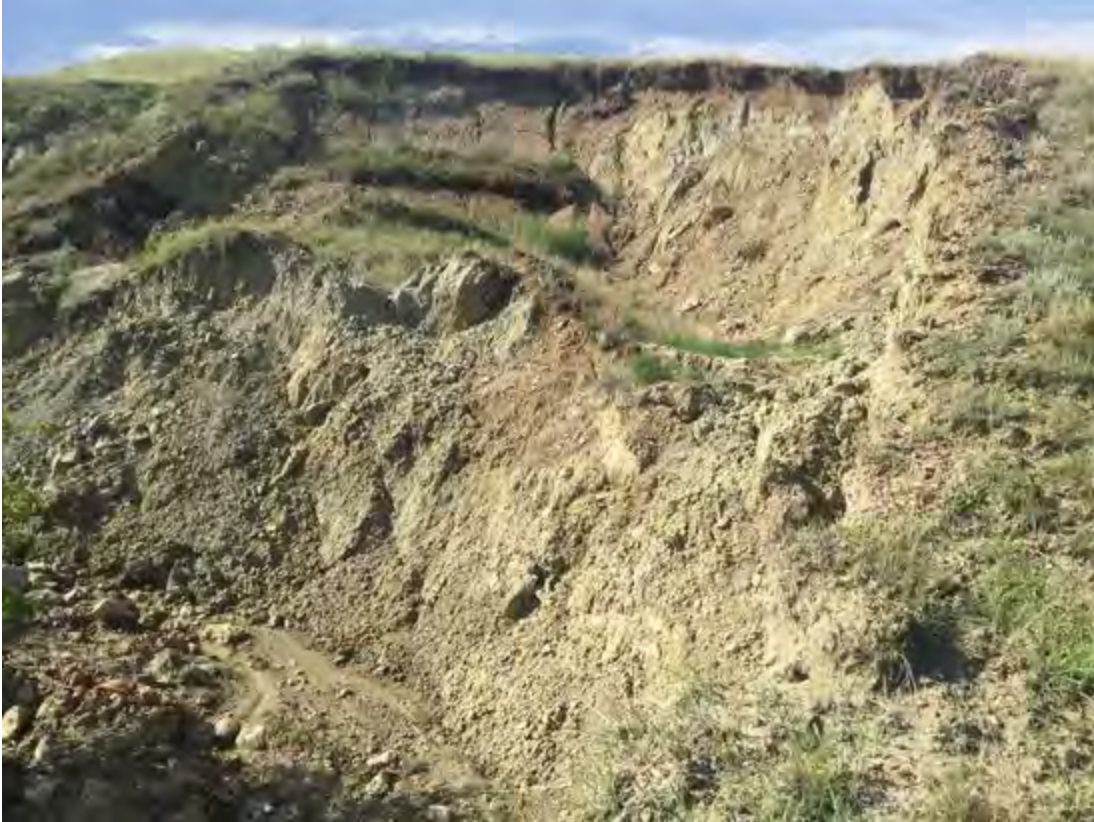
**Photo #3**

**Photo Type:** Slope movement evidence | **Photo Bearing:** 333 degrees  
**Photo Description:** Looking at scarp and slide mass.

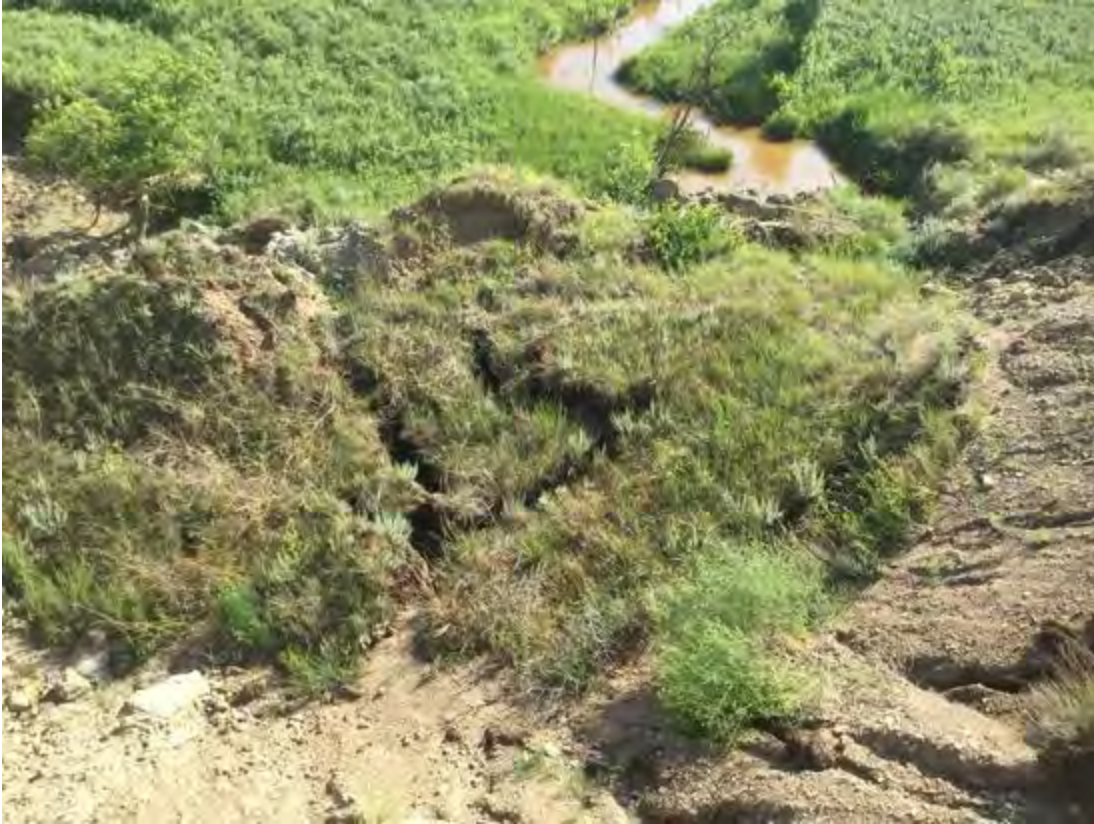
**Photo #4**

**Photo Description:** Looking down slope at slide mass.

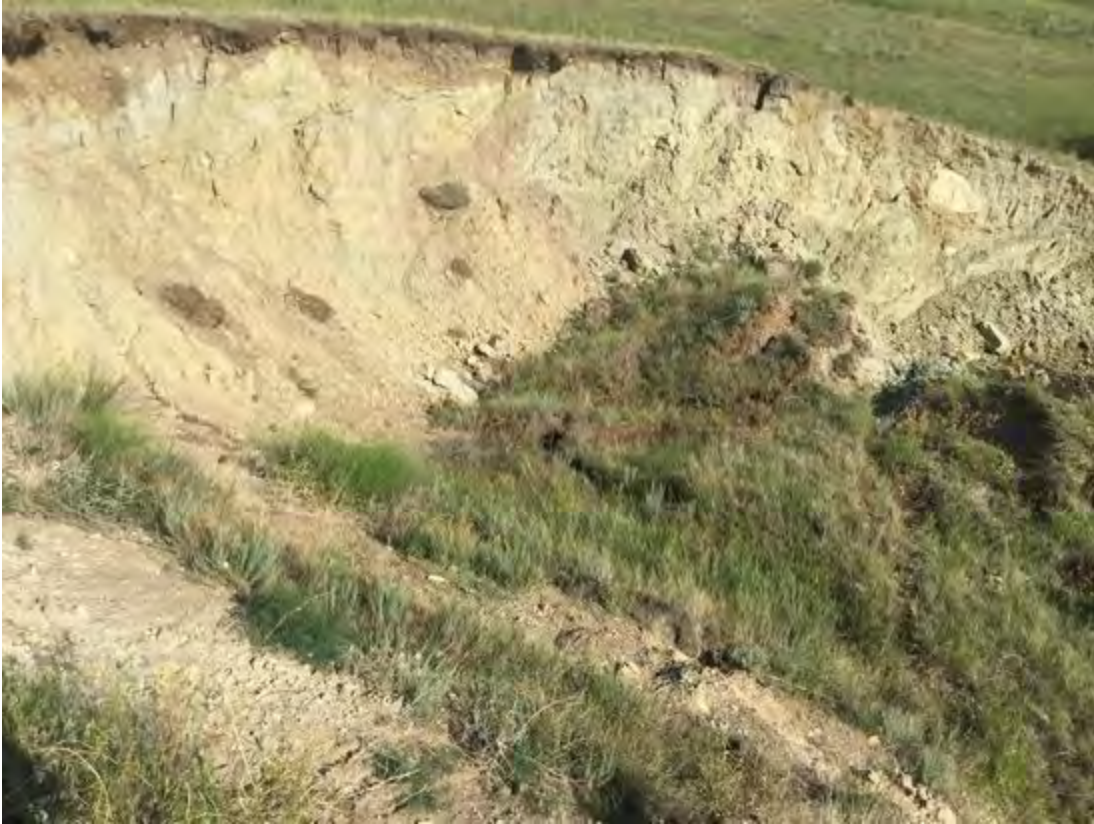
**Photo #5**

**Photo Type:** Slope movement evidence | **Photo Bearing:** 126 degrees  
**Photo Description:** Looking at slide mass.

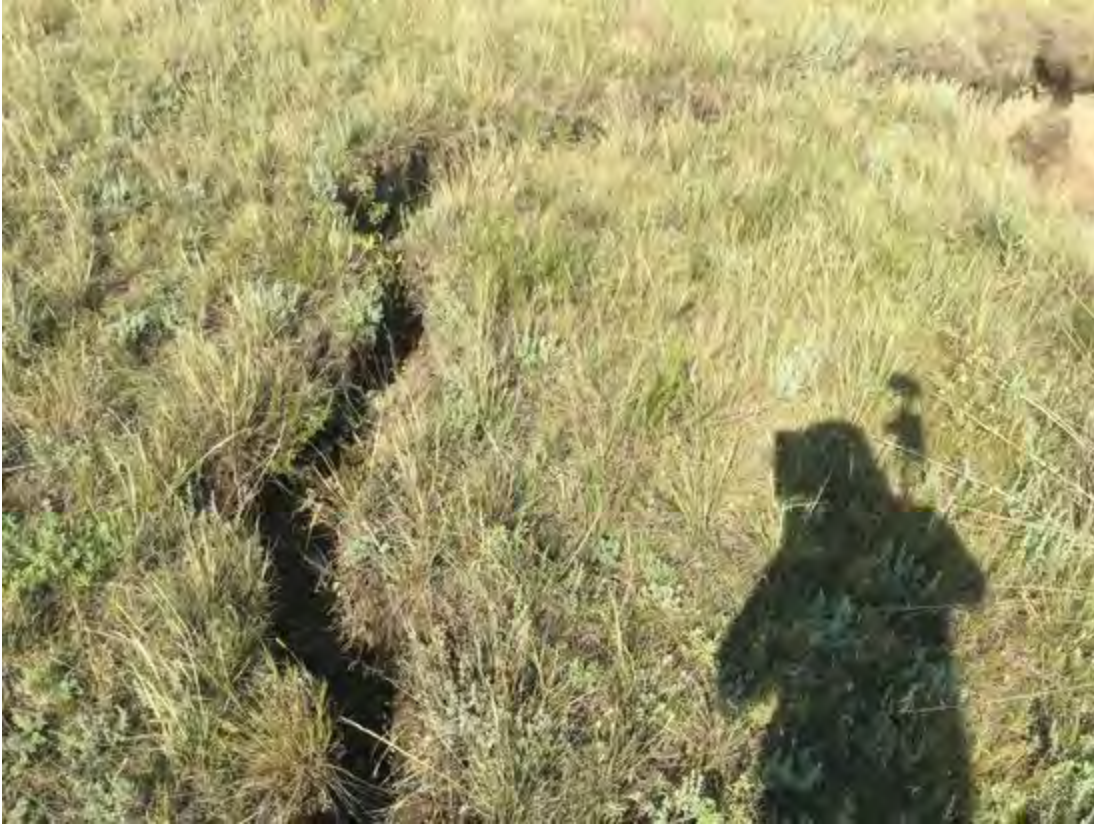
**Photo #6**

**Description:** A tension crack was observed just beyond the head scarp on the northwest side of the slide and was approximately 20 feet in length. The tension crack was roughly 4 to 6 inches in width.

**Photo Type:** Slope movement evidence | **Photo Bearing:** 64 degrees  
**Photo Description:** Looking at tension crack.

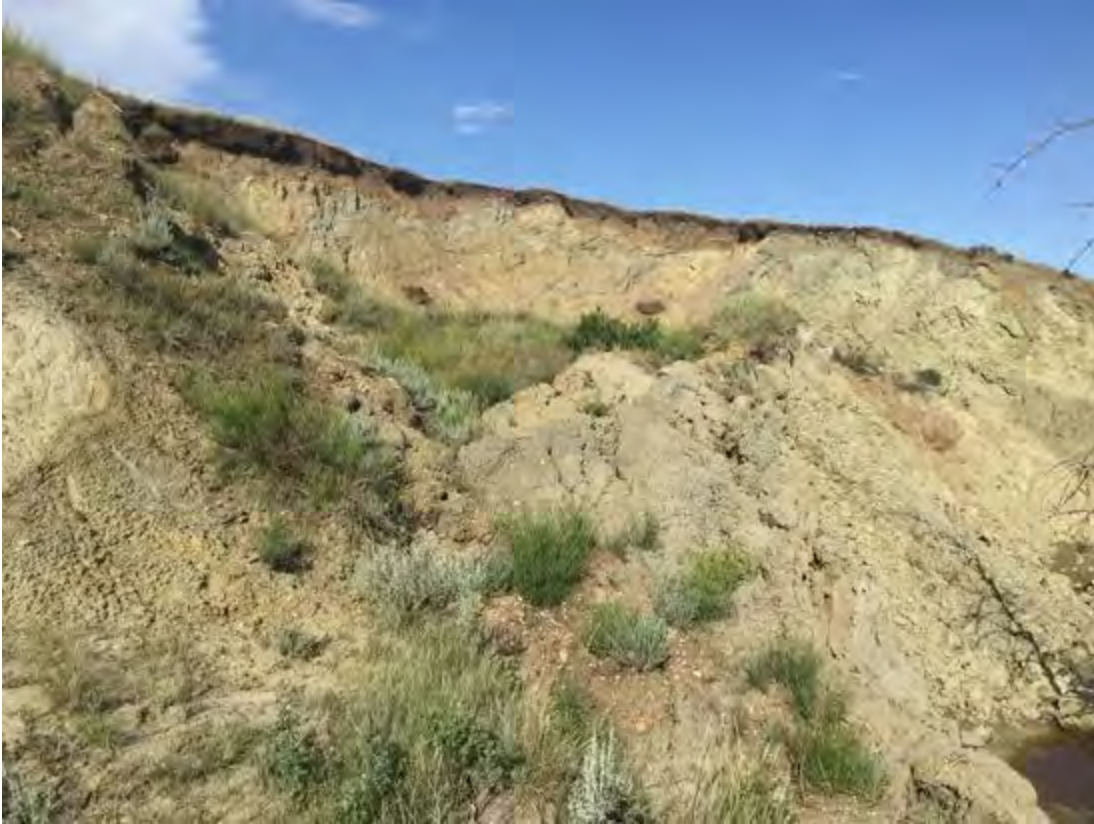
**Photo #9**

**Photo Type:** Slope movement evidence | **Photo Bearing:** 61 degrees  
**Photo Description:** Looking upslope at slide mass.

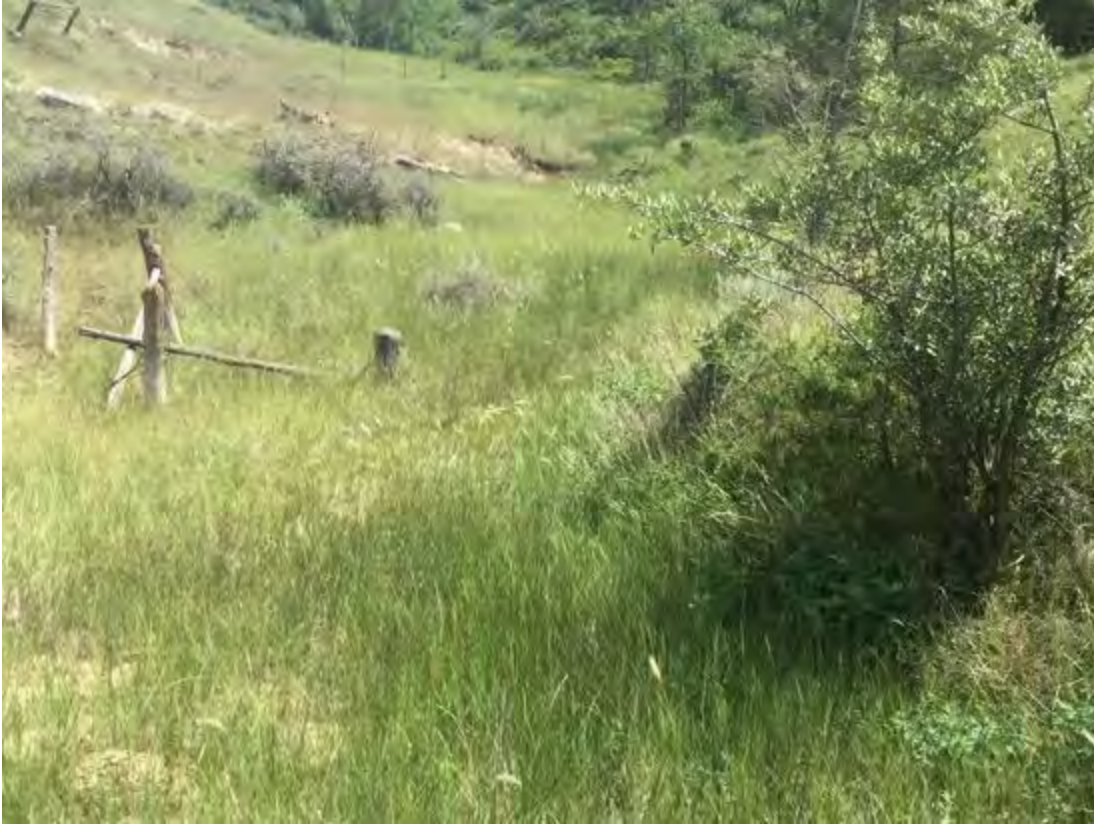
**Photo #4**

**Photo Type:** Water source | **Photo Bearing:** 141 degrees  
**Photo Description:** Looking upstream at drainage located at the toe of the slope.  
-----

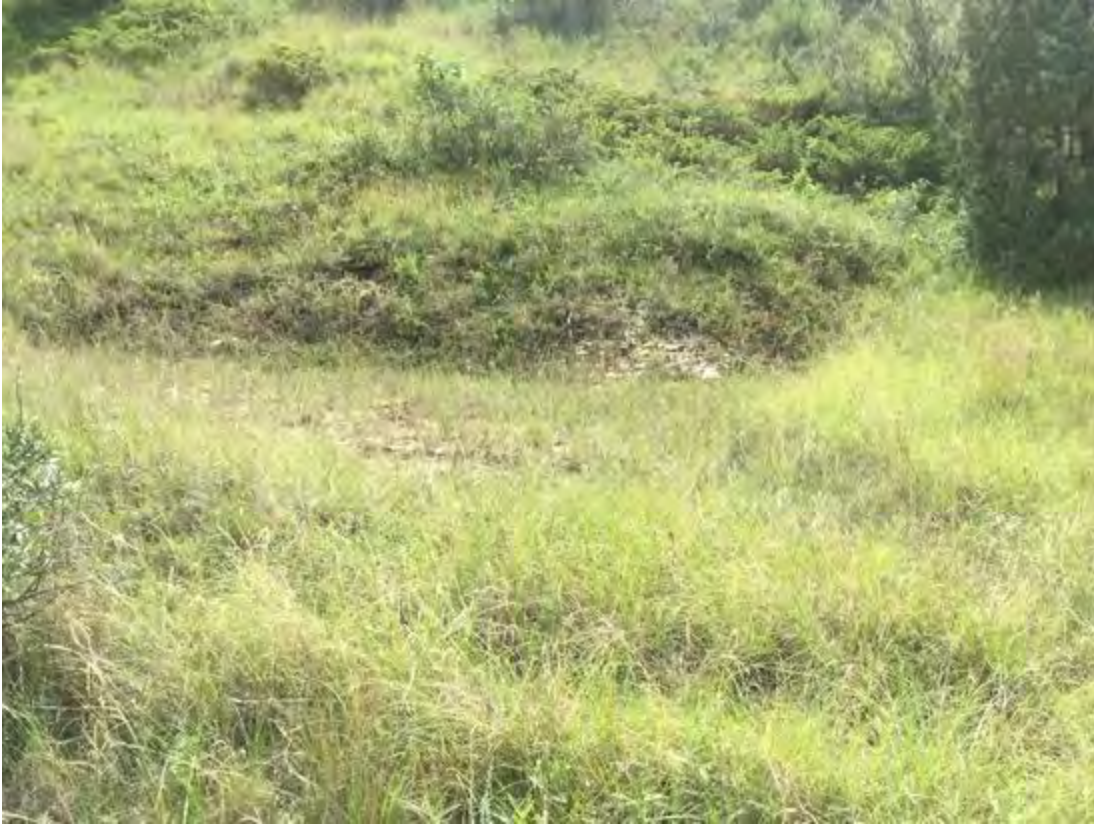
**Photo #5**

**Description:** Historic slump observed near toe of the slope. Slump is approximately 25 feet wide and 25 feet long, with its mass extending up to 3 feet above surrounding areas. No recent movement was apparent.

**Photo Type:** Slope movement evidence | **Photo Bearing:** 224 degrees  
**Photo Description:** Slump near the toe of the slope.

Monitor the slope for signs of changing conditions or movement during future site visits. A slide was observed approximately 100 feet northwest of the pipeline corridor at the confluence of a larger drainage, suggesting this slope may also be susceptible to sliding.
