8" WILSON TO BOWLINE BELLE FOURCHE PIPELINE (PU-18-404) Final Permit Compliance Inspection Report 2020

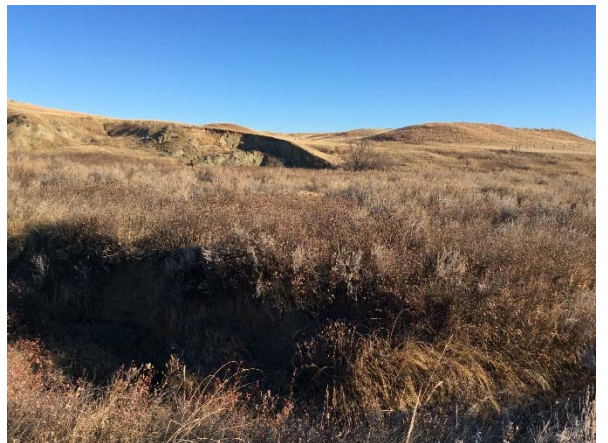
- sustainable vegetation establishment was observed throughout the pipeline corridor with one (1) minor erosion and sedimentation issue within a waterbody channel in Section 4, T147N, R101W (**Appendix B, Photo 6**).

Photo 6: Waterbody crossing
(Section 4, T147N, R101W)

In conclusion, the Project is currently in compliance with all the provisions set forth by the Commission with the exception of what appears to be one (1) minor erosion and sedimentation area. The Commission may elect to require Belle Fourche to correct the above minor issues in order to reduce the possibility of damage or interference of the underground pipeline and aboveground facilities. The Commission may elect to conduct subsequent field verifications to ensure that the coverage of the bare earth areas, the repair of the erosion areas.

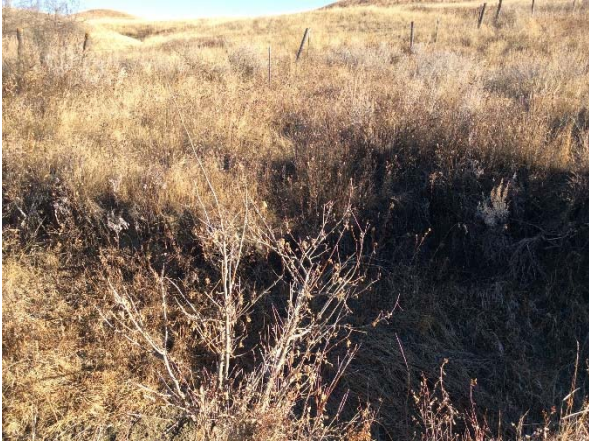
Photo 7: Waterbody crossing, facing north.
(Section 4, T147N, R101W)

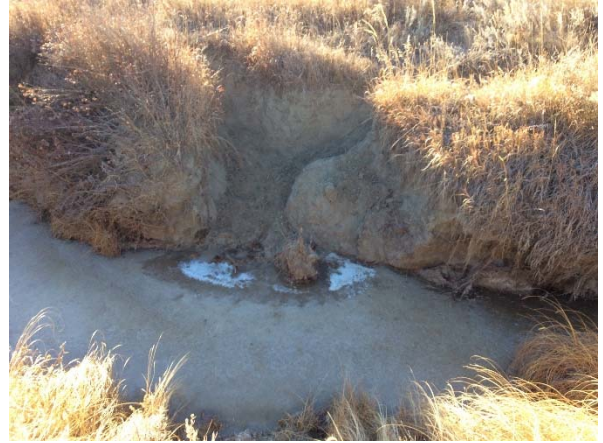
Erosion and sedimentation controls, reclamation of roads, and reseeding of disturbed areas were not prevalent for this project because the pipeline and support facilities were already constructed previously. Some minor erosion was observed at the waterbody crossing at Section 4, Township 147W, Range 101N (See **Photo 8**). This erosion appears to be minor, and no corrective issues are recommended at this time.

Photo 8: Erosion at waterbody crossing.
(Section 4, T147N, R101W)

In conclusion, the Project is currently in compliance with all the provisions set forth by the Commission. The Commission may elect to require Belle Fourche to correct the minor erosion in order to reduce the possibility of further erodibility and degradation of conditions at those sites.
