# Little Missouri Lateral NGL Pipeline Topsoil Removal Inspection Report PU-19-85

*Prepared for:*  
**North Dakota  
Public Service Commission**

**PU-19-85 CONSTRUCTION INSPECTION**

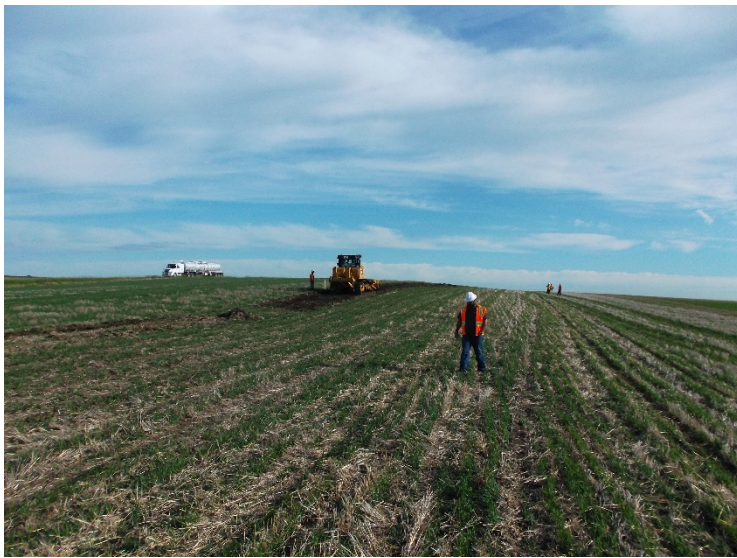
**Observation Point: 54**

Photo Description: Beginning of topsoil removal and Jomax crew inspection.

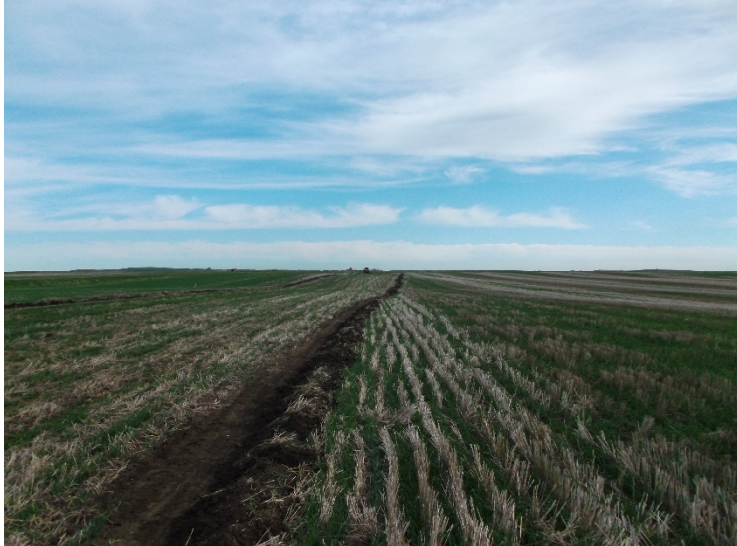
**Observation Point: 55**

Photo Description: ROW boundary cut in a cultivated field.

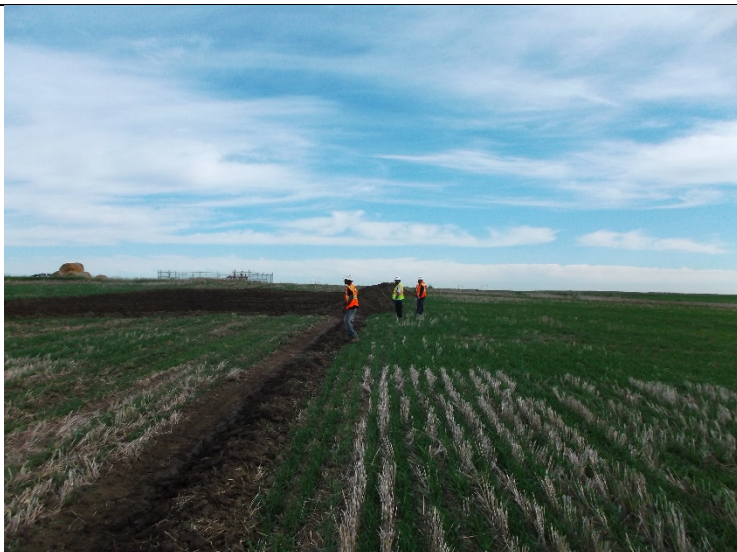
**Observation Point: 56**

Photo Description: Spotters guiding heavy machine operators to keep topsoil stockpile within ROW boundary.

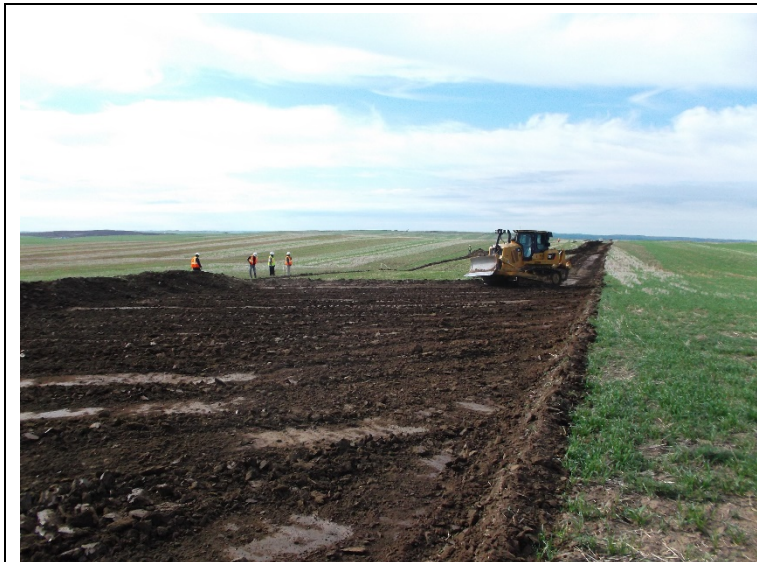
**Observation Point: 57**

Photo Description: Topsoil stripped approximately 5 inches on backslope.

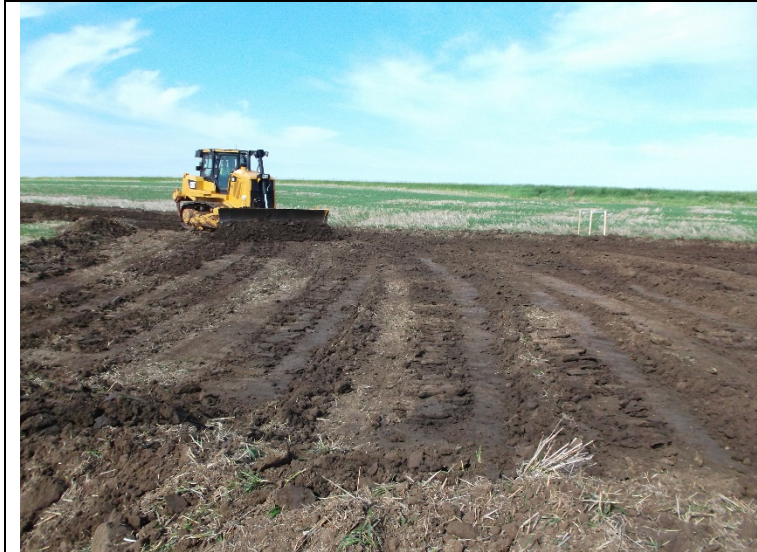
**Observation Point: 58**

Photo Description: Topsoil stripping too shallow within a swale. Discussed with Jared Walters, Jomax ROW Clean-up Foreman. Issue resolved on-site.

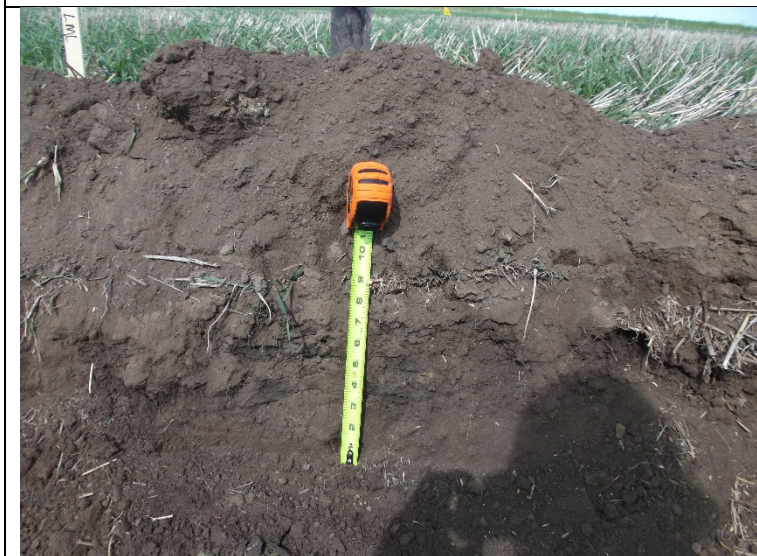
**Observation Point: 59**

Photo Description: Approximately 8-9 inches of topsoil removed from back/shoulder slope.

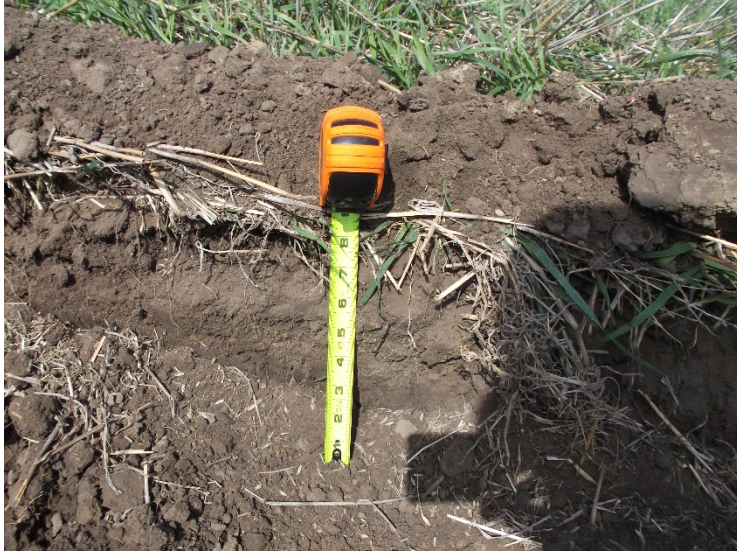
**Observation Point: 60**

Photo Description: Approximately 7-8 inches of topsoil removed from hill summit.

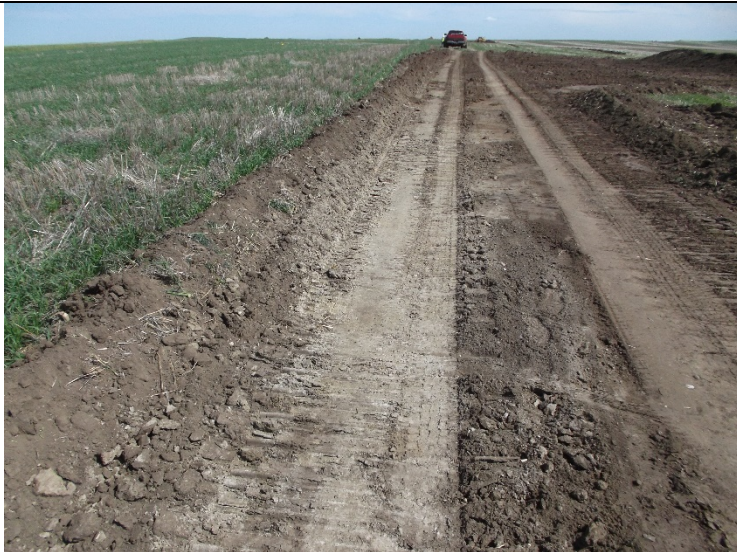
**Observation Point: 61**

Photo Description: Calcareous subsoil under approximately 7 inches of topsoil on backslope. Stripping terminated at location.

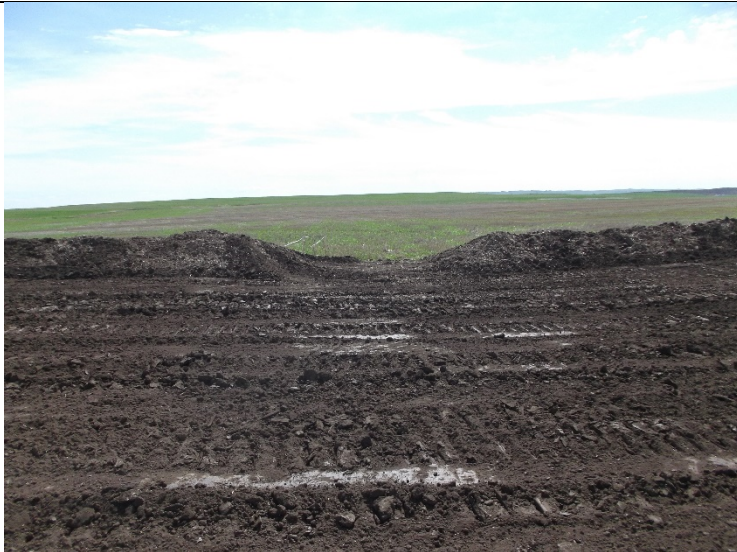
**Observation Point: 62**

Photo Description: Gap in topsoil stockpile for water erosion control placed properly within a swale.

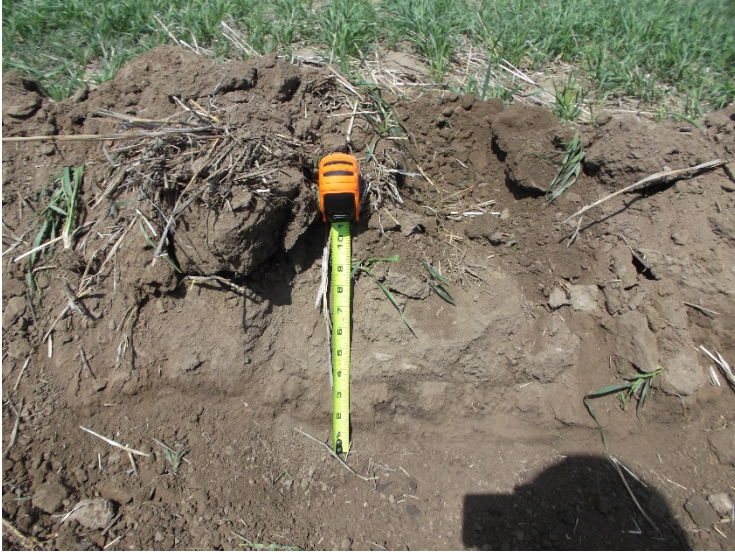
**Observation Point: 63**

Photo Description: Approximately 9-10 inches removed from backslope.

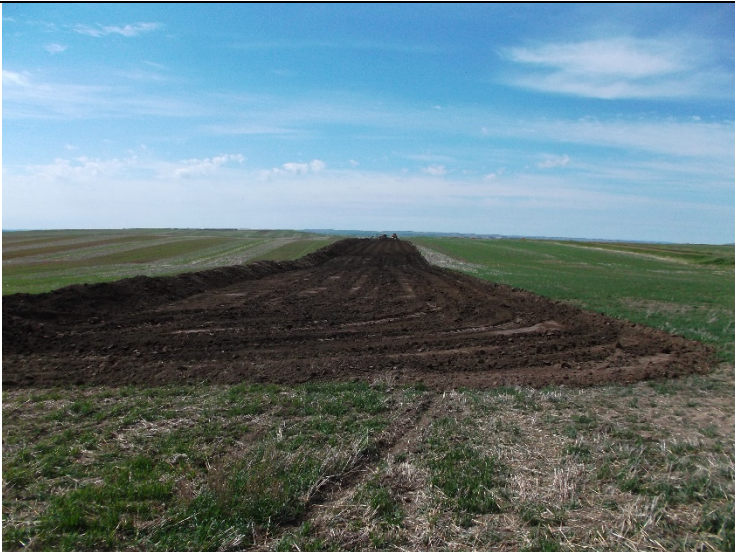
**Observation Point: 64**

Photo Description: ROW at the southwest quarter of T149N, R100W, Section 1. The Little Missouri Pipeline will interconnection with ONEOK's Demicks Lake Pipeline (PU-18-399) approximately 100 feet north from this point.

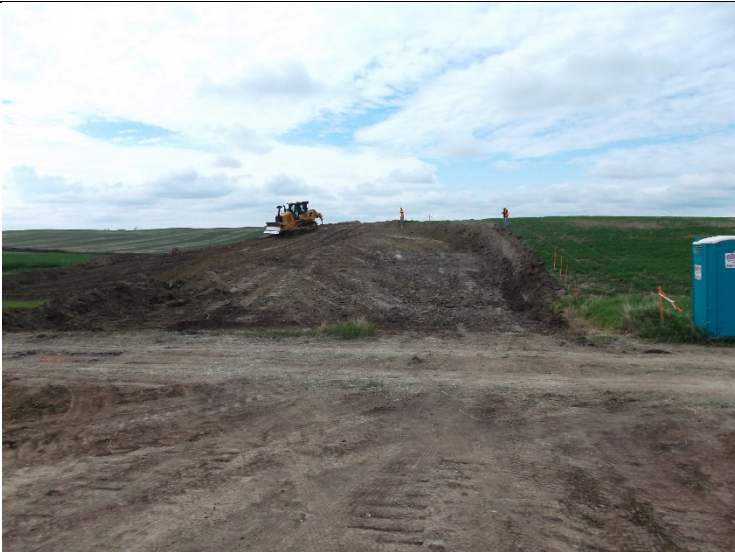
**Observation Point: 75**

Photo Description: Grading of ROW to mitigate for topography.

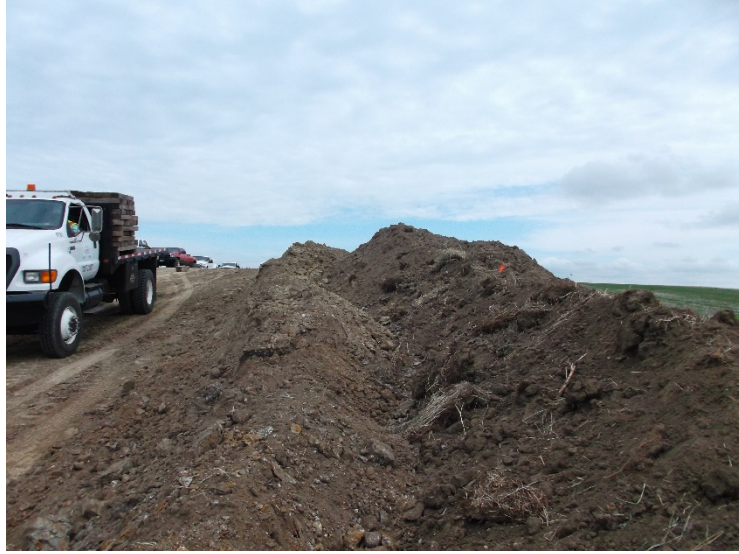
**Observation Point: 76**

Completed topsoil removal looked adequate. However, Wenck's Field Inspector observed that topsoil and subsoil stockpiles were touching at one location. (**Appendix A, Observation Point 76**). This was brought to the attention of Jomax ROW clean-up foreman, Jared Walters. This issue was resolved with Mr. Walters acknowledging the problem and offering to vigilantly watch to keep the stockpiles segregated. Equipment

Photo Description: Lack of topsoil and subsoil segregation. Discussed with Jared Walters, Jomax ROW clean-up Foreman that subsoil and topsoil stockpiles should not be touching. Issue resolved on-site.

operators will need to re-spread the excavated soil by pulling from the pile starting with the subsoil during subsequent backfilling activities. After all the subsoil is graded, another pass with the grader will be completed to spread the slightly mixed soil where topsoil and subsoil had contacted each other. Lastly, the topsoil will be placed over the disturbed subsoils. This proposed soil handling procedure will help ensure that any subsoil/topsoil mix is located above the subsoil layer, while still being buried beneath the unmixed topsoil.

During site inspections, there were a few locations where the subsoil stockpile was observed touching the topsoil stockpile or was mixed slightly within the topsoil stockpile. Isolated instances of soil mixing is to be expected when working with large, heavy machinery. On hilltops, subsoil was removed and manipulated in order to create a level surface to operate and install pipe. Some of these subsoil stockpiles were observed in contact with the adjacent topsoil stockpiles. This will result in slight mixing of the subsoil and topsoil at the points of contact. Also, the final pass taken by graders during topsoil stripping inevitably disturbed a small amount of subsoil along some areas of the ROW. Both of these types of observed mixing were minimal and were recognized by the contractors. The mixed soils are located on the surface and front side of the stockpile facing the ROW. Thus, the mixed soil will be re-spread prior to topsoil during replacement. As a result, the mixed soils will be covered with the stockpiled topsoil, which should not adversely affect reclamation.

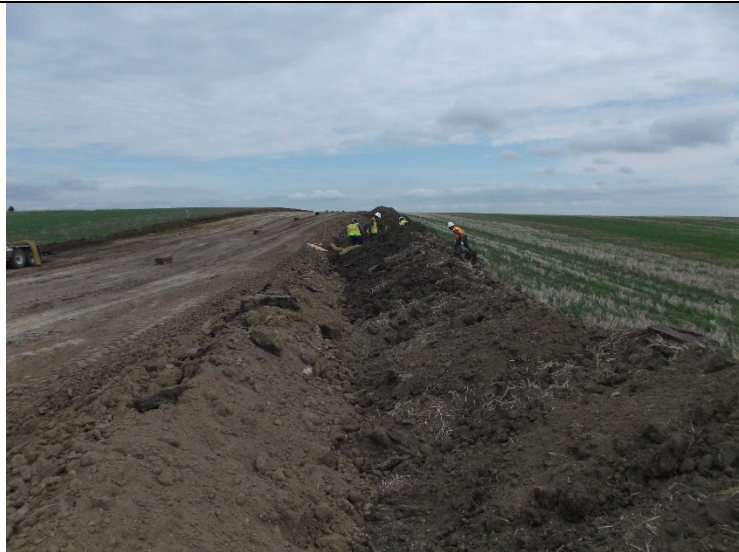
**Observation Point: 77**

Photo Description: Soil segregation. SWPPP installation for water erosion mitigation.

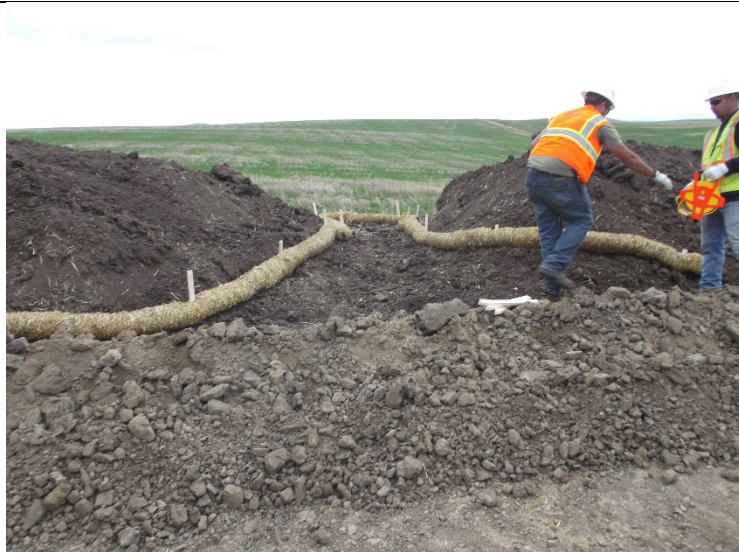
**Observation Point: 78**

Photo Description: SWPPP erosion control installation.

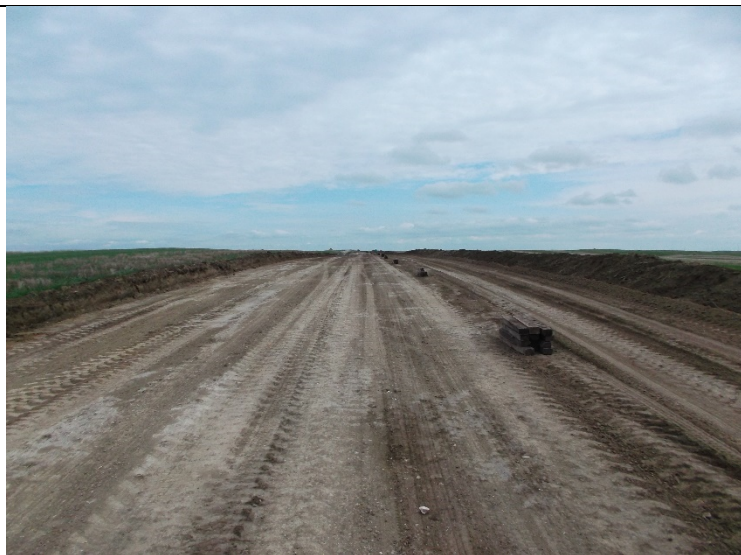
**Observation Point: 79**

Photo Description: ROW stripped and graded.

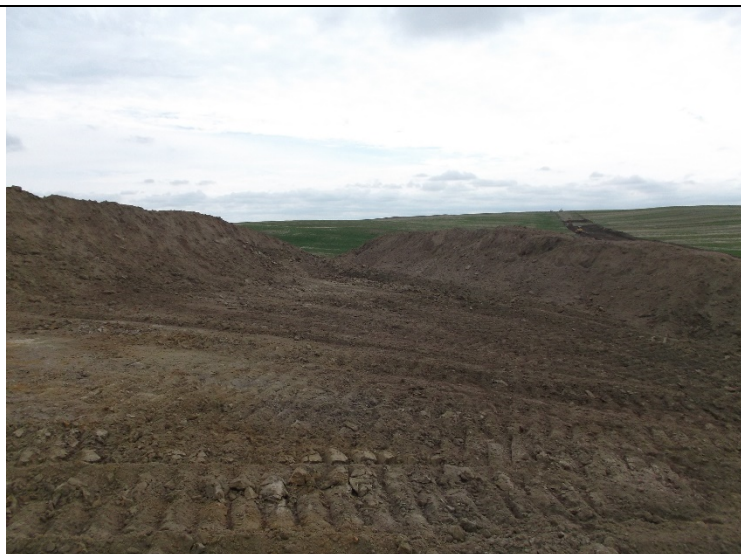
**Observation Point: 80**

Photo Description: Topsoil stockpile on the right. Subsoil stockpile on the left. Topsoil from hill summit and of poor quality, slight effervescence on topsoil stockpile and moderate effervescence on subsoil stockpile.

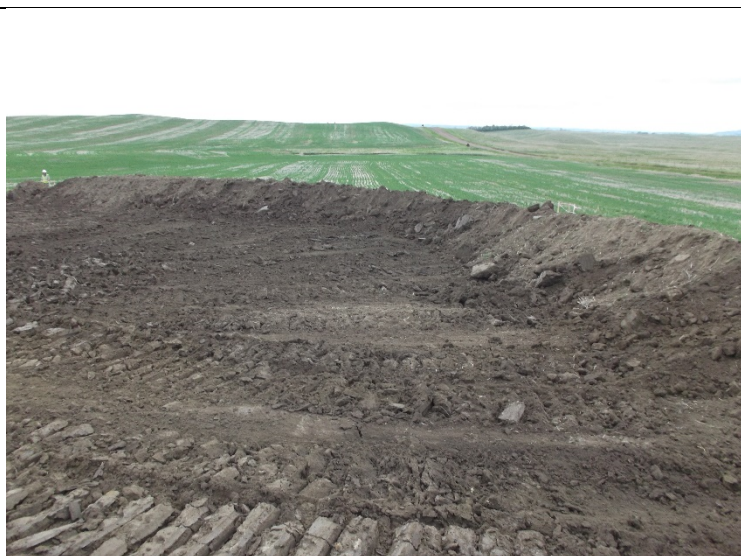
**Observation Point: 81**

Photo Description: Topsoil stripped to color change.

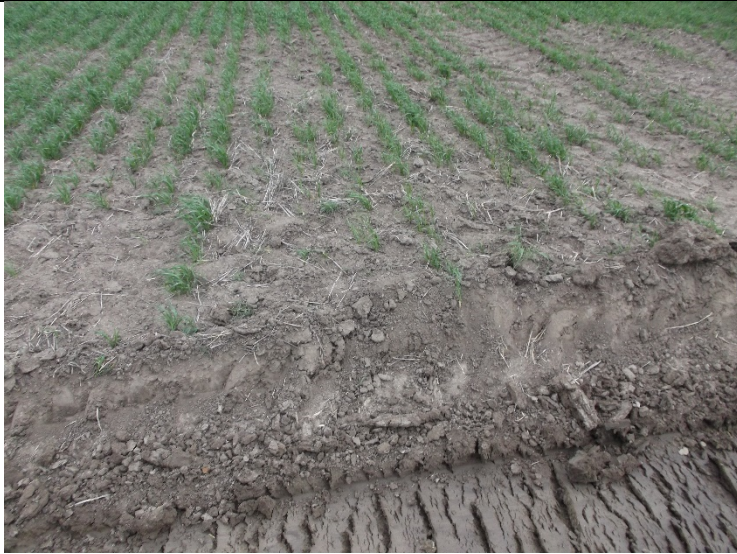
**Observation Point: 82a**

Photo Description: Naturally calcareous topsoil and of poor quality.

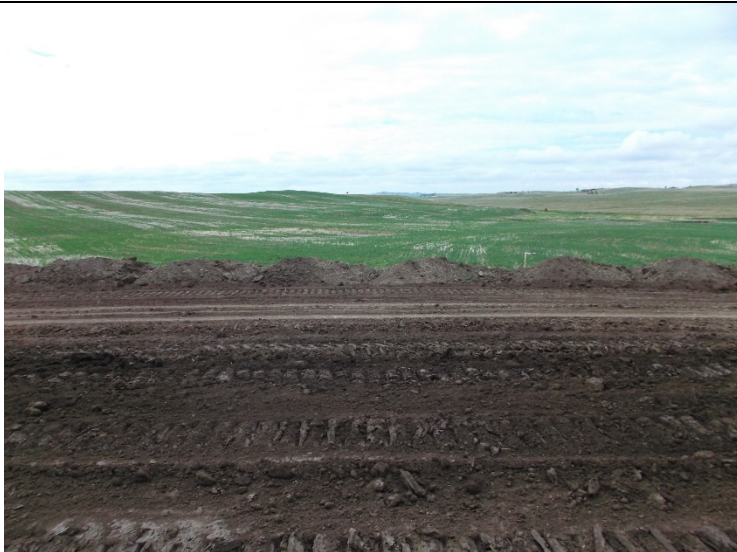
**Observation Point: 82b**

Photo Description: Topsoil stockpile reflects the limited topsoil supply and poor quality.

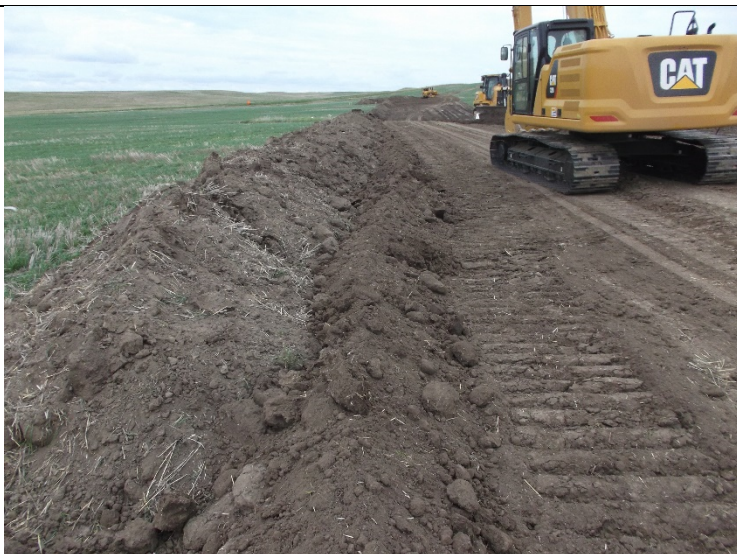
**Observation Point: 83**

Photo Description: Topsoil and subsoil stockpiles. Subsoil stockpile was clayey.

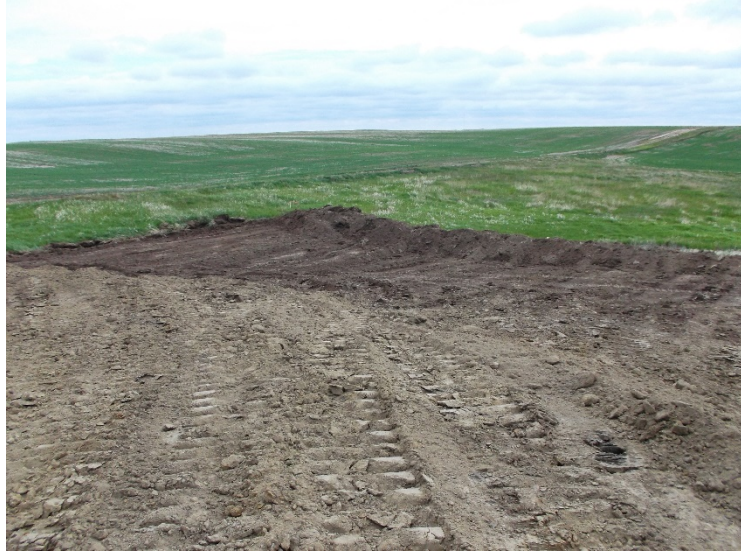
**Observation Point: 84**

Topsoil Inspections included a hilltop area with limited topsoil thickness. Topsoil was pushed to the south side of the ROW and then another pass was made into the subsoil to create a level surface for installing the pipe along the hill. The subsoil stockpile was stored to the northeast of the topsoil. Both stockpiles revealed an effervescence reaction with hydrochloric acid (HCl) (**Appendix A, Observation Point 80**). Extra workspace was created in conjunction with this hilltop so that subsoil could be manipulated in the leveling of the ROW. The far northeast corner and area close to the topsoil stockpile had not been completely stripped of topsoil. Mr. Burrow was made aware of this and understands that if the workspace were to be utilized for further stripping or stockpiling, topsoil would have to be fully stripped and kept segregated from subsoil(**Appendix A, Observation Point 84**).

Photo Description: Extra ROW workspace at bottom of slope. Workspace not fully stripped of topsoil. Discussed with David Burrow, Jomax Superintendent, that if workspace was to be utilized that additional approximately 1-2 inches would need to be stripped.
