Little Missouri Lateral NGL Pipeline Construction Inspection Report PU-19-85

Prepared for:
**North Dakota
Public Service Commission**

The North Dakota Public Service Commission (PSC) retained Wenck Associates, Inc. (Wenck) to complete site inspections during construction of the ONEOK Little Missouri Lateral Pipeline (i.e., the Project). The project is a 12-inch Natural Gas Liquids (NGL) pipeline in McKenzie County, North Dakota, constructed by ONEOK Bakken Pipeline L.L.C. (ONEOK). The purpose of the inspections was to ensure the project was constructed in compliance with the siting laws and rules and the applicable PSC Orders for the Project.

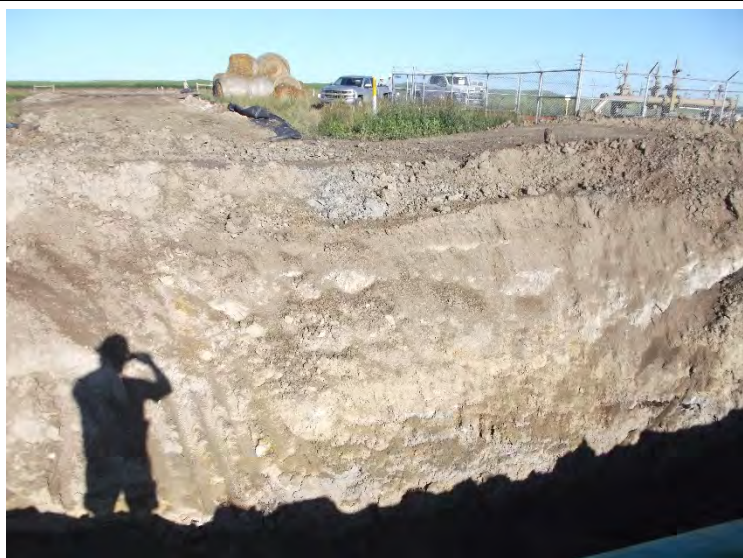
Observation Point: 168

Photo Description: Pipe depth approximately 72 inches. Appropriately no topsoil in trench profile.

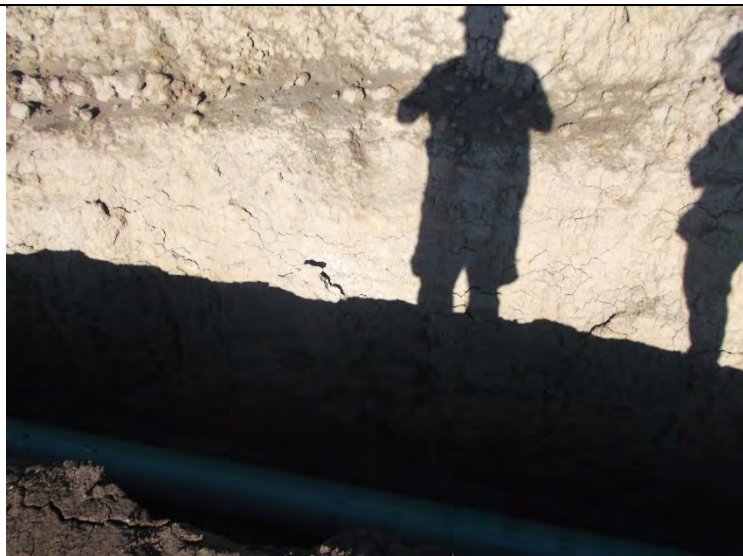
Observation Point: 169

Photo Description: Pipe depth approximately 72 inches. Appropriately no topsoil in trench profile.

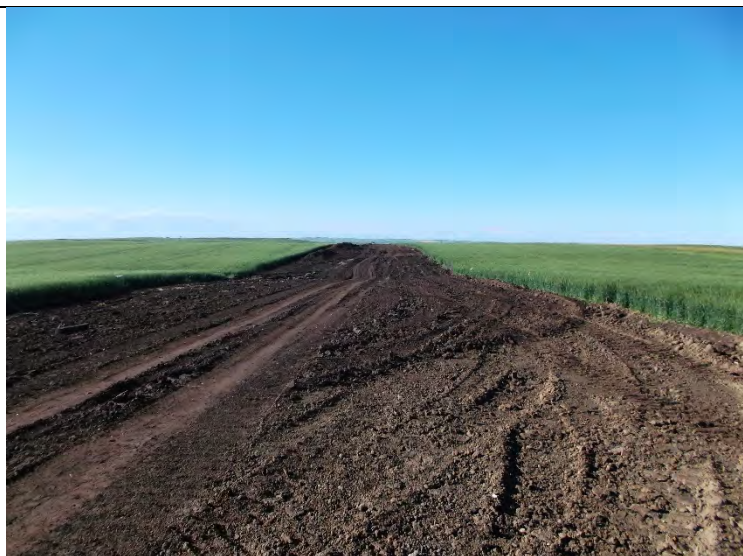
Observation Point: 170

Photo Description: Topsoil stockpiles in process of being properly redistributed on ROW backslope.

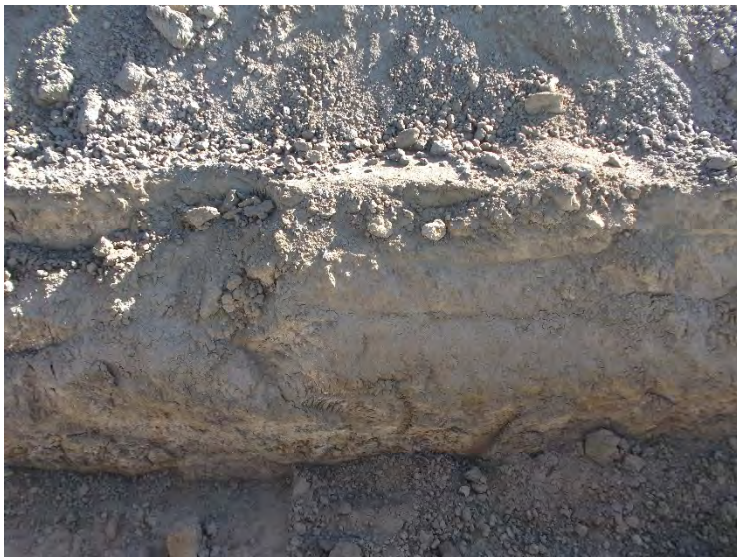
Observation Point: 171

Photo Description: Appropriately no topsoil in trench profile. No pipe in trench.

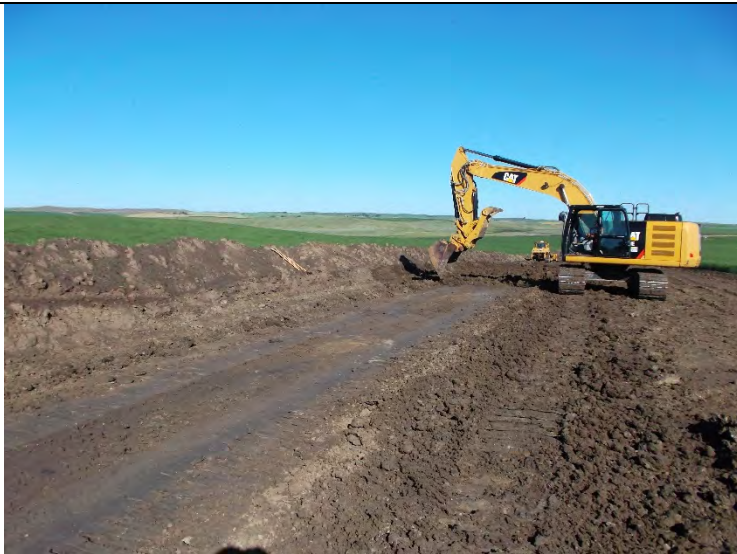
Observation Point: 172

Photo Description: Backhoe gathering the majority of subsoil from stockpile. Motor grader will then make passes to more precisely move the remaining subsoil from the stockpile to fill the ROW.

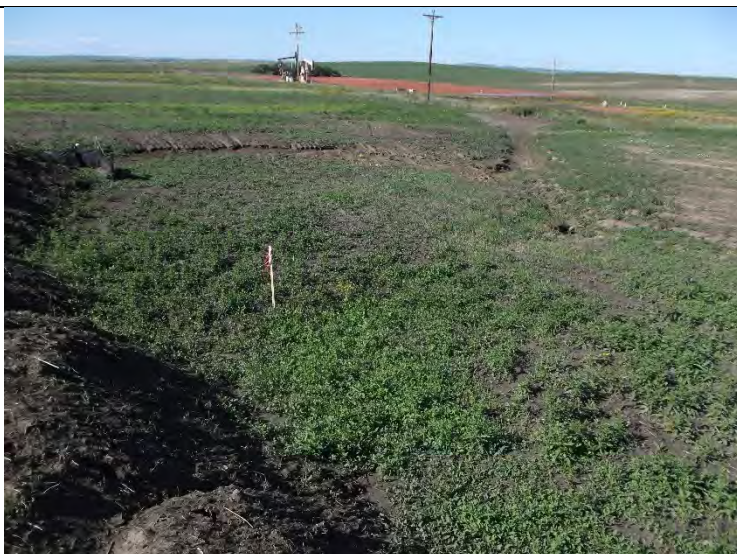
Observation Point: 173

Photo Description: Swale on non-working side with potential for erosion. No erosion control in place. Brought to the attention of Alex Compton, QSC Environmental inspector. Crew sent to resolve this issue.

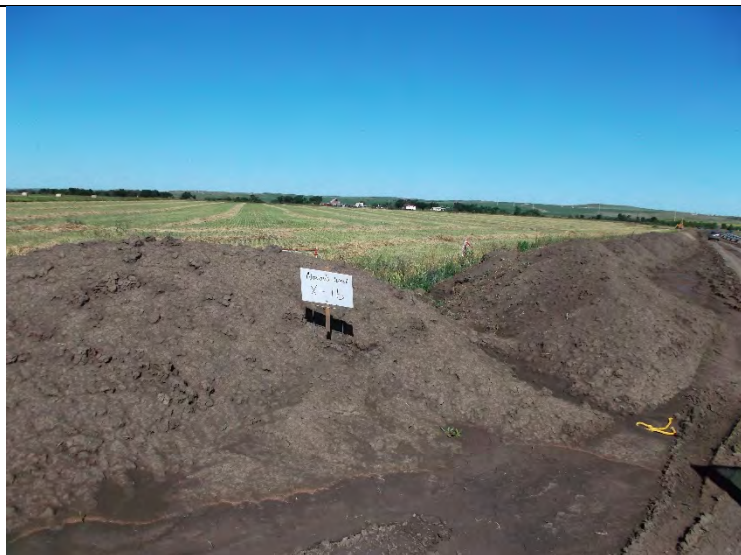
Observation Point: 174

Photo Description: Noxious weed area X-16 marked appropriately.

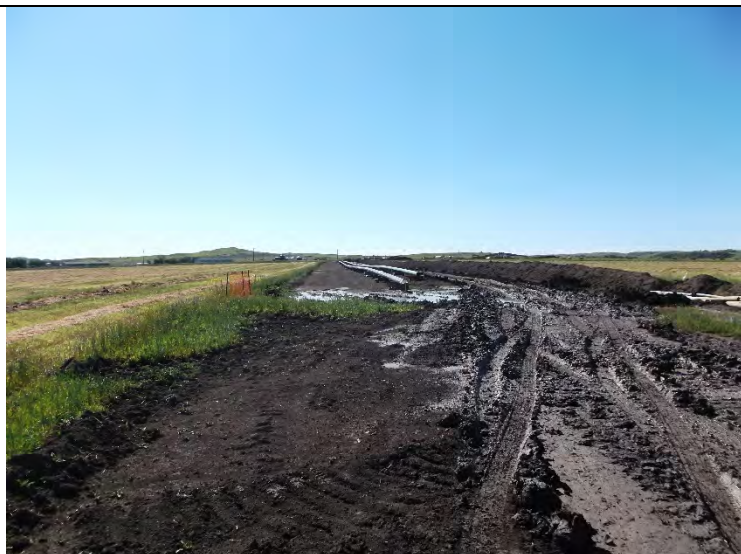
Observation Point: 175

Photo Description: HDD pipe to be bored under the Cherry Creek waterbody.

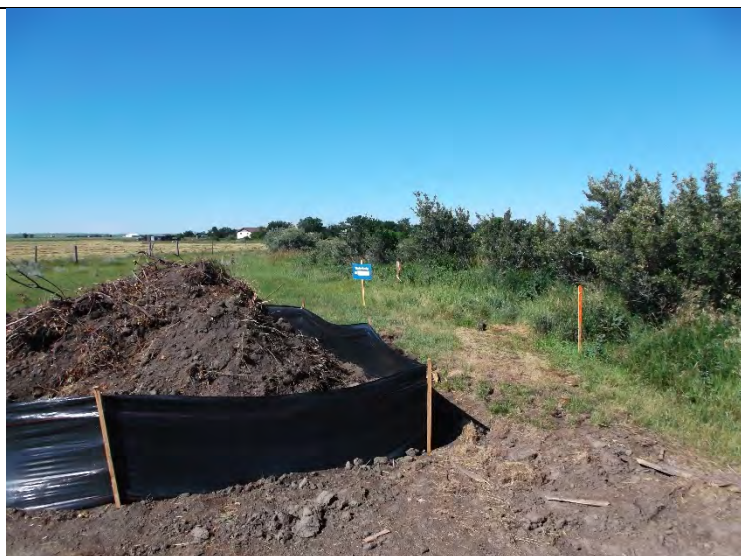
Observation Point: 176a

Photo Description: Cherry creek waterbody S-5 appropriately marked.

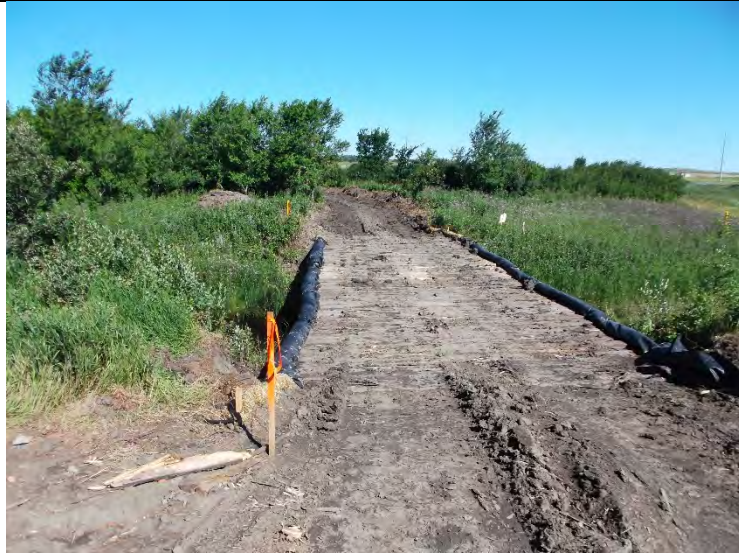
Observation Point: 176b

Photo Description: Temporarily constructed bridge over Cherry Creek waterbody S-5.

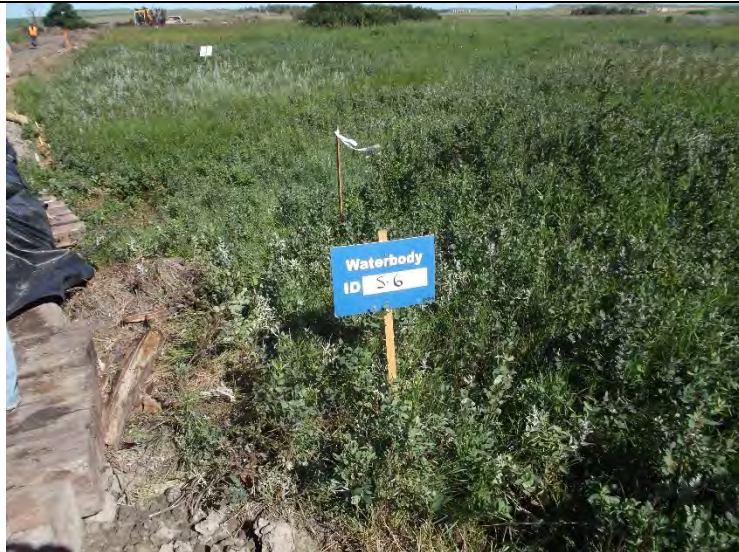
Observation Point: 177

Photo Description: Waterbody S-6 appropriately marked.

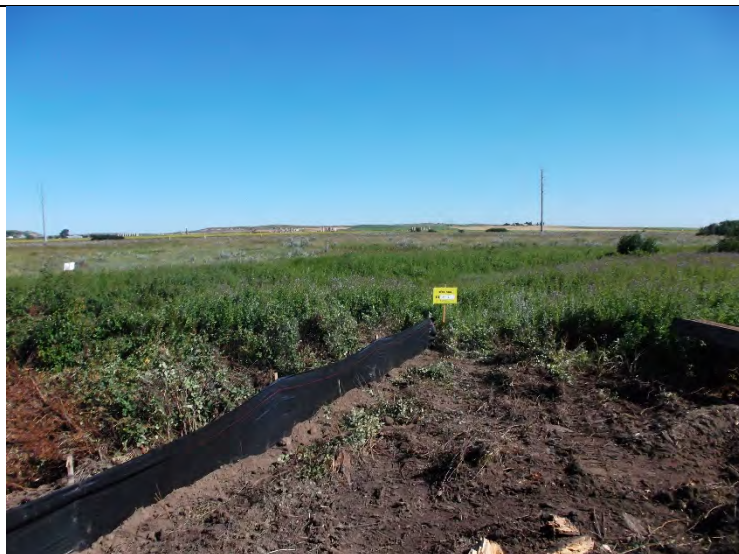
Observation Point: 178a

Photo Description: Wetland W-7 marked and surrounded with silt fence erosion control.

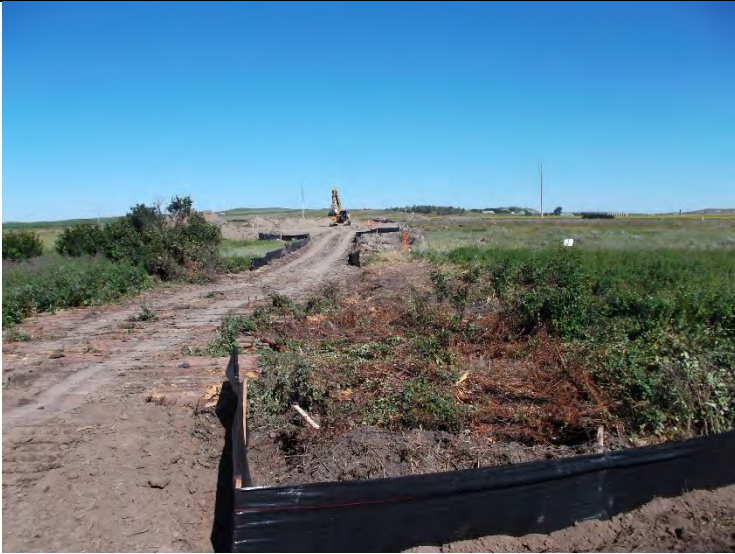
Observation Point: 178b

Photo Description: Timber mats placed within wetland W-7.

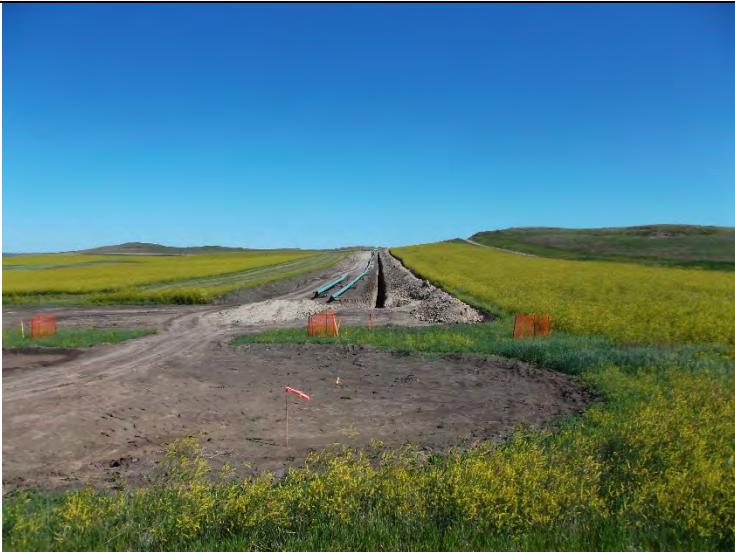
Observation Point: 179

Photo Description: Trench dug and awaiting pipe placement.

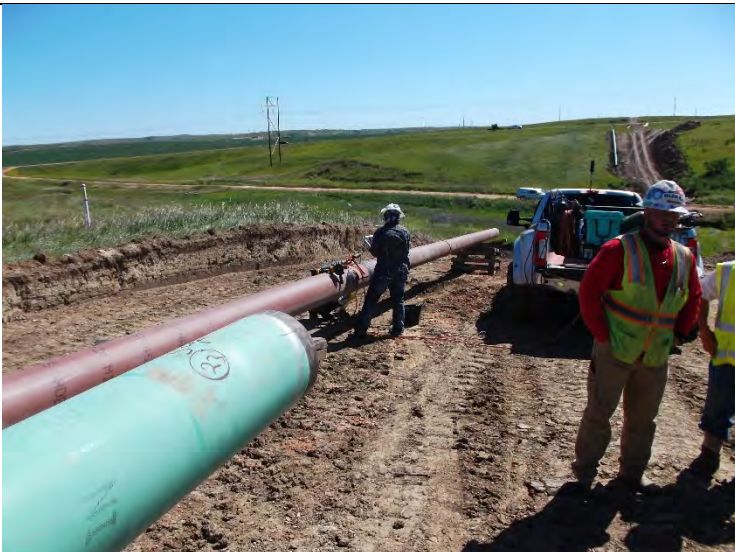
Observation Point: 180

Photo Description: Bore pipe being welded and inspected. Pipe to be bored under wetland and access road.

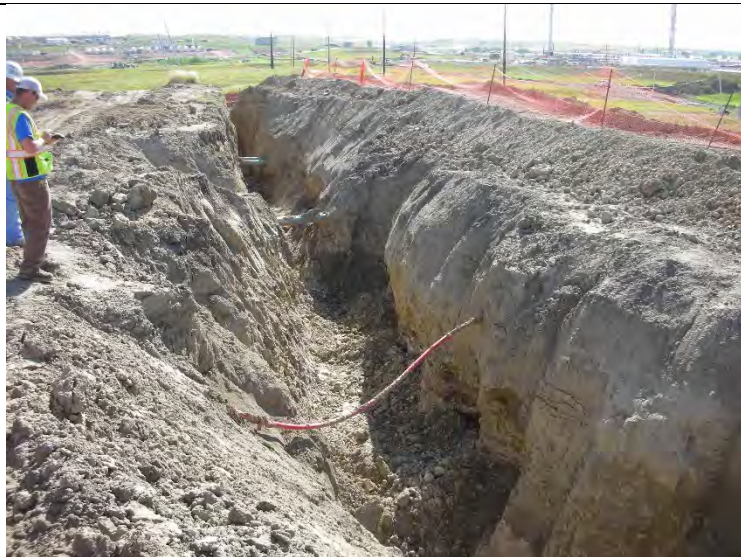
Observation Point: 2745

Photo Description: Approximately 10-foot wide trench near east end of project.

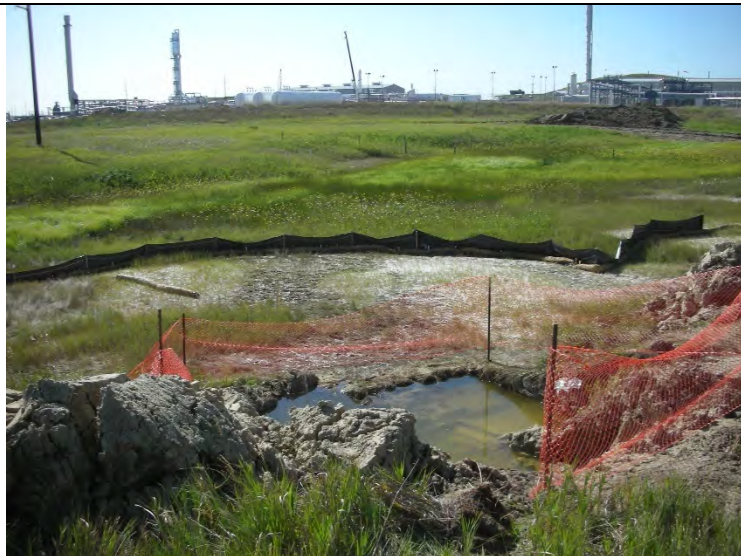
Observation Point: 2746se

Photo Description: Spring Creek. Overlooking HDD and effective erosion control.

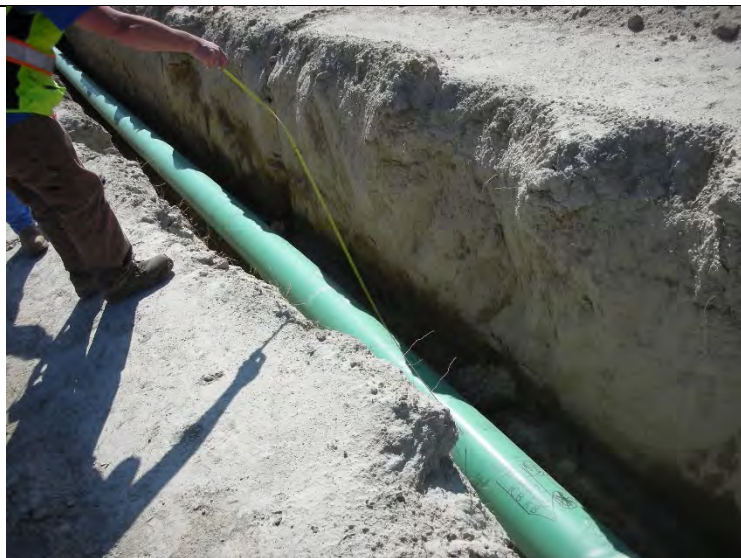
Observation Point: 2747

Photo Description: Wenck measured pipe at 48-inches. Survey stake reads 3.7 feet. Appropriately no topsoil in trench profile.

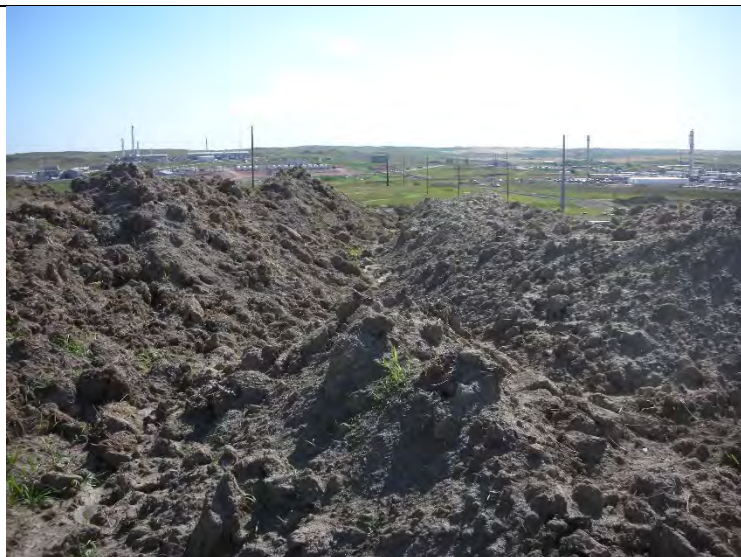
Observation Point: 2748e

Photo Description: Topsoil and subsoil mostly segregated. Minor mixing.

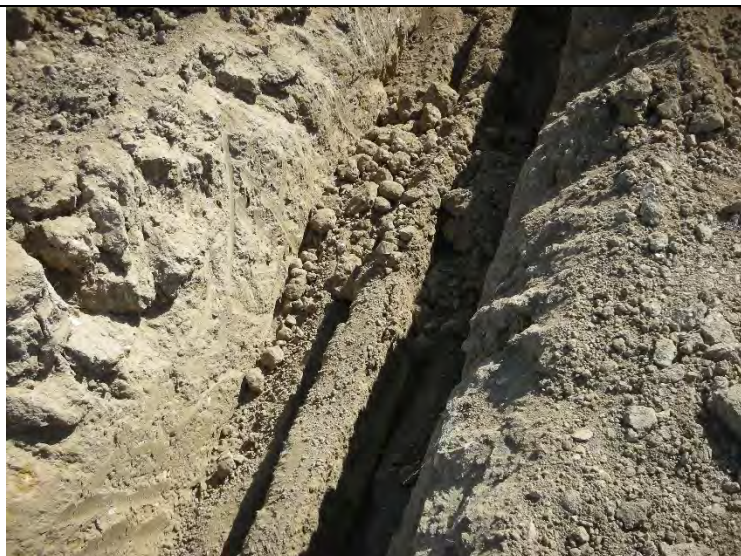
Observation Point: 2749ne

Photo Description: Pipe depth measured at 48-inches within open trench.

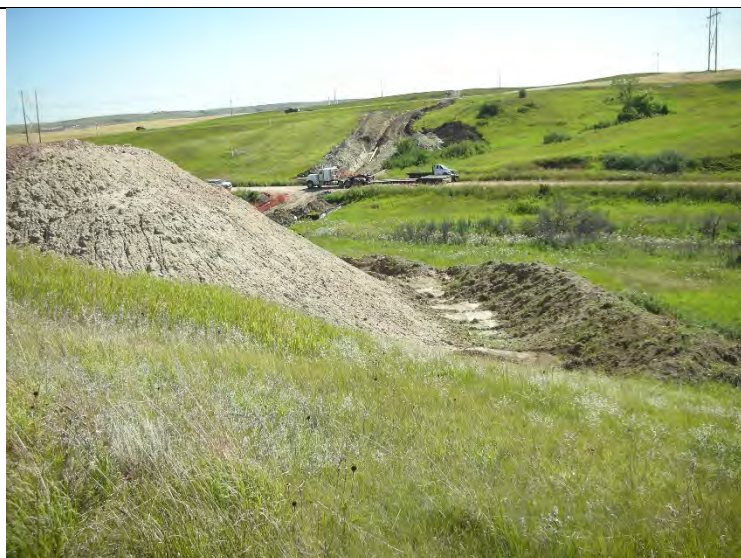
Observation Point: 2750

Photo Description: Topsoil and subsoil segregated appropriately. Erosion control recommended.

- ▲ Continue implementing erosion control measures, especially if stockpiles are to be left over winter.
- ▲ Timely chemical and/or physical control to suppress weeds within topsoil stockpiles will facilitate successful revegetation of the project during reclamation.
- ▲ Use of spotters and careful handling of soil during subsequent trench backfilling to minimize subsoil/topsoil mixing, and to assure subsoil and topsoil remains segregated to the best extent feasible.
- ▲ Backfill of the trench is to be conducted to assure the pipeline is buried with a minimum of 48 inches of cover. This is increased to 72 inches of cover across unimproved section lines.

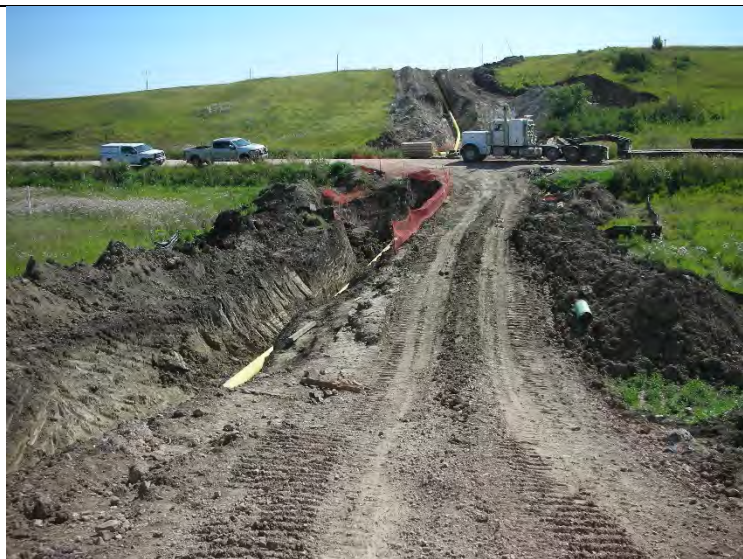
Observation Point: 2751e

Photo Description: Overlooking wetland 5. Some soil mixing has occurred.

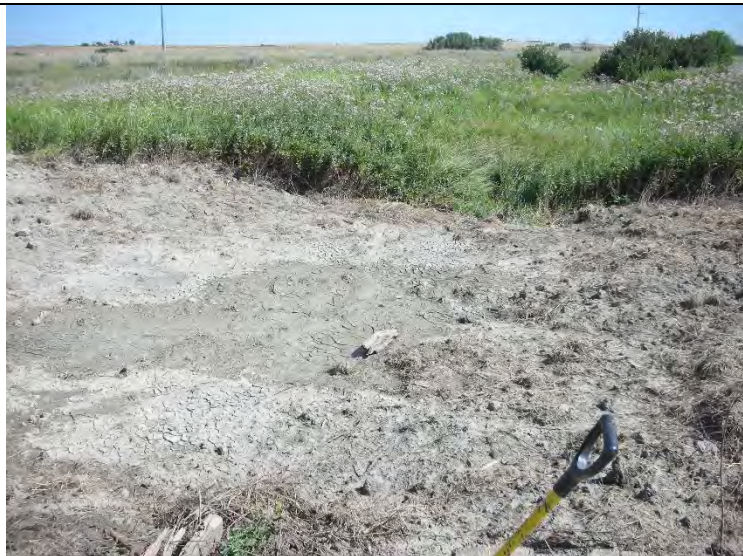
Observation Point: 2752ne

Photo Description: overlooking area that was open trenched through wetland.

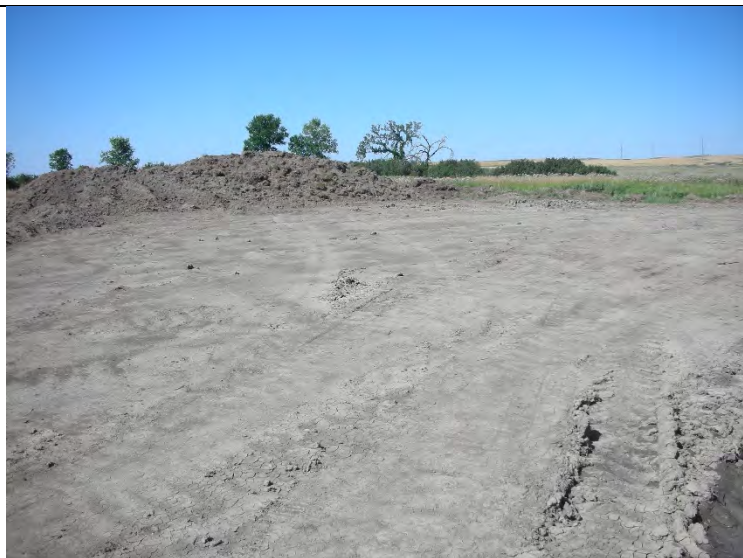
Observation Point: 2753w

Photo Description: Topsoil stockpile and HDD workspace near Cherry Creek.

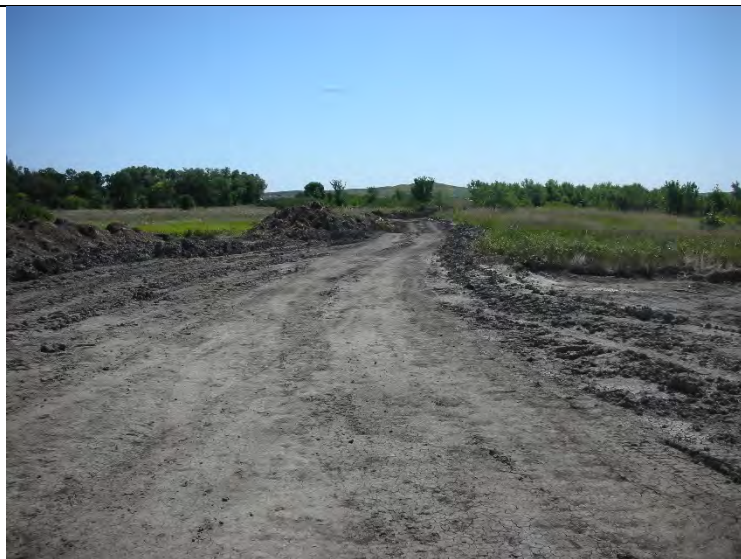
Observation Point: 2754se

Photo Description: Cherry Creek HDD access road.

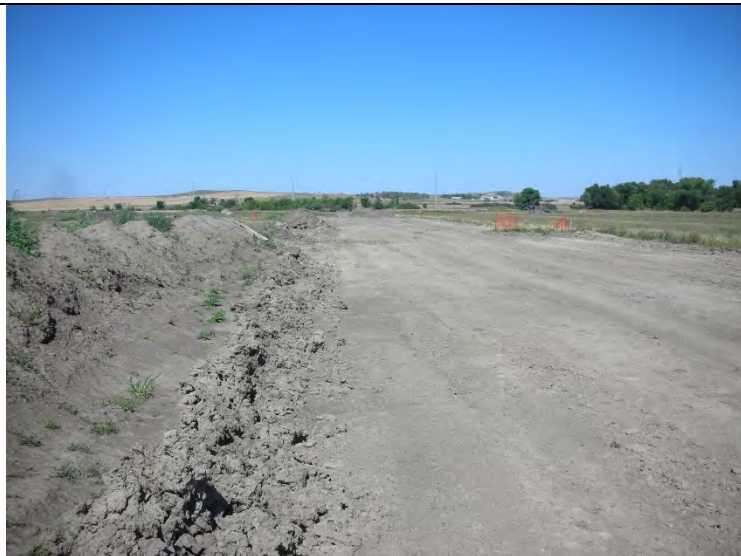
Observation Point: 2755nw

Photo Description: Overlooking backfilled ROW. Awaiting final topsoil redistribution.

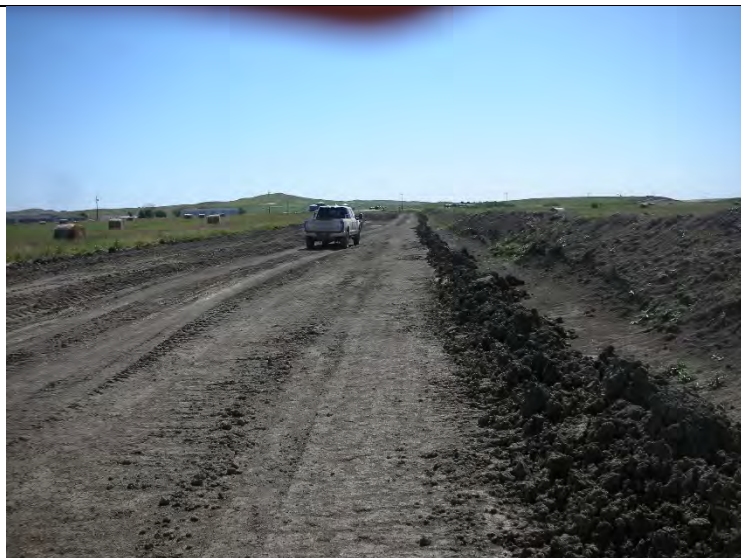
Observation Point: 2756se

Photo Description: Overlooking backfilled ROW. Awaiting final topsoil redistribution.

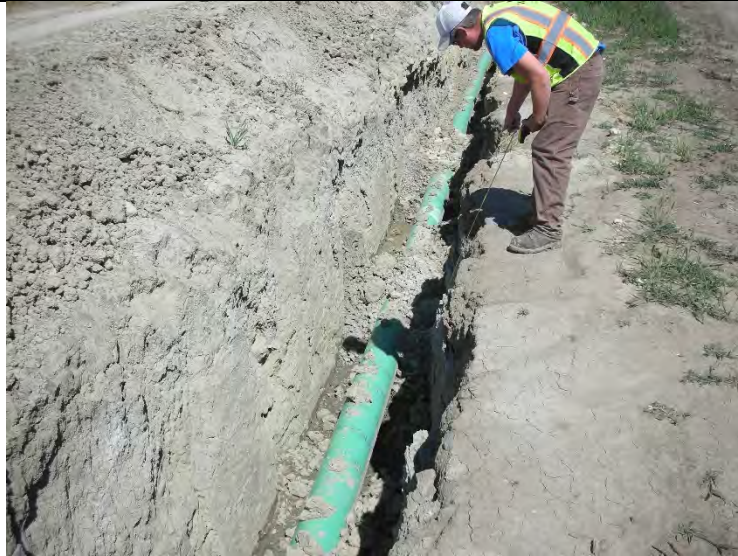
Observation Point: 2757

Photo Description: Pipe measured at 64-inches near Demicks Lake tie-in. Appropriately no topsoil in trench profile.

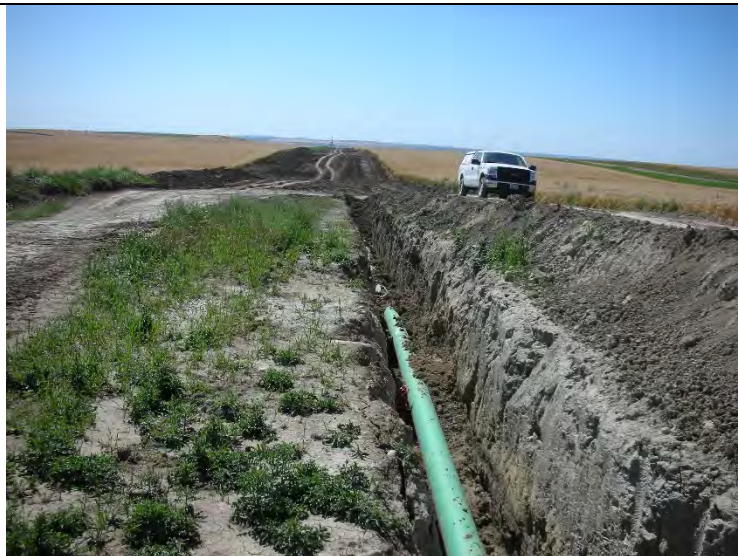
Observation Point: 2758n

Photo Description: Overlooking trenching near the Demicks Lake pipeline tie-in.

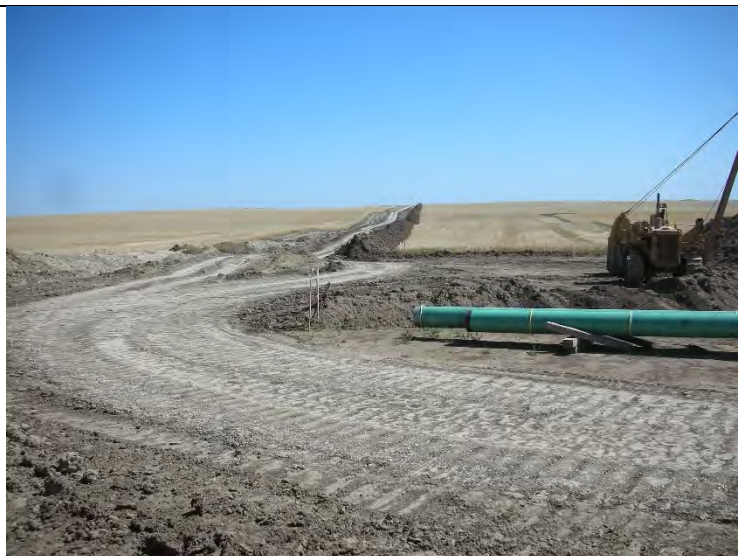
Observation Point: 2759e

Photo Description: Overlooking Demicks Lake pipeline tie-in. Looks good.
