**PU-19-85
ONEOK Bakken Pipeline, LLC.
Little Missouri Lateral, 12-inch NGL
Reclamation Inspection Report**

File No. 227701275

September 2021

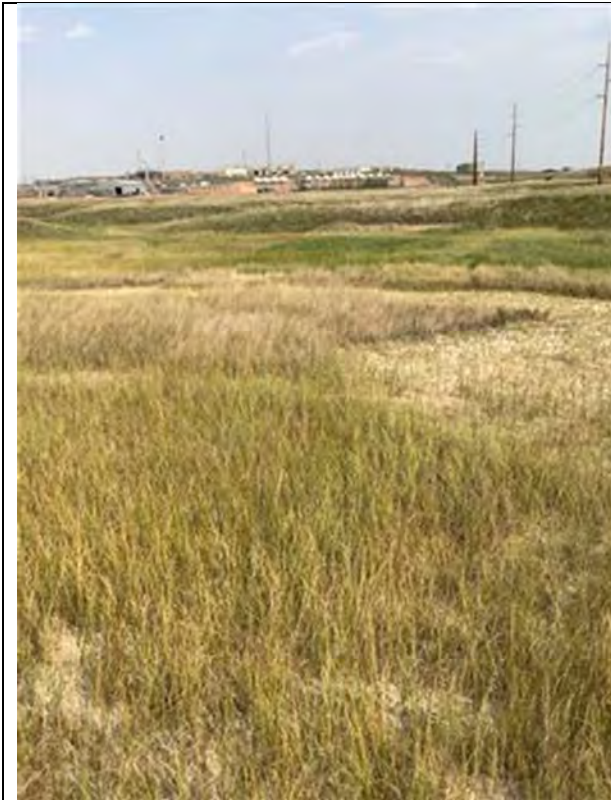
Observation Point: 9060001
Date Taken: September 6, 2021 3:58 PM
Direction Photo is Taken: East

Photo Description: Vegetation conditions similar inside and outside of ROW.

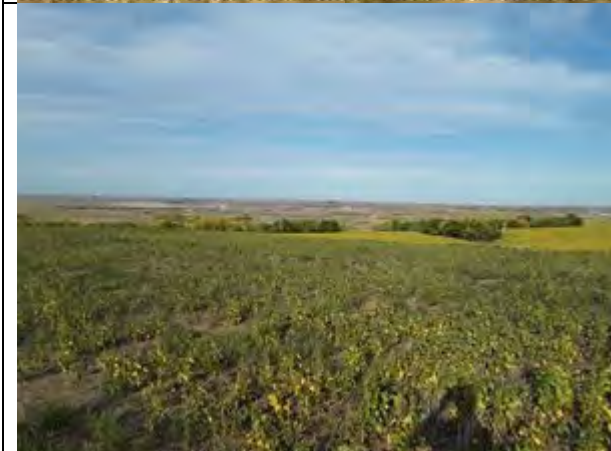
Observation Point: 9080001
Date Taken: September 8, 2021 6:08 PM
Direction Photo is Taken:

Photo Description: Might need to revisit about weed control on hilltop. heavy presence of kochia with stunted or chopped soybeans. Poor crop compared to surrounding plants, bare soil appeared lacking in organic matter.

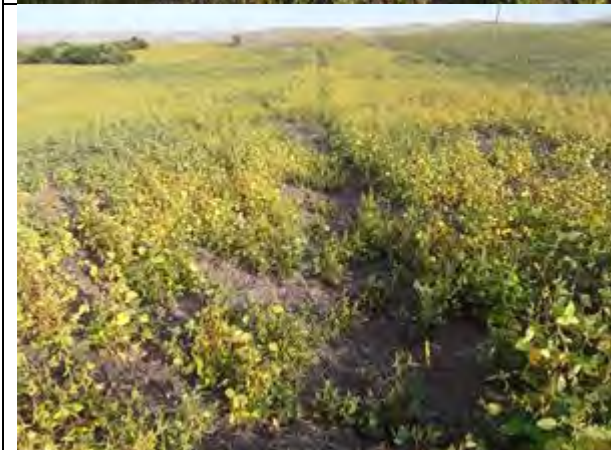
Observation Point: 9080002
Date Taken: September 8, 2021 6:05 PM
Direction Photo is Taken: Southeast

Photo Description: Subsidence present in soybean ROW.

Exposed subsoil was observed at several locations throughout the ROW. Stantec recommends the PSC inquire about these areas with ONEOK. Adding topsoil or soil biological amendments could be possible methods to improve the organic matter content and improve vegetative restoration.

Soil decompaction at select areas could mitigate the adverse impacts to soil quality that resulted in reduced vegetation growth and could result in increased runoff from the ROW. Landowners producing crops in the compacted portions of the ROW soil may experience declined crop yields due to poor root penetration. ONEOK should coordinate with the landowner(s) on possible ways to address these areas noted through either tillage, cover crops, or other methods.

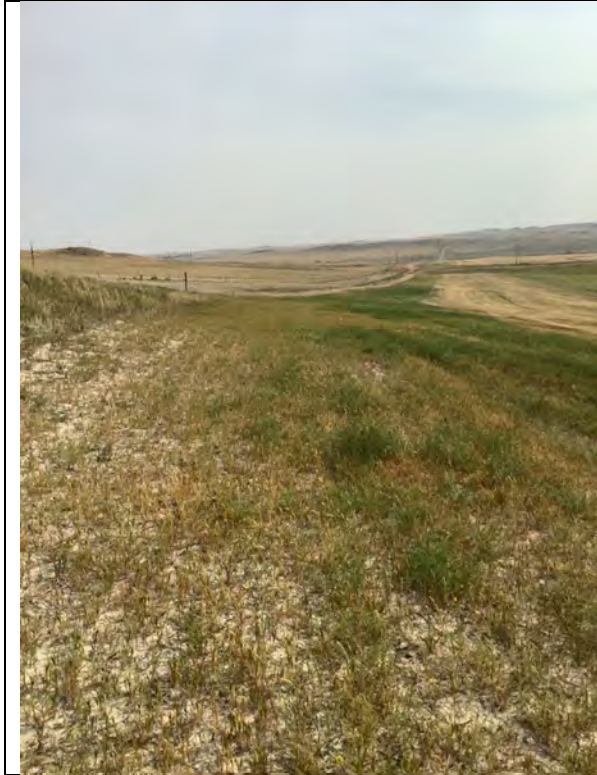
Observation Point: 9060002
Date Taken: September 6, 2021 4:30 PM
Direction Photo is Taken: South

Near **Observation Point 9060002**, a slope cut in the ROW near a sectional road was observed to be largely unvegetated. Stantec noted a lack of topsoil and visible subsoil on the surface. **Observation Point 9080009** contained possible minor surface subsidence and compaction in the ROW. Lastly, annual weeds, primarily kochia and prickly Russian thistle (*Kali tragus*), were observed in hay lands with kochia frequently being the most dominant species within the ROW.

Photo Description: Slope cut still visible. Areas with sparse vegetation are due to lack of topsoil and subsoil contact.

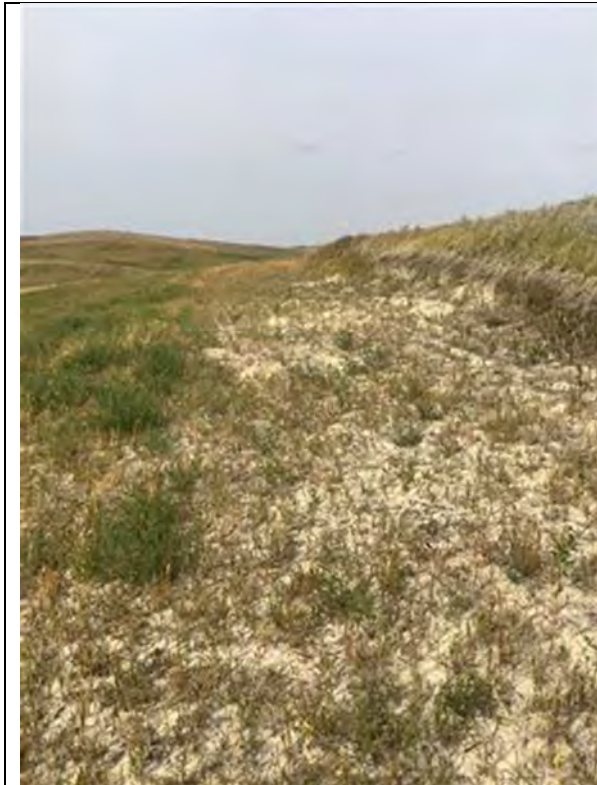
Observation Point: 9060002
Date Taken: September 6, 2021 3:58 PM
Direction Photo is Taken: North

Photo Description: Vegetation conditions similar inside and outside of ROW.

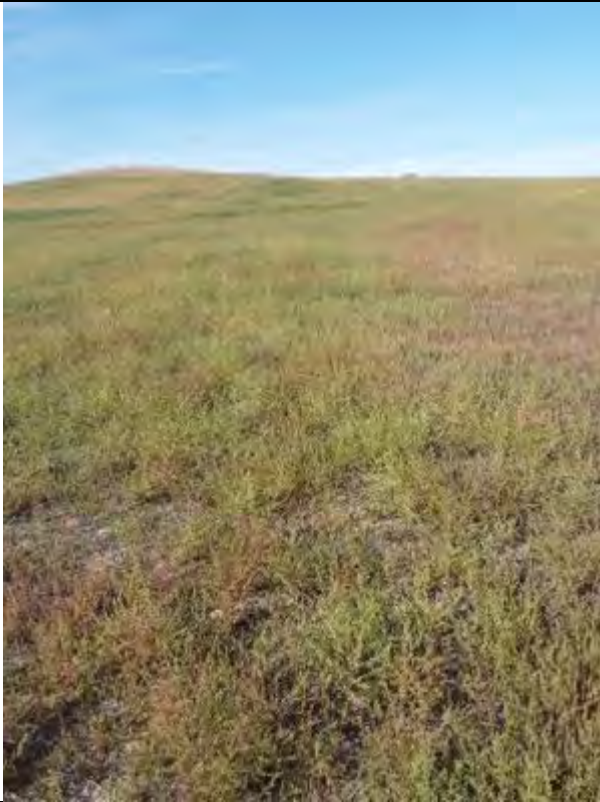
Observation Point: 9080007

Photo Description: Minimal bare ground and no erosion. Species observed: yellow sweetclover, kochia, green foxtail.

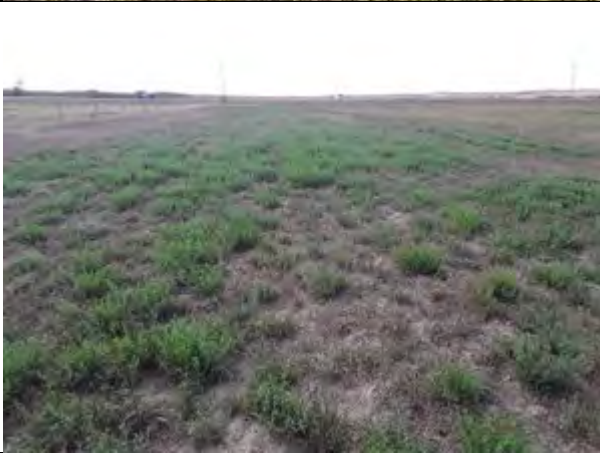
Observation Point: 9080008

Photo Description: Alfalfa and grass cover mix, some bare topsoil present. Also crested and slender wheatgrass, kochia present. Reclamation achieved very similar to surrounding hay land.
